Asbestos Containing Materials Inspection

Good Faith Inspection

August 6, 2024

- Prepared For: City of Puyallup 333 S Meridian Puyallup, WA 98371
- Project: 1702 13th St. SE Puyallup, WA 98371
- RE: Pre-Demolition Good Faith Asbestos Survey

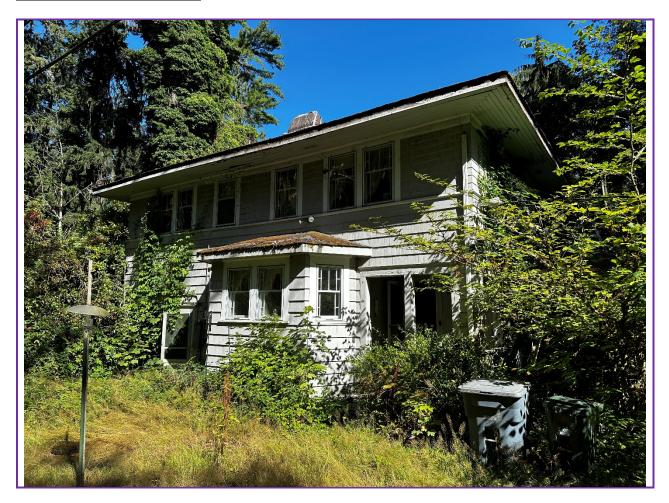
FRONT OF STRUCTURE

The main structure is a wood framed, 2 story single family residence approx. 2,288SF with a 900SF basement. To the south of the house there are 2 wood framed single story garages. Year Built: 1920

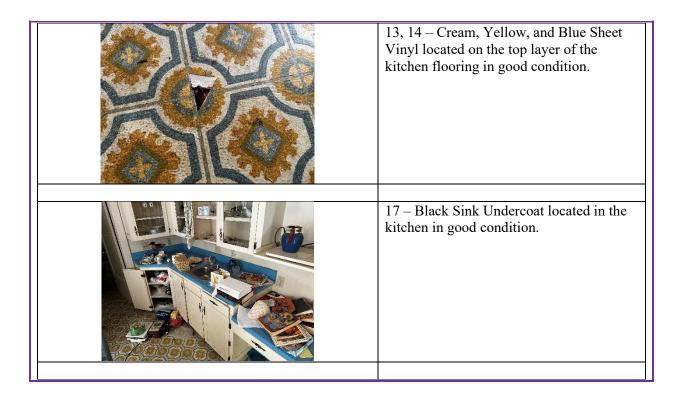
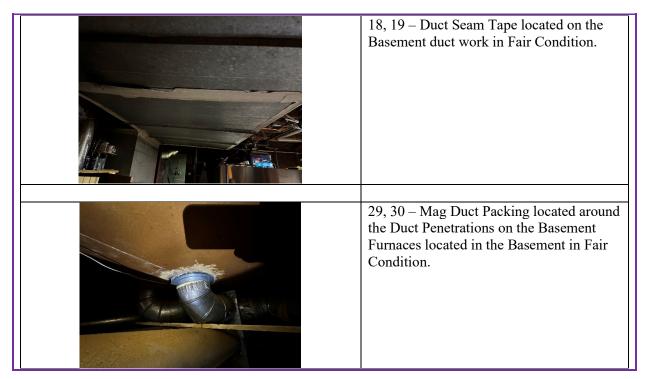
Sample #	Material Description	Sample Location	Friability / Condition / Category	Lab Result	Quantity
13, 14	Cream, Yellow and Blue Sheet Vinyl	Top Layer-Kitchen	NF / Good	15% Chrysotile /PACM	200SF
17	Sink Undercoat	Small Kitchen Sink	NF / Good	3% Chrysotile	1 EA
18, 19	Duct Seam Tape	Basement Duct Work	NF / Fair	55% Chrysotile / PACM	80 LF
29, 30	Mag Duct Packing	Around Duct Penetrations on Basement Furnace	F / Fair	60% Chrysotile / PACM	4 SF

3 Kings Environmental, Inc. recommends that any ACM or PACM to be impacted during the course of the renovation or demolition be removed by a licensed, bonded, and insured asbestos abatement firm. Removal and disposal of asbestos containing materials should only be performed by certified firms following all local, state, and federal guidelines. Should materials not noted in this report be discovered during the course of the work, stop all demolition and have the newly discovered materials tested for asbestos or treat the materials as an asbestos containing material. Be sure to notify the governing authorities and clean-air agencies prior to disturbing materials over the recordable limits.
