# GOOD FAITH ASBESTOS SURVEY

Date Performed: 9/23/2020

Cornforth Building  
115 2nd St. SE  
Puyallup, WA 98371

City of Puyallup  
1201 4th St. NW  
Puyallup, WA 98371

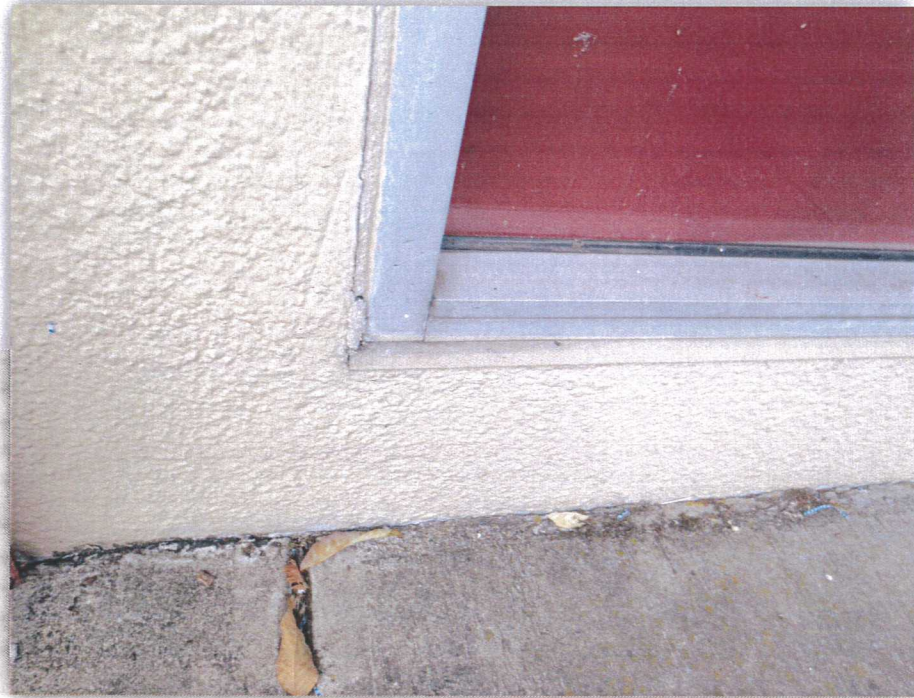
- Glazing associated with most of the windows (Sample #'s **CJ-01 & 02**). Point count analysis was performed that brings the asbestos content to less than 1% asbestos for both samples.

| Sample ID | Collected | Cust. ID | Location | Asbestos Fibers | Other Materials |
|---|---|---|---|---|---|
| Layer 1: Window Glazing<br>White/Gray, Granular, Homogenous | | | | 0.50% CHRYSOTILE | 99.50% NON FIBROUS MATERIAL |

| Sample ID | Collected | Cust. ID | Location | Asbestos Fibers | Other Materials |
|---|---|---|---|---|---|
| Layer 1: Window Glazing<br>White/Gray, Granular | | | | 2% CHRYSOTILE | 98% NON FIBROUS MATERIAL |

Photo 1: Window Glazing

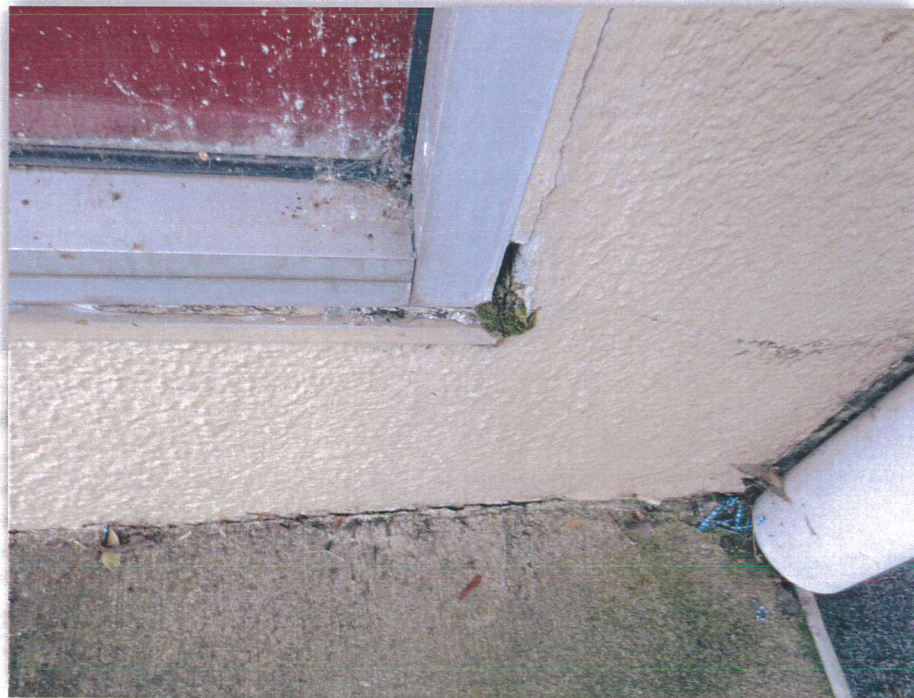
| Sample ID | Collected | Cust. ID | Location | Asbestos Fibers | Other Materials |
|---|---|---|---|---|---|
| Layer 1: Window Glazing<br>Gray, Granular, Homogenous | | | | 0.75% CHRYSOTILE | 99.25% NON FIBROUS MATERIAL |

| Sample ID | Collected | Cust. ID | Location | Asbestos Fibers | Other Materials |
|---|---|---|---|---|---|
| Layer 1: Window Glazing<br>Gray, Granular | | | | 2% CHRYSOTILE | 98% NON FIBROUS MATERIAL |

Photo 2: Window Glazing

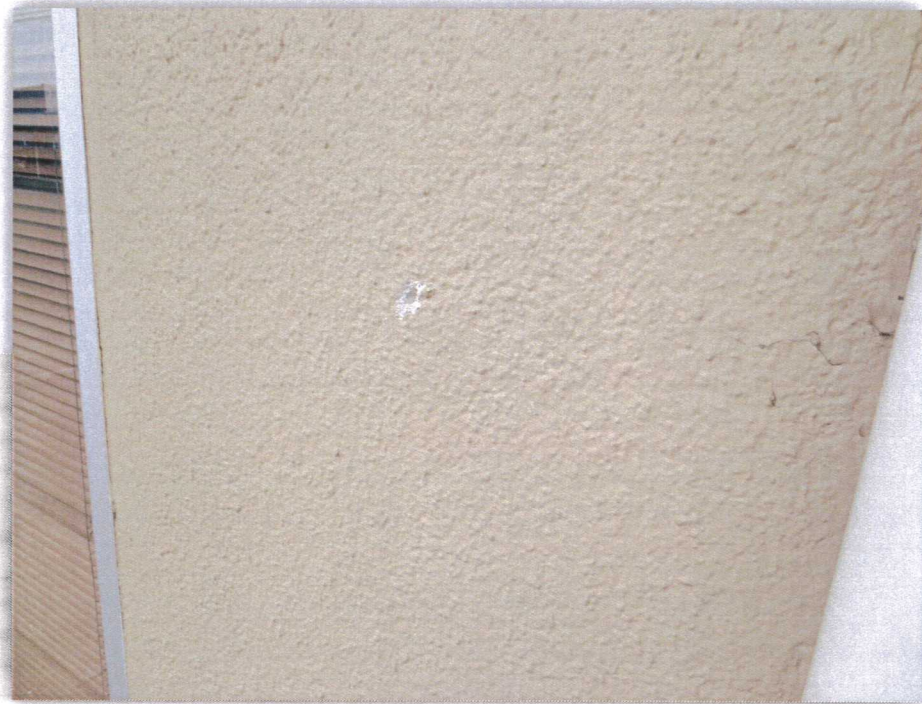
| Sample ID | Collected | Cust. ID | Location | Asbestos Fibers | Other Materials |
|---|---|---|---|---|---|
| Layer 1: Stucco<br>Tan/Gray, Granular | | | | None Detected | 100% NON FIBROUS MATERIAL |

Photo 3: Stucco

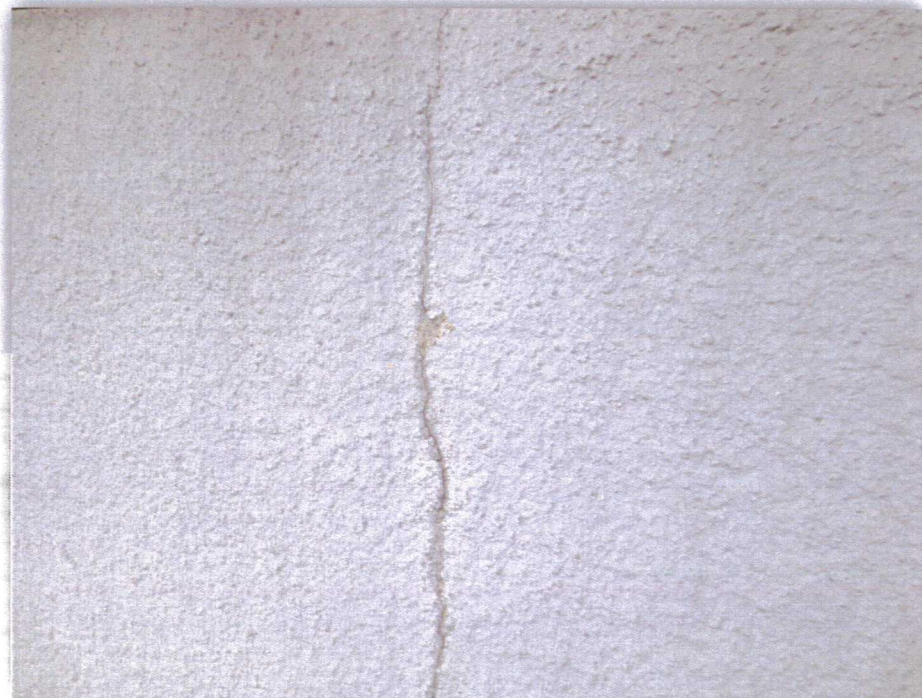
| Sample ID | Collected | Cust. ID | Location | Asbestos Fibers | Other Materials |
|---|---|---|---|---|---|
| Layer 1: Stucco<br>Beige, Granular | | | | <1% CHRYSOTILE | 100% NON FIBROUS MATERIAL |

Photo 4: Stucco

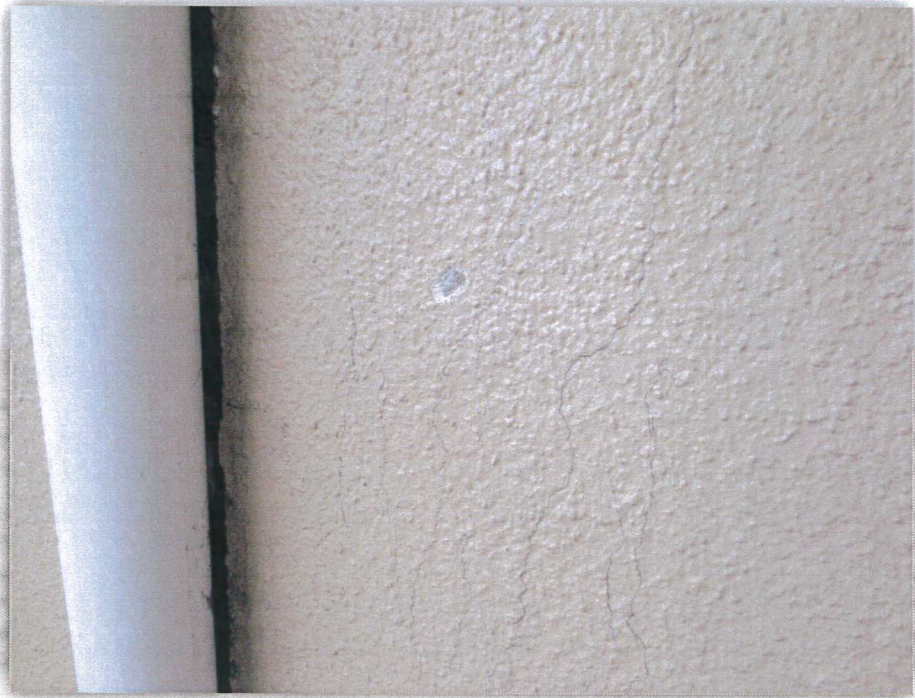
| Sample ID | Collected | Cust. ID | Location | Asbestos Fibers | Other Materials |
|---|---|---|---|---|---|
| Layer 1: Stucco<br>Beige, Granular | | | | <1% CHRYSOTILE | 100% NON FIBROUS MATERIAL |

Photo 5: Stucco

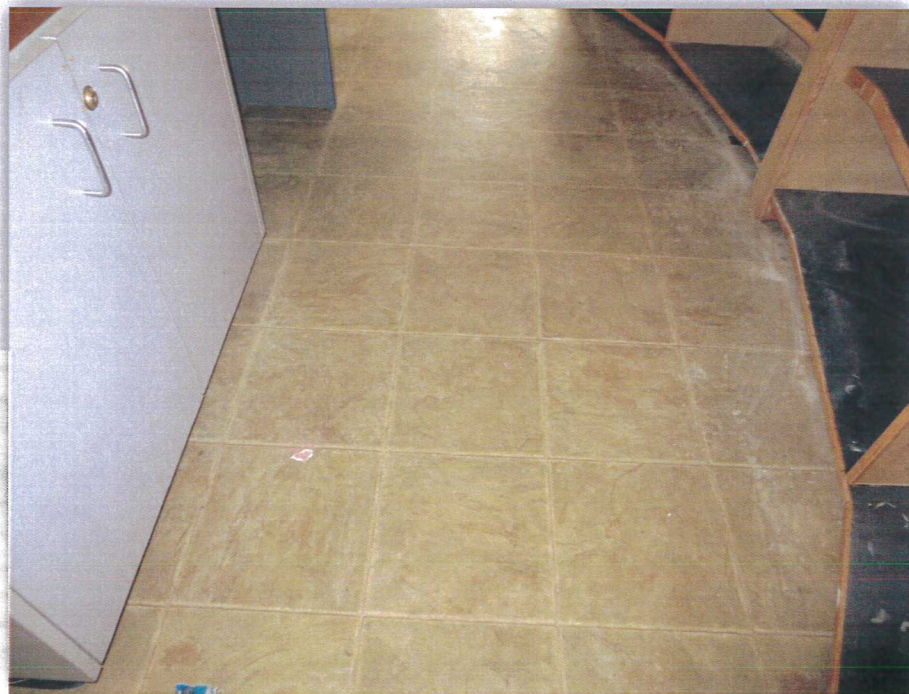
| Sample ID | Collected | Cust. ID | Location | Asbestos Fibers | Other Materials |
|---|---|---|---|---|---|
| Layer 1: Sheet Vinyl<br>Gray, Org.Bound/Fibrous | | | | None Detected | 35% CELLULOSE FIBER<br>15% MINERAL/GLASS WOOL<br>50% NON FIBROUS MATERIAL |

Photo 6: Grey Square Patterned Sheet Vinyl

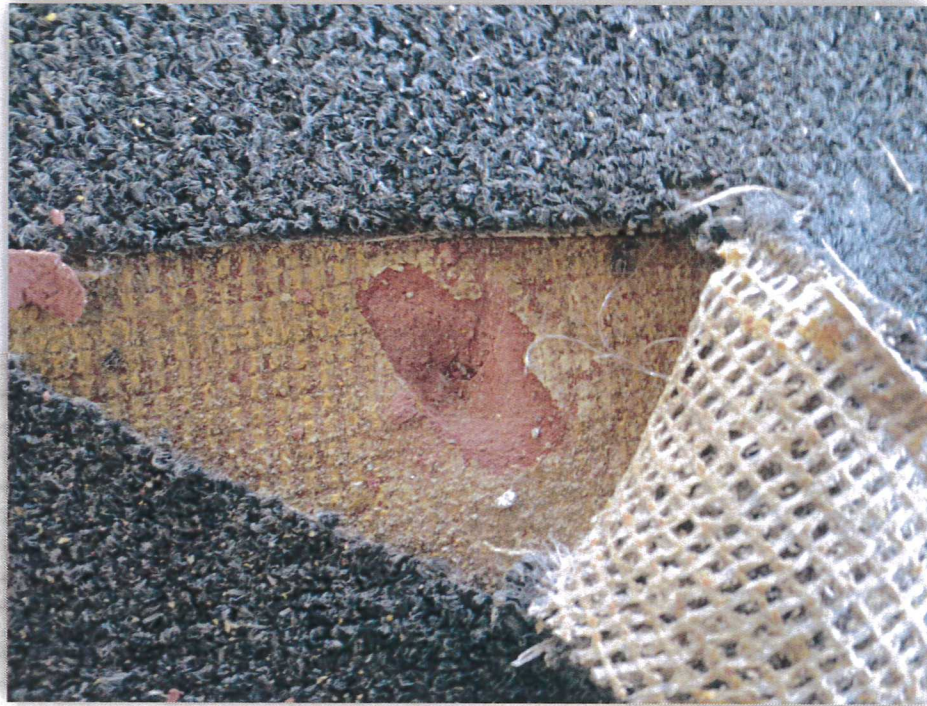
| Sample ID | Collected | Cust. ID | Location | Asbestos Fibers | Other Materials |
|---|---|---|---|---|---|
| Layer 1: Flooring<br>Red, Organically Bound, Homogenous | | | | 0.50% CHRYSOTILE | 99.50% NON FIBROUS MATERIAL |

| Sample ID | Collected | Cust. ID | Location | Asbestos Fibers | Other Materials |
|---|---|---|---|---|---|
| Layer 1: Flooring<br>Red, Organically Bound | | | | 2% CHRYSOTILE | 98% NON FIBROUS MATERIAL |

Photo 7: Red Flooring Underlayment

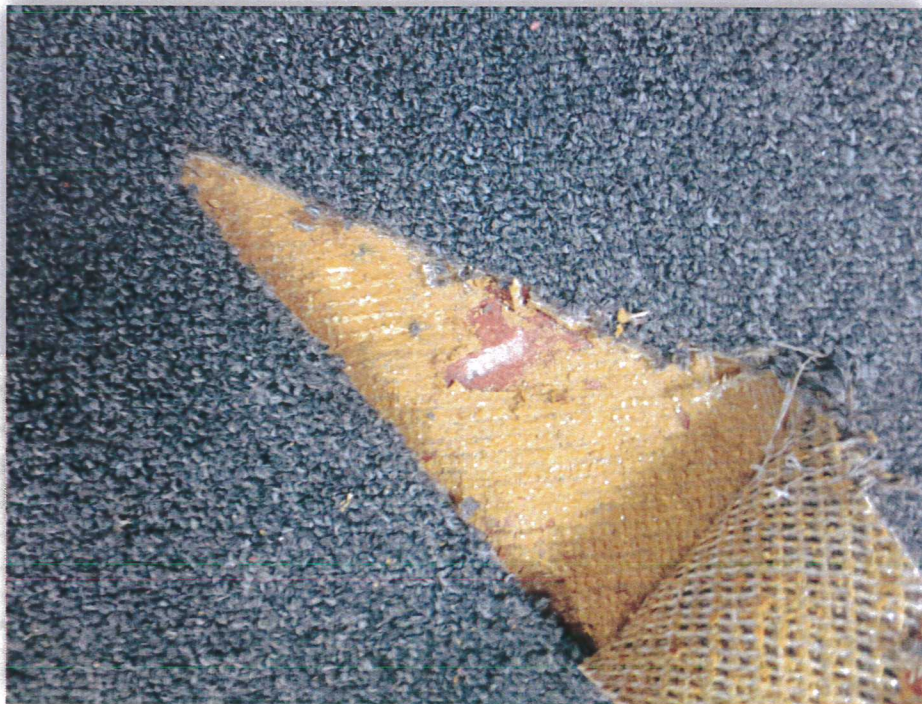
Photo 8: Yellow Carpet Glue

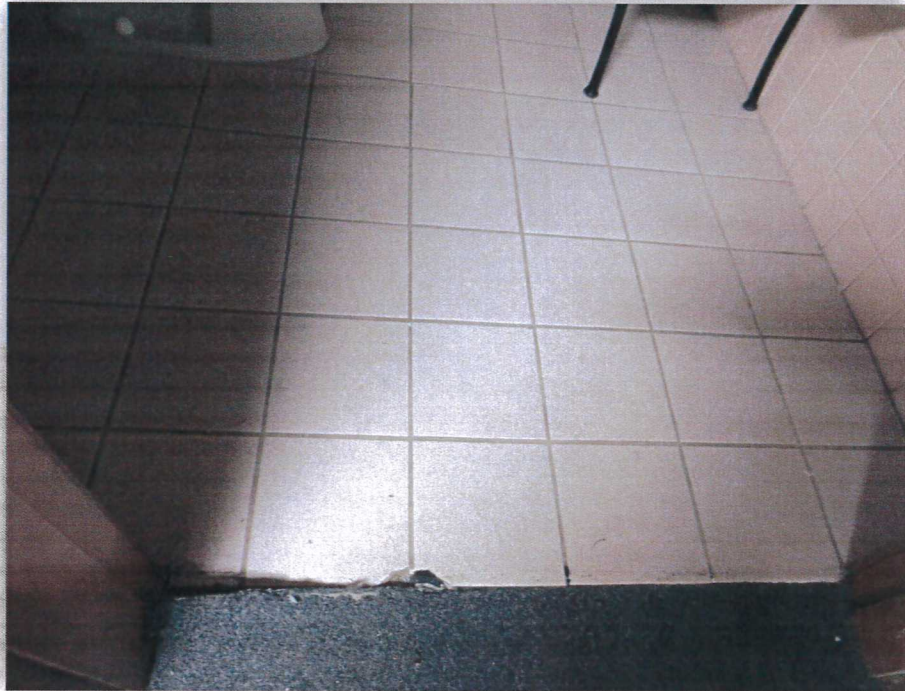
Photo 9: Ceramic Tile Grout

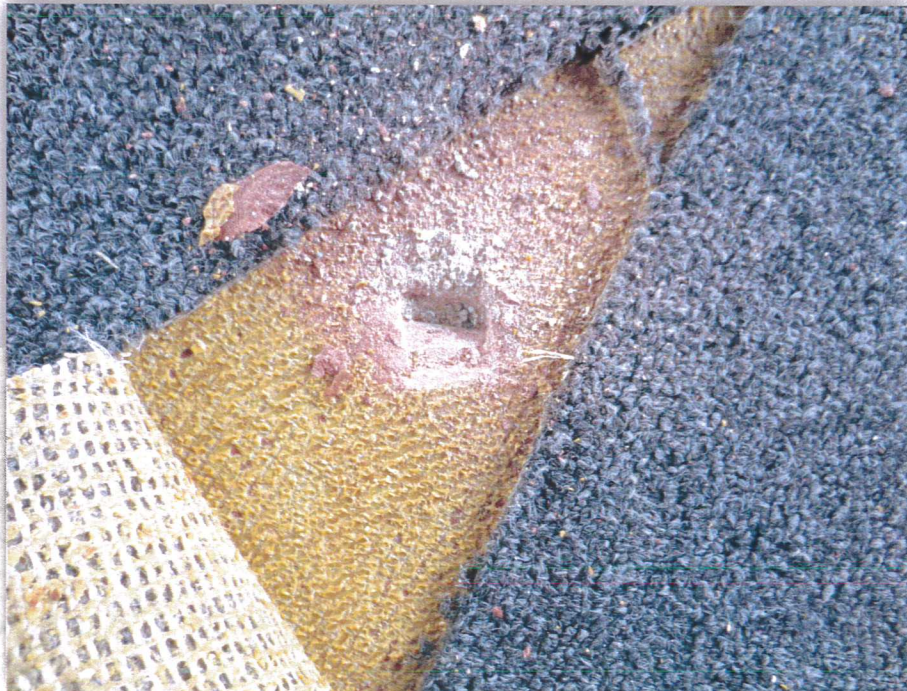
| Sample ID | Collected | Cust. ID | Location | Asbestos Fibers | Other Materials |
|---|---|---|---|---|---|
| Layer 1: Flooring<br>Red, Organically Bound, Homogenous | | | | 0.50% CHRYSOTILE | 99.50% NON FIBROUS MATERIAL |

Photo 10: Red Flooring Underlayment

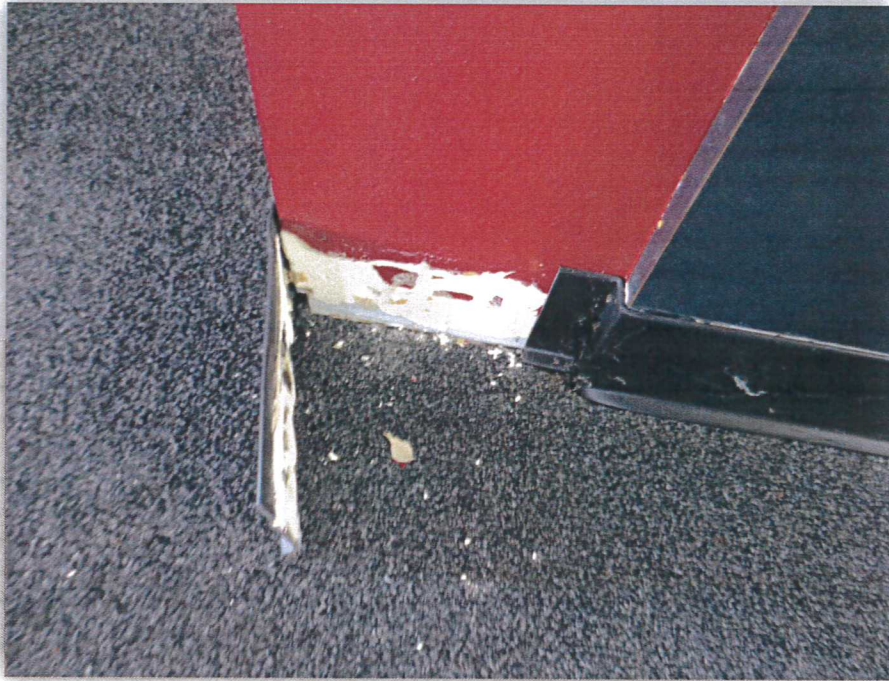
Photo 11: Cove Base Mastic

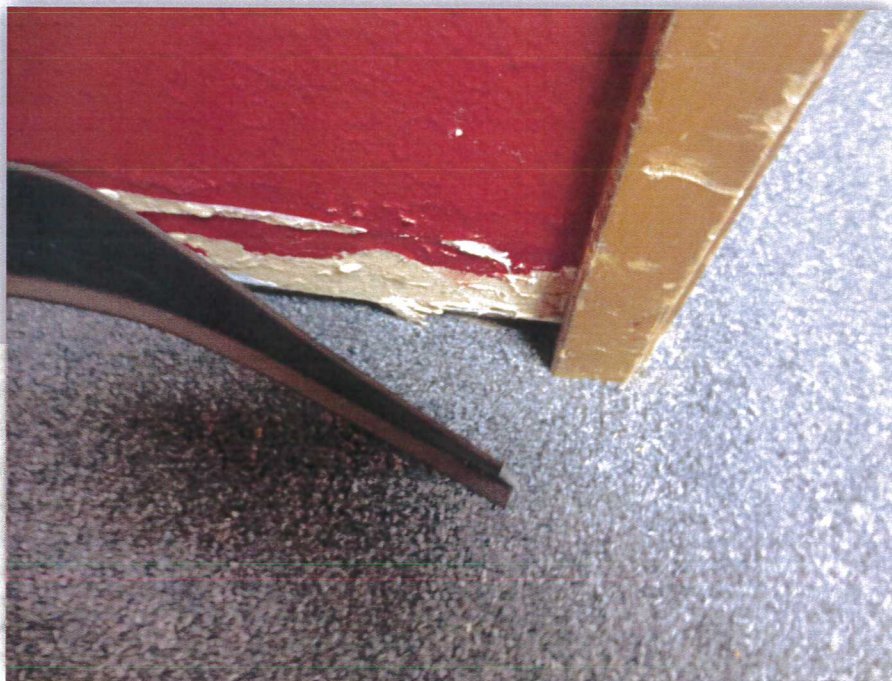
Photo 12: Cove Base Mastic

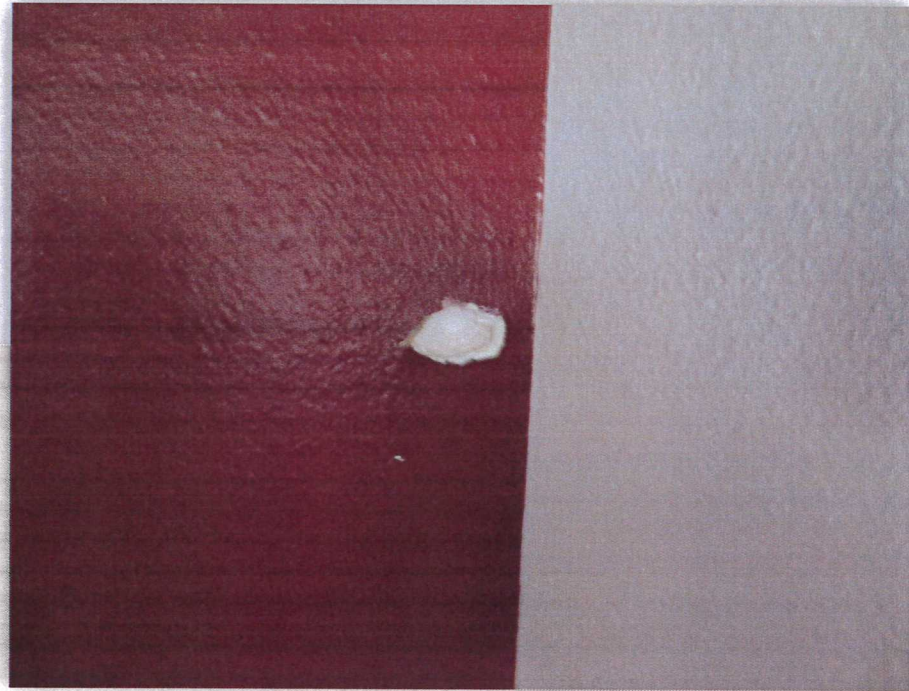
Photo 13: Joint Compound and Drywall

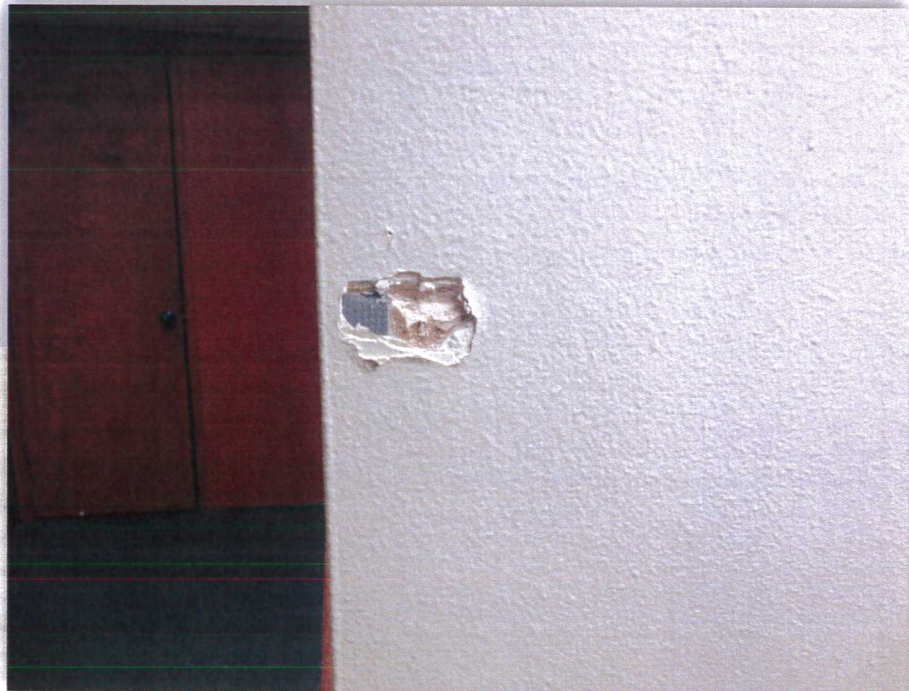
Photo 14: Joint Compound and Drywall

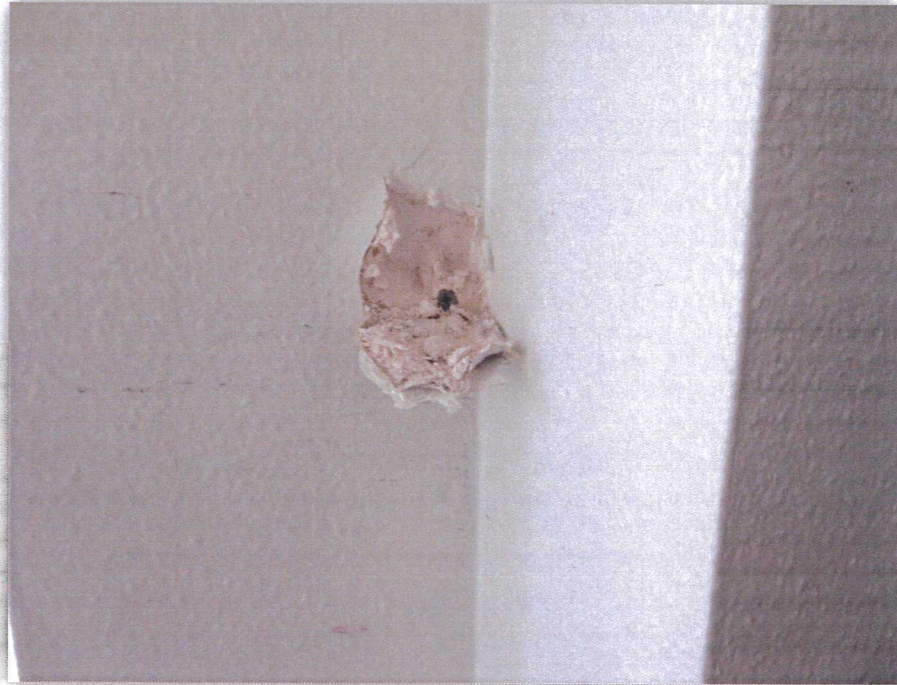
Photo 15: Joint Compound and Drywall

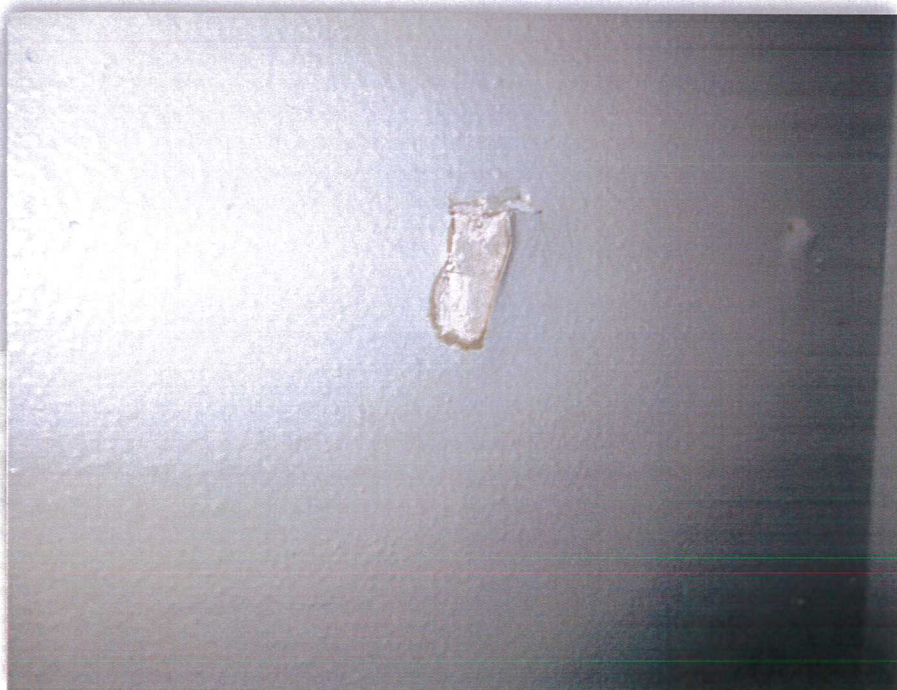
Photo 16: Orange Peel Wall Texture

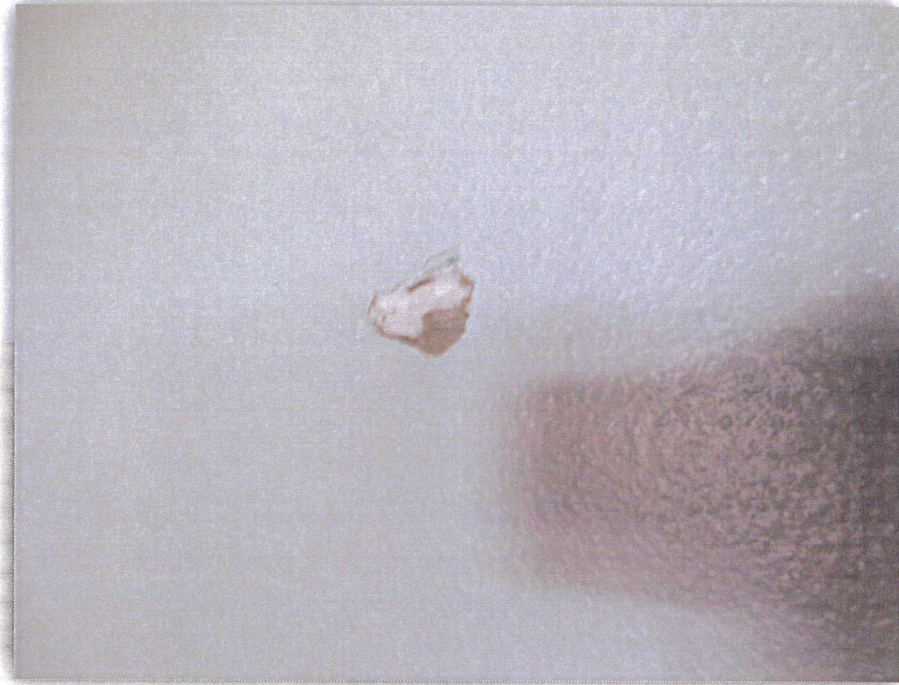
Photo 17: Orange Peel Wall Texture

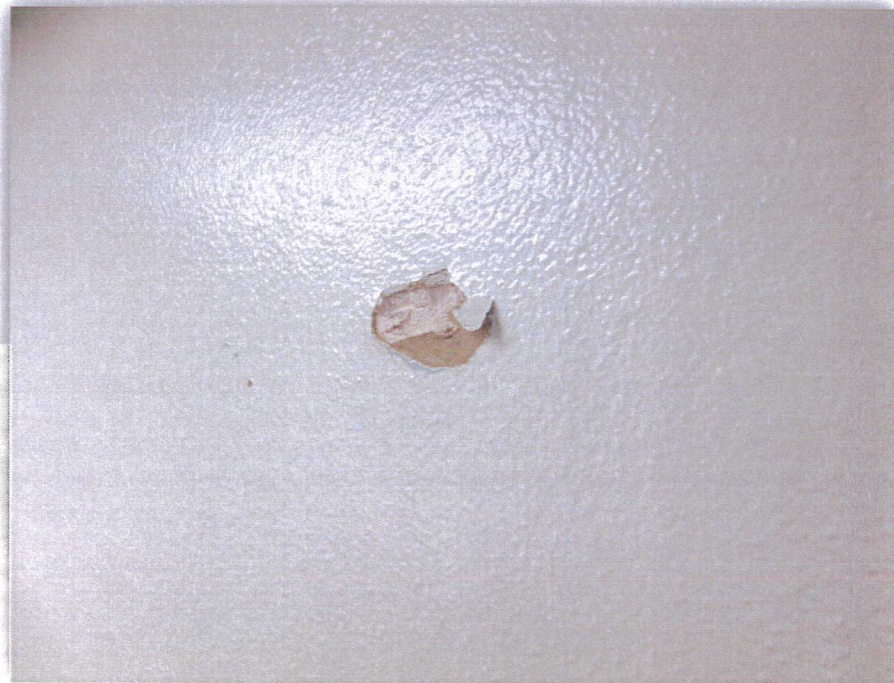
Photo 18: Orange Peel Wall Texture

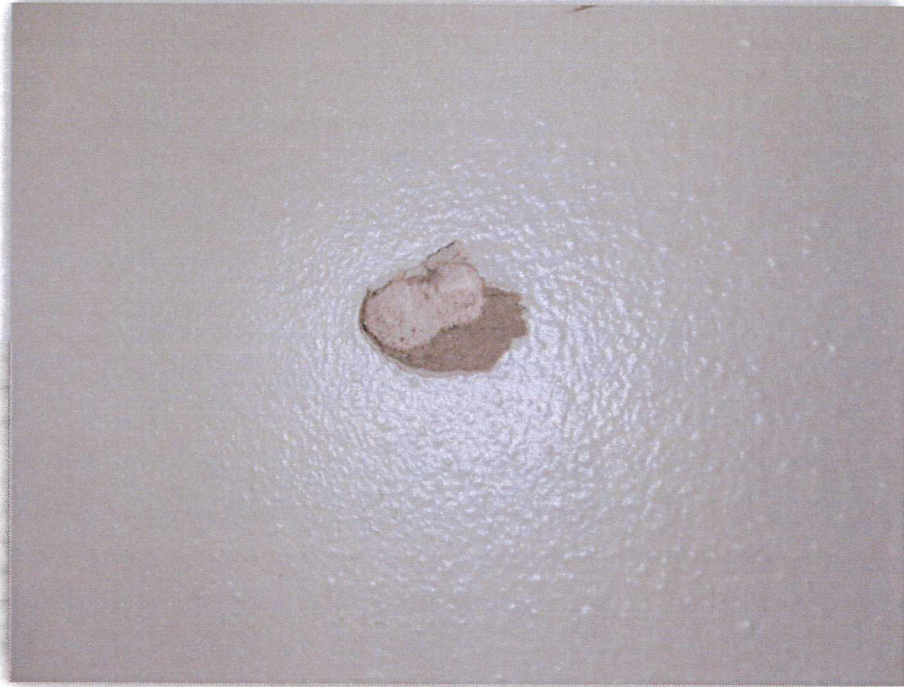
Photo 19: Orange Peel Wall Texture

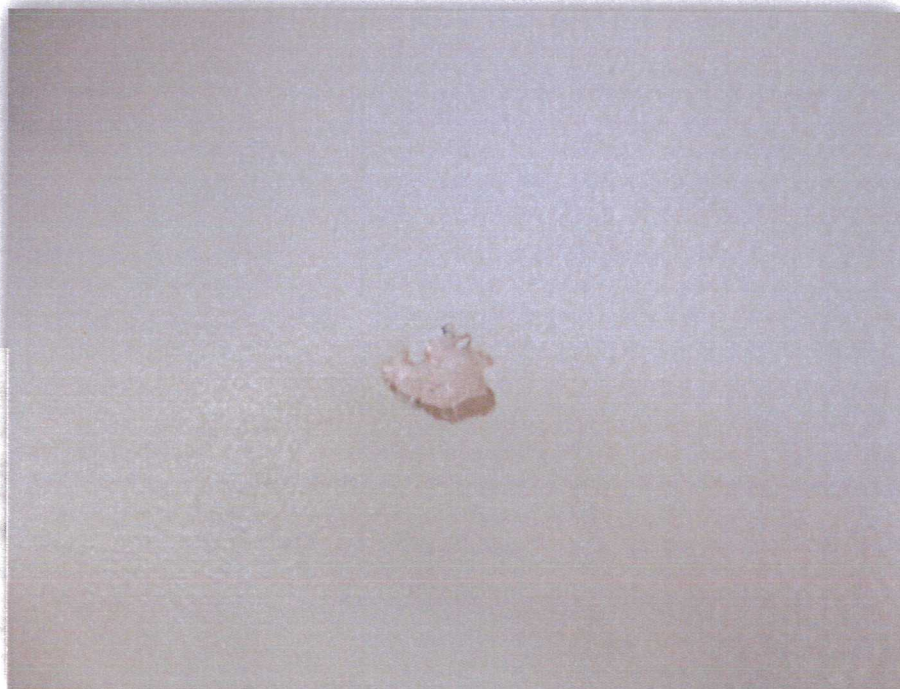
Photo 20: Orange Peel Wall Texture

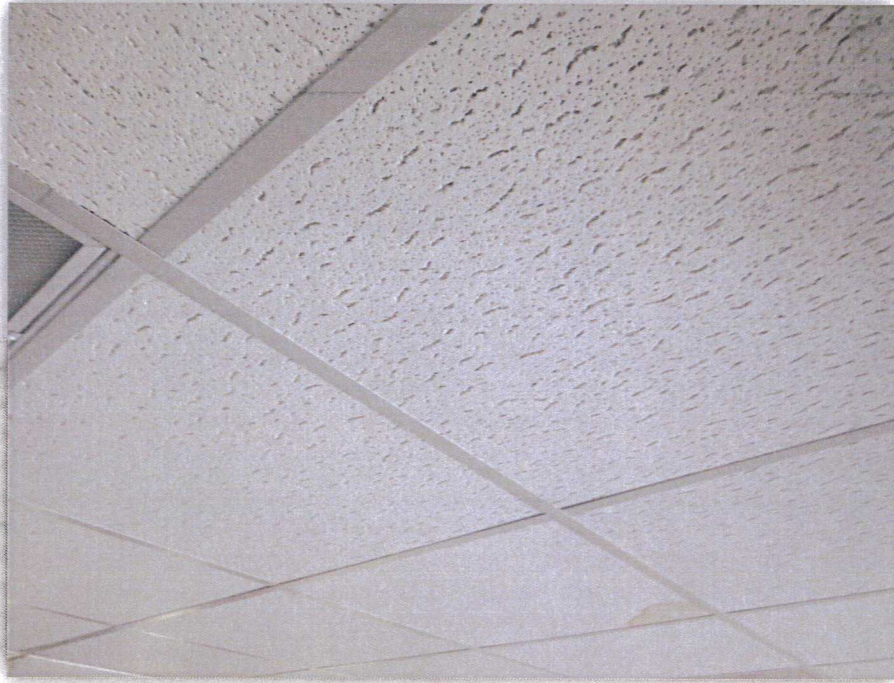
Photo 21: White Suspended Ceiling Tile

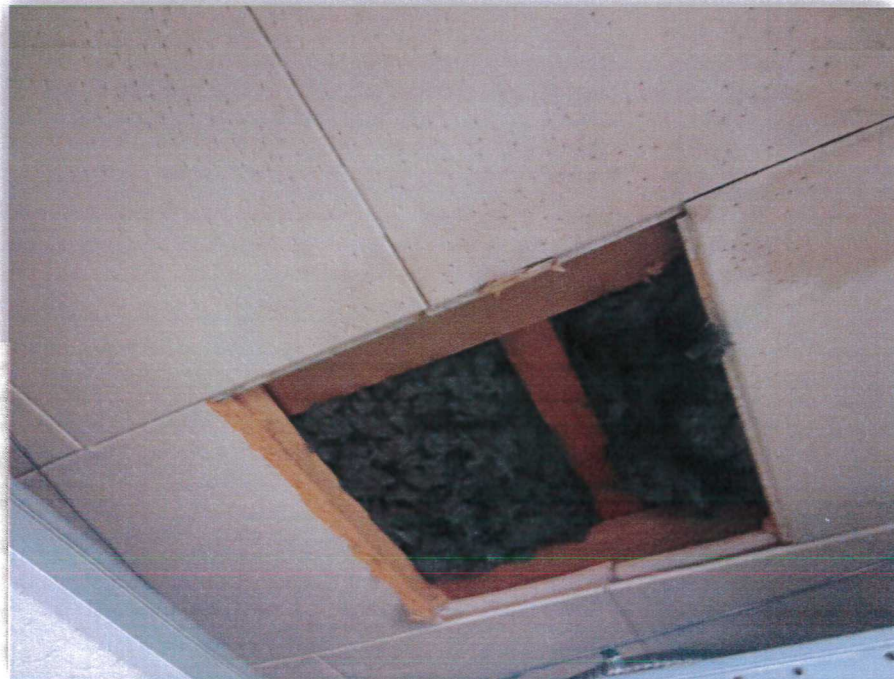
Photo 22: White Stapled on 12x12 Ceiling Tile

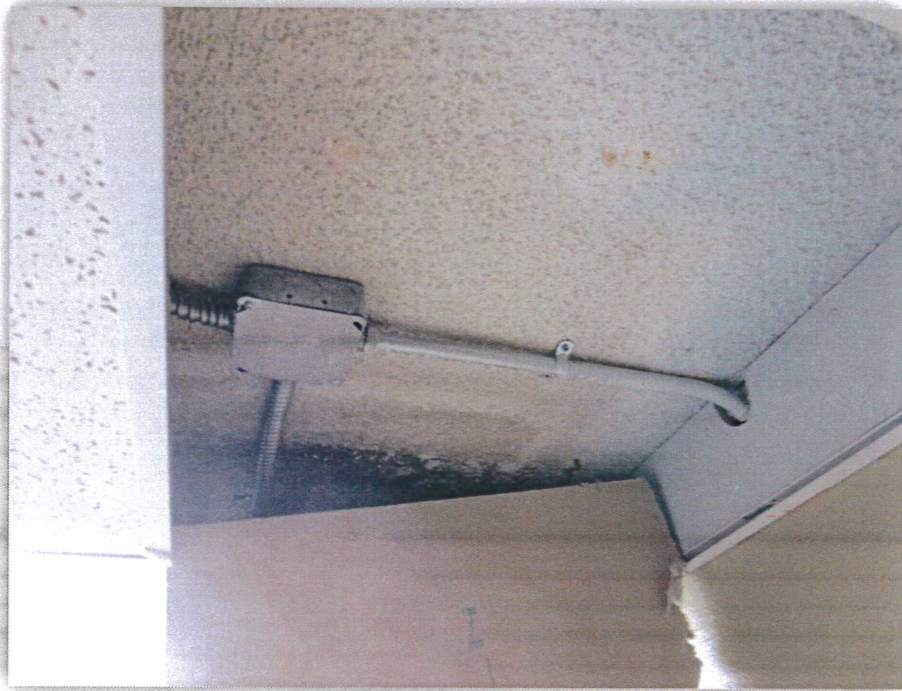
- Popcorn ceiling texture located above the drop ceiling in the back half of the retail area (Sample #'s **CJ-23, 24 & 25**). Point count analysis was performed that brings the asbestos content to less than 1% asbestos for all three samples.

| Sample ID | Collected | Cust. ID | Location | Asbestos Fibers | Other Materials |
|---|---|---|---|---|---|
| Layer 1: Popcorn Ceiling<br>White, Granular, Homogenous | | | | 0.75% CHRYSOTILE | 99.25% NON FIBROUS MATERIAL |

Photo 23: Popcorn Ceiling Texture

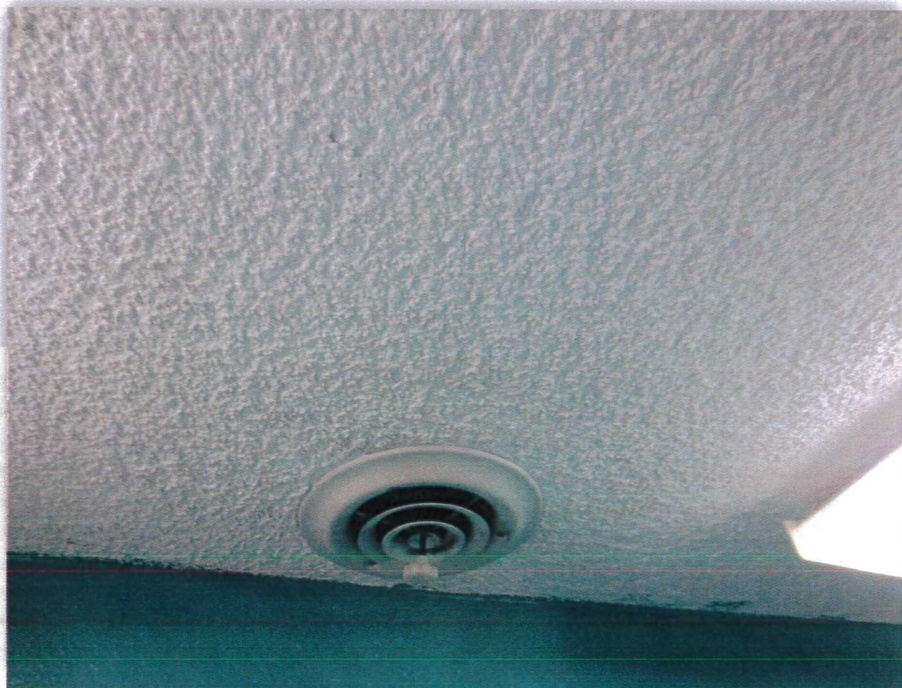
| Sample ID | Collected | Cust. ID | Location | Asbestos Fibers | Other Materials |
|---|---|---|---|---|---|
| Layer 1: Popcorn Ceiling<br>White, Granular, Homogenous | | | | 0.50% CHRYSOTILE | 99.50% NON FIBROUS MATERIAL |

Photo 24: Popcorn Ceiling Texture

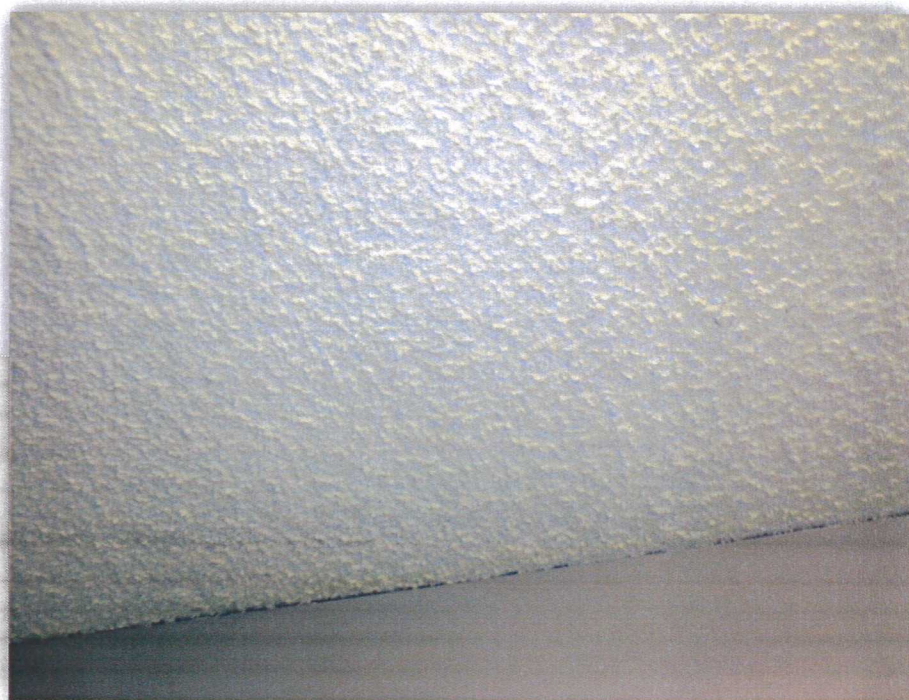
| Sample ID | Collected | Cust. ID | Location | Asbestos Fibers | Other Materials |
|---|---|---|---|---|---|
| Layer 1: Popcorn Ceiling<br>White, Granular, Homogenous | | | | 0.50% CHRYSOTILE | 99.50% NON FIBROUS MATERIAL |

Photo 25: Popcorn Ceiling Texture

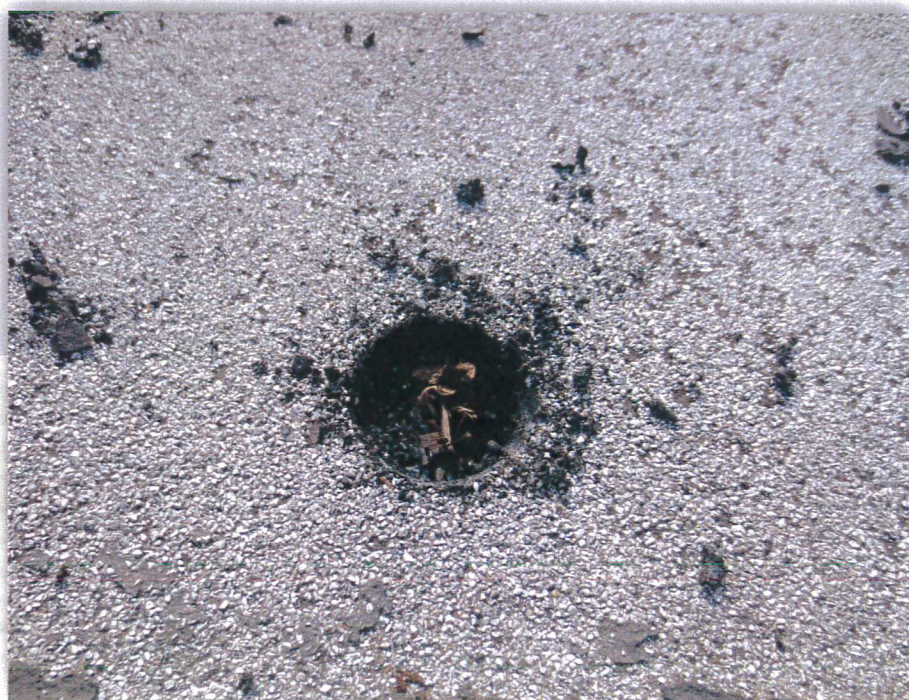
Photo 26: Built Up Roofing

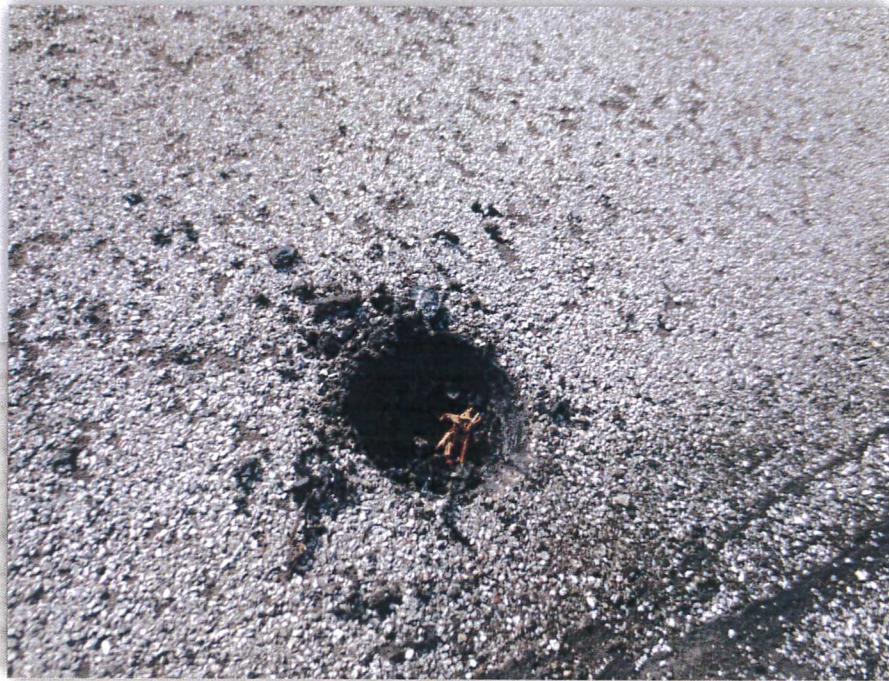
Photo 27: Built Up Roofing

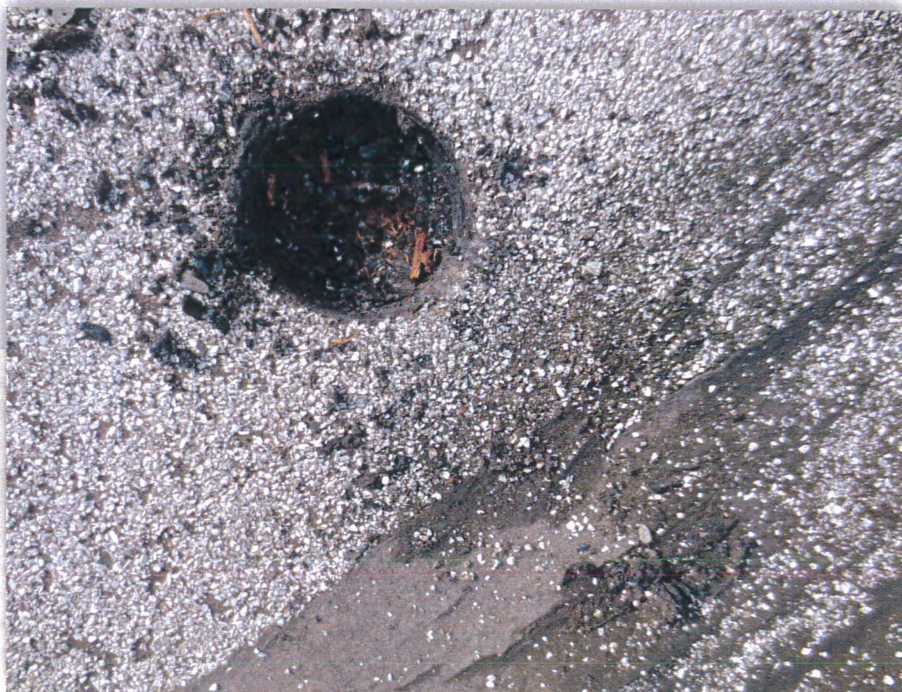
Photo 28: Built Up Roofing

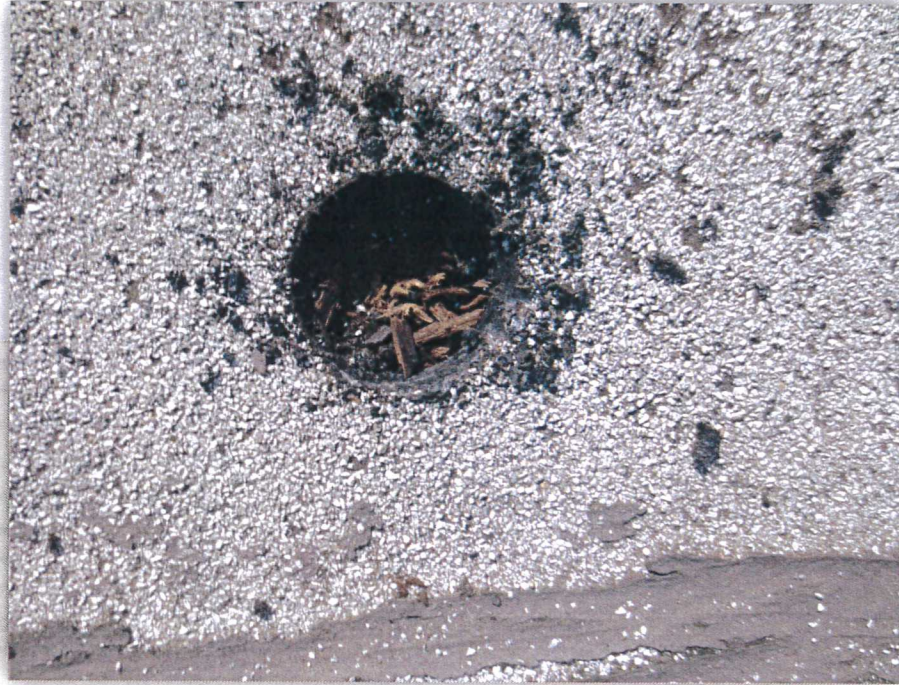
Photo 29: Built Up Roofing

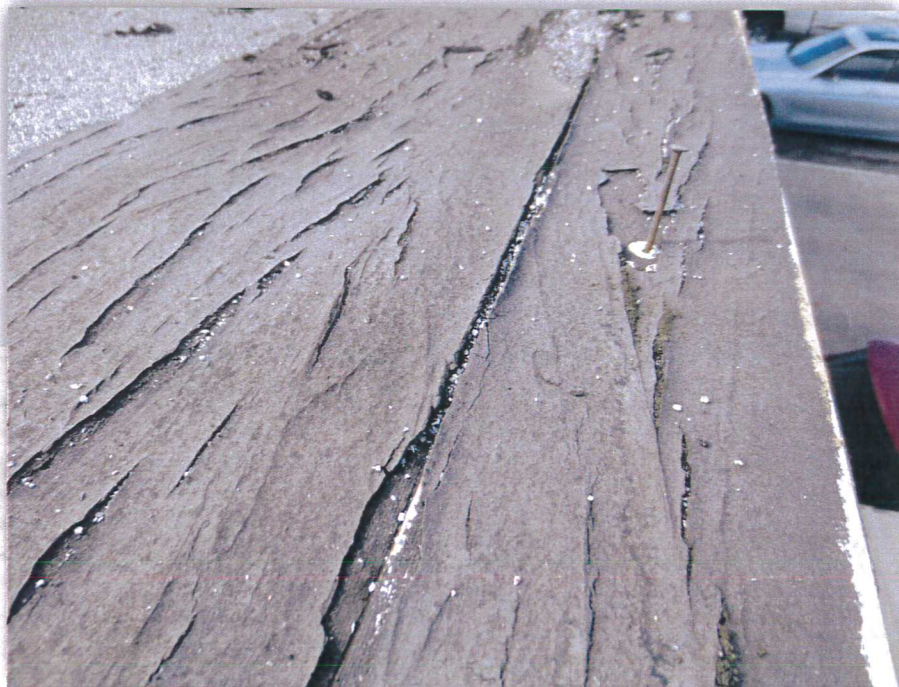
- Roofing mastics and silver coating associated with the roofing (Sample #'s **CJ-30, 44, 45, and 46**). Point count analysis was performed that brings the asbestos content to less than 1% asbestos on all four samples.

| Sample ID | Collected | Cust. ID | Location | Asbestos Fibers | Other Materials |
|---|---|---|---|---|---|
| Layer 1: Roof Mastic<br>Dark Gray/Black, Bituminous, Homogenous | | | | 0.50% CHRYSOTILE | 99.50% NON FIBROUS MATERIAL |

Photo 30: Dark Grey Roofing Mastic

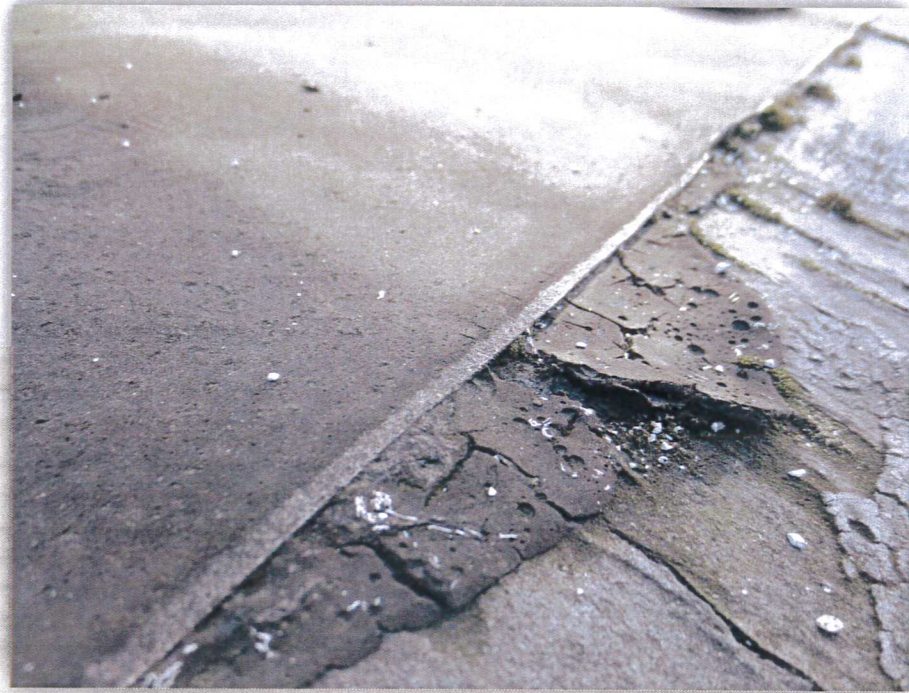
Photo 31: Black Roofing Mastic

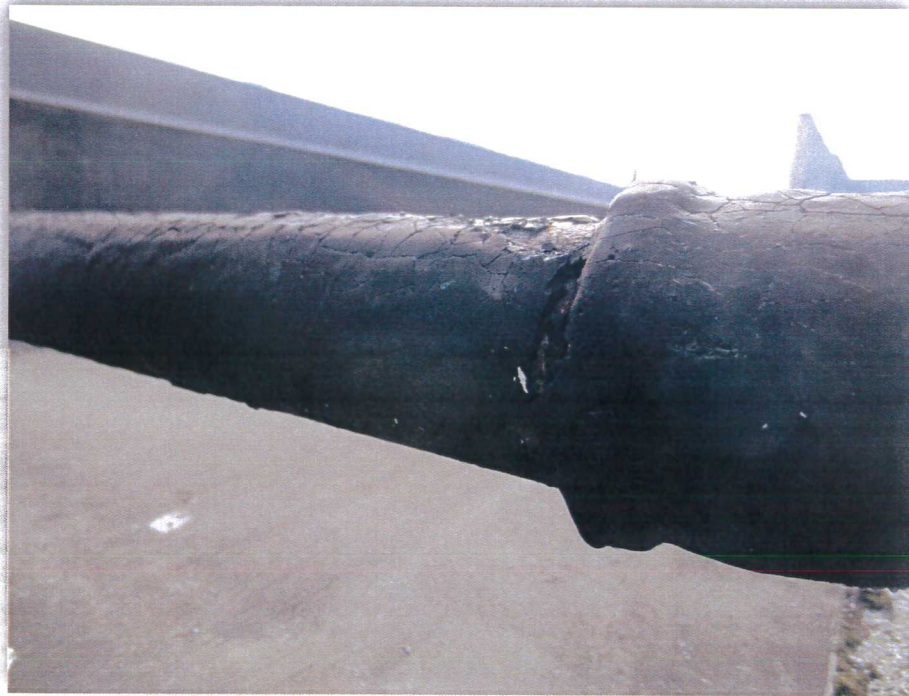
Photo 32: Tar on Piping

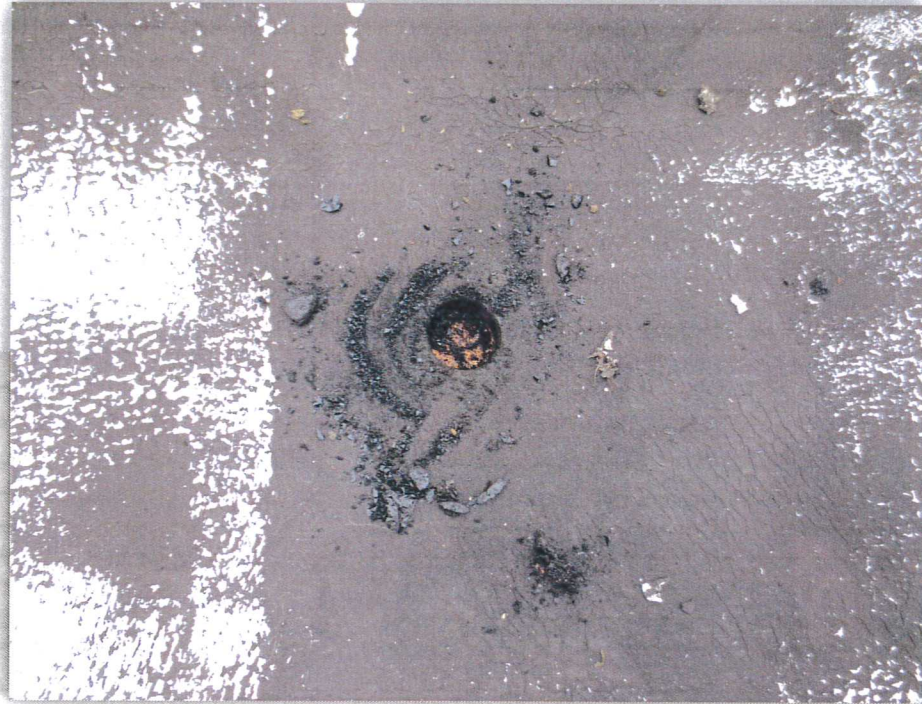
Photo 33: Black Roofing Felt

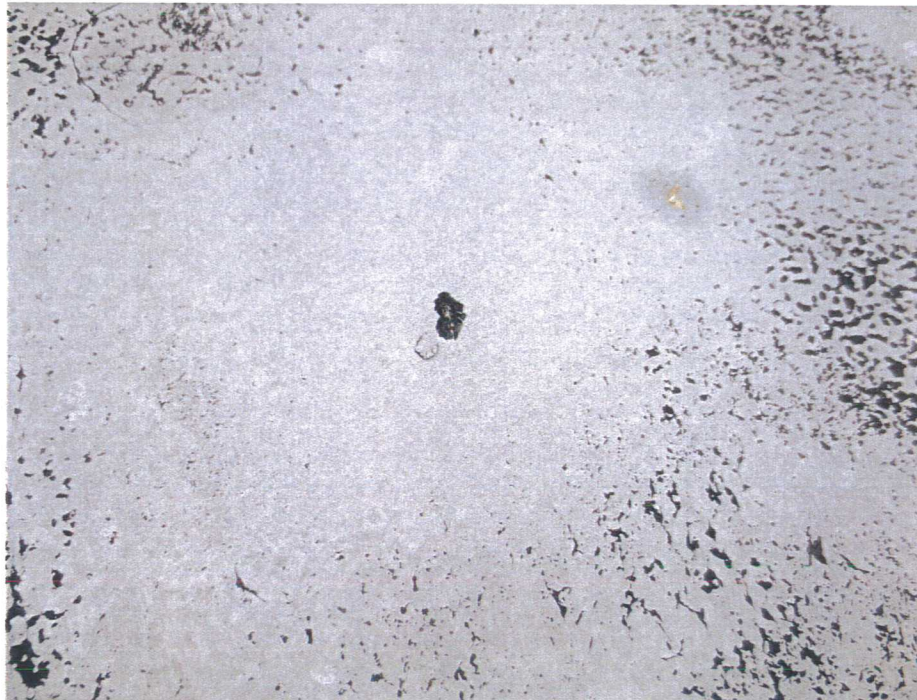
Photo 34: Silver Coat
