# GOOD FAITH ASBESTOS SURVEY

Date Performed: 9/23/2020

Cornforth Building  
115 2nd St. SE  
Puyallup, WA 98371

City of Puyallup  
1201 4th St. NW  
Puyallup, WA 98371

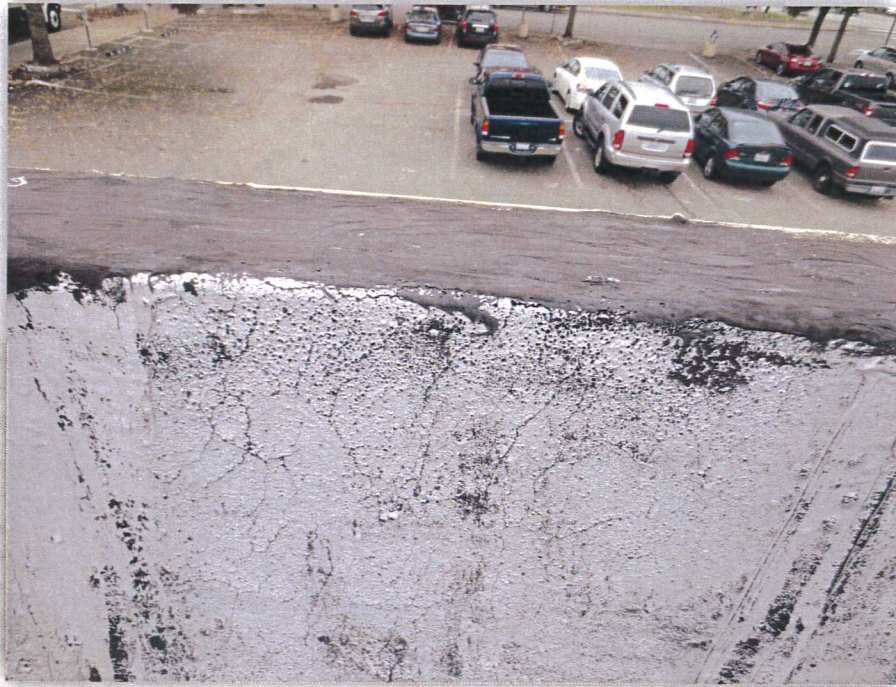
Photo 35: Silver Coat

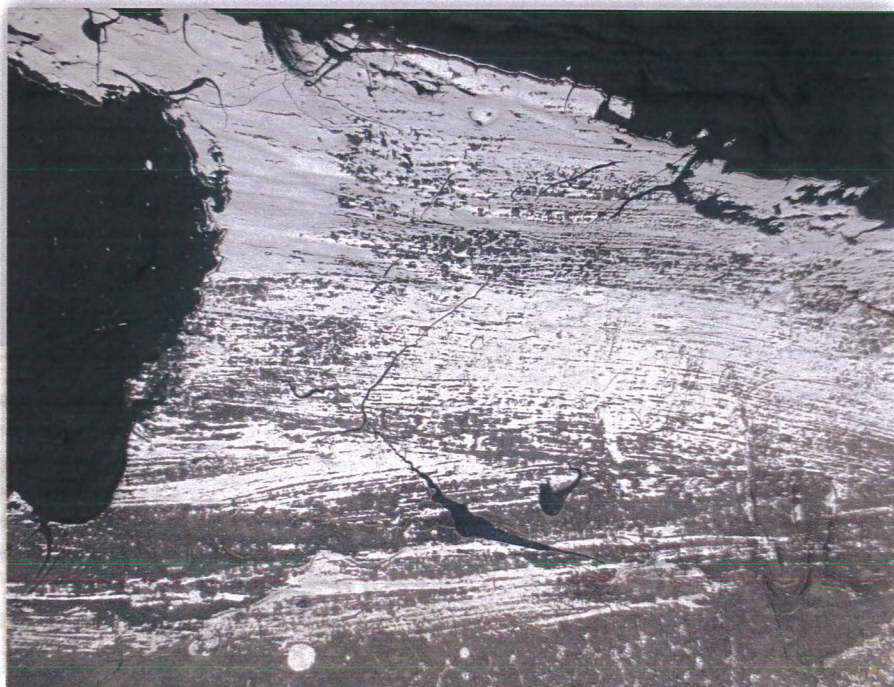
Photo 36: Silver Coat

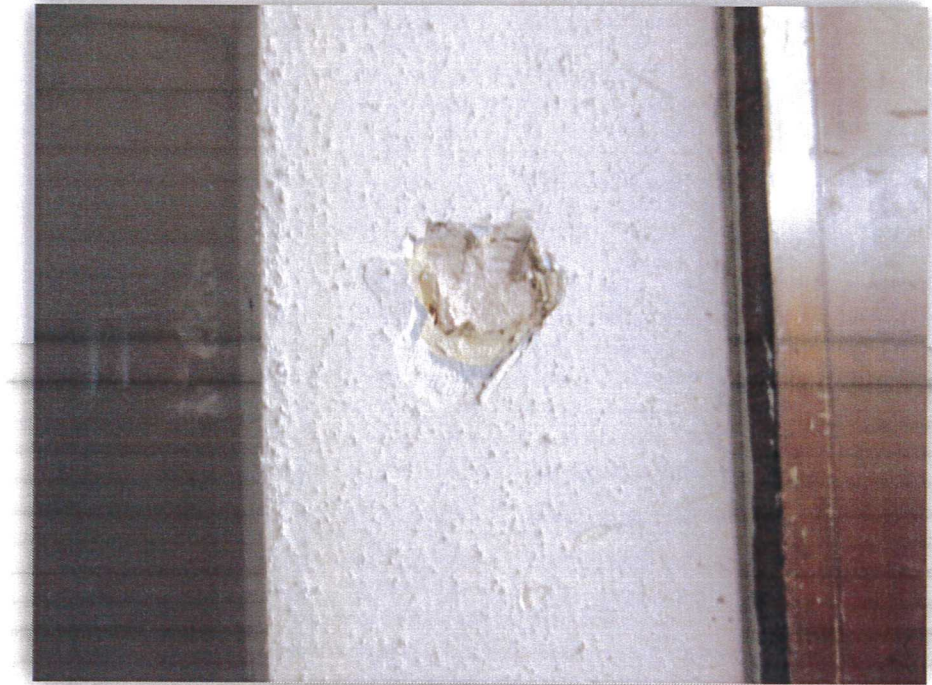
Photo 37: Joint Compound and Drywall

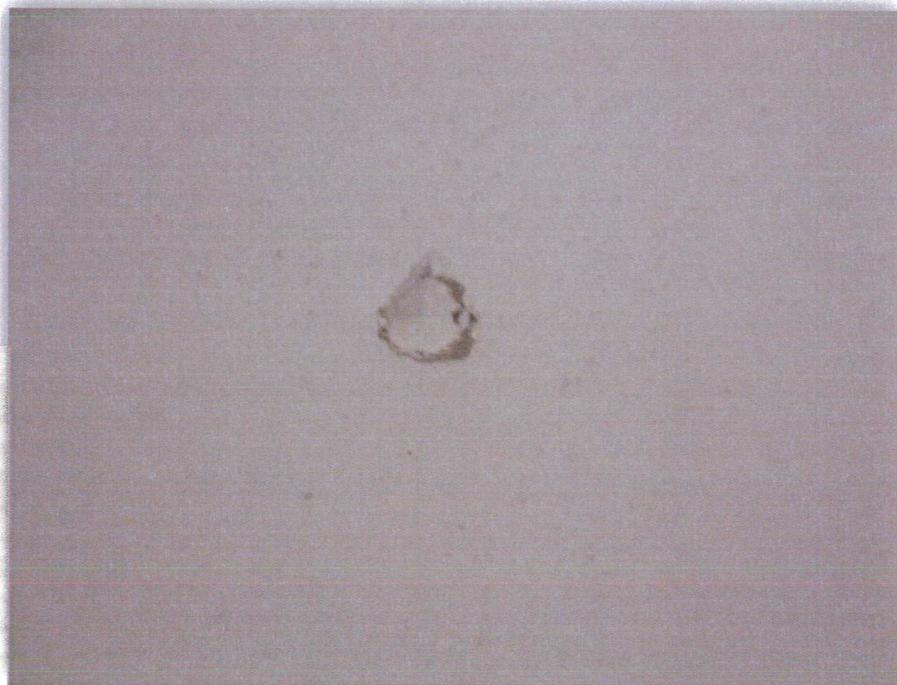
Photo 38: Sand Texture

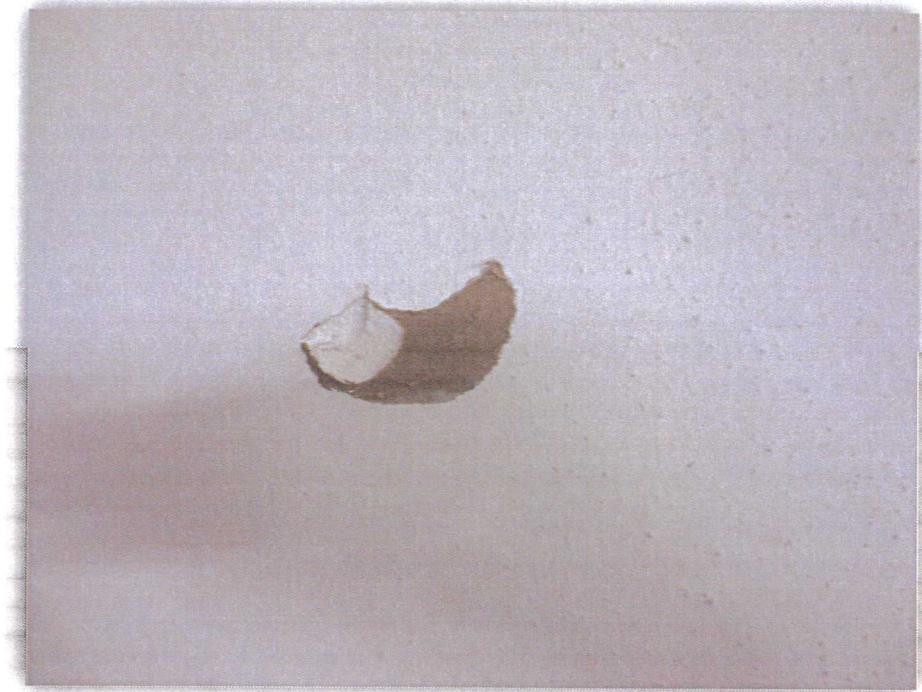
Photo 39: Sand Texture

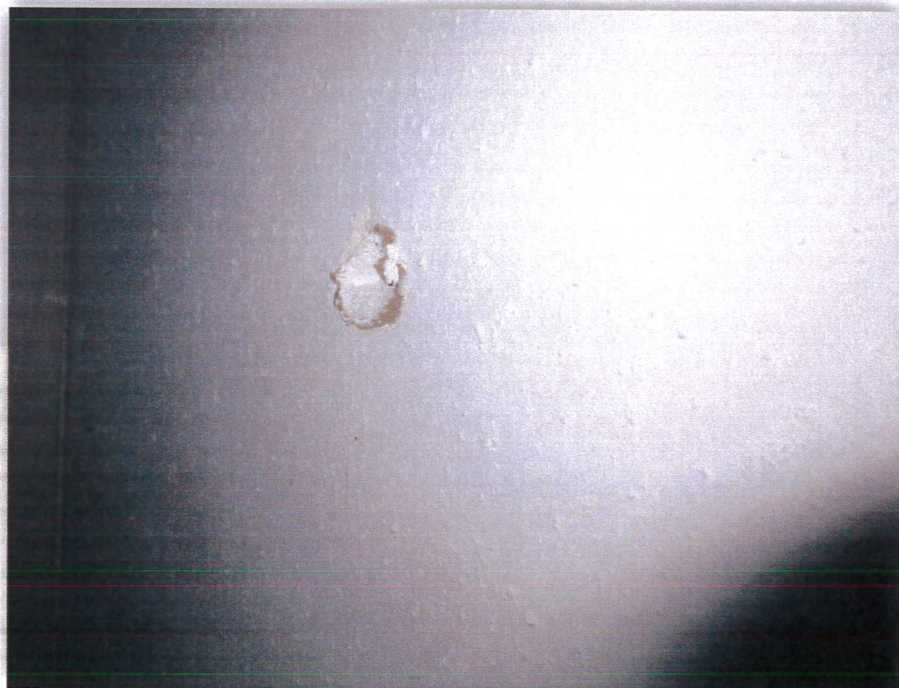
Photo 40: Sand Texture

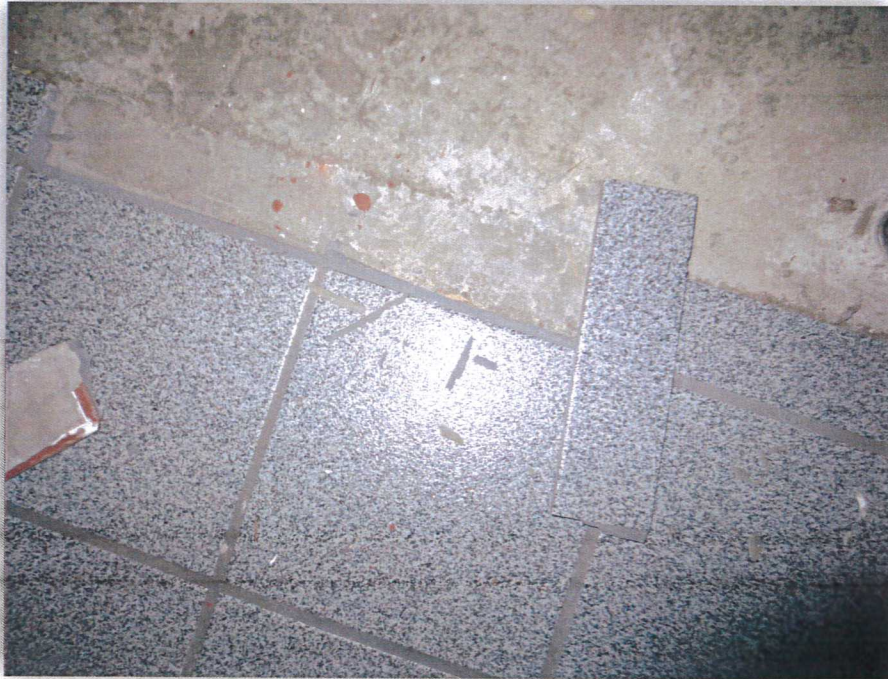
Photo 41: Ceramic Tile Grout

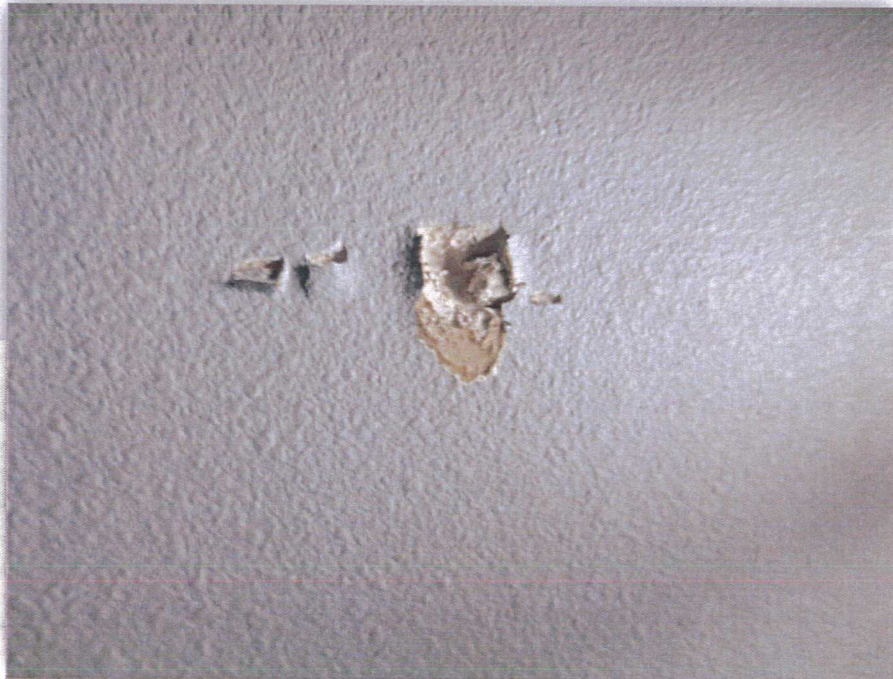
Photo 42: Orange Peel Texture

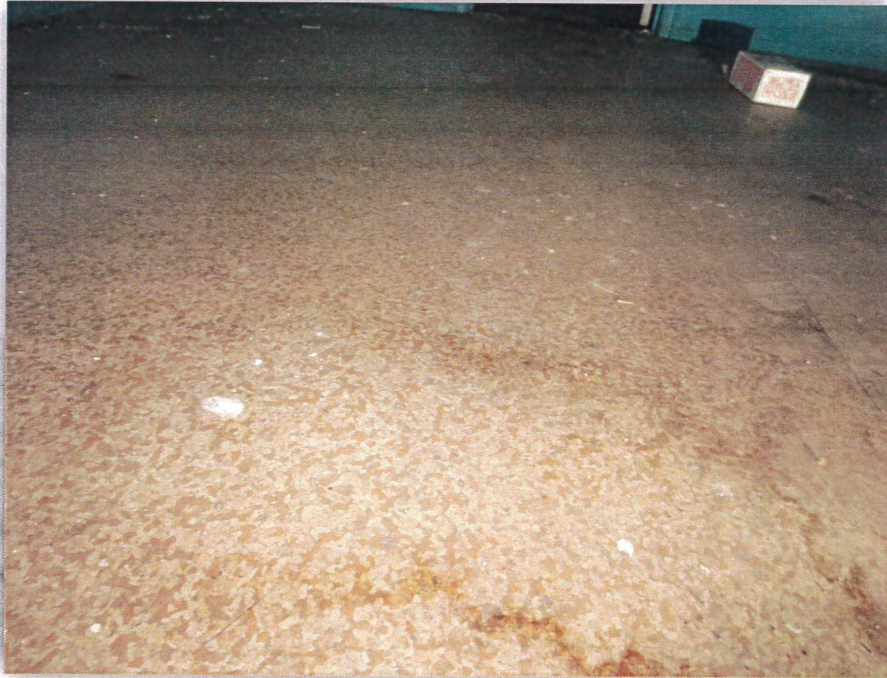
Photo 43: Gold Speckled Sheet Vinyl

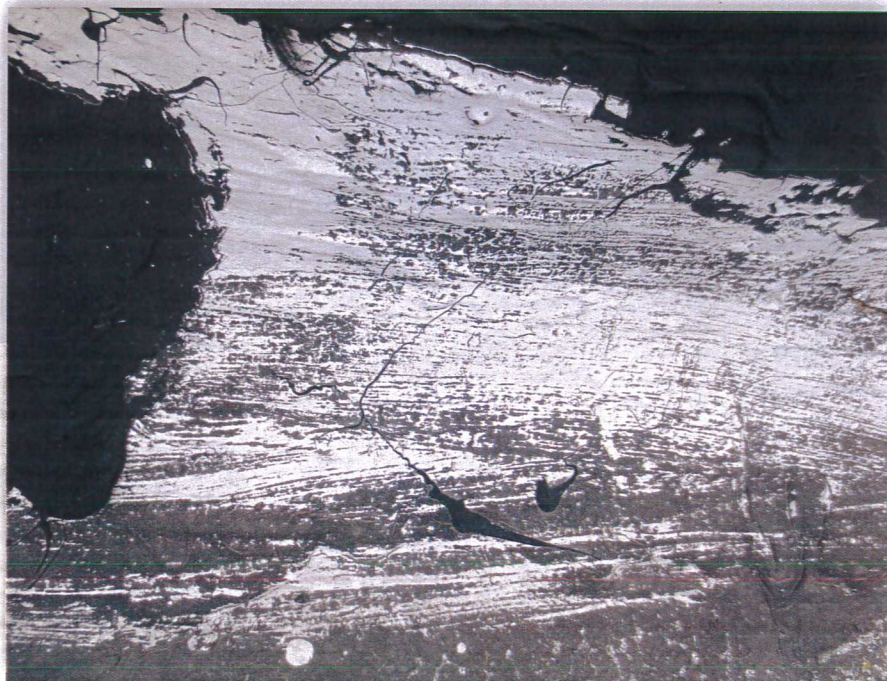
- Roofing mastics and silver coating associated with the roofing (Sample #'s **CJ-30, 44, 45, and 46**). Point count analysis was performed that brings the asbestos content to less than 1% asbestos on all four samples.

| Sample ID | Collected | Cust. ID | Location | Asbestos Fibers | Other Materials |
|---|---|---|---|---|---|
| Layer 1: | Coating | | | 0.25% CHRYSOTILE | 99.75% NON FIBROUS MATERIAL |

Photo 44: Silver Coat

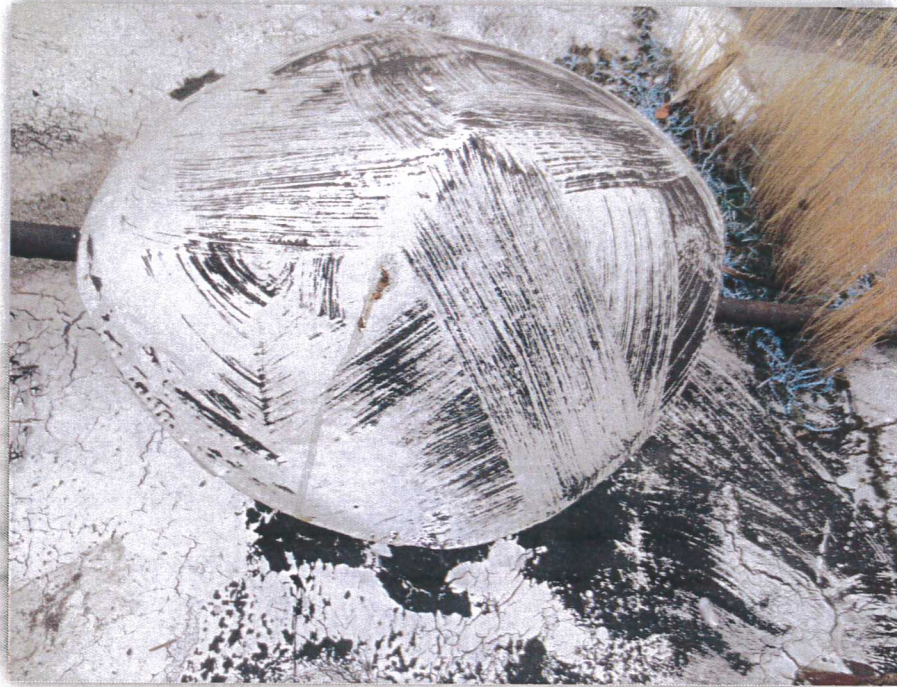
| Sample ID | Collected | Cust. ID | Location | Asbestos Fibers | Other Materials |
|---|---|---|---|---|---|
| Layer 1: | Coating | | | 0.50% CHRYSOTILE | 99.50% NON FIBROUS MATERIAL |

Photo 45: Silver Coat

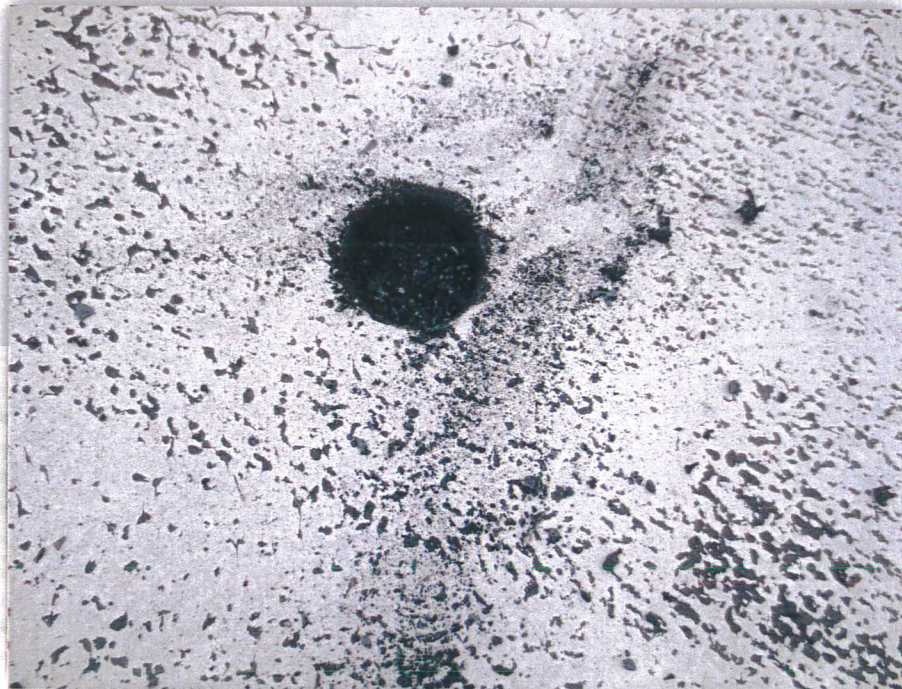
| Sample ID | Collected | Cust. ID | Location | Asbestos Fibers | Other Materials |
|---|---|---|---|---|---|
| Layer 1: | Roofing Material | | | 0.50% CHRYSOTILE | 99.50% NON FIBROUS MATERIAL |

Photo 46: Built Up Roofing
