Existing Structural Conditions Report

Don's Drive-In
925 S Meridian
Puyallup, WA 98371

Project No.: 24-007

April 17, 2024

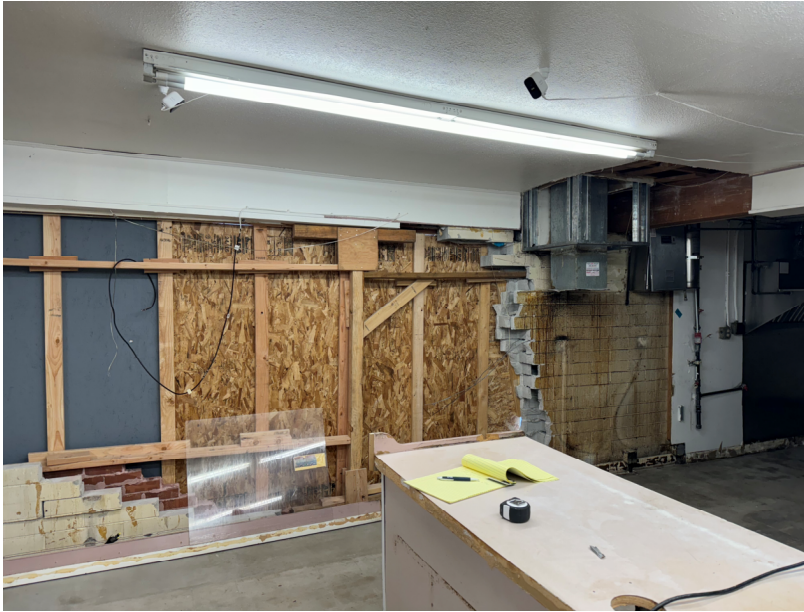
The car collision occurred at the north-facing wall where the order window was located, and broke through a portion of the existing, unreinforced CMU wall. Cracks were noticeable at the remaining portion of wall closest to the area of impact, and based on the exposed, broken CMU blocks remaining, the block walls appear to be hollow and unreinforced, with horizontal mesh every so often along its height.

Based on comparison between predamage length of CMU wall along the north and south facing walls (total length of 54'-9"), and length of wall loss (11'-9" long), the building has seen a reduction of 21.5% of lateral capacity. This is less than 33% and therefore is not considered a "substantial structural damage" as defined in the Washington State Existing Building Code (WSEBC). In addition, the damaged wall can be restored to pre-damaged condition as noted in WSEBC section 405.2.1.

North facing wall where car collision occurred (interior)

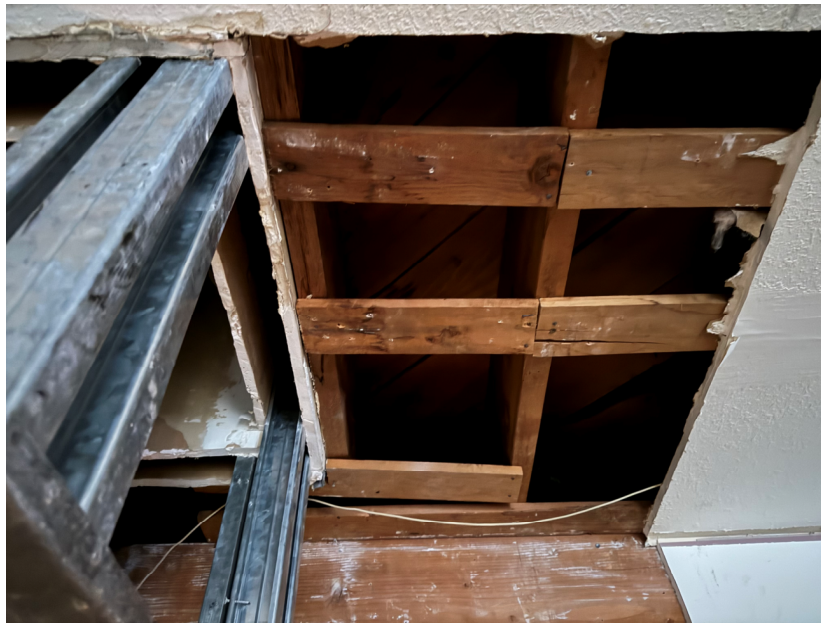
Existing roof framing (interior)

The affected existing roof and wall framing will need to be analyzed for the new hood system to verify that it can handle the additional load, along with anchorage calcs for the support connections.

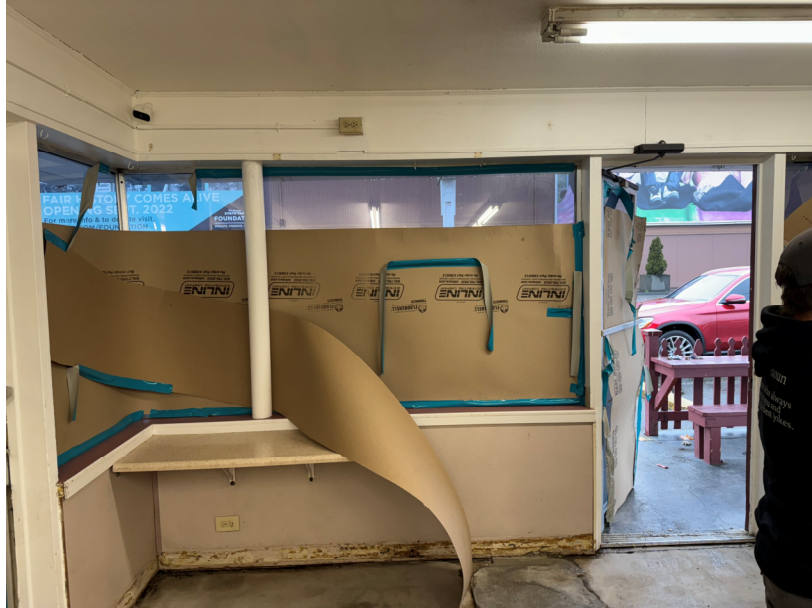
Front entry wall (interior – southwest corner)

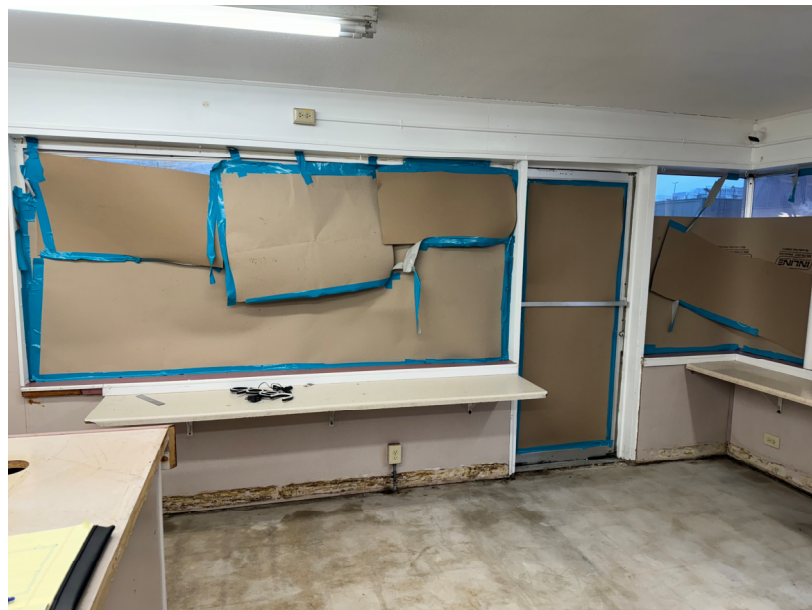
Front entry wall (interior – northwest corner)
