GOOD FAITH ASBESTOS SURVEY

Date Performed: 9/23/2020

20253

Cornforth Building
115 2nd St. SE
Puyallup, WA 98371

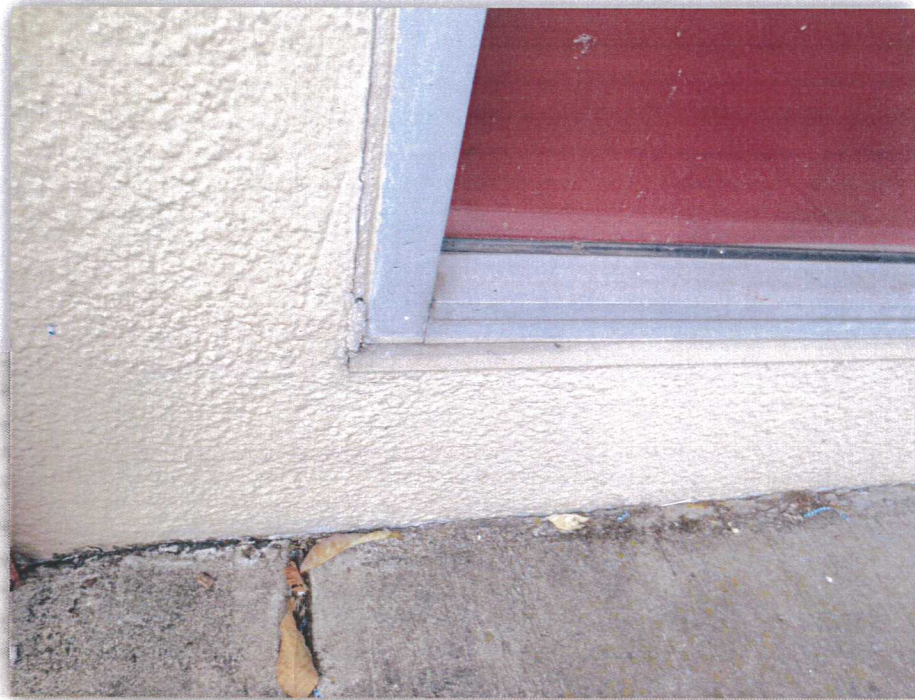
- Glazing associated with most of the windows (Sample #'s **CJ-01 & 02**). Point count analysis was performed that brings the asbestos content to less than 1% asbestos for both samples.

Photo 1: Window Glazing

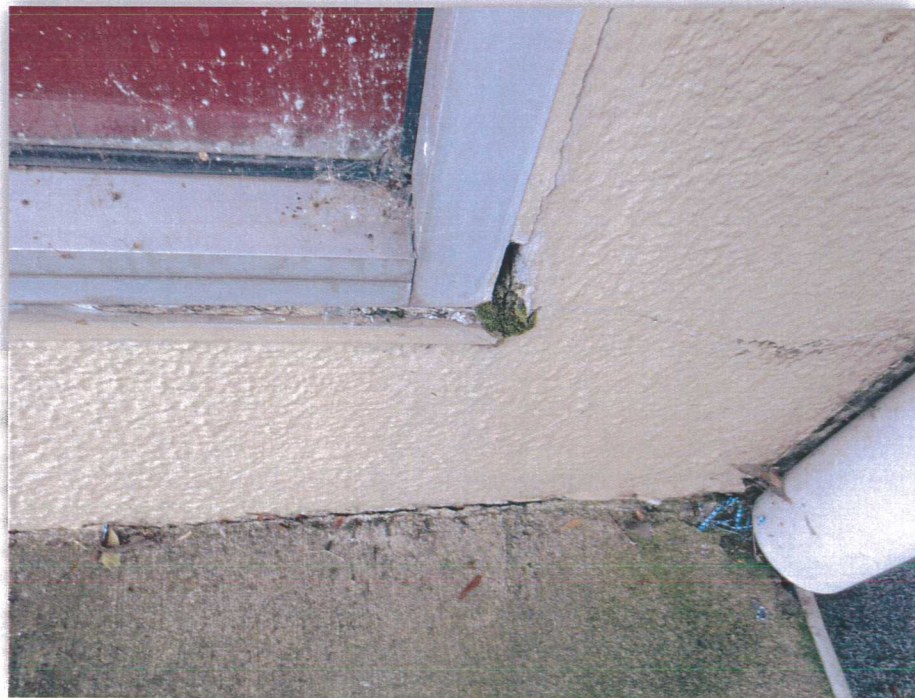
Photo 2: Window Glazing

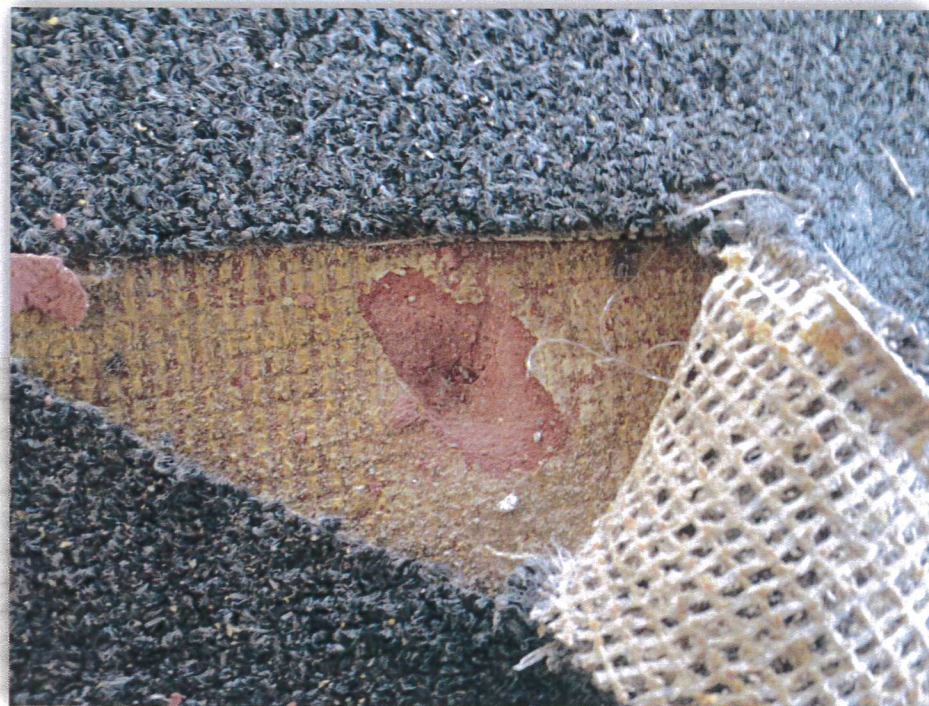
Photo 7: Red Flooring Underlayment

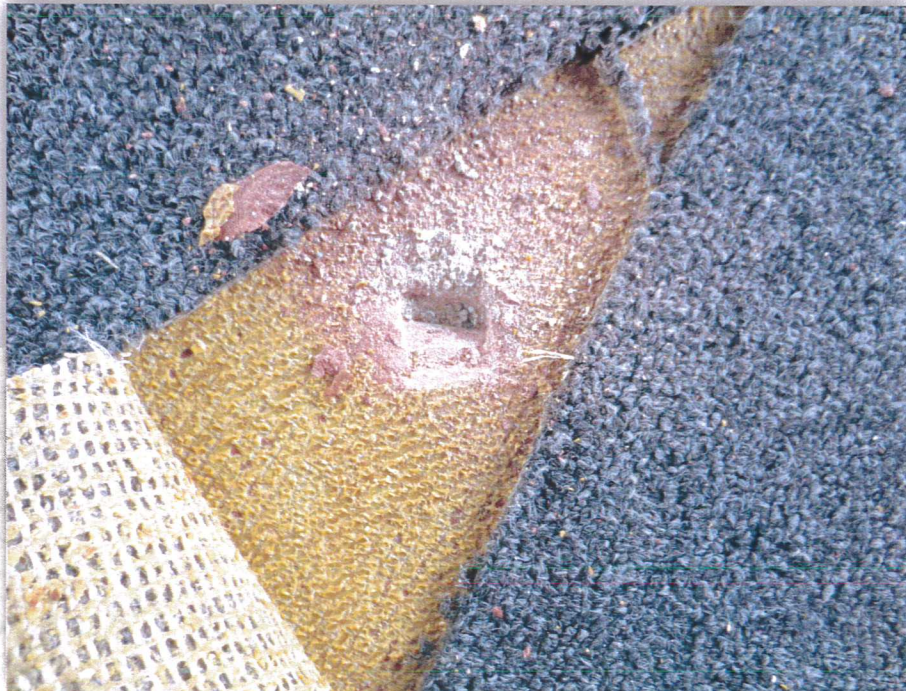
Photo 10: Red Flooring Underlayment

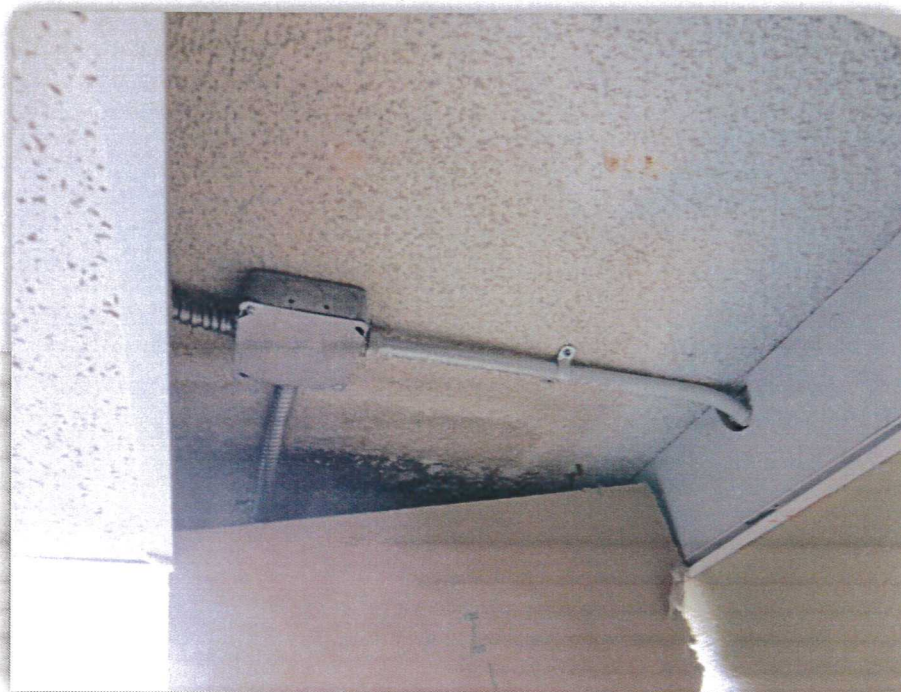
- Popcorn ceiling texture located above the drop ceiling in the back half of the retail area (Sample #'s **CJ-23, 24 & 25**). Point count analysis was performed that brings the asbestos content to less than 1% asbestos for all three samples.

Photo 23: Popcorn Ceiling Texture

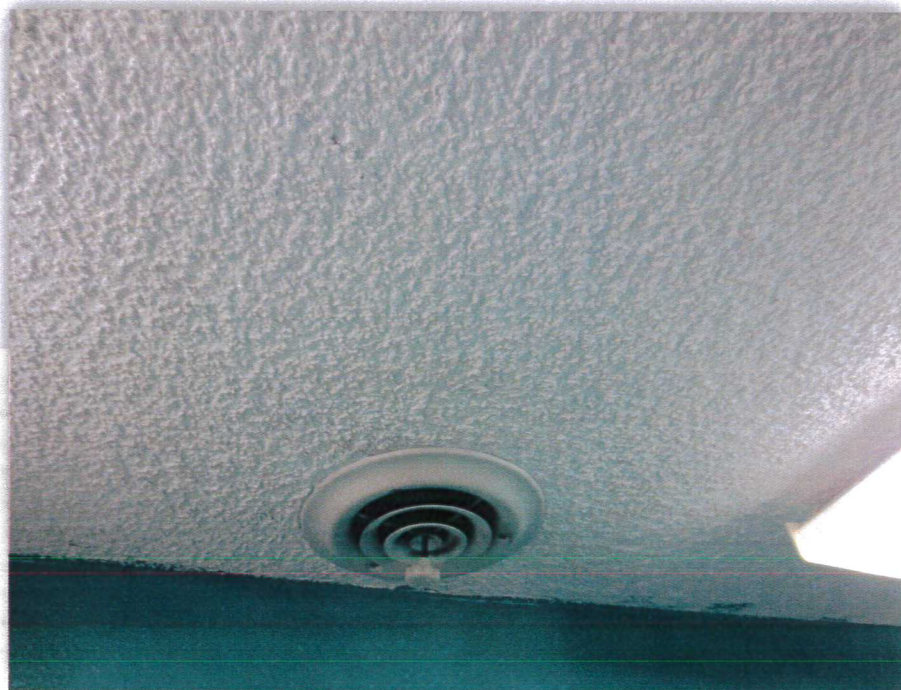
Photo 24: Popcorn Ceiling Texture

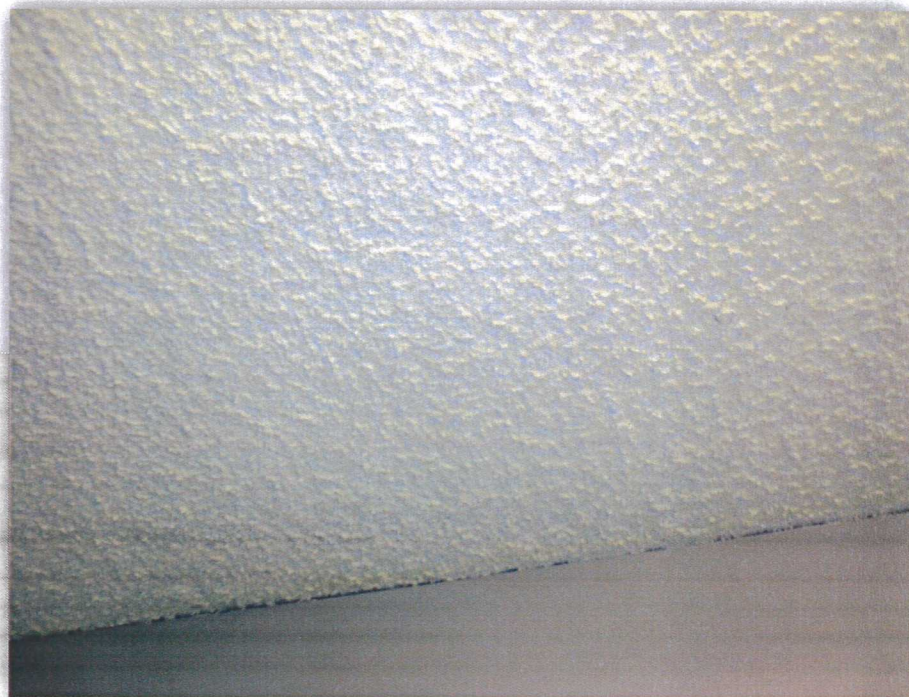
Photo 25: Popcorn Ceiling Texture

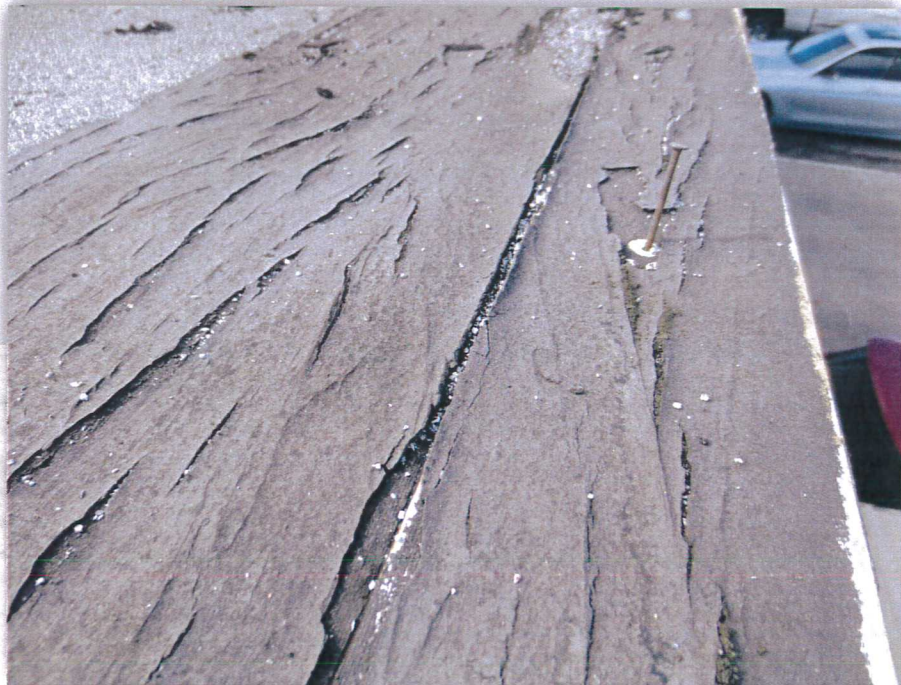
- Roofing mastics and silver coating associated with the roofing (Sample #'s **CJ-30, 44, 45, and 46**). Point count analysis was performed that brings the asbestos content to less than 1% asbestos on all four samples.

Photo 30: Dark Grey Roofing Mastic

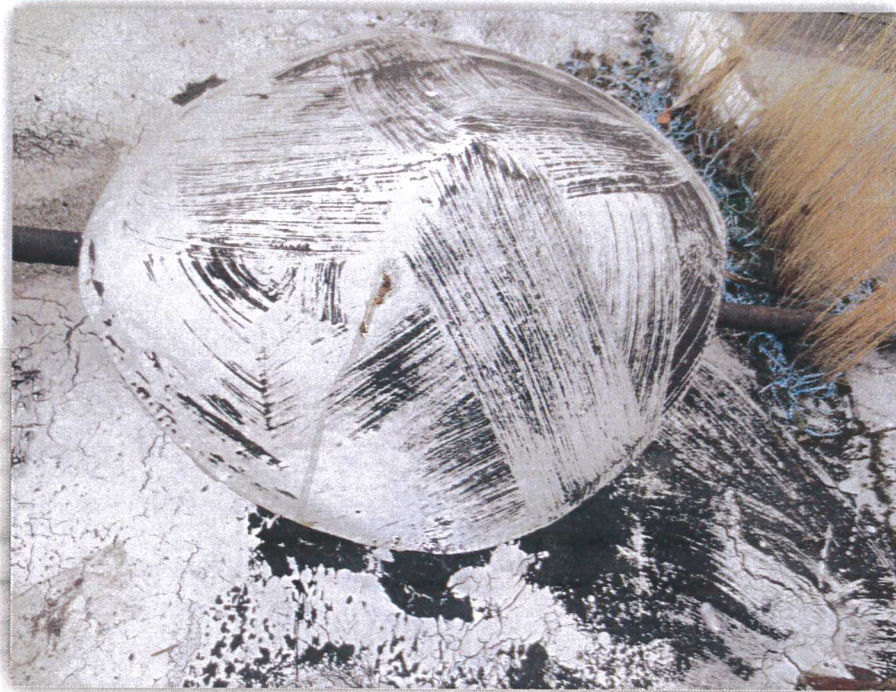
387498-045	09/29/20	CJ45	Ext N. Side of Roof		
Layer 1:	Coating			2% CHRYSOTILE	98% NON FIBROUS MATERIAL
	Black/Silver, Bituminous/Brittle

Photo 45: Silver Coat

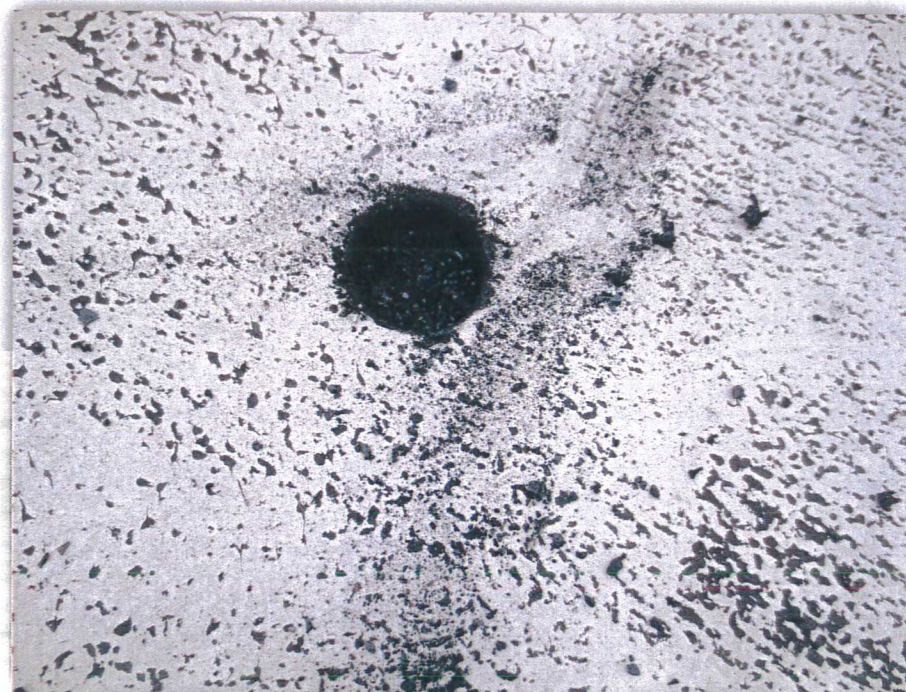
387498-046	09/29/20	CJ46	Ext W. Side of Roof		
Layer 1:	Built-up Roofing			None Detected	60% CELLULOSE FIBER
	Black, Bituminous/Fibrous				20% MINERAL/GLASS WOOL
					20% NON FIBROUS MATERIAL
Layer 2:	Roofing Material			2% CHRYSOTILE	98% NON FIBROUS MATERIAL
	Black/Silver, Bituminous

Photo 46: Built Up Roofing
