Appendix 2

Ecolube Recovery Puyallup Site (T)
213 - 10th Street SE
Puyallup, WA

Tank Number	3
Owner	EcoLube LLC
Design Standard	Unknown
Tank Location	Puyallup, WA
Product	Deicer
Specific Gravity	1.28
Manufacturer	Unknown
Manufacture Date	1988
Cathodic Protection	No
Data Plate Present	No
Data Plate Condition	N/A

4.0 Summarized Recommendations

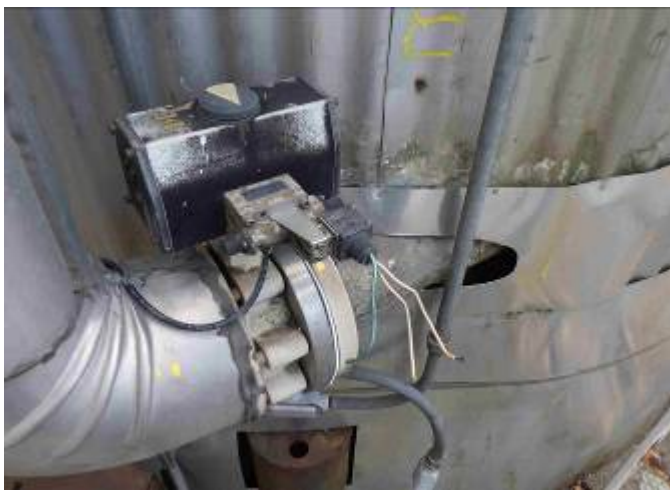
Deteriorated Insulation at Nozzle Penetration.

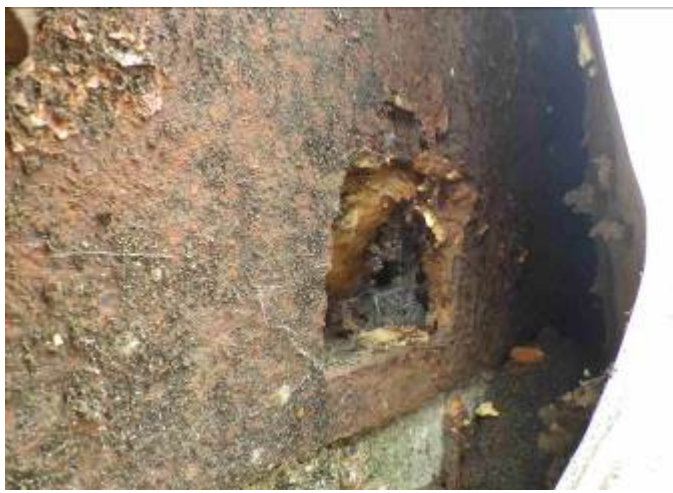
- 6) The dead space between the double floor has 3 visible 3" x 3" cutouts in the shell. The space appears to have been filled with a type of spray foam in effort to seal the area from any potential bottom leaks. This configuration is not ideal for typical leak detection. These cutouts should be closed up by welded inserts. The customer should also install a threaded coupling with a bull plug in the lower region of the space so that periodic leak monitoring can be performed. Note: There are likely more of these cutouts behind the insulation sheeting which aren't readily visible.

Dead Space Cut Out

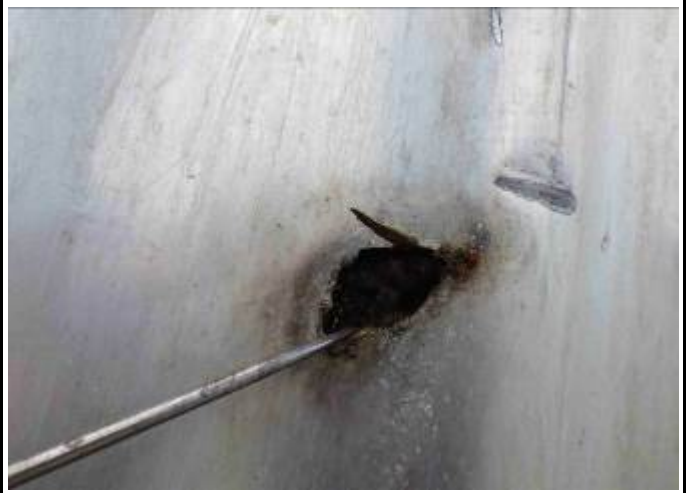
- 11) There were many suspect CUI (corrosion under insulation) areas throughout the exterior of the shell due to various openings and damage within the jacketing. Internal UT testing was performed on the shell interior of course 1 and 2 confirming that external metal loss up 0.06" has occurred in some locations. The external shell was also visible through UT ports that were installed during this inspection, and there appears to be a heavily degraded coating present in the upper courses of the tank. If the tank is to be re-used, the client should highly consider stripping sample areas of insulation at strategic locations to better evaluate the exterior condition of the tank shell.

Shell Jacket Hole

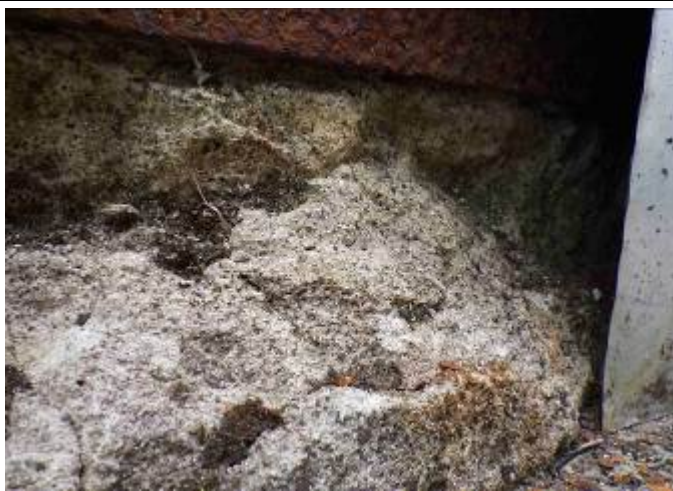
- 4) The tank rests on a 6" raised concrete pad. The viewable areas contained some moderate spalling and erosion. The customer should repair these areas in the future to mitigate further degradation.

2.2 Concrete pad or ring wall?	Cracking or spalling	<input checked="" type="checkbox"/> Yes* <input type="checkbox"/> No <input type="checkbox"/> N/A	The viewable areas contained some moderate spalling and erosion.

Edge of Foundation Pad

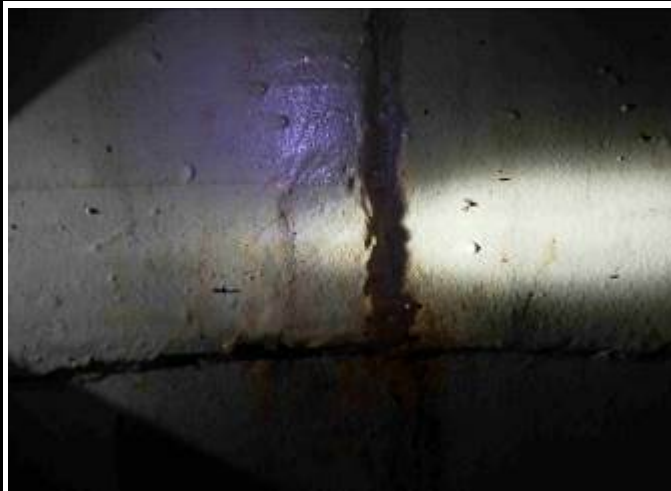
- 9) There are areas of heavy internal coating degradation present with scale buildup and non-measurable corrosion forming. The client should prep and recoat the affected area at the next opportunity. **Note: If an internal liner is required for the new intended service, this recommendation would be mandatory.**

Floor Coating Failure

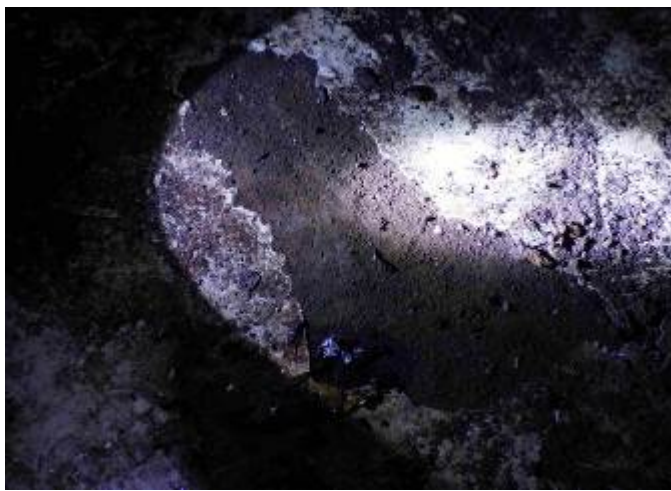
- 12) There are areas of heavy internal coating degradation present with scale buildup and non-measurable corrosion forming. The client should prep and recoat the affected area at the next opportunity. **Note: If an internal liner is required for the new intended service, this recommendation would be mandatory.**

Shell Internal Coating Failure

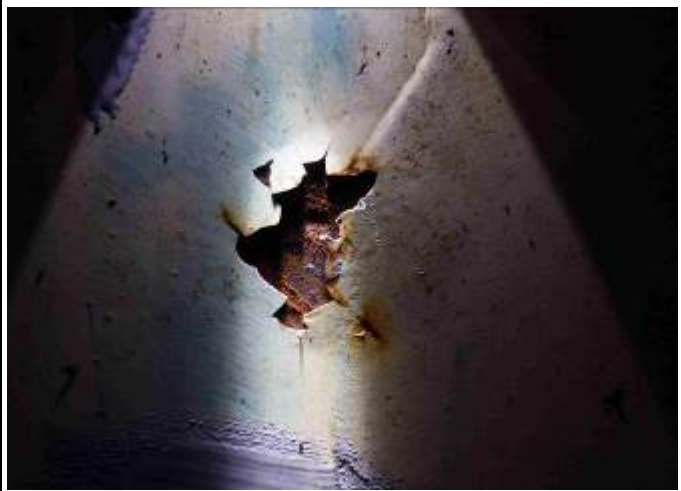
Lower Shell Large Coating Failure

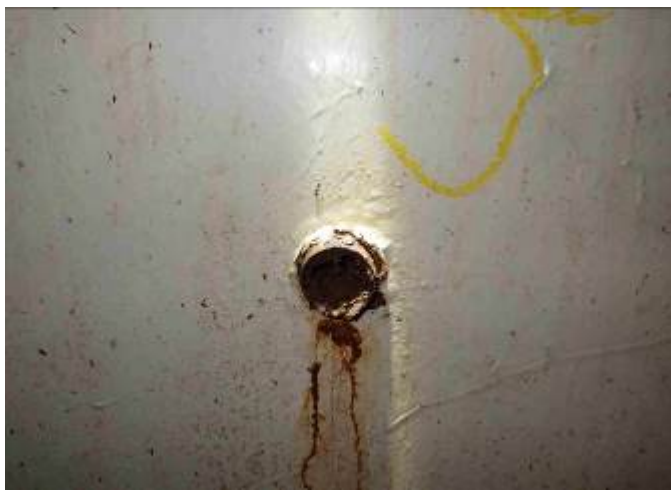
Nozzle G Interior. Note Coating Degradation

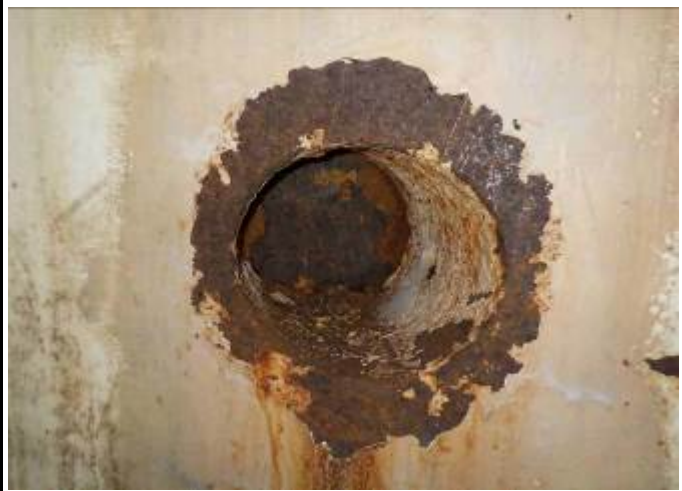
Shell Jacketing Hole

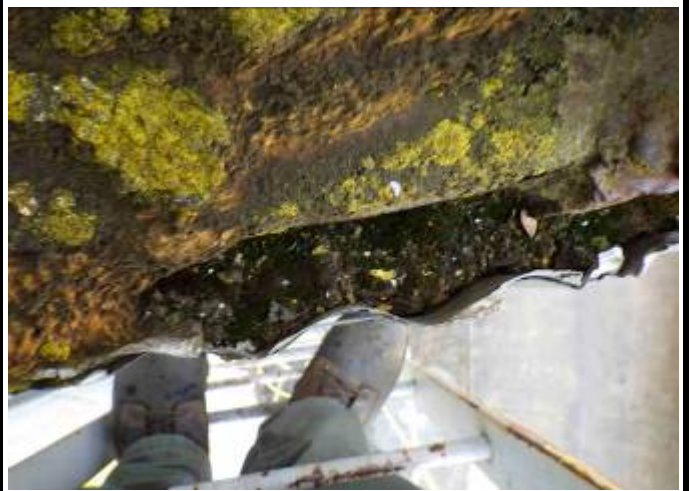
Shell Top Angle. Note Opening.
