# Greenforest Incorporated

REFERENCE: Arborist Report  
South Hill Building & Technology Center

SITE ADDRESS: Puyallup WA

DATE: January 31, 2022

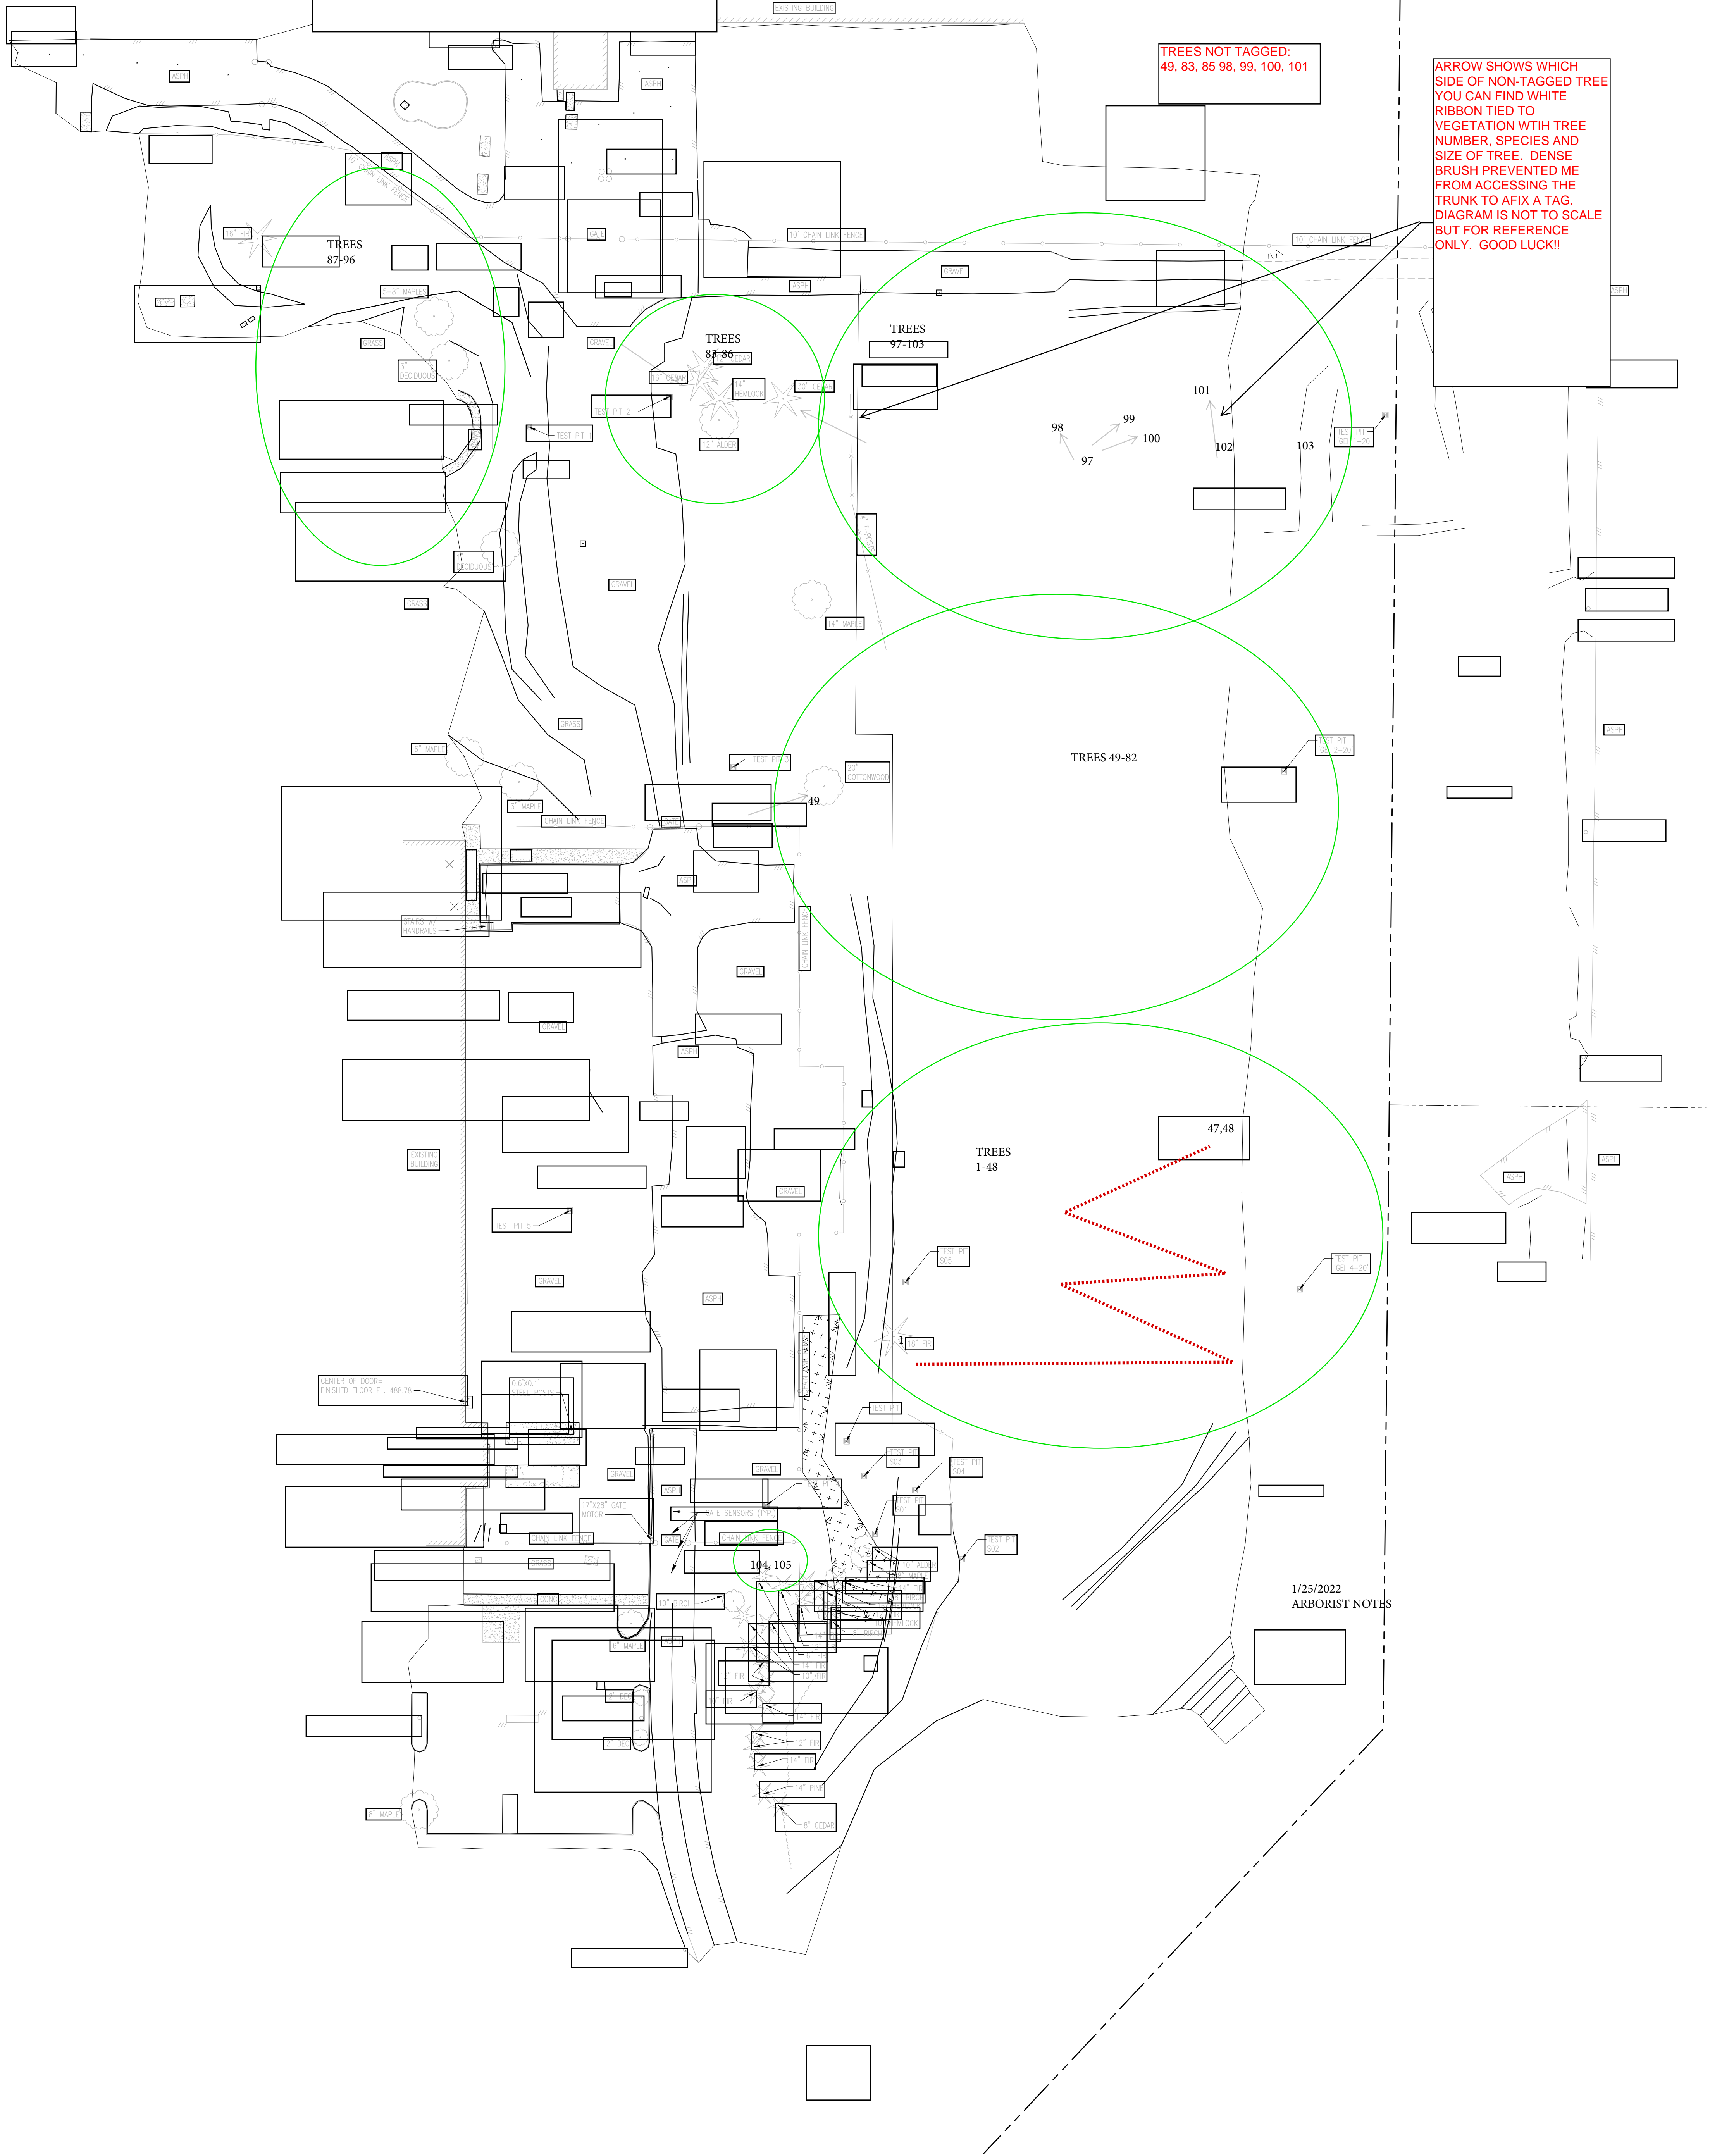
Darren Sandeno, Parametrix  
RE: Arborist Report, South Hill Building & Technology Center, Puyallup WA  
January 31, 2022  
Page 12 of 12  
Attachment No. 4 - Tree Number Exhibit

TREES NOT TAGGED:  
49, 83, 85 98, 99, 100, 101
