**Arborist Report
DRAFT**

To: Absher Construction c/o Blaine Wolfe and Integrus Architects c/o Sara Wilder
Site: 1601 39th Ave SE Puyallup, WA 98374
Re: Tree Inventory
Date: January 28, 2022
Project Arborists: George White, ISA Certified Arborist #PN-8098A
ISA Qualified Tree Risk Assessor
Sean Dugan, Registered Consulting Arborist # 475
ISA Board Certified Master Arborist #PN-5459B
ISA Qualified Tree Risk Assessor
Referenced Documents: Survey Existing Conditions A100 (Integrus, 1/20/2022)
Attached: Draft - Table of Trees

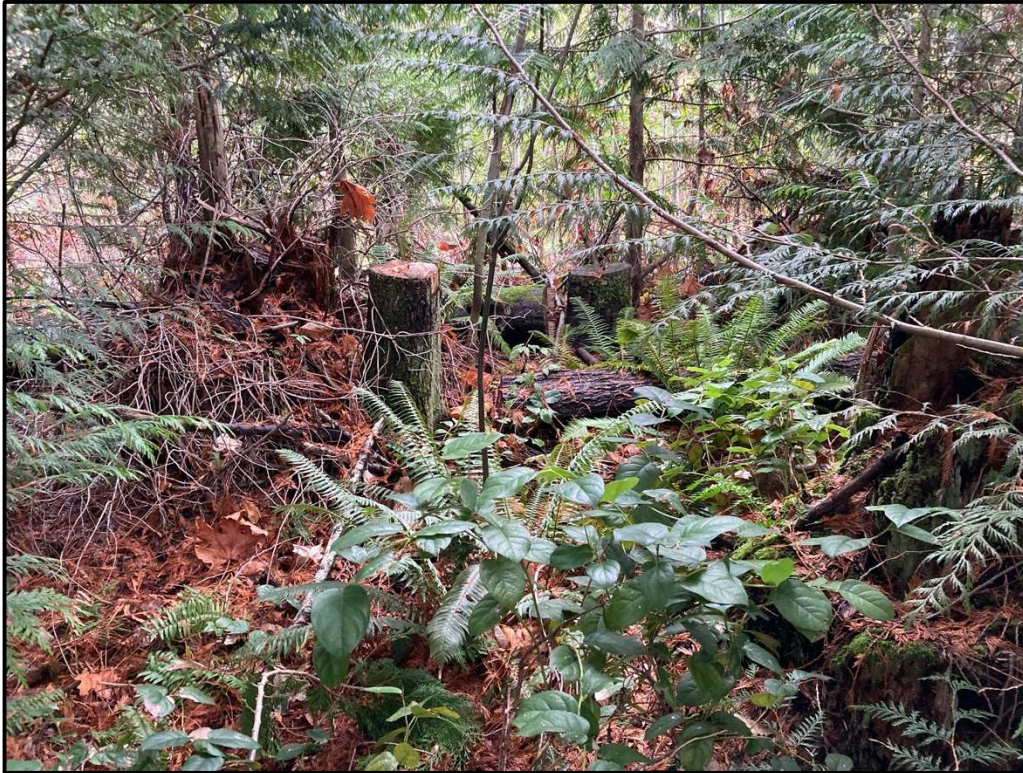
The understory vegetation on site was a mix of native plants such as sword ferns (*Polystichum munitum*), Salal (*Gaultheria shallon*), and huckleberry (*Vaccinium parvifolium*), and invasive species including Himalayan blackberry (*Rubus bifrons*), cut-leaf blackberry (*Rubus laciniatus*), ivy (*Hedera spp*), and English holly (*Ilex aquifolium*). The amount of invasive species coverage fluctuated across the site with some areas with mainly native underbrush, and some areas that had been entirely overrun with invasive species, most notably, Himalayan blackberry (See photos 1-3). All invasive plant species should be managed prior to development.

Photo 1. Native understory vegetation including Salal and sword ferns.

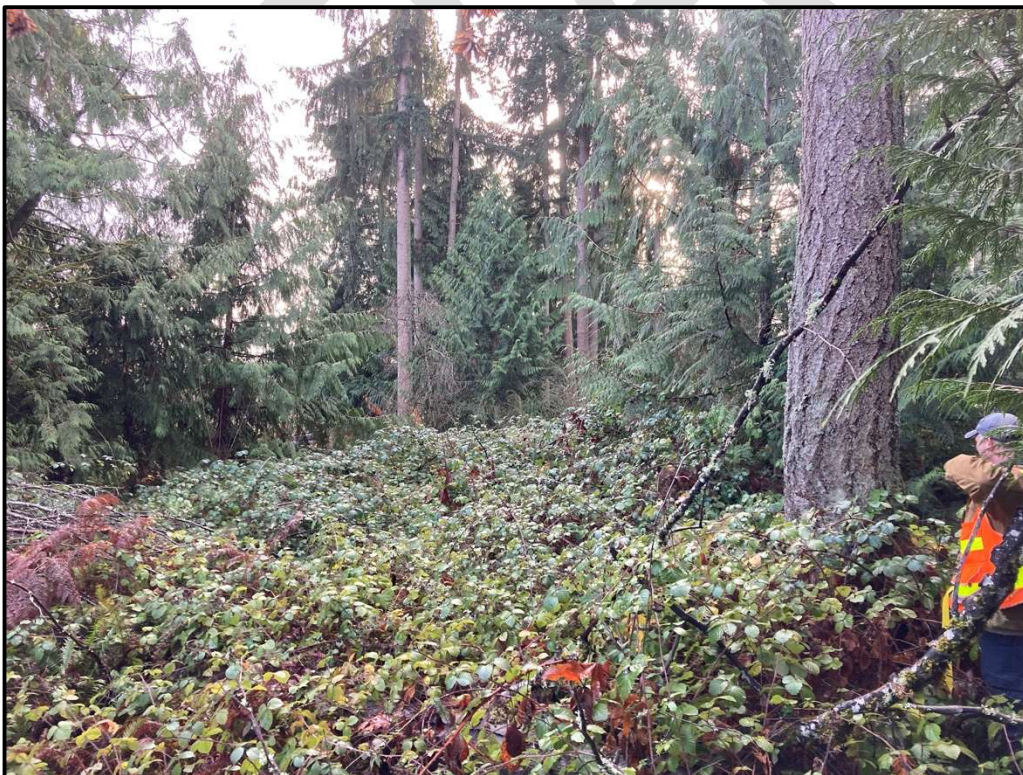
Photo 2. A portion of the site understory that has been overrun with Himalayan blackberry.

- Tree 422 should have an advanced assessment if proposed for retention.
- All pruning should be conducted by an ISA certified arborist and following ANSI A300 specifications.¹
- Invasive species should be managed prior to development.

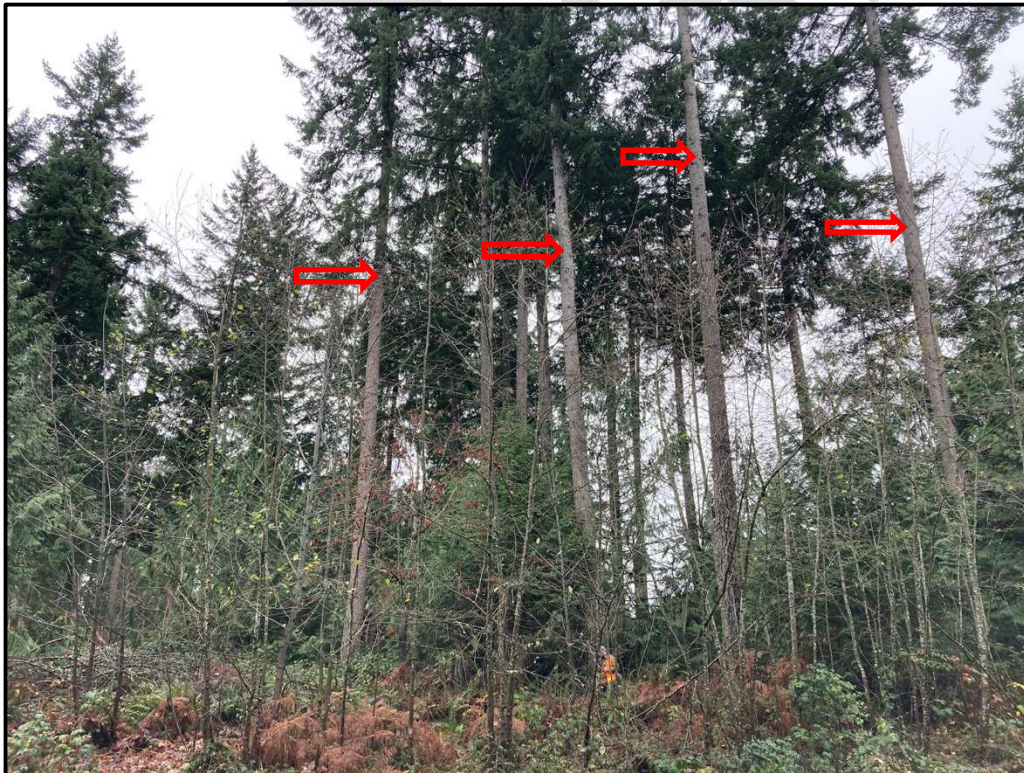
We observed that many of the large Douglas-firs had a low live-crown ratio (LCR). LCR is an approximation of the percent of the trunk that supports a live canopy. This low-LCR condition is typical for Douglas-firs growing in the middle of a forest stand, where they must compete with adjacent trees for sunlight.

When a disturbance, such as a clear cut, exposes low-LCR trees to novel wind forces it can increase the likelihood of failure. We refer to these freshly exposed trees as edge trees. (See photo 4.) We find that

the likelihood of failure for an edge tree is elevated for approximately 10 years following the initial disturbance, until the tree is able to compensate for the altered environmental conditions. This should be considered for any trees retained following proposed development activities.

Photo 4. Edge trees with a low live crown ratio (indicated with red arrows). Note the presence of young red alders (*Alnus rubra*) trees in the foreground. These trees readily colonize recently disturbed areas.
