VVOLDEN

STRUCTURAL

July 12, 2022

Re: Foundation Assessment and Repair Recommendations for the Ross Family Residence at 110 9th Street SW in Puyallup, Washington

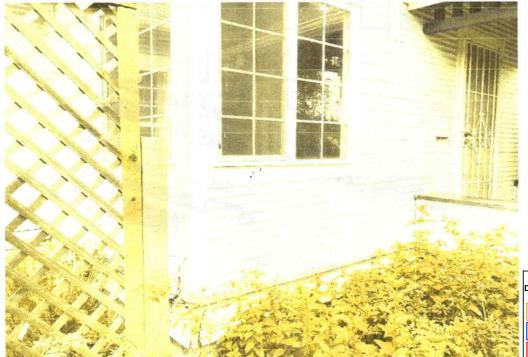
View from the Southeast Corner of Residence - Greatest Settlement at this Corner

In conclusion, I found that the southeast corner of the Ross Family residence at 110 9<sup>th</sup> Street SW in Puyallup, Washington has experienced up to 2½-inches of settlement and the cracked foundation for this single-story residence should be stabilized to prevent increased settlement or damage to the foundation. Please refer to my attached repair plan for repair/stabilization recommendations possible with two hydraulically driven helical piers with foundation brackets placed under the footings of the home and steel angles placed on top of the brackets.

I recommend that the southeast corner be supported on two (2) helical piers; one at the front or east side and one at the south side wall shown above. These piers will use the standard foundation bracket (4038) or the modified RD 3177 brackets. In addition to the brackets, I have shown the use of 6x6 steel angles placed on top of the brackets to ensure that the lifting force is applied uniformly along the wall in order to support the cracked corner and to prevent more cracking as it is unlikely the footings are reinforced.

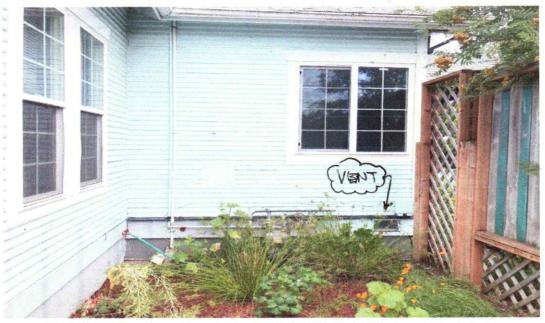
View from South looking at the South Wall - Add Pier near Vent Hole

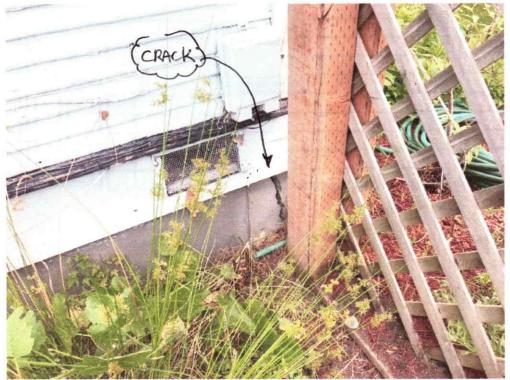
Cracked Foundation at the Southeast Corner - Two Piers and Angles under this Corner

These piers will allow this structure to be lifted enough to ensure the load of the home is on the piers as this is only a stabilization project. The piers will ensure that this portion of the foundation is stabilized against future settlement. Once the piers are installed and loaded, I recommend that the crack be sealed with a non-shrink cement grout (hydraulic cement) to seal it against pest infiltration or spalling from freezing water in the crack. The locations of the piers are shown in the attached repair plan.
