**Arborist Report
DRAFT**

To: Absher Construction c/o Blaine Wolfe and Integrus Architects c/o Sara Wilder
Site: 1601 39th Ave SE Puyallup, WA 98374
Re: Tree Inventory
Date: January 28, 2022
Project Arborists: George White, ISA Certified Arborist #PN-8098A
ISA Qualified Tree Risk Assessor
Sean Dugan, Registered Consulting Arborist # 475
ISA Board Certified Master Arborist #PN-5459B
ISA Qualified Tree Risk Assessor
Referenced Documents: Survey Existing Conditions A100 (Integrus, 1/20/2022)
Attached: Draft - Table of Trees

Tree 397

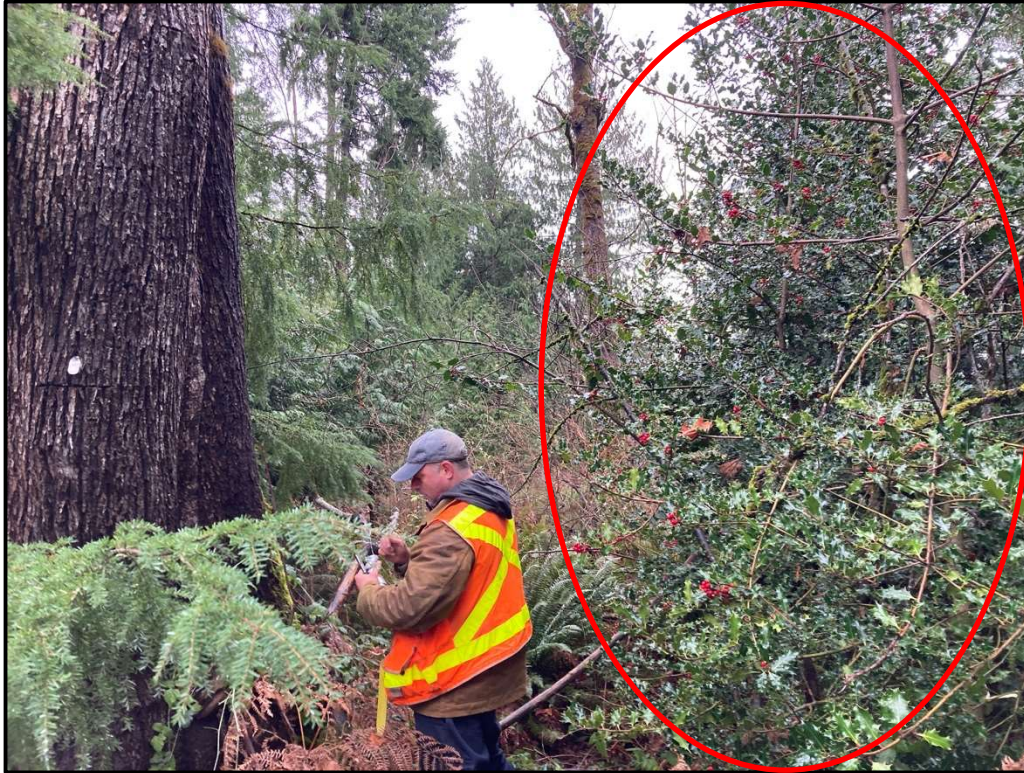
Photo 3. A well-established English holly. (Indicated with red circle.) Holly is an invasive species and can spread rapidly if not contained.

- Tree 422 should have an advanced assessment if proposed for retention.
- All pruning should be conducted by an ISA certified arborist and following ANSI A300 specifications.¹
- Invasive species should be managed prior to development.

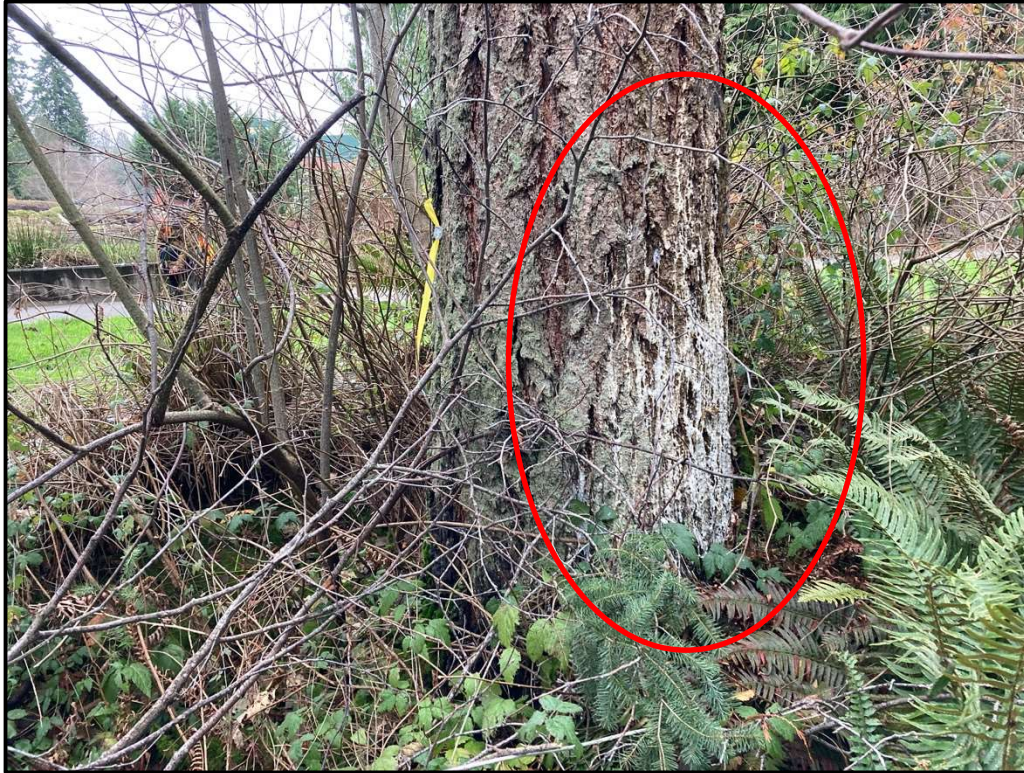
Tree 397 is a Douglas-fir tree adjacent to the pedestrian path (see Appendix C – Figure 1). This tree has a thin canopy compared to other Douglas-fir trees in the area and has excessive pitch flow near the base (See photos 5 and 6). These are both typical symptoms for root decay caused by *Armillaria* fungi. The tree currently presents a moderate risk potential to the surrounding targets. The risk will increase over time and will be a high risk when the site is developed. It is our opinion that this tree is in need of management. We recommend that this tree should be prioritized for reduction to a wildlife snag or removal.

Photo5. Excessive pitch flow near the base of tree 397 (Indicated with red circle). This is a tell-tail symptom of root decay caused by an *Armillaria* fungi.

Tree 397 presents an elevated risk potential that will not improve. This tree should be reduced to a wildlife snag or removed. Trees 408 and 422 are being considered for retention within the site design. If chosen for retention, Tree 422 should have an advanced assessment to evaluate the internal structure and possible management needs.

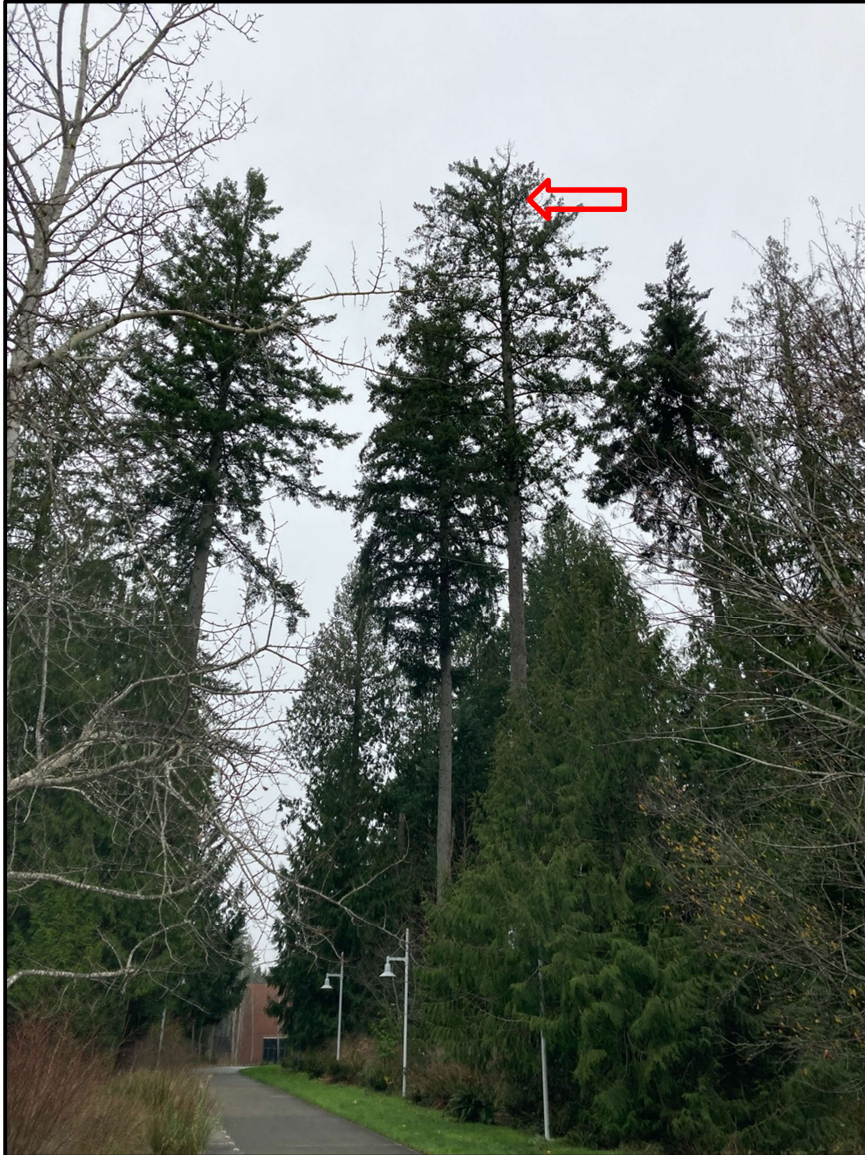
Photo 3. The canopy of tree 397 (Indicated by red arrow). Note how thin the foliage is compared with other healthy Douglas firs in the area. This stress symptom is likely affiliated with root decay caused by *Armillaria sp.*
