wallace
design
collective

Location/WOs: Walmart Store #2403 in Puyallup, WA
Wallace Project No. 2210879, Client Project No. 37554607

Purpose: Preconstruction Meeting

Preconstruction Meeting Photos

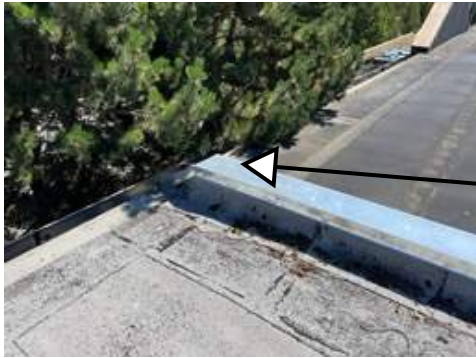
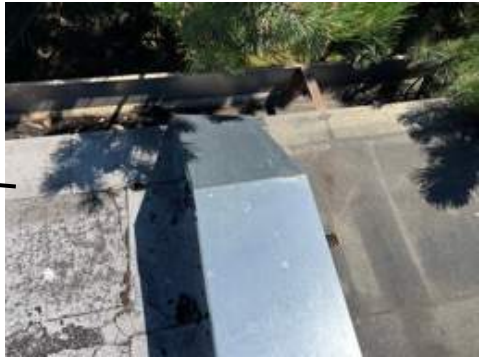
Item # 1 Number Grid:

Description:
B.8a Metal expansion joint cover

Action: Repair as noted
B.8a Remove metal expansion joint cover, rebuild w/ blocking, insulation & vapor retarder per original detail. or approved

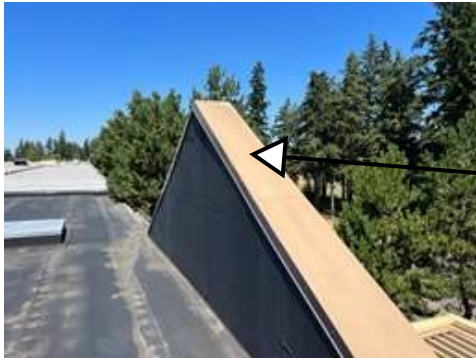
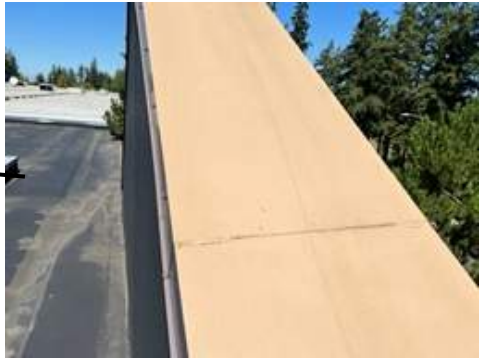
Item # 2 Number Grid:

Description:
E.3 Full width metal cap at sloped and/or level parapets

Action: Repair as noted
E.3 Remove cap, wrap with TPO 2" past top of CMU or EIFS/stucco, cope with ES-1

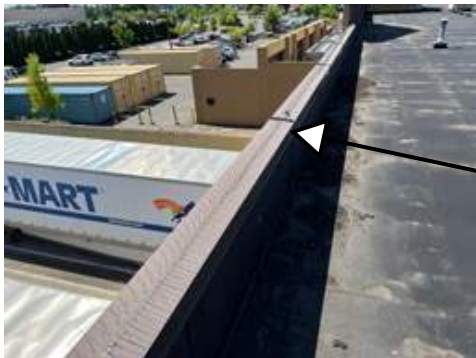
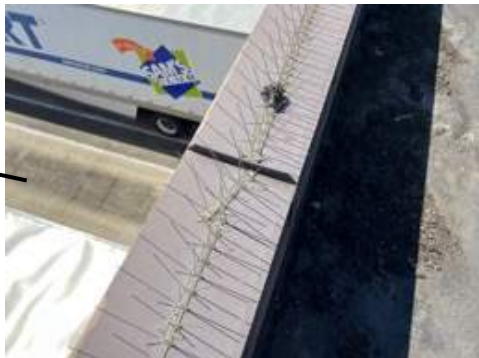
Item # 3 Number Grid:

Description:
L.1 Bird deterrent spikes

Action: Repair as noted
L.1 Submit change order for removing and replacing bird deterrent spikes

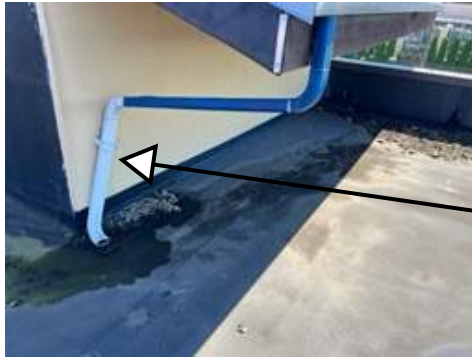
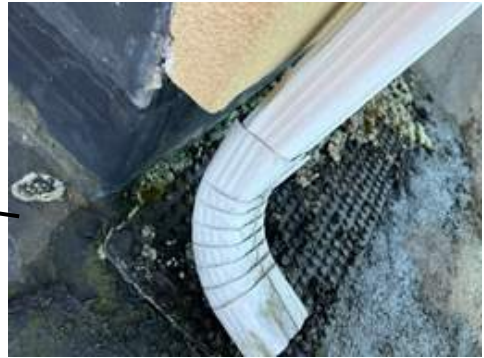
Item # 5 Number Grid:
Doc Ref: RA/Specs Letter Grid:

Description:
10. Damaged downspout(s)

Action: Repair as noted
10. Reattach damaged downspout

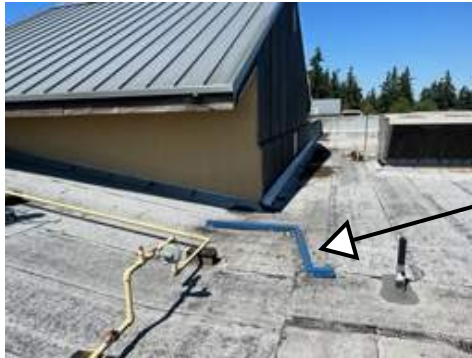
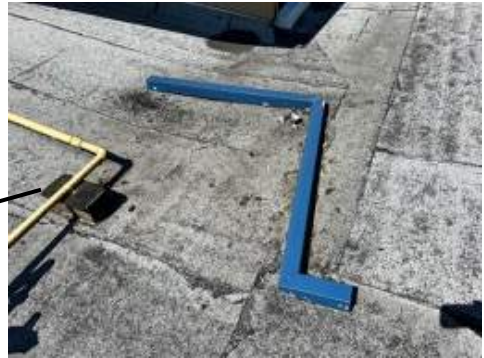
Item # 6 Number Grid:
Doc Ref: RA/Specs Letter Grid:

Description:
10. Damaged downspout(s)

Action: Repair as noted
10. Reattach damaged downspout

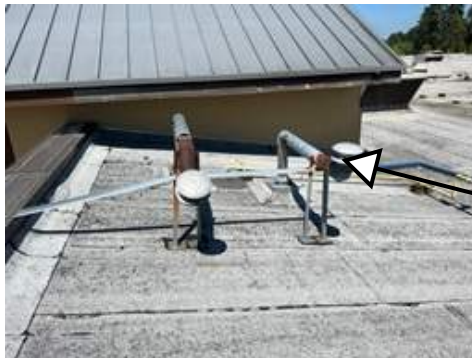
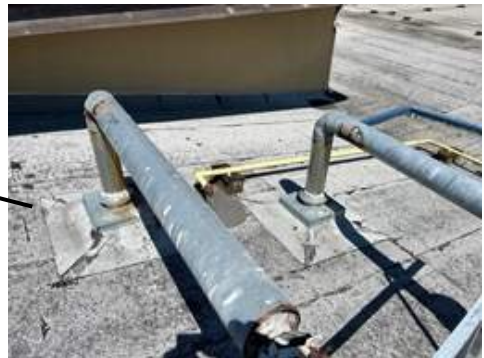
Item # 7 Number Grid:
Doc Ref: RA/Specs Letter Grid:

Description:
L.2 Corroded horizontal heater vent pipes

Action: Repair as noted
L.2 Remove corroded horizontal pipe and elbow joint; leave vertical pipe, reinstall and seal vent cap to vertical pipe

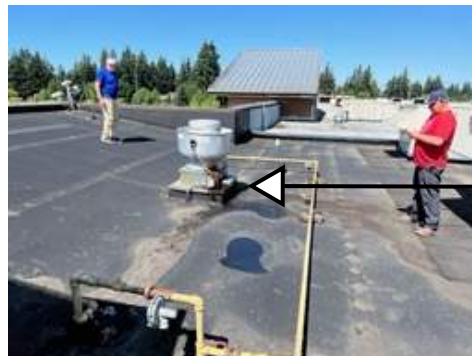
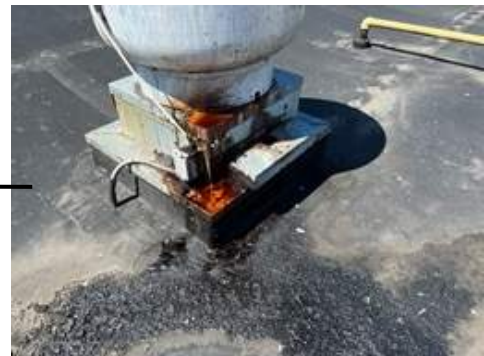
Item # 8 Number Grid:
Doc Ref: RA/Specs Letter Grid:

Description:
21. Defective HVAC equipment (Vender grease trap needs servicing)

Action: Repair as noted
21. Wallace Design Collective has reported this issue to the Walmart HVAC team

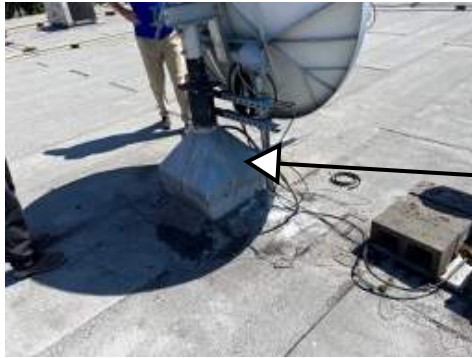
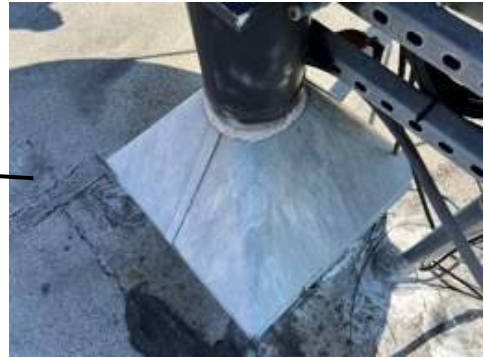
Item # 9 Number Grid:
Doc Ref: RA/Specs Letter Grid:

Description:
L.3 Metal cap at satellite

Action: Repair as noted
L.3 Reseal all edges of metal satellite cover and install new storm collar if damaged or missing and seal with polyurethane sealant

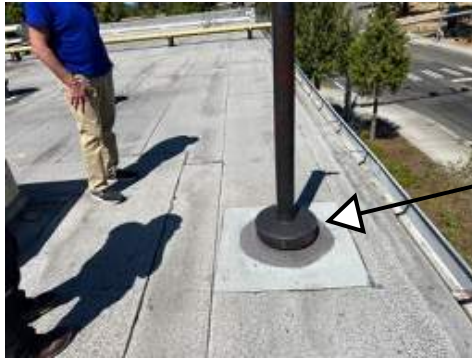
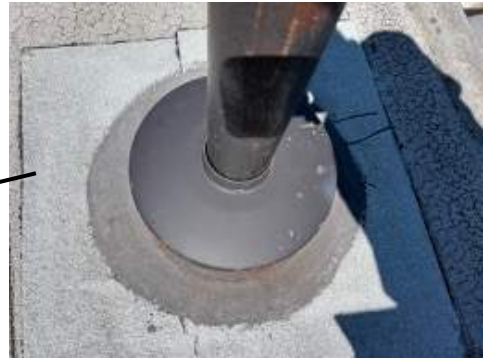
Item # 10 Number Grid:
Doc Ref: RA/Specs Letter Grid:

Description:
C.1 Pipe or vents up to storm collar

10. Install new storm collar if damaged or missing; clean and prime; field wrap to underside of storm collar; seal to pipe w/ butyl-based sealant; clamp at top; remove and replace weathered or missing sealant with polyurethane sealant

Action: Repair as noted
C.1 Install new storm collar if damaged or missing; clean and prime; field wrap to underside of storm collar; seal to pipe w/

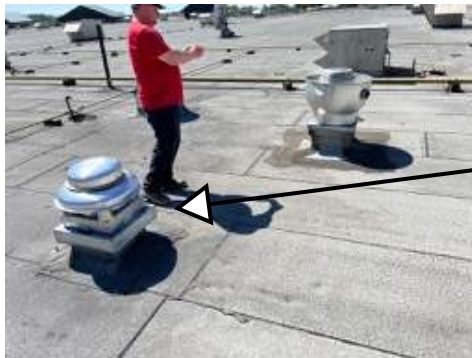
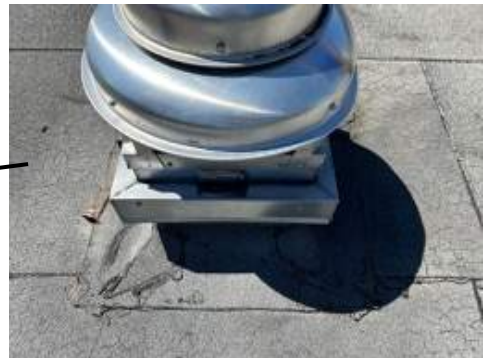
Item # 11 Number Grid:
Doc Ref: RA/Specs Letter Grid:

Description:
K.1 Vent hood with > 2" gap

11. Center hood on curb; if > 2" gap insert pressure treated blocking/foam backer rod; attach hood and blocking/rod to curb w/ (2) gasketed screws ea. Side

Action: Repair as noted
K.1 Center hood on curb; if > 2" gap insert pressure treated blocking/foam backer rod; attach hood and blocking/rod to curb w/ (2)

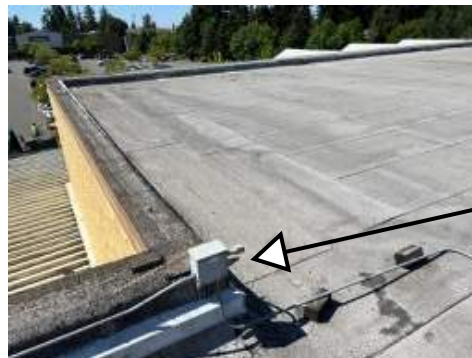
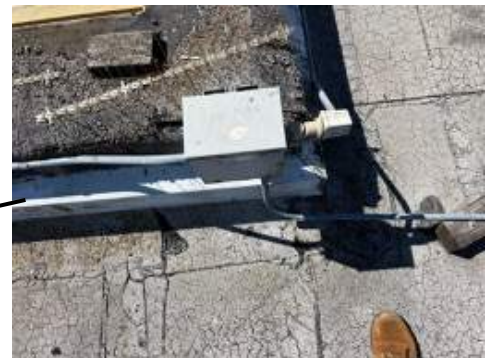
Item # 12 Number Grid:
Doc Ref: RA/Specs Letter Grid:

Description:
L.4 Abandoned electrical fixture box at parapet

Action: Repair as noted
L.4 Remove and dispose of electrical fixture box at parapet once WM approved licensed electrician has verified power has been

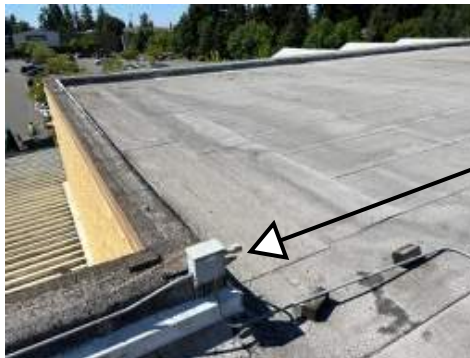
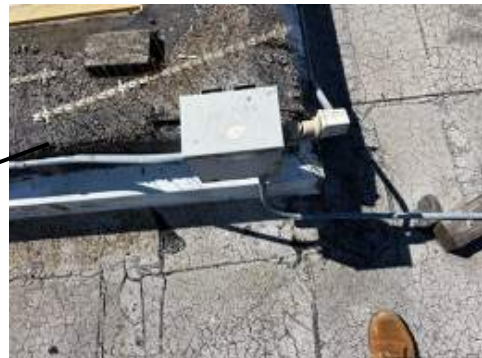
Item # 13 Number Grid:

L.5 Roof to wall perimeter expansion

L.5 At perimeter wall non-structural expansion joints, remove existing expansion joint cover. wood blocking. and/or metal

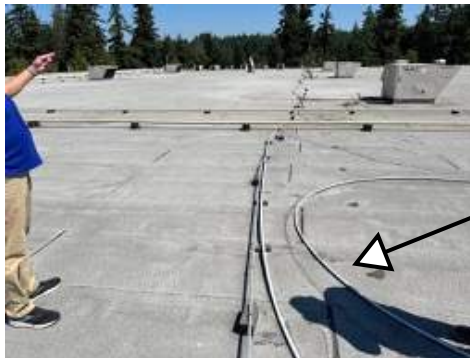
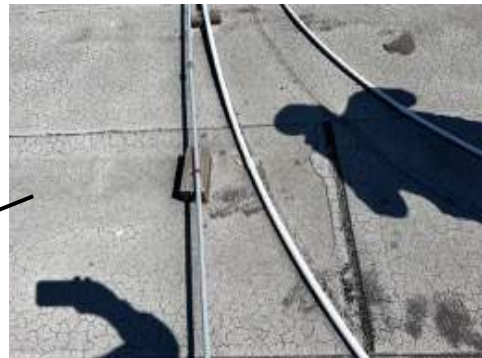
Item # 14 Number Grid:

13c. Abandoned equipment

13d. Remove and dispose of abandoned condensate lines

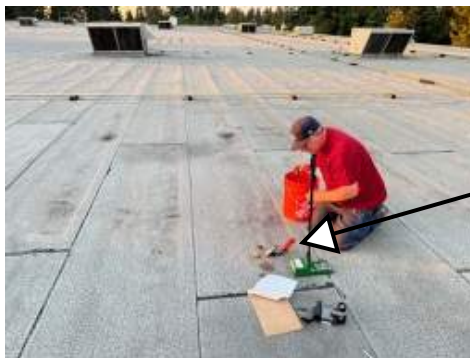
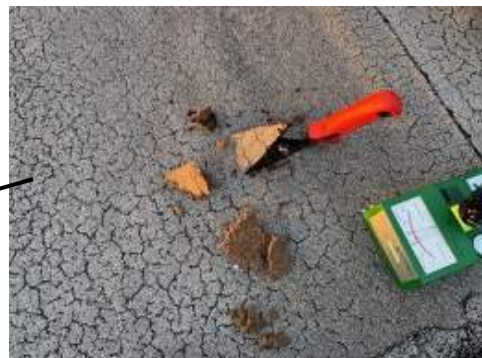
Item # 15 Number Grid:

L.6 Roof core cut

L.6 Proceed as originally specified in RA since existing roof system is Mod-Bit over 1" Perlite over 2" Poly-Iso over metal deck

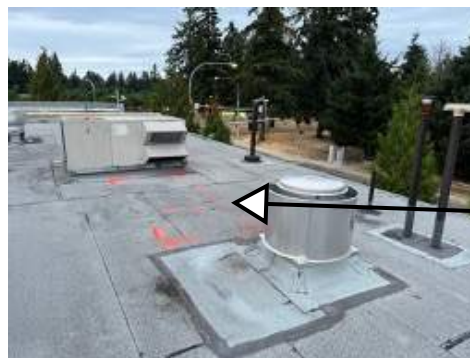
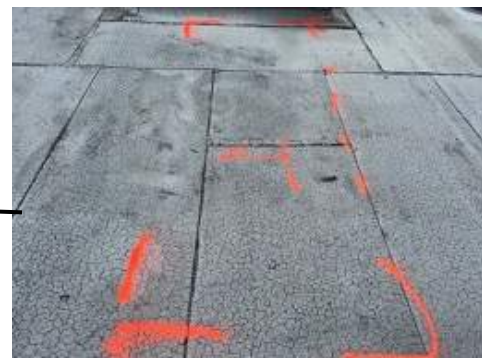
Item # 16 Number Grid:

L.7 Wet insulation that will require replacement as indicated and marked on roof during IR scan (total 1400 sq. ft.)

L.7 Submit CO if added insulation is above amount included in bid, with usage documentation per submitted unit price

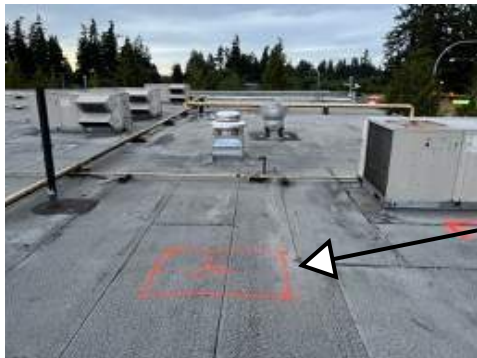
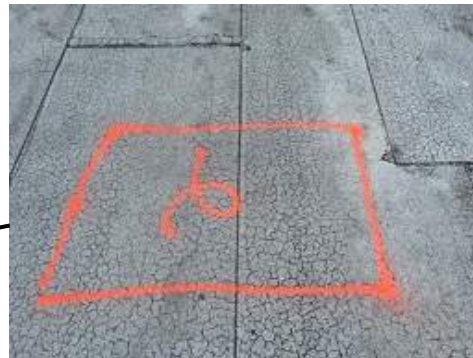
Item # 17 Number Grid:
Doc Ref: RA/Specs Letter Grid:

Description:
L.7 Wet insulation that will require replacement as indicated and marked on roof during IR scan (total 1400 sq. ft.)
Action: Repair as noted
L.7 Submit CO if added insulation is above amount included in bid, with usage documentation per submitted unit price

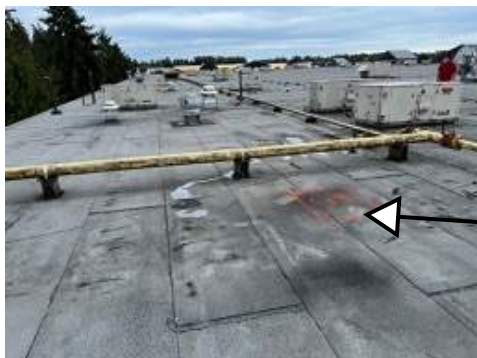
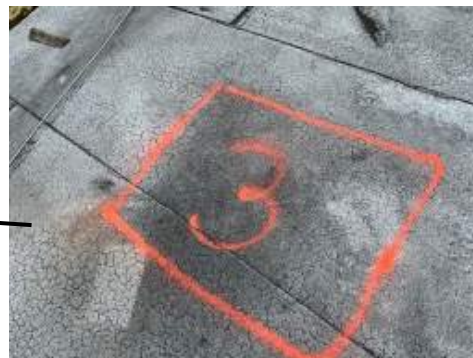
Item # 18 Number Grid:
Doc Ref: RA/Specs Letter Grid:

Description:
L.7 Wet insulation that will require replacement as indicated and marked on roof during IR scan (total 1400 sq. ft.)
Action: Repair as noted
L.7 Submit CO if added insulation is above amount included in bid, with usage documentation per submitted unit price

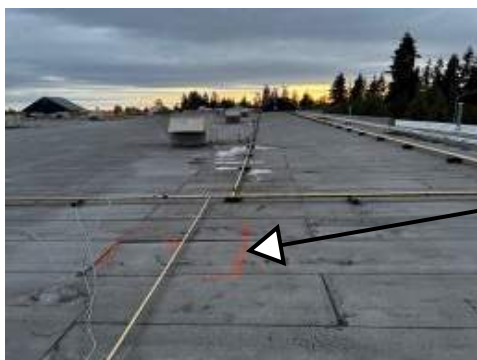
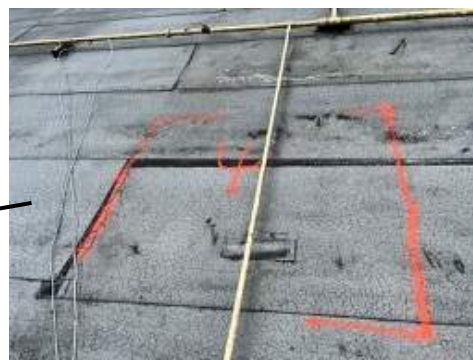
Item # 19 Number Grid:
Doc Ref: RA/Specs Letter Grid:

Description:
L.7 Wet insulation that will require replacement as indicated and marked on roof during IR scan (total 1400 sq. ft.)
Action: Repair as noted
L.7 Submit CO if added insulation is above amount included in bid, with usage documentation per submitted unit price

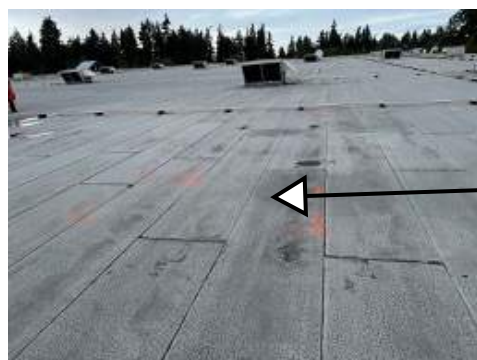
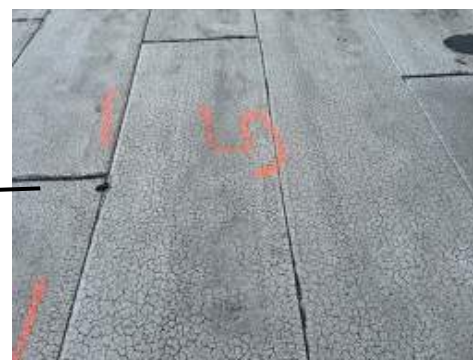
Item # 20 Number Grid:
Doc Ref: RA/Specs Letter Grid:

Description:
L.7 Wet insulation that will require replacement as indicated and marked on roof during IR scan (total 1400 sq. ft.)
Action: Repair as noted
L.7 Submit CO if added insulation is above amount included in bid, with usage documentation per submitted unit price

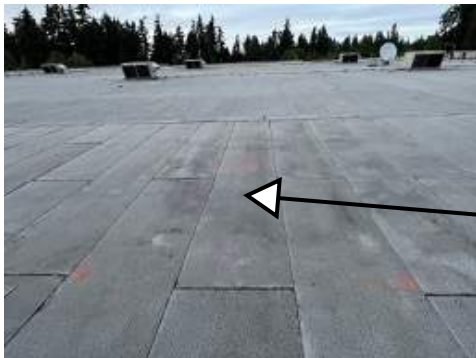
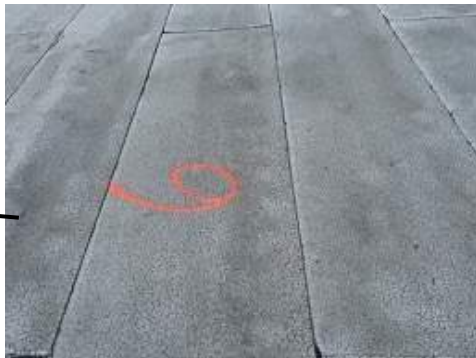
Item # 21 Number Grid:
Doc Ref: RA/Specs Letter Grid:

Description:
L.7 Wet insulation that will require replacement as indicated and marked on roof during IR scan (total 1400 sq. ft.)
Action: Repair as noted

L.7 Submit CO if added insulation is above amount included in bid, with usage documentation per submitted unit price

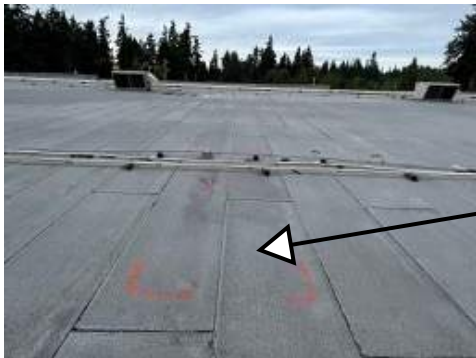
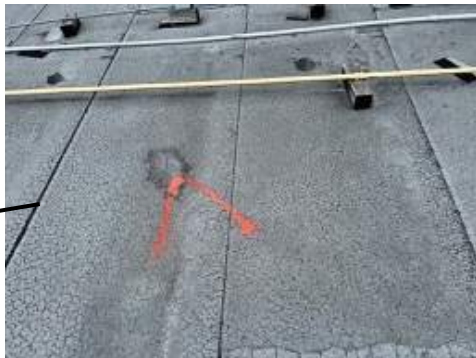
Item # 22 Number Grid:
Doc Ref: RA/Specs Letter Grid:

Description:
L.7 Wet insulation that will require replacement as indicated and marked on roof during IR scan (total 1400 sq. ft.)
Action: Repair as noted

L.7 Submit CO if added insulation is above amount included in bid, with usage documentation per submitted unit price

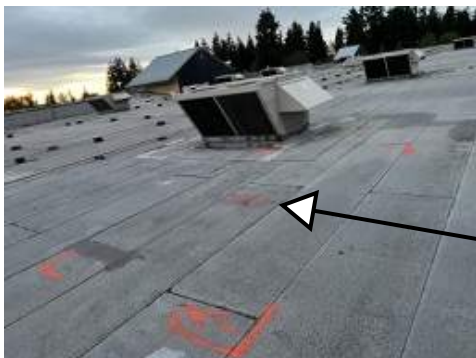
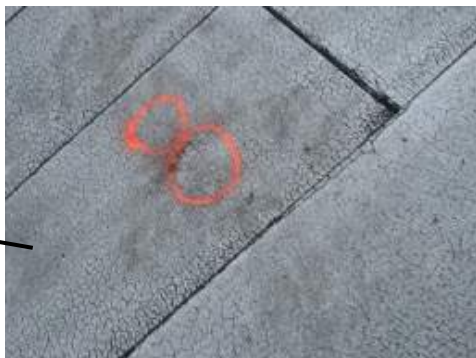
Item # 23 Number Grid:
Doc Ref: RA/Specs Letter Grid:

Description:
L.7 Wet insulation that will require replacement as indicated and marked on roof during IR scan (total 1400 sq. ft.)
Action: Repair as noted

L.7 Submit CO if added insulation is above amount included in bid, with usage documentation per submitted unit price

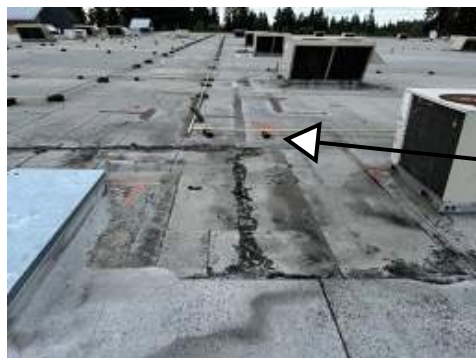
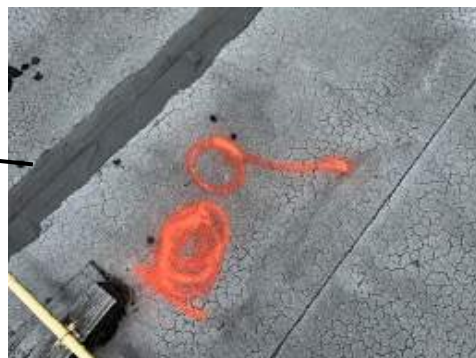
Item # 24 Number Grid:
Doc Ref: RA/Specs Letter Grid:

Description:
L.7 Wet insulation that will require replacement as indicated and marked on roof during IR scan (total 1400 sq. ft.)
Action: Repair as noted

L.7 Submit CO if added insulation is above amount included in bid, with usage documentation per submitted unit price
