- Tree Protection Plan -

PIERCE COLLEGE PUYALLUP

1601 39th Avenue SE
Puyallup, WA

Report Date: November 1, 2022

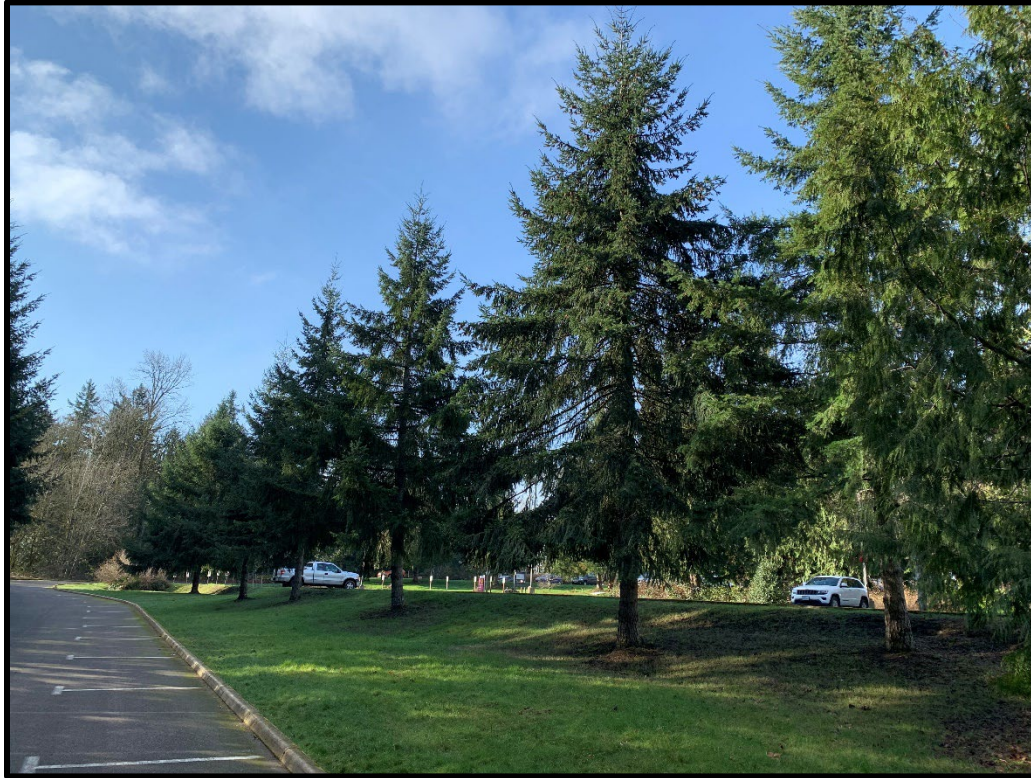
Photo 1. View of trees on Site 1 of the Pierce College Puyallup Site.

Site 1. -- This is located in the SW area of the campus. It consists of a lightly treed landscape area of an existing parking lot. There are 10 significant trees and 5 smaller trees in or potentially impacted around the project area. Tree species in the type include bigleaf maple (*Acer macrophyllum*), Douglas-fir (*Pseudotsuga menziesii*), and western redcedar (*Thuja plicata*).

The tree diameters range from in diameter from 7 to 61 inches DBH. Thirteen (14) of the trees were classified as sound, healthy, long-term trees. The 1 unhealthy tree is a large, dead western redcedar snag. The understory plants include grasses, forbs, and Himalayan blackberry (*Rubus armeniacus*).

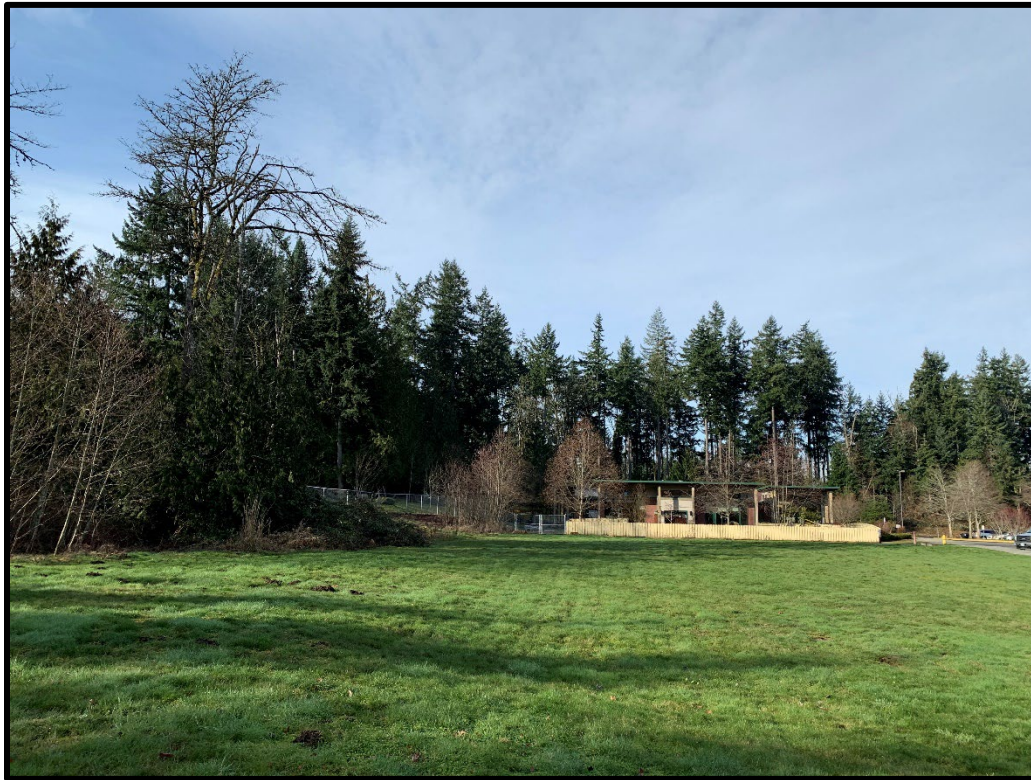
Photo 2. View of Site 2 of the Pierce College Puyallup Site.

Site 2. -- This site is located near the center of campus. Most of the site is a grass field with 3 significant trees along the southern property line. Tree diameters range from 14 to 28 inches DBH. All 3 trees are in ‘Very Poor’ condition and are not long-term trees due to structural defects or poor health (dead, diseased, or hazardous). The understory plants include Himalayan blackberry, grasses, and forbs.

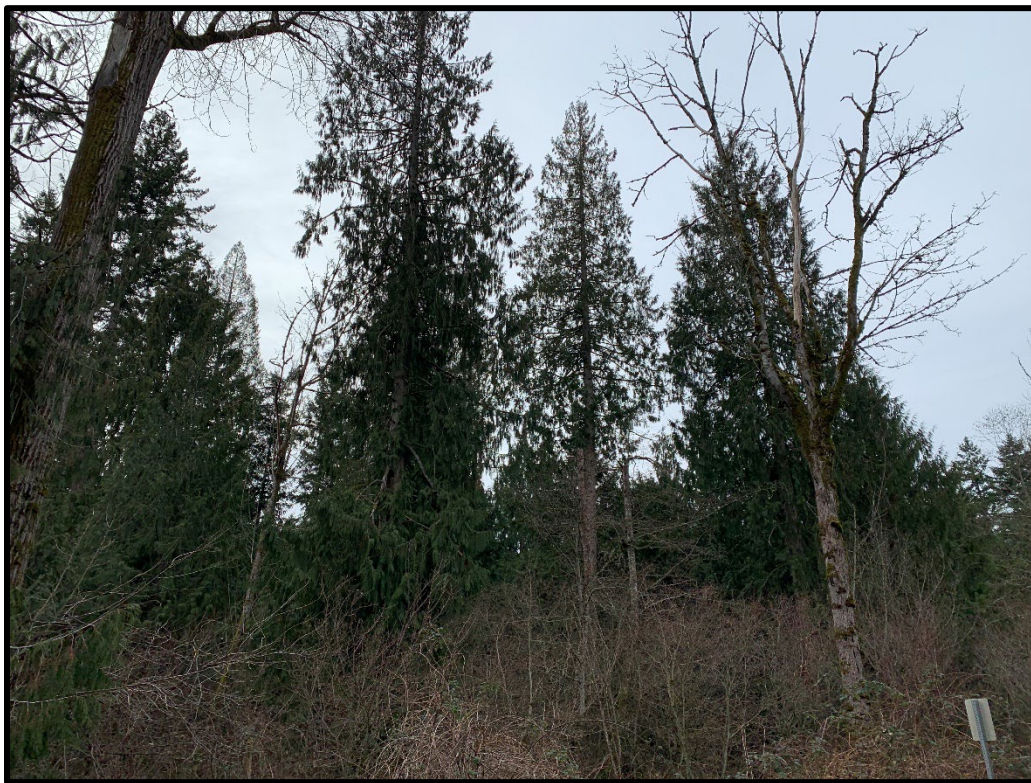
Photo 3. View of Site 3 of the Pierce College Puyallup Site.

Site 3. -- This is located in the northern area of the campus near the Health Education Center building. It is a fully stocked forest of western redcedar, bigleaf maple, Douglas-fir, red alder (*Alnus rubra*), black cottonwood (*Populus trichocarpa*), and western hemlock (*Tsuga heterophylla*).

The tree diameters range from in diameter from 15 to 50 inches DBH. Twenty-six trees were previously inventoried for a different version of the site plan but are now out of the project area. These trees were removed from the significant tree list in Attachment 2 and not included in the tree counts. Fifty-seven (57) of the trees were classified as sound, healthy, long-term trees. Twenty-four (24) trees are in ‘Poor’ or worse condition. The understory is very dense with Himalayan blackberry, vine maple (*Acer circinatum*), sword fern (*Polystichum munitum*), and salmonberry (*Rubus spectabilis*).
