Pre-Demolition Hazardous Material Inspection (ACM)

Parcel #7845100032 Taco Time NW Limited Interior Survey

1115 E Main Ave. Puyallup, WA, 98372

Date of Completion: 8/26/2024

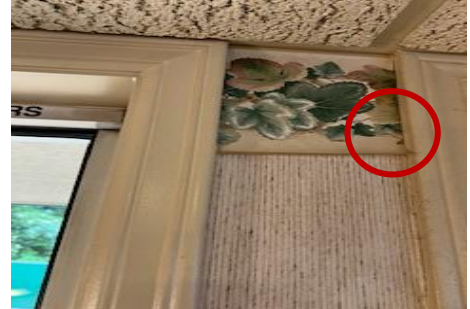
Description:	Wall-Wallpaper/Mastic
Location:	1-1 Main Area
Asbestos Content:	0.000%
Sample No.	1

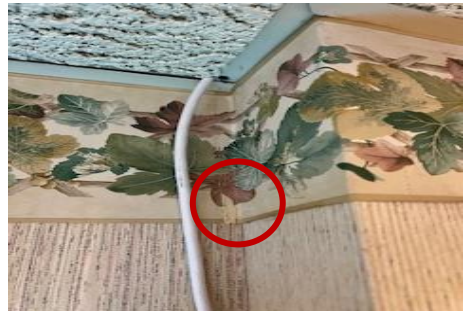
Description:	Wall-Wallpaper/Mastic
Location:	1-2 Main Area
Asbestos Content:	0.000%
Sample No.	2

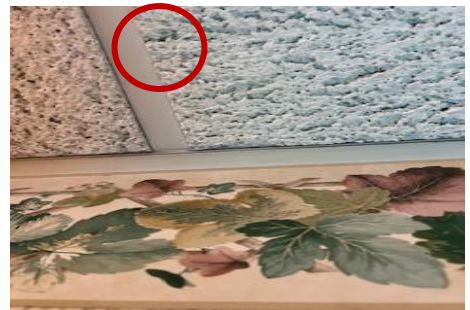
Description:	Ceiling Tile
Location:	2-1 Main Area
Asbestos Content:	0.000%
Sample No.	3

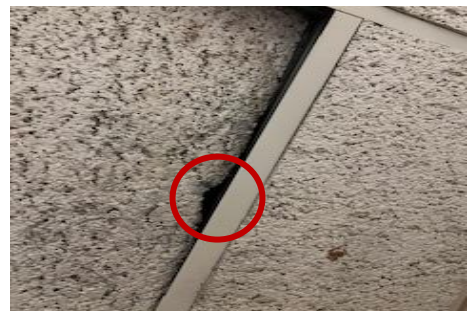
Description:	Ceiling Tile
Location:	2-2 Hall
Asbestos Content:	0.000%
Sample No.	4

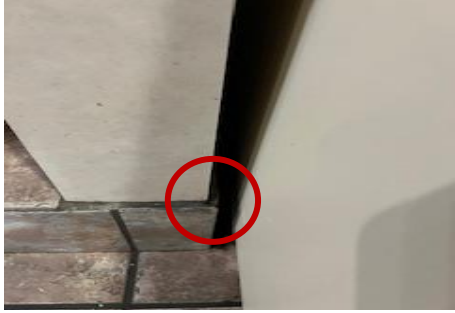
Description:	Wall/Floor Tile/Mortar
Location:	3-1 Main Area
Asbestos Content:	0.000%
Sample No.	5

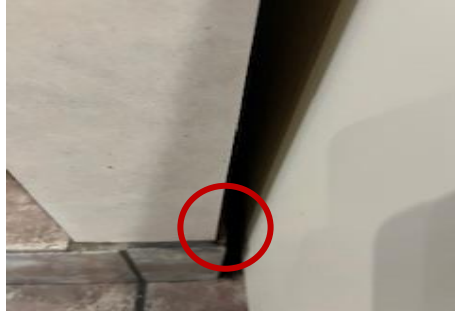
Description:	Wall/Floor Tile/Mortar
Location:	3-2 Main Area
Asbestos Content:	0.000%
Sample No.	6

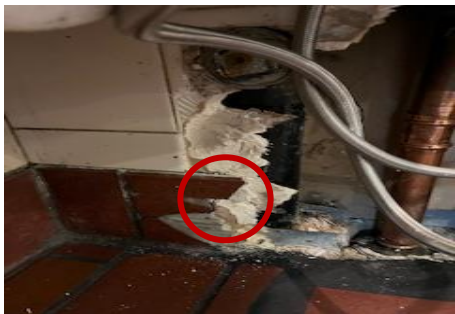
Description:	Wall/Floor Tile/Mortar
Location:	4-1 Main Area
Asbestos Content:	0.000%
Sample No.	7

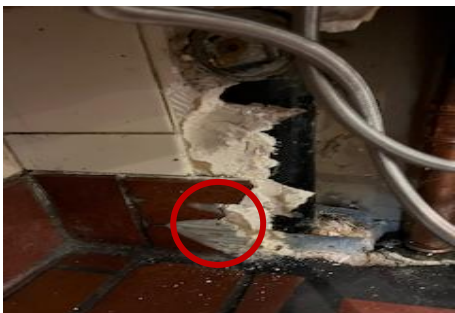
Description:	Wall/Floor Tile/Mortar
Location:	4-2 Main Area
Asbestos Content:	0.000%
Sample No.	8

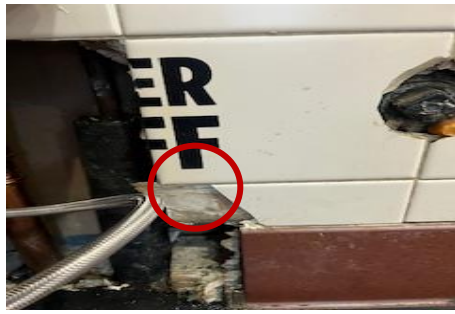
Description:	Wall Tile/Mortar
Location:	5-1 Main Area
Asbestos Content:	0.000%
Sample No.	9

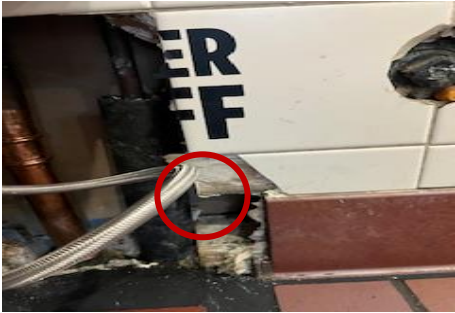
Description:	Wall Tile/Mortar
Location:	5-2 Main Area
Asbestos Content:	0.000%
Sample No.	10

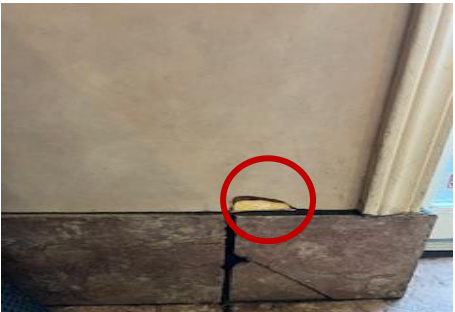
Description:	Wall Paneling /Mastic
Location:	6-1 Entrance
Asbestos Content:	0.000%
Sample No.	11

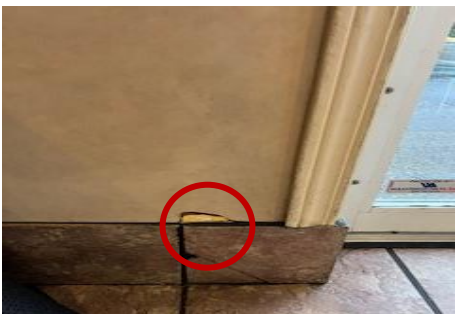
Description:	Wall Paneling /Mastic
Location:	6-2 Entrance
Asbestos Content:	0.000%
Sample No.	12

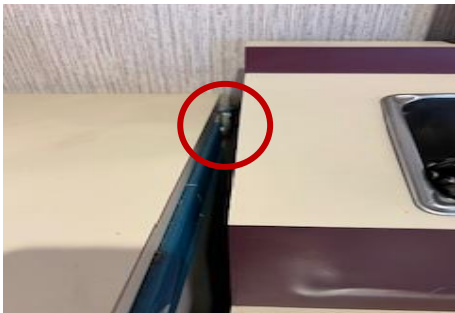
Description:	Wall Tile/Mortar
Location:	7-1 Main Area
Asbestos Content:	0.000%
Sample No.	13

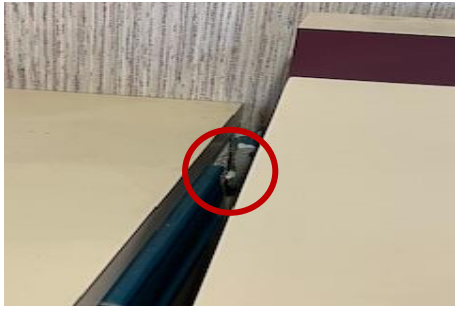
Description:	Wall Tile/Mortar
Location:	7-2 Main Area
Asbestos Content:	0.000%
Sample No.	14

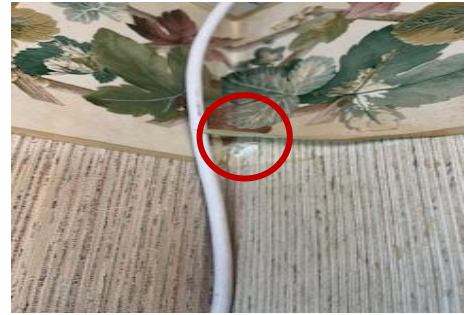
Description:	Wall-Wallpaper/Texture/WB
Location:	8-1 Hall
Asbestos Content:	0.000%
Sample No.	15

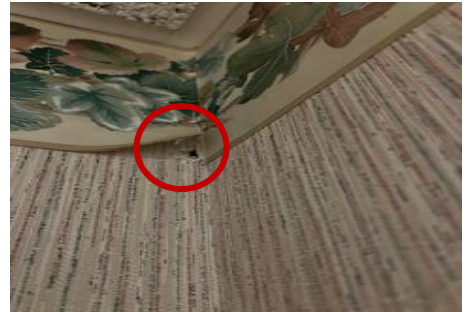
Description:	Wall-Wallpaper/Texture/WB
Location:	8-2 Main Area
Asbestos Content:	0.000%
Sample No.	16

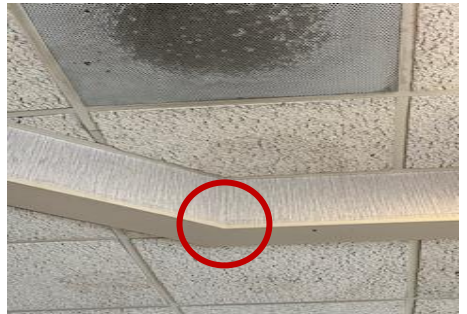
Description:	Wall-Wallpaper/Texture/WB
Location:	8-3 Main Area
Asbestos Content:	0.000%
Sample No.	17

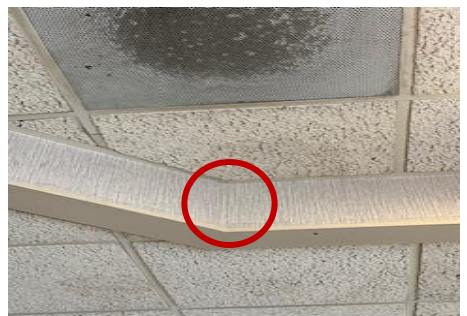
Description:	Wall-Wallpaper/Texture/WB
Location:	8-4 Main Area
Asbestos Content:	0.000%
Sample No.	18

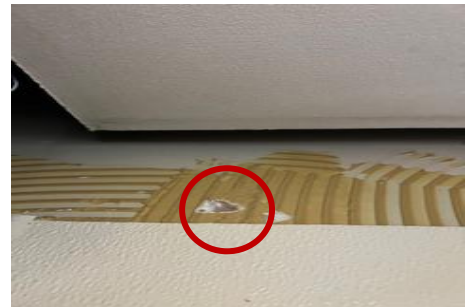
Description:	Wall-Wallpaper/Texture/WB
Location:	8-5 Kitchen
Asbestos Content:	0.000%
Sample No.	19

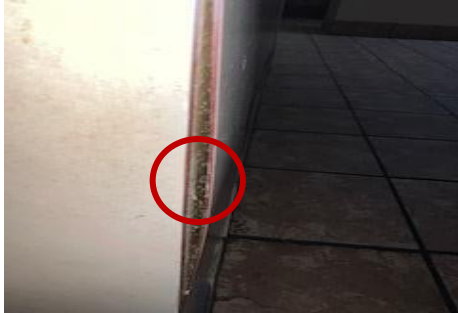
Description:	Paneling Glue
Location:	9-1 Main Area
Asbestos Content:	0.000%
Sample No.	20

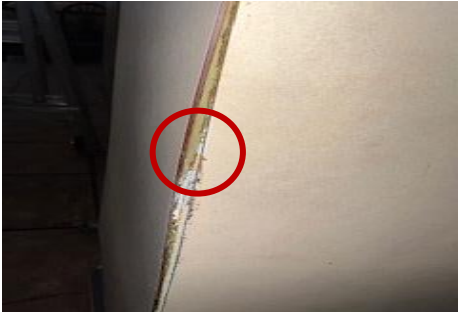
Description:	Paneling Glue
Location:	9-2 Hall
Asbestos Content:	0.000%
Sample No.	21

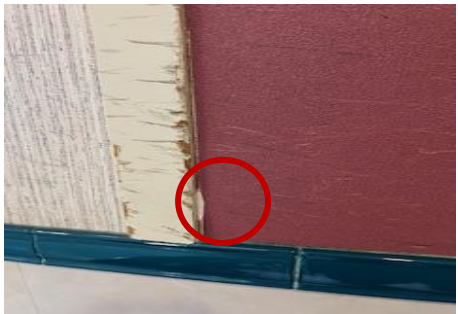
Description:	Wall-Wallpaper/Mastic
Location:	10-1 Main Area
Asbestos Content:	0.000%
Sample No.	22

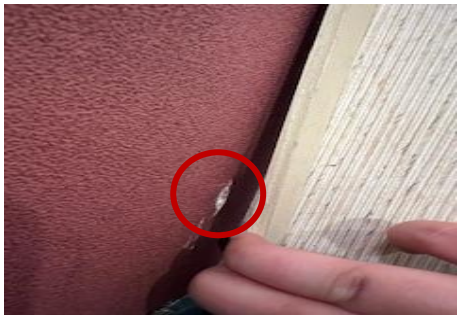
Description:	Wall-Wallpaper/Mastic
Location:	10-2 Main Area
Asbestos Content:	0.000%
Sample No.	23

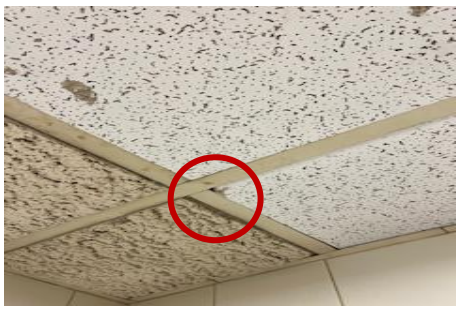
Description:	Ceiling Tile
Location:	11-1 Men's Restroom
Asbestos Content:	0.000%
Sample No.	24

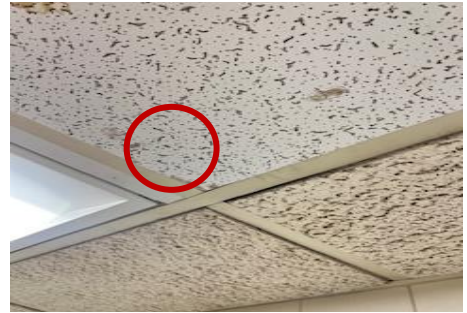
Description:	Ceiling Tile
Location:	11-2 Men's Restroom
Asbestos Content:	0.000%
Sample No.	25

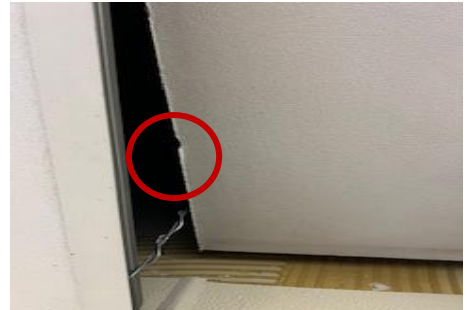
Description:	Ceiling Tile
Location:	12-1 Kitchen
Asbestos Content:	0.000%
Sample No.	26

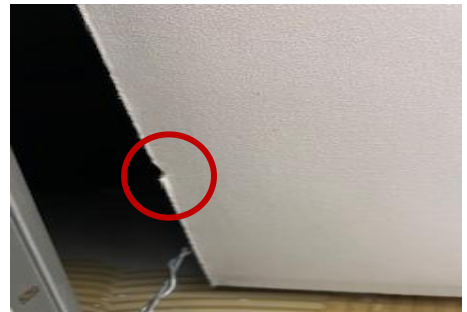
Description:	Ceiling Tile
Location:	12-2 Kitchen
Asbestos Content:	0.000%
Sample No.	27

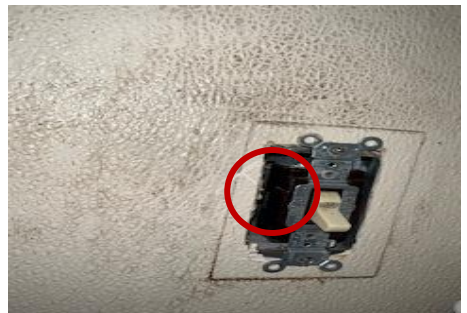
Description:	Paneling Glue
Location:	13-1 Closet
Asbestos Content:	0.000%
Sample No.	28

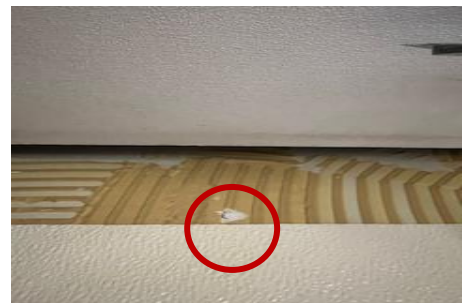
Description:	Paneling Glue
Location:	13-2 Kitchen
Asbestos Content:	0.000%
Sample No.	29
