Arborist and TRAQ Report for Meridian Pointe

Prepared on June 13th, 2023

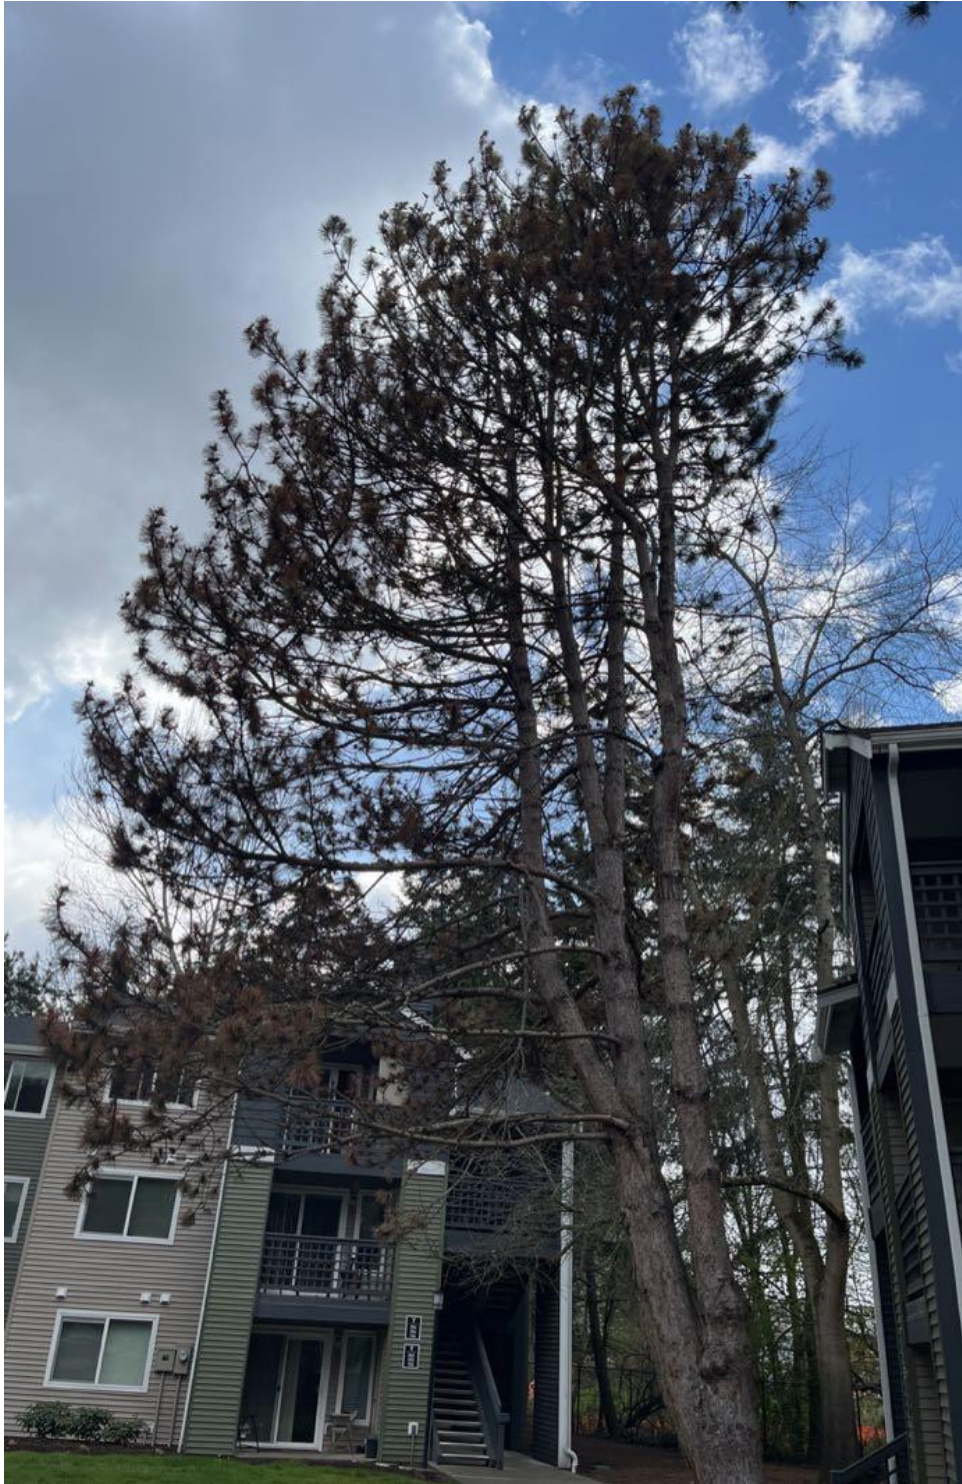
Photo – A

- Tree 1
 - Austrian Pine, *Pinus nigra*
 - The tree has a DBH of 23.5".

- The height of the tree is approximately 55 feet tall.
- The foliage color is brown.
- Borer holes and frass are present.
- The tree has a lean towards a lawn and sidewalk and mounding of the soil was observed on the tension side.

- The branches on the building side appear to have been repeatedly cleared, leaving the crown unbalanced, with most remaining branches on the side of the lean.

- The tree has codominant leaders with a poor union, one of which further splits into another codominant.
- The targets of the tree are pedestrian walkway, building, and parking lot.

Taken 4/20/23. Showing full view of tree #1. Note limbs on building side have been removed.

For tree 1, the beetle holes and frass observed, along with the brown color of the foliage indicates that the tree is in very poor health and will most likely continue to decline as time passes. The mounding on the tension side of the lean, along with claims from residents saying they have seen the root plate shifting during high winds, indicates that failure is **probable**. There is a **medium** likelihood of the tree failing into a car, a **high** likelihood of the tree failing towards the lawn and sidewalk, and a **low** likelihood of the tree failing into the building or hitting a pedestrian. The failure and impact rating is **somewhat likely** for a car, **likely** for the lawn and sidewalk, and **unlikely** for the building and pedestrians. Consequences would be **significant** if a car were hit, **minor** if the lawn and sidewalk or building were hit, and **severe** if a person were hit. The overall risk rating of the tree is **moderate**. As the most likely method of failure of this tree is uprooting, pruning would not adequately mitigate the risk. My recommendation is removal.

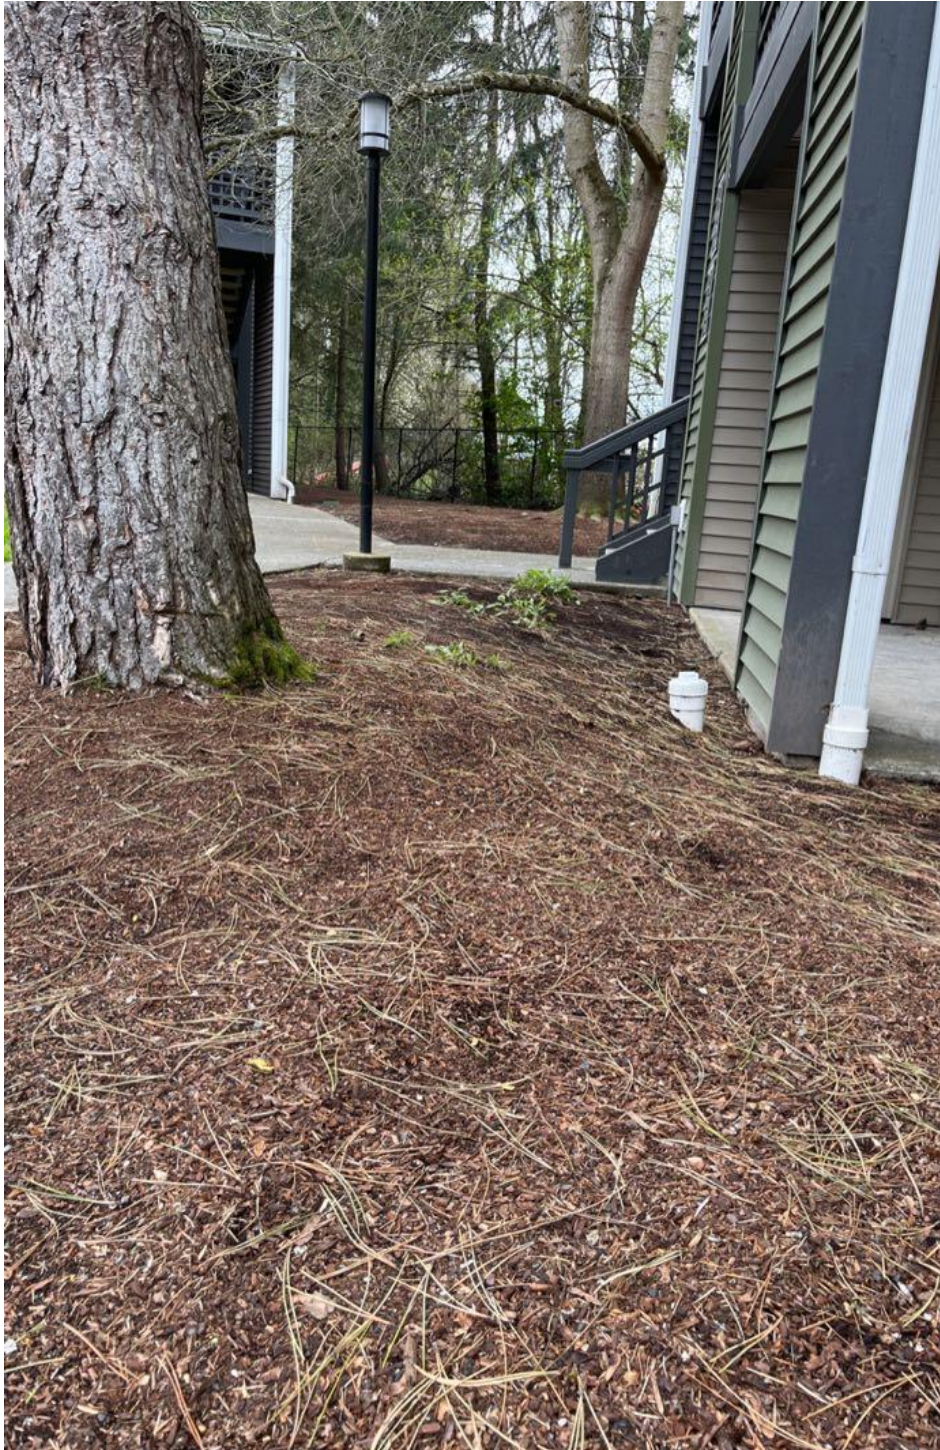
Photo – B
Taken 4/20/23. Showing upheaval on tension side of lean on tree #1.

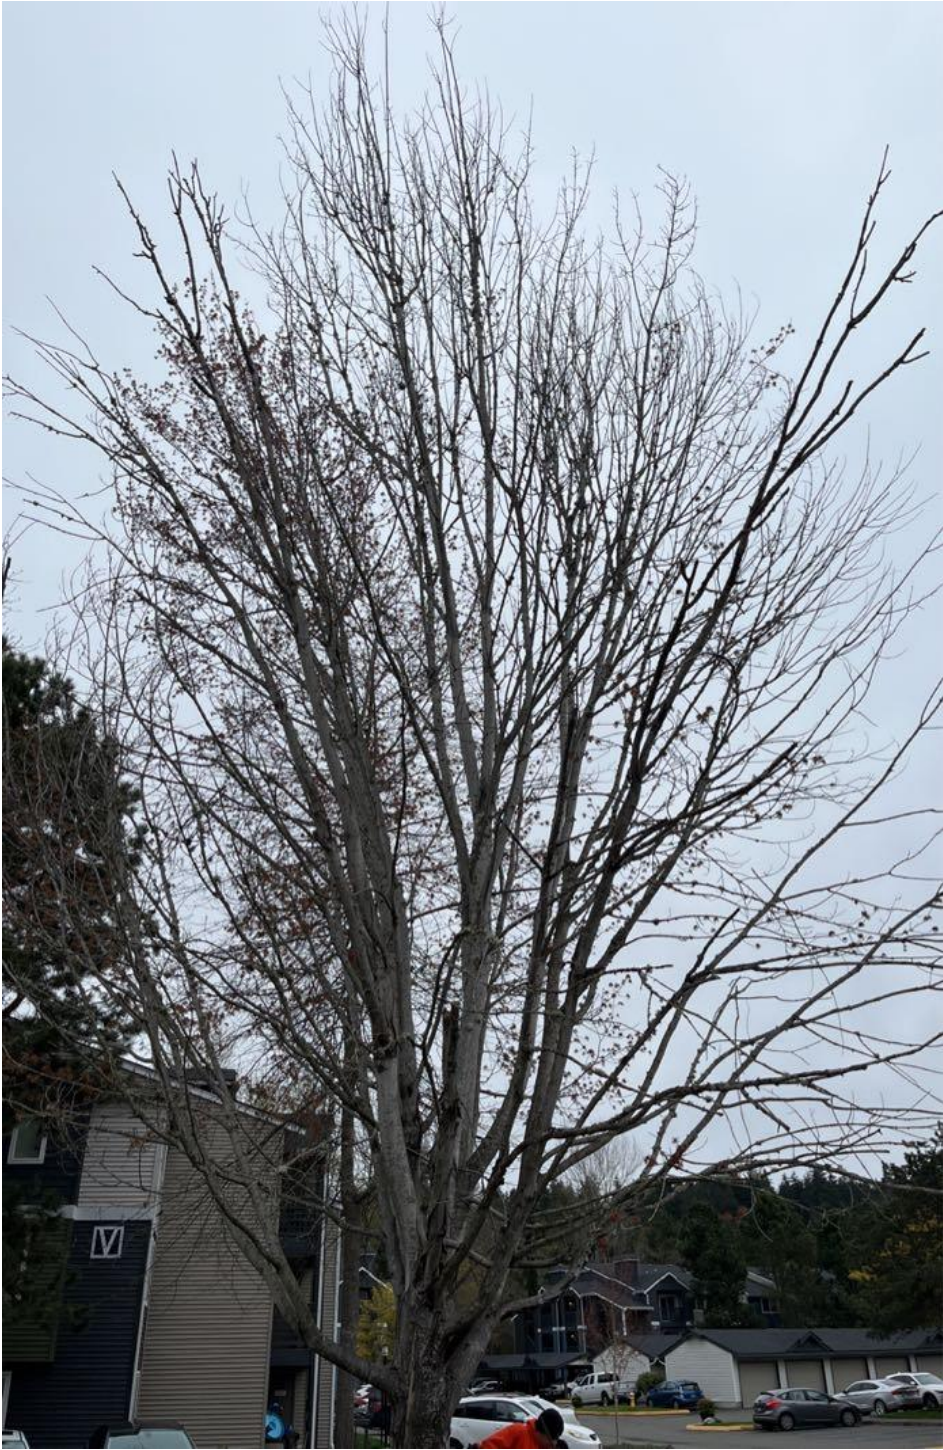
- Tree 1
 - Red Maple, *Acer rubrum*
 - The tree has a DBH of 23.2".
 - The height of the tree is approximately 45 feet tall.
 - Approximately 60% of the tree is dead.

- The remaining foliage color is brown.
 - Many branches on the tree are dead with bark sloughing off.
 - Cankers and discoloration were observed.
 - The targets of the tree are the parking lot and roadway.

Photo – C
Taken 4/20/23. Showing full view of tree #2.

Tree 2 is in decline with very little chance of recovery. There is a significant amount of deadwood in the tree. Whole tree failure is **possible** and large limb failure is **probable**. There is a **high** chance of either of these tree parts striking a car in the parking lot. Consequences would be significant if this were to happen. The overall risk rating of this tree is **high**. Pruning the tree to remove the deadwood is not a viable course of action to mitigate the associated risk, as this would remove the majority of the crown and leave the tree with very poor structure. My recommendation is removal.

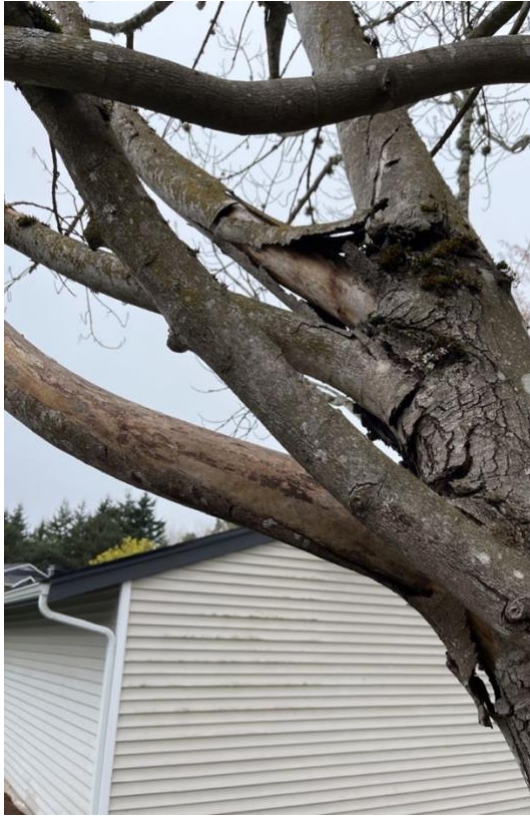
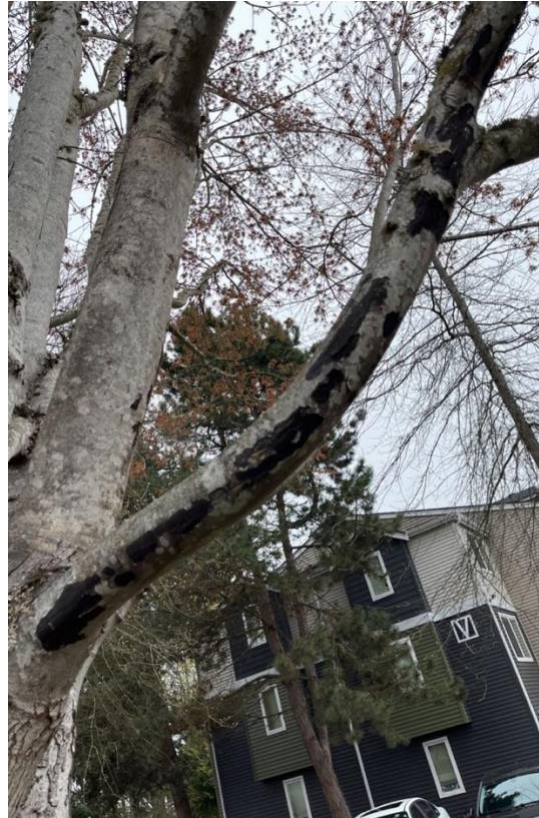
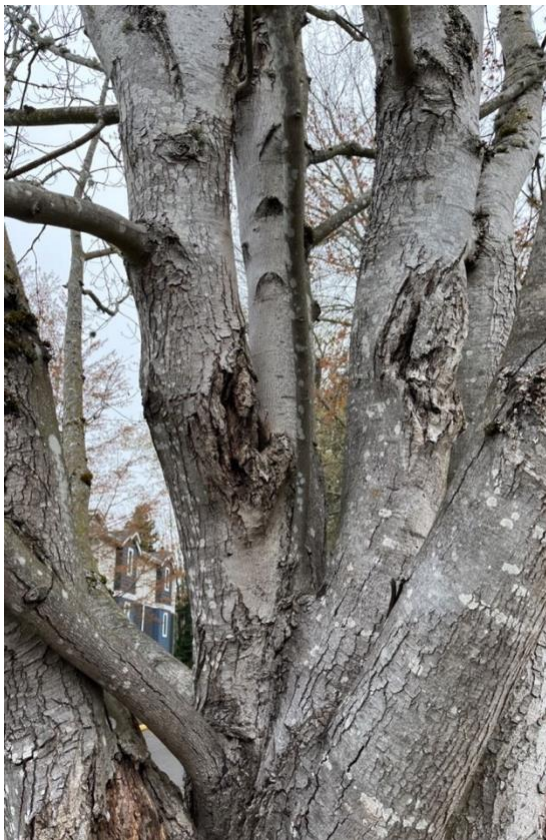
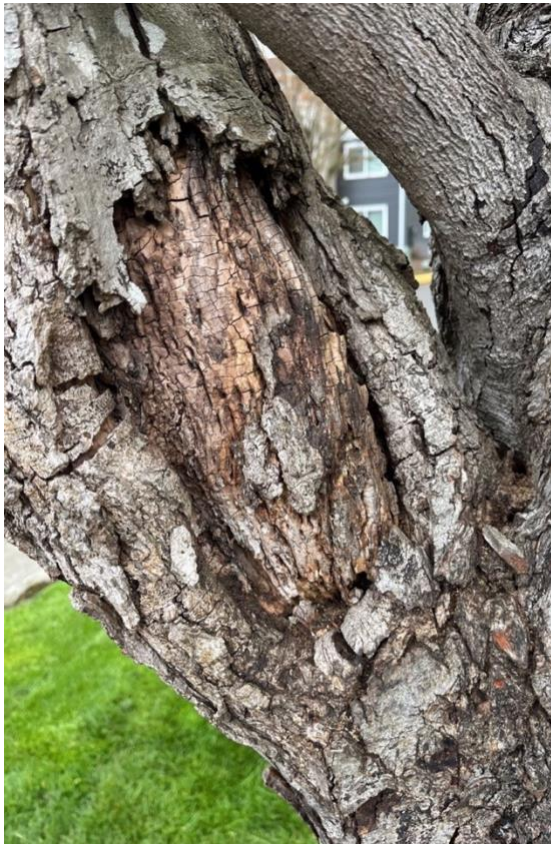
Photo – D, E, and F
Taken 4/2/23. Sloughing bark, discoloration, cankers, and decay on tree #2.

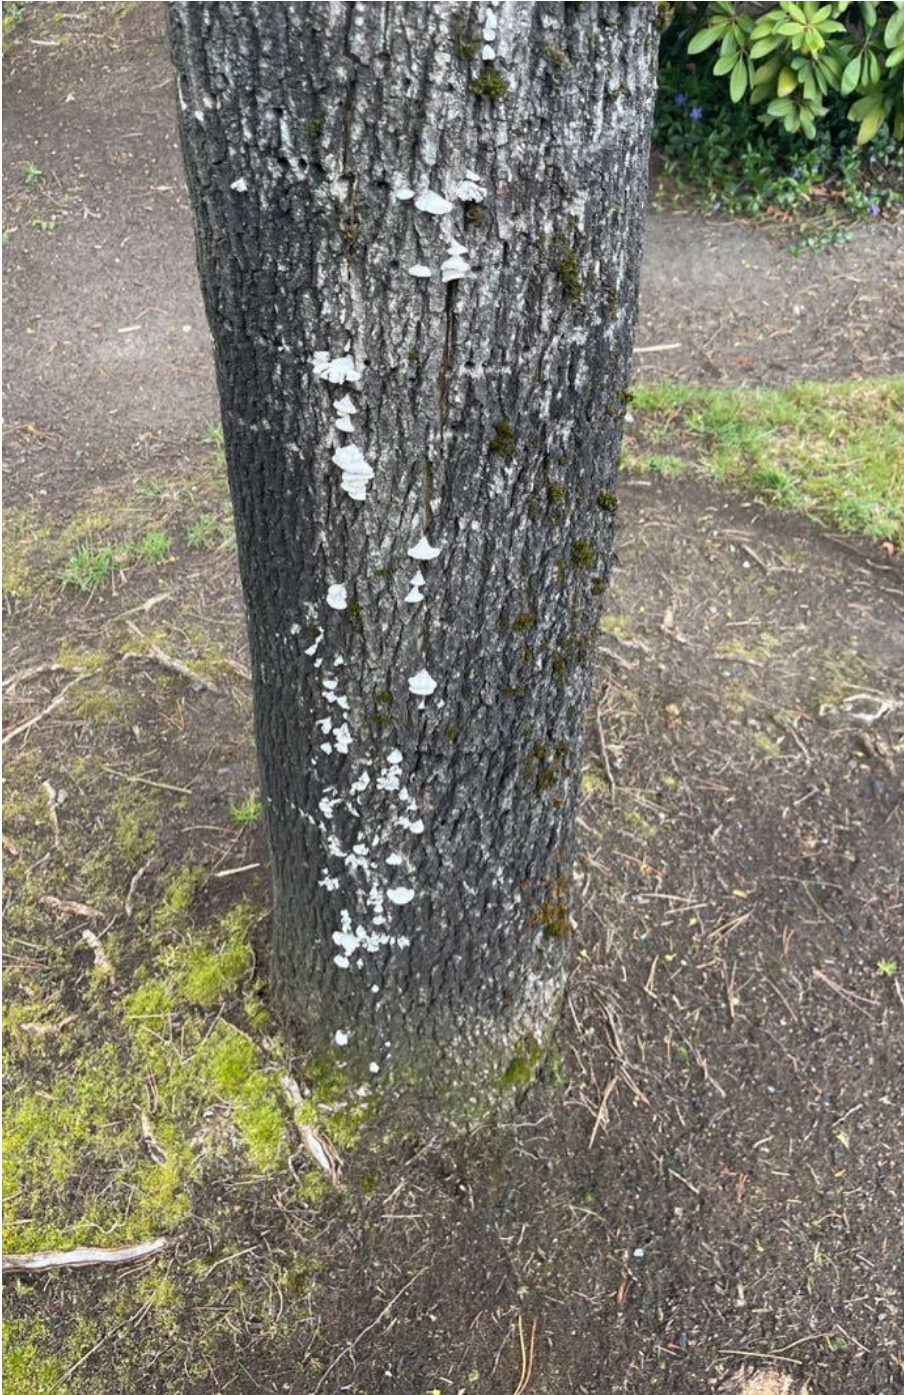
- Tree 3
 - Norway Maple, *Acer platanoides*
 - The tree has a DBH of 10.7".
 - The height of the tree is approximately 25-30 feet tall.
 - Approximately 65% of the tree is dead.

- The remaining foliage color is green.
 - Sapwood rot/fruiting bodies were observed.
 - The targets of the tree are pedestrians on the sidewalk and frequently trafficked arterial roadway.

Photo – G
Taken 4/21/23. Fungal fruiting bodies on trunk of tree #3.

Tree 3 is in decline with very little change of recovery. The majority of the tree is dead and there were fungal fruiting bodies observed on the trunk, indicating sapwood rot. This tree is located in the public ROW. Whole tree failure into the frequently trafficked arterial roadway and the public sidewalk is **possible**. The likelihood of impact onto the sidewalk or roadway is **medium**. The failure and impact rating is **unlikely**, but the consequences would be **significant**. The overall risk rating of this tree is **low**. Although the risk associated with this tree is low, it will most likely continue to decline, and the best course of action is to remove it.

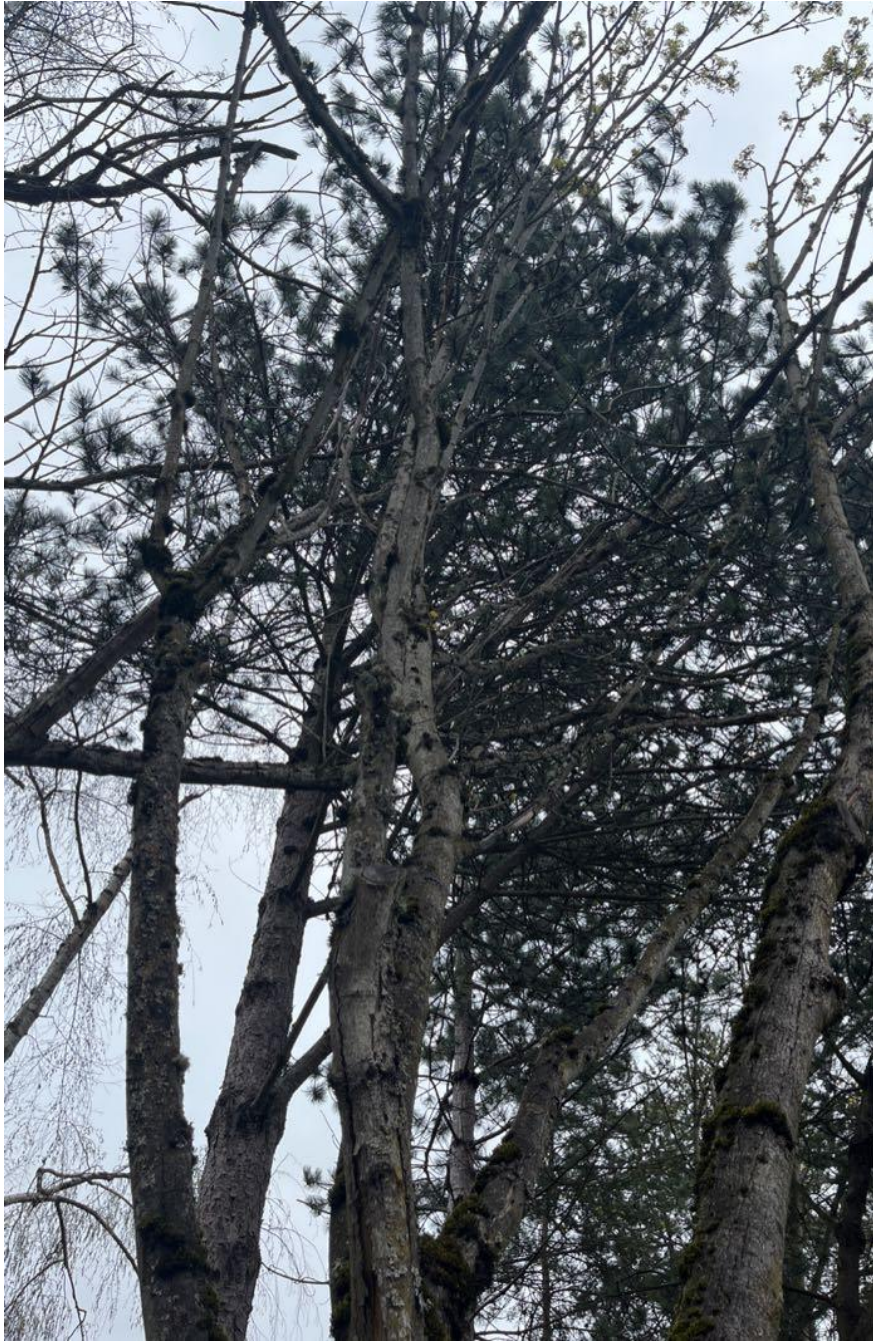
Photo – H
Taken 4/21/23. Crown of tree 3.

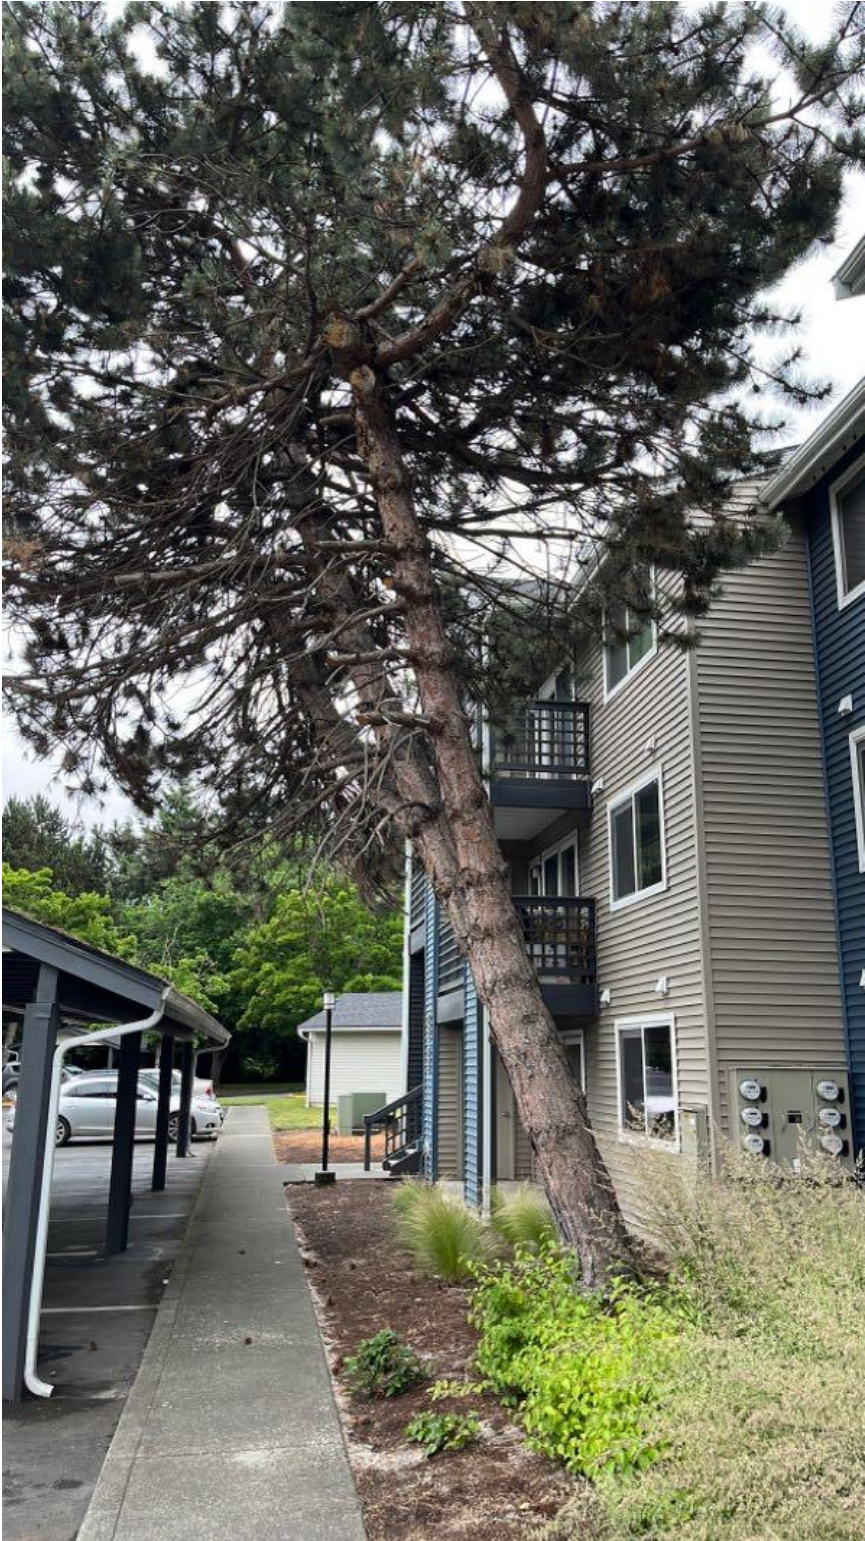
- Tree 4
 - Austrian Pine, *Pinus nigra*
 - The tree has a DBH of 18.5".
 - The height of the tree is approximately 50 feet tall.
 - The foliage color is green.

- Tree is leaning towards carport/parking area and walkway.
 - The root plate appears to be lifting.
 - The targets of the tree are the carport and cars under it and pedestrians on the walkway.

Photo – I
Taken 6/9/23. Showing full view of tree #4.

The lean on tree 4 has been monitored since 2018 and has clearly increased over that time. The increasing lean, along with the soil upheaval on the backside of the tree indicates that whole tree failure is **probable**. There is a **high** likelihood that the tree would strike the carport and cars parked under it if it were to fail. The failure and impact rating is **likely**. The consequences of failure would be **significant**. The overall risk rating of this tree is **high**. As the most likely method of failure of this tree is uprooting, pruning would not adequately mitigate the risk. My recommendation is removal.

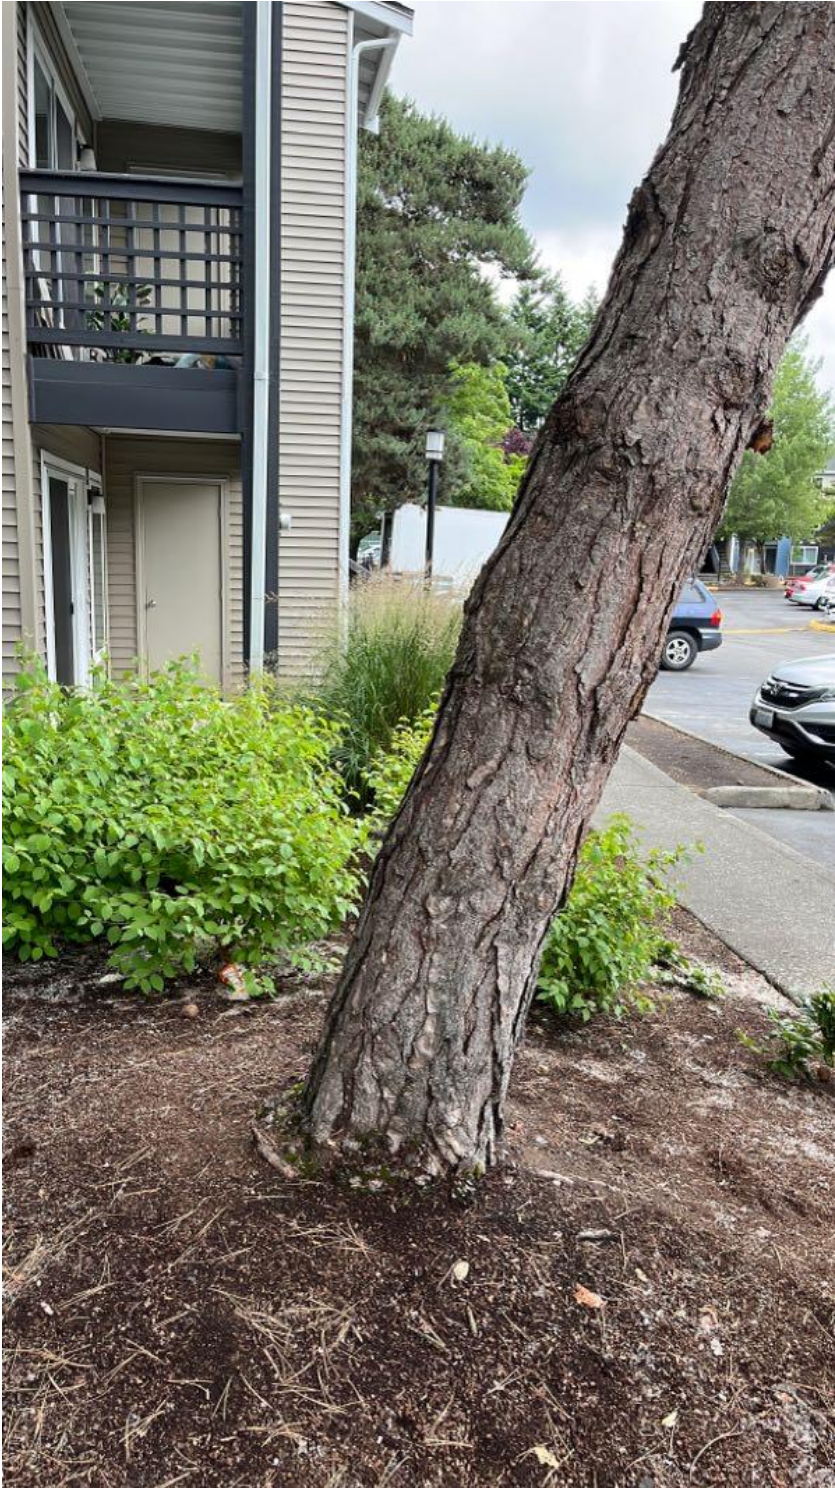
Photo – J
Taken 6/9/23. Base of tree #4.
