Re: *Fire Construction Permit Application*
CUP Modification
Reuse of Storage Tank 5 & 6 for Used Oil

Tank Inspection Report – Mistras

SP001 Formal Internal Inspection

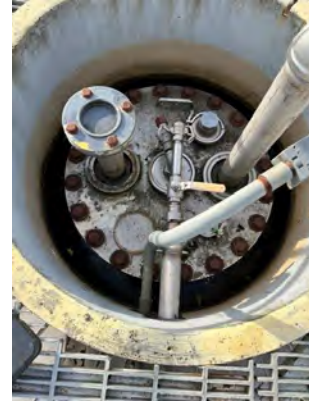
Observable nozzles and appurtenances appeared to be in acceptable condition. Nozzles appeared to be square, flanges were aligned properly, and no notable concerns were noted at time of inspection.

Top Head Appurtenance

- 1) Tank has a 3-inch vent that was plugged at the time of inspection. Per UL-142, Aboveground Steel Tanks for Flammable & Combustible Liquids, for a tank of this size and capacity, a 4" vent is required. This is per Table 8.2 of UL-142. Therefore the recommendation is to install a 4" vent.
- 2) Also per UL-142, Table 8.1, an Emergency Vent (for use in case of a fire) of a size of 10" is required for a tank of this size and capacity. Since the tank does not have one, the installation of a 10" Emergency Vent is recommended.

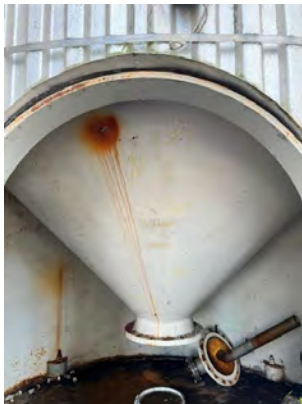
The tank bottom consisted of a 45-degree cone bottom. The external and internal cone bottom were coated at time of inspection. The external coating had areas of coating failure, but the cone bottom is in an enclosed area and not exposed to the elements. The interior coating was in acceptable condition. The cone bottom appeared to be in acceptable condition with no distortions, mechanical damage, or other abnormal conditions.

Cone Bottom

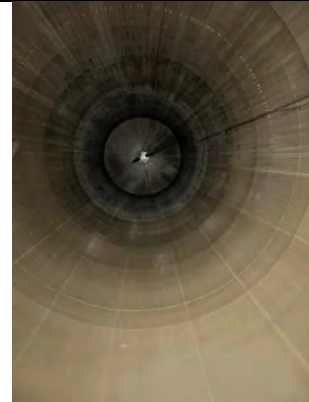
Tank 6 was coated internally and externally. The coating inside the tank appeared to be in acceptable condition. The observable internal shell courses appeared to be in acceptable condition with no notable distortions, mechanical damage or other abnormal conditions. The external shell was insulated and could not be visually inspected. The insulation appeared to be in acceptable condition with no product stains, damage, or other abnormal conditions.

Internal Overview

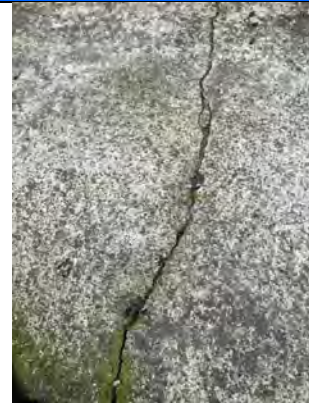
Tank 6 rests within a concrete containment area and is supported by four (4) anchor bolts and an elevated steel skirt. There were hairline cracks noted throughout the concrete containment area. The containment otherwise appeared to be acceptable condition. The steel leg supports, and skirt appeared to be in acceptable condition with no notable distortions, mechanical damage or other abnormal conditions observed.

Hairline Crack in Concrete

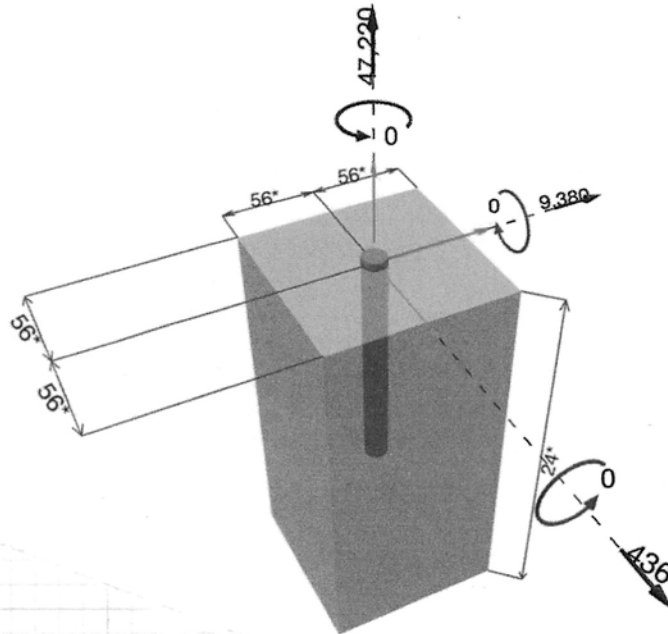
5 Combined tension and shear loads, per ACI 318-19 section 17.8

β_N	β_V	ζ	Utilization $\beta_{N,V}$ [%]	Status
1.256	0.428	1.000	141	not recommended

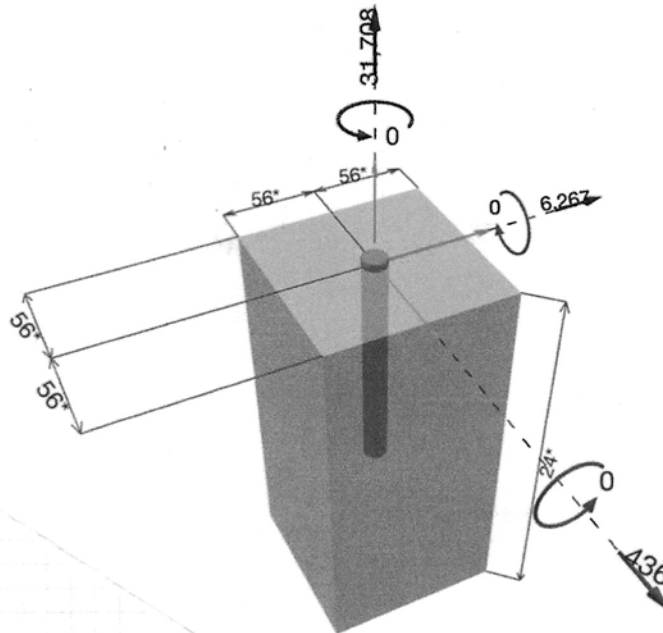
5 Combined tension and shear loads, per ACI 318-19 section 17.8

β_N	β_V	ζ	Utilization β_{NV} [%]	Status
0.844	0.287	5/3	88	OK
