WASHINGTON FORESTRY CONSULTANTS, INC.

RE: Tree Assessment for Bradley Park Phase II Project.

Bradley Park Phase II - Tree Evaluation

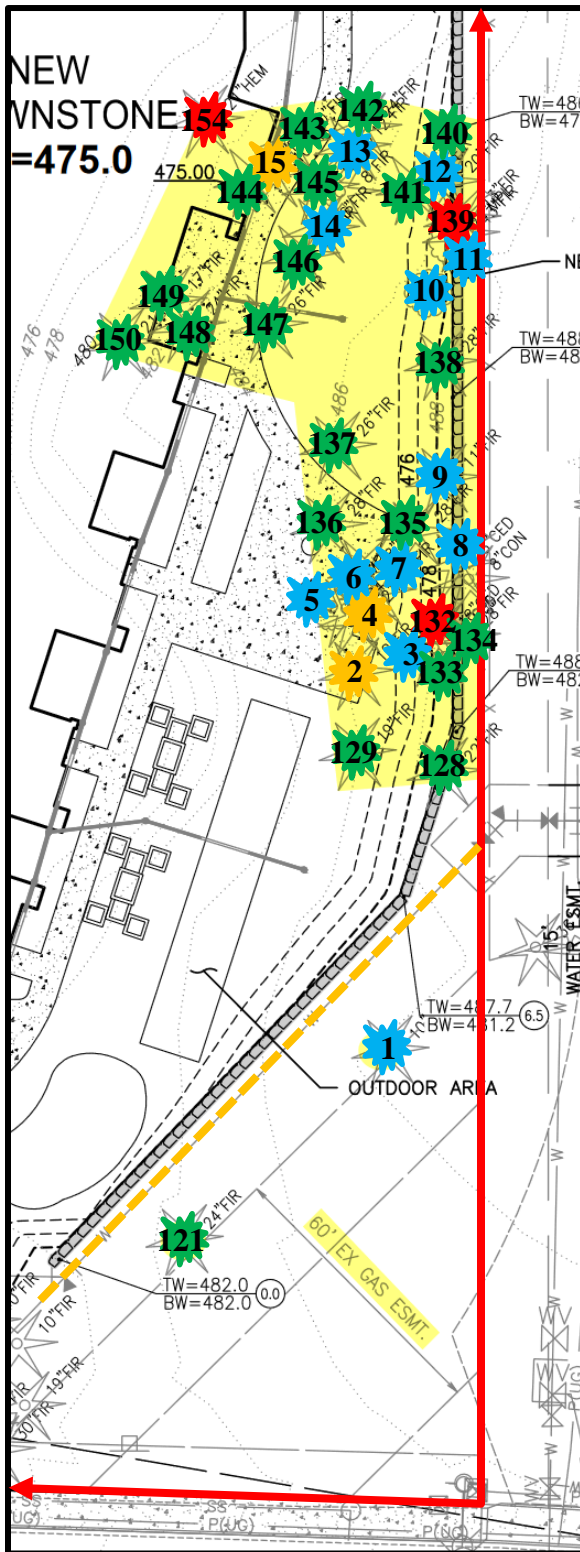
Attachment 2. Bradley Park Phase II Site Plan.

A retaining wall is proposed to be installed along the east side of the parcel. The grade change to the west of the wall will be a 1- to 7-foot cut. All trees to the west of the wall will need to be removed to construct the wall as shown. There are two Douglas-firs (#'s 1 & 121) growing between the wall and adjacent power line rights-of-way that will be able to be retained. The site plan showing the locations of all assessed trees are found on the site plan in Attachment 2 and photos of the site are shown in Attachment 3.

Thirty-eight trees were evaluated for potential construction impacts on the Bradley Park Phase II site. Thirty-six of the trees will need to be removed to construct a proposed wall and complete the required grading. Two Douglas-fir trees can be retained. A tree protection fence shall be installed at the back of wall excavation near the two save trees.

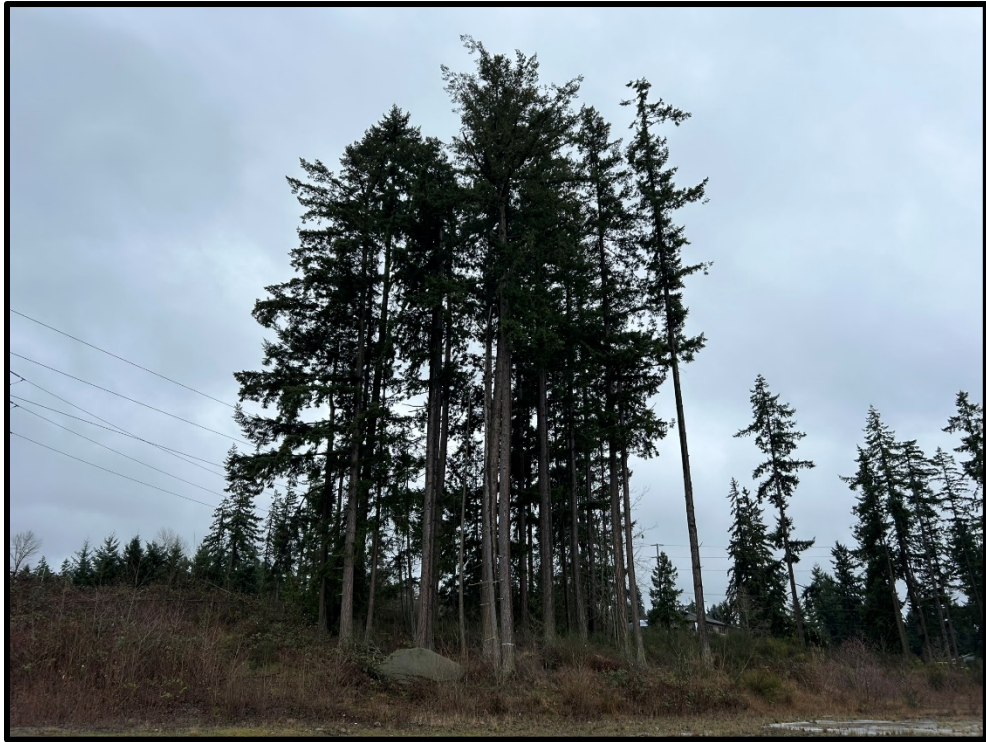
Photo 1. View of trees subject trees on Bradley Park Phase II site.

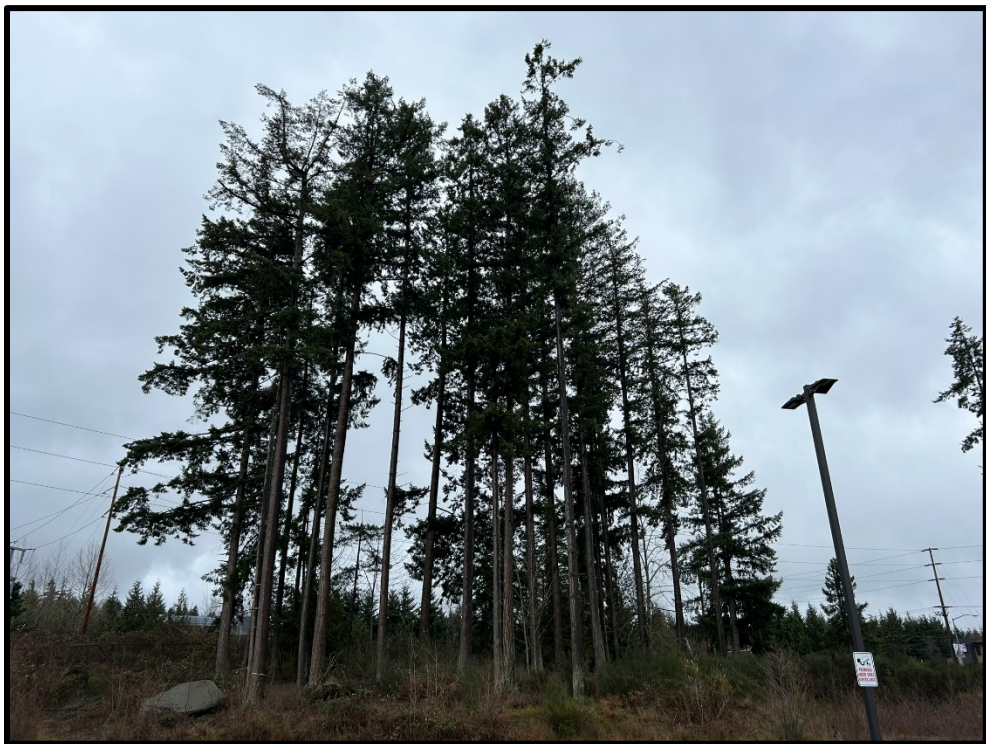
Photo 2. View of trees subject trees on Bradley Park Phase II site.
