Consulting Arborist Services

Reference: Tree Assessment

Site Address: 212 Todd Road NE, Puyallup, WA

Parcel: 0420222008

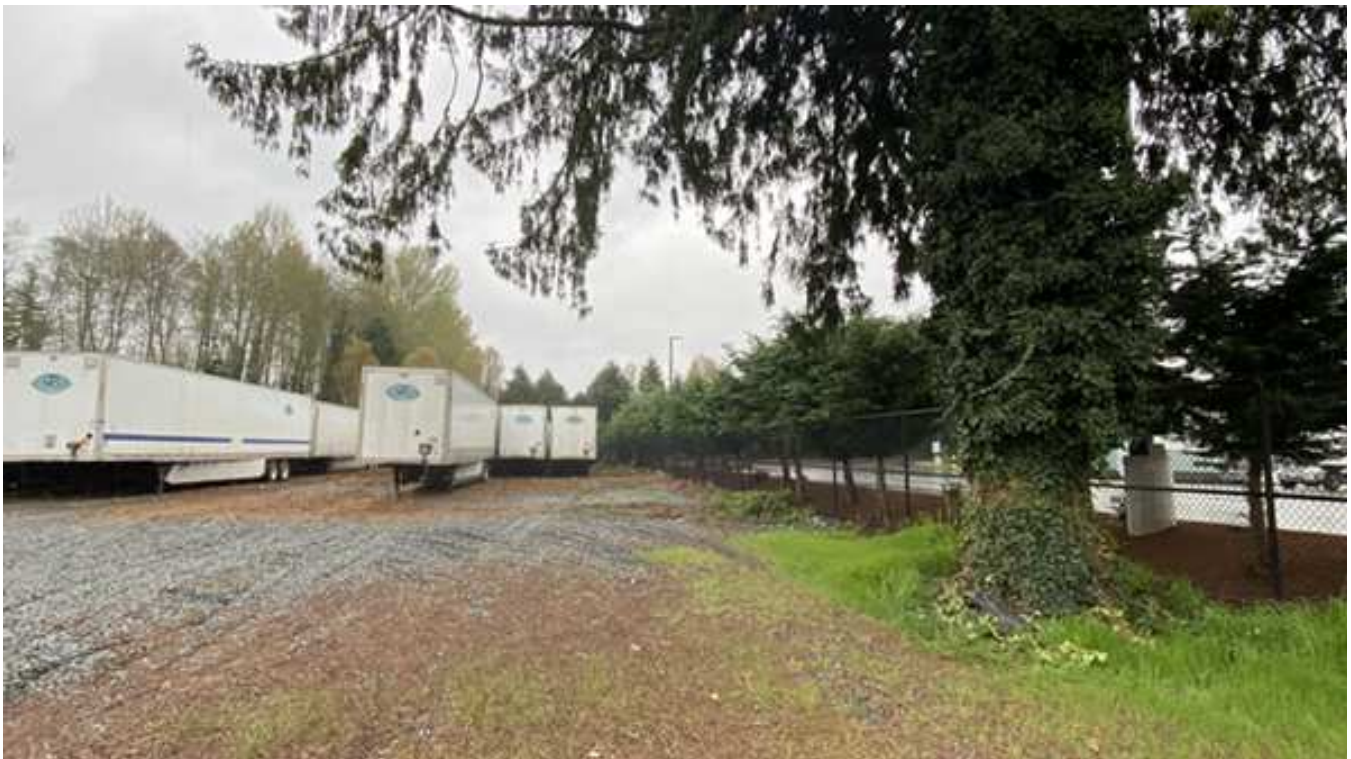
Above, looking south – Tree #1 can be seen on the right. A coarse gravel has been installed and tire tracks are visible within six feet of the trunk. Thick ivy is growing on the trunk. The tree has likely been topped in the past. Recent landscaping to the west includes installation of topsoil and bark within two feet of the trunk. All of these conditions have likely stressed the tree, which exhibits low foliage vigor and an abnormal trunk taper. See more photos on page 9.

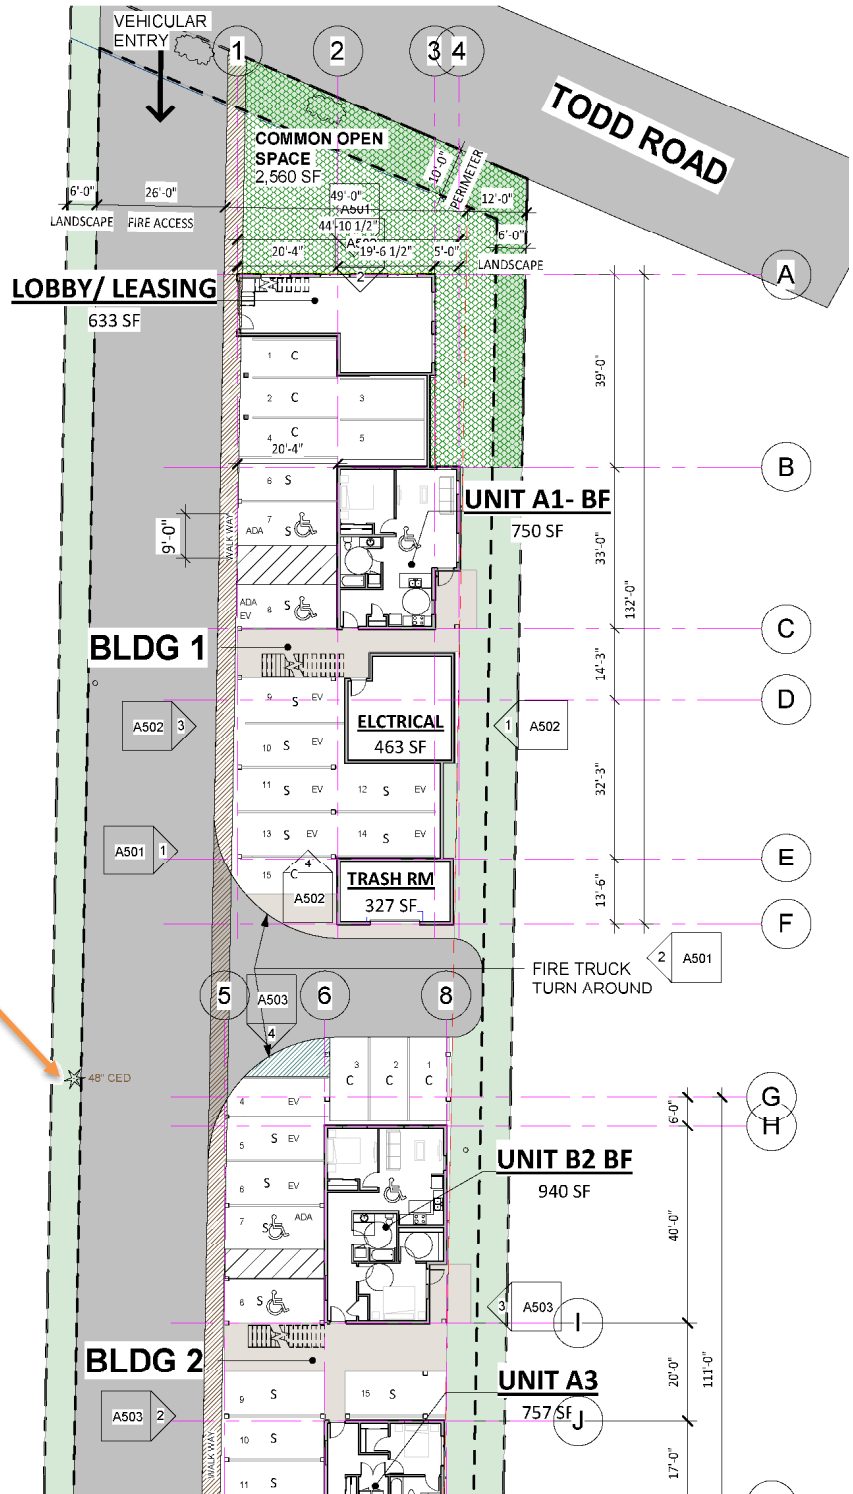
Attachment 4: Site Plan

Tree #1 – a 42-inch Western red cedar. The tree would likely not survive proposed construction given existing stress and disturbance adjacent to the tree.

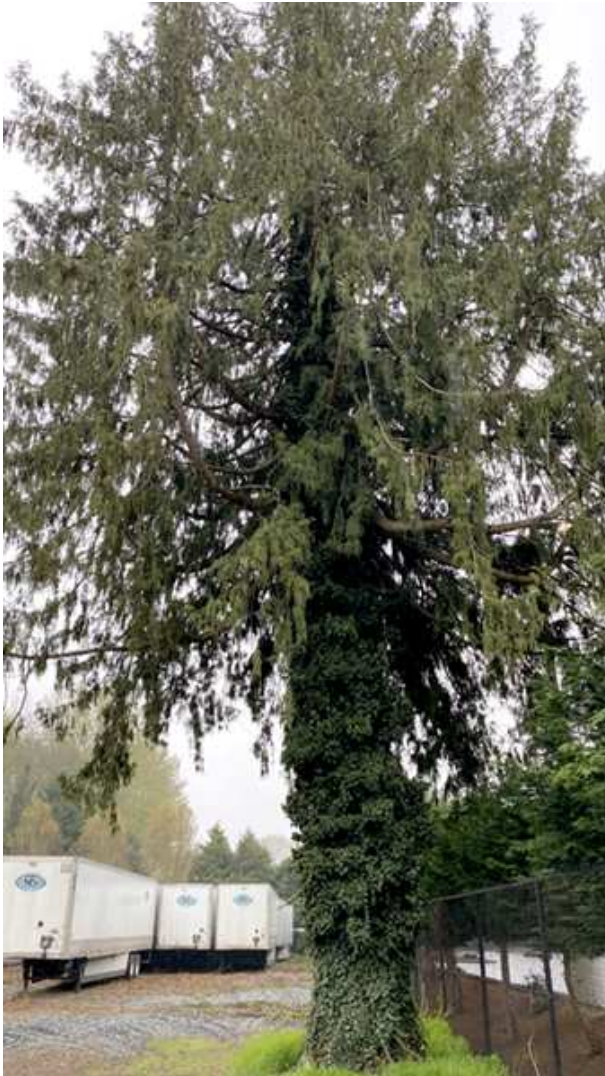
Above left, looking south – Tree #1. Abnormal taper of the trunk indicates the tree has likely been topped in the past. Ivy is growing on trunk and up into canopy.

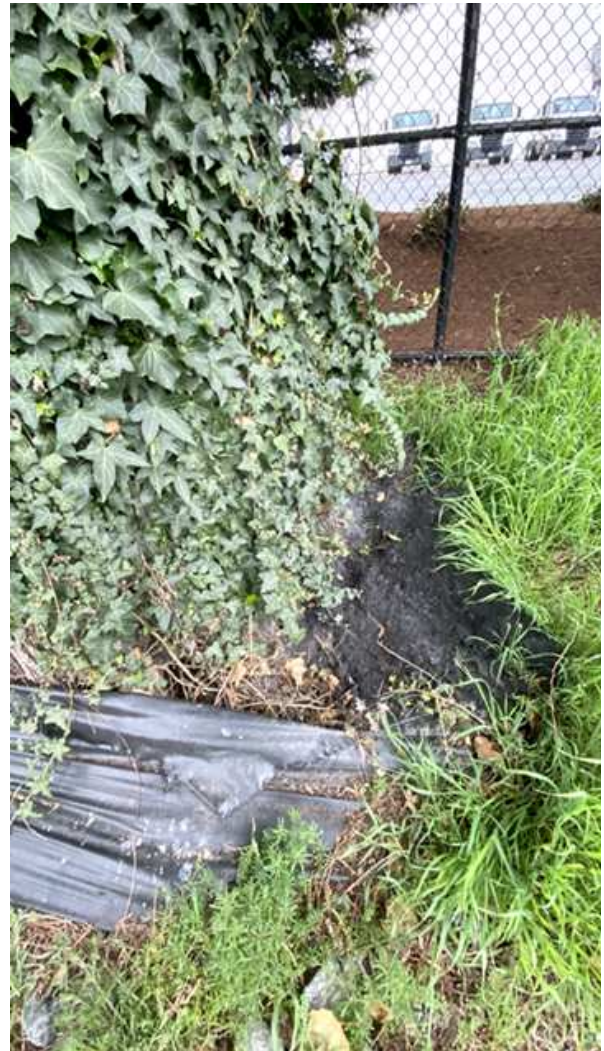
Above right – Detail of trunk base with landscape cloth close to trunk, topsoil and bark placed over roots.

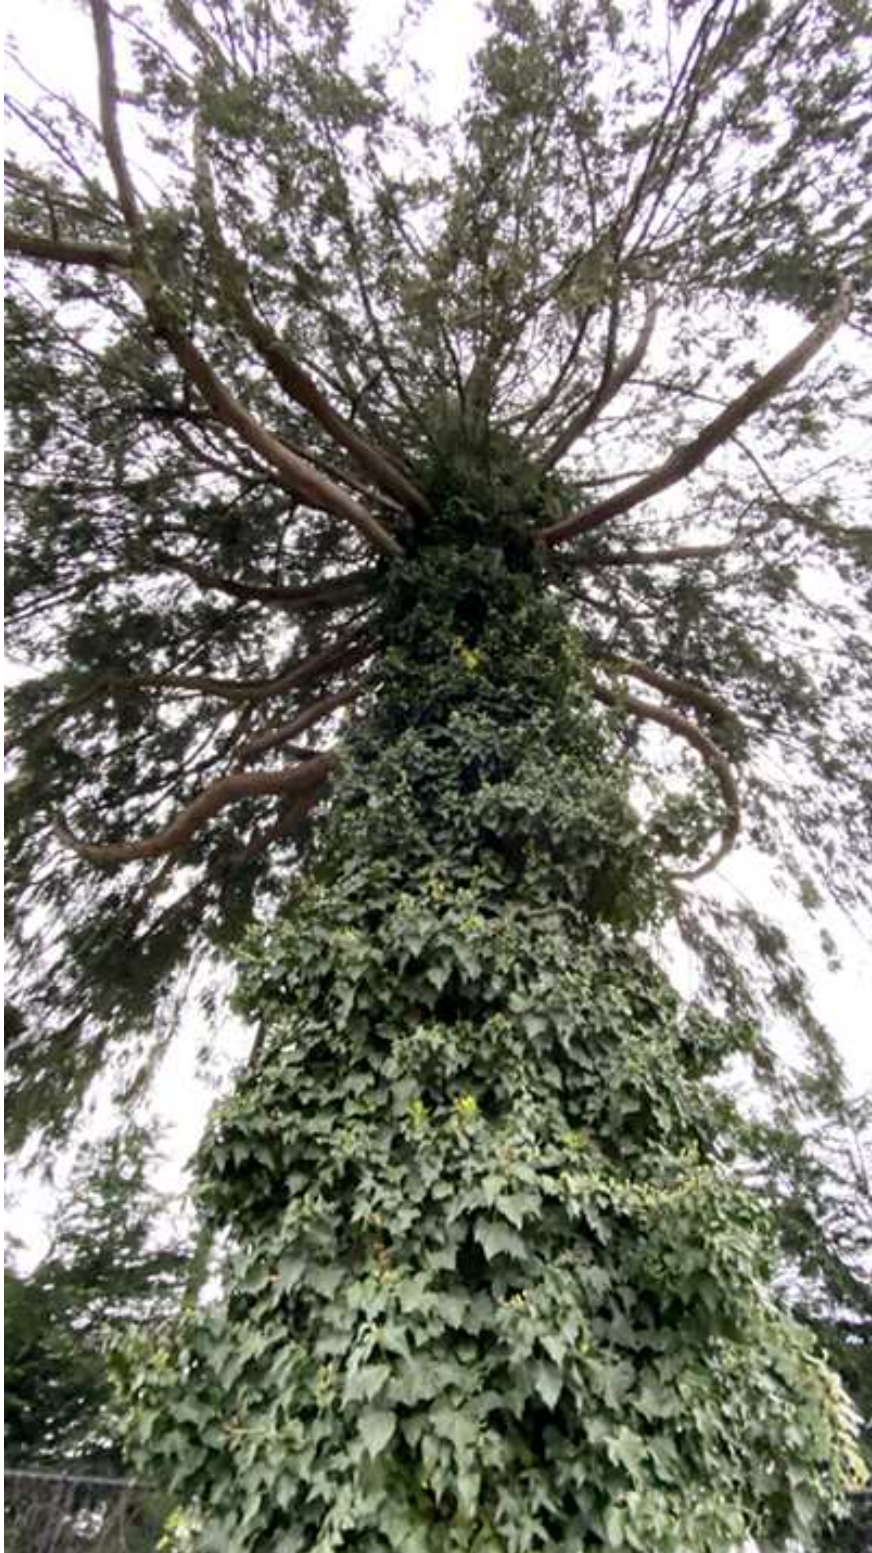
Left, looking up into canopy of the 42-inch Western red cedar. Lack of taper in trunk and low foliage vigor are clearly visible.
