Consulting Arborist Services

Reference: Tree Assessment

Site Address: 212 Todd Road NE, Puyallup, WA

Summary:

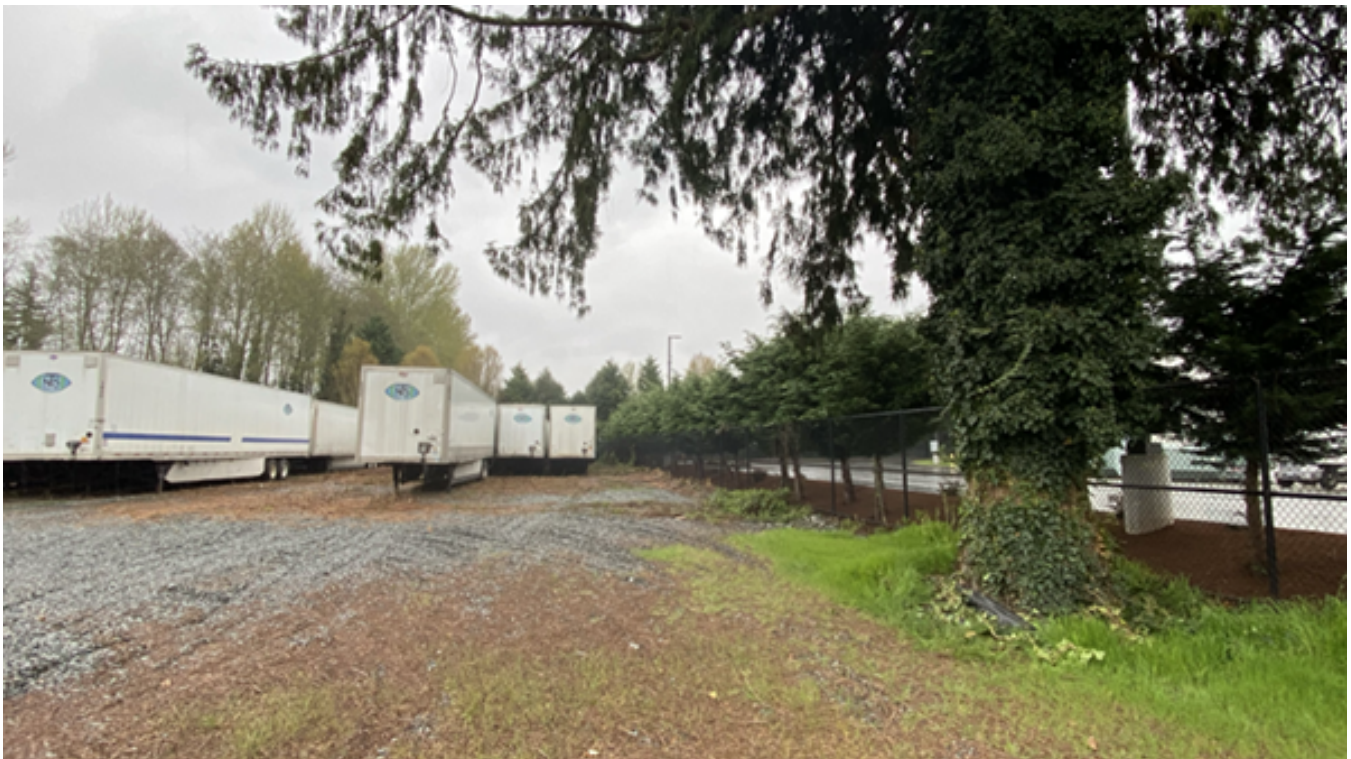
Above, looking south – Tree #1 can be seen on the right. A coarse gravel has been installed and tire tracks are visible within six feet of the trunk. Thick ivy is growing on the trunk. The tree has likely been topped in the past. Recent landscaping to the west includes installation of topsoil and bark within two feet of the trunk. All of these conditions have likely stressed the tree, which exhibits low foliage vigor and an abnormal trunk taper. See more photos on page 9.

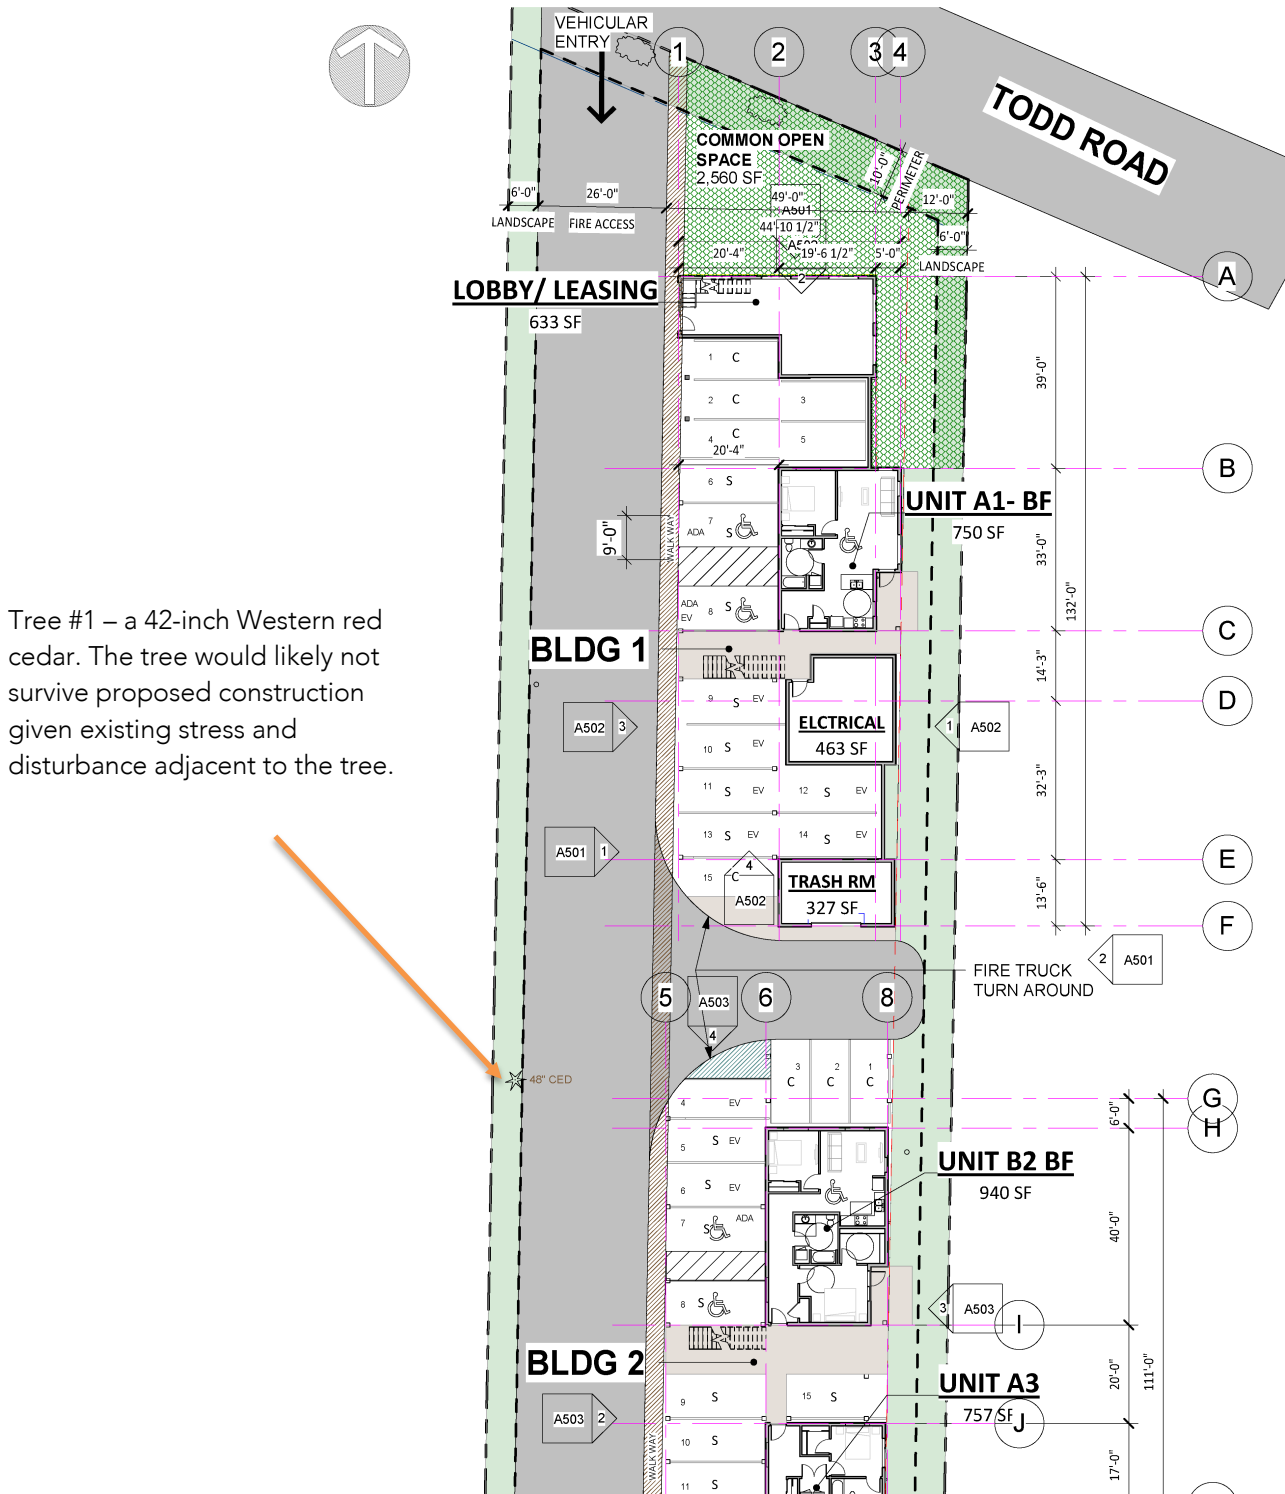
Attachment 4: Site Plan

A 42-inch Western red cedar requires a minimum 16 feet of protection, meaning no root cuts within 16 feet of the trunk. If the tree were healthy and the design could accommodate permeable paving, avoiding all cuts to roots, the tree would likely survive. Given existing disturbance and signs of stress observed, the project as designed would not provide adequate tree protection.

Tree #1 – a 42-inch Western red cedar. The tree would likely not survive proposed construction given existing stress and disturbance adjacent to the tree.

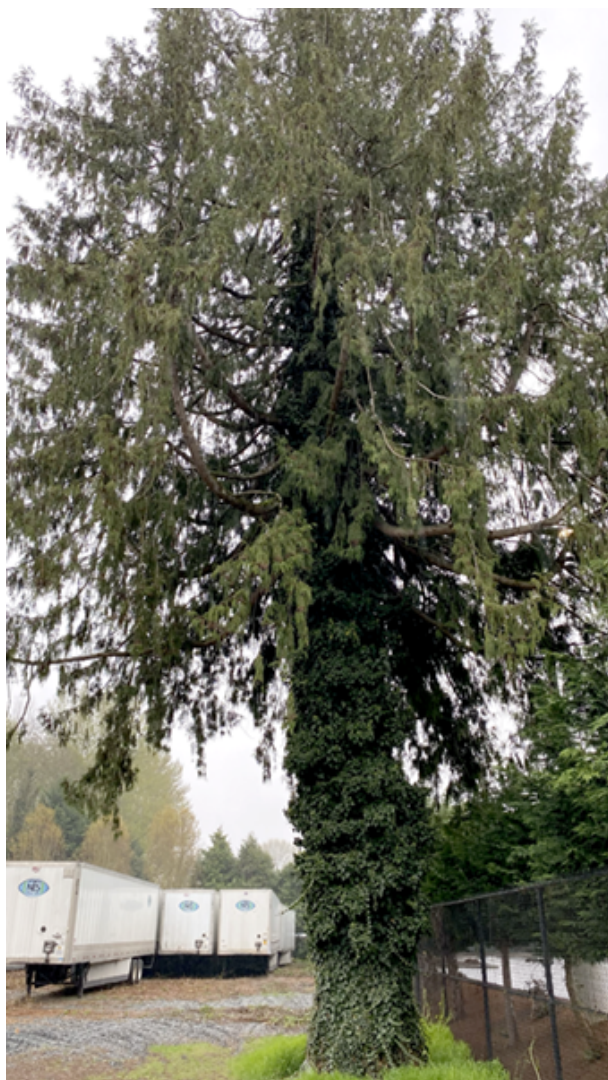
Above left, looking south – Tree #1. Abnormal taper of the trunk indicates the tree has likely been topped in the past. Ivy is growing on trunk and up into canopy.

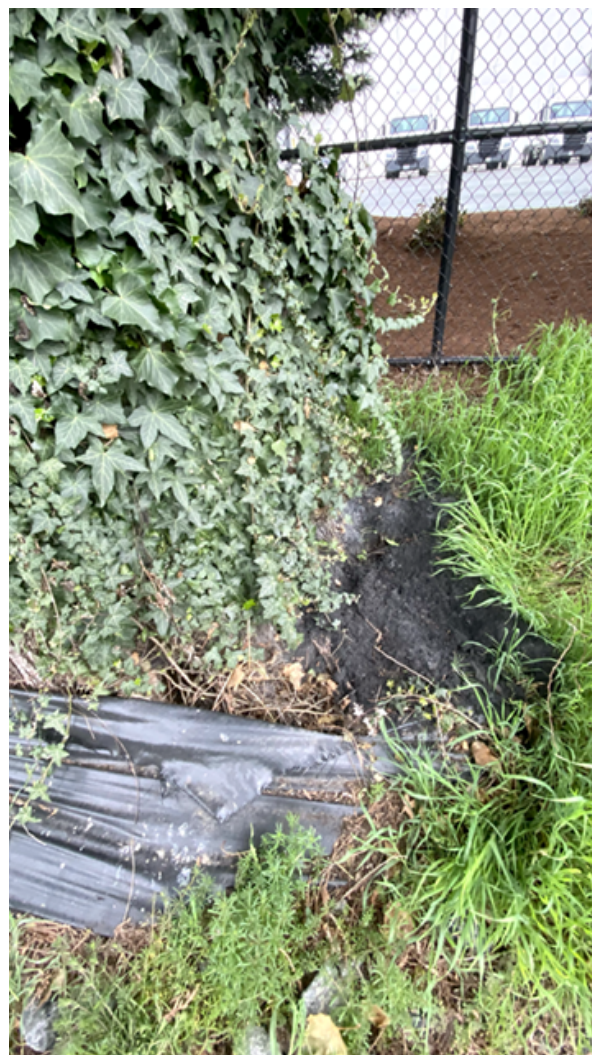
Above right – Detail of trunk base with landscape cloth close to trunk, topsoil and bark placed over roots.

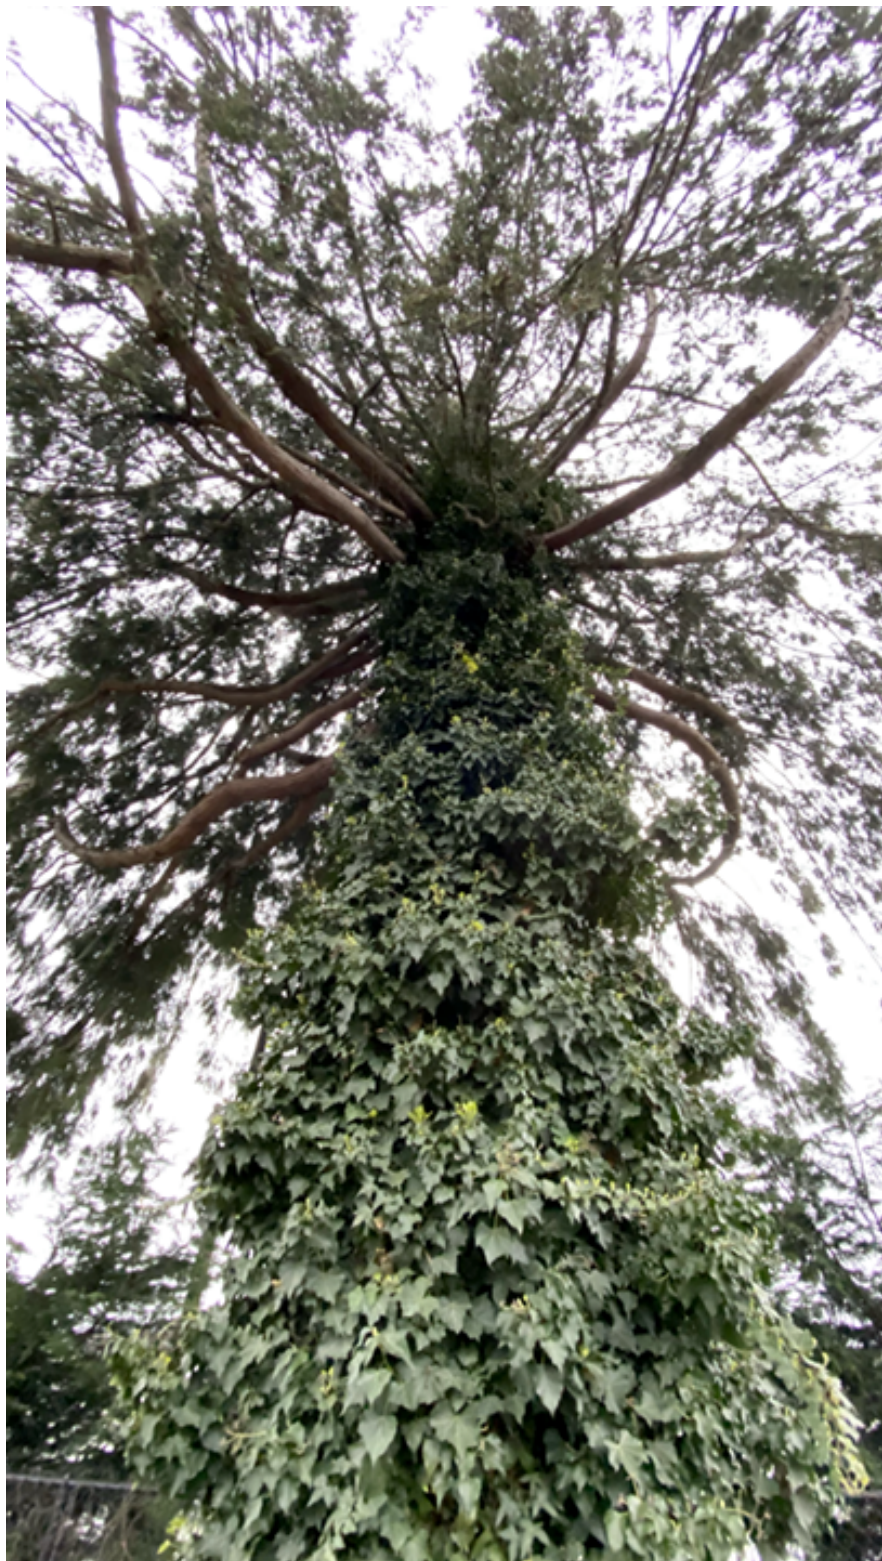
Left, looking up into canopy of the 42-inch Western red cedar. Lack of taper in trunk and low foliage vigor are clearly visible.
