**SUF**  
**SOUND URBAN FORESTRY, LLC**

RE: 330 3<sup>rd</sup> St SW/AOB Tree Risk Assessment

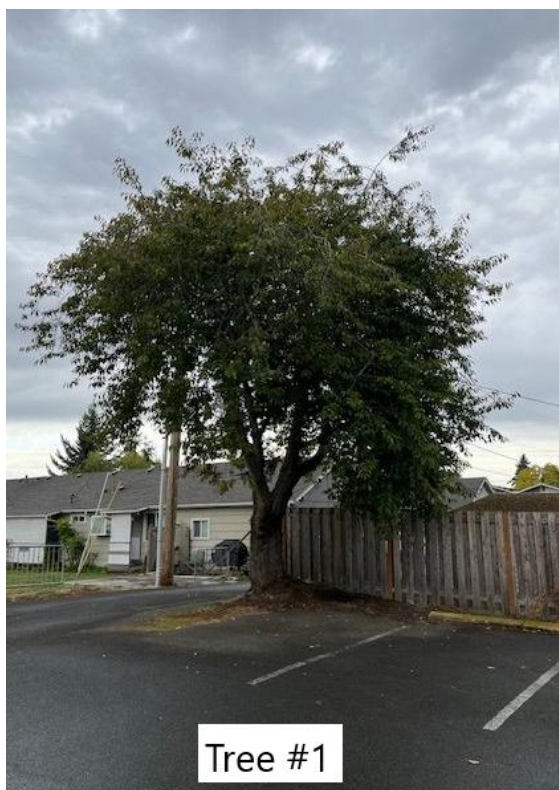
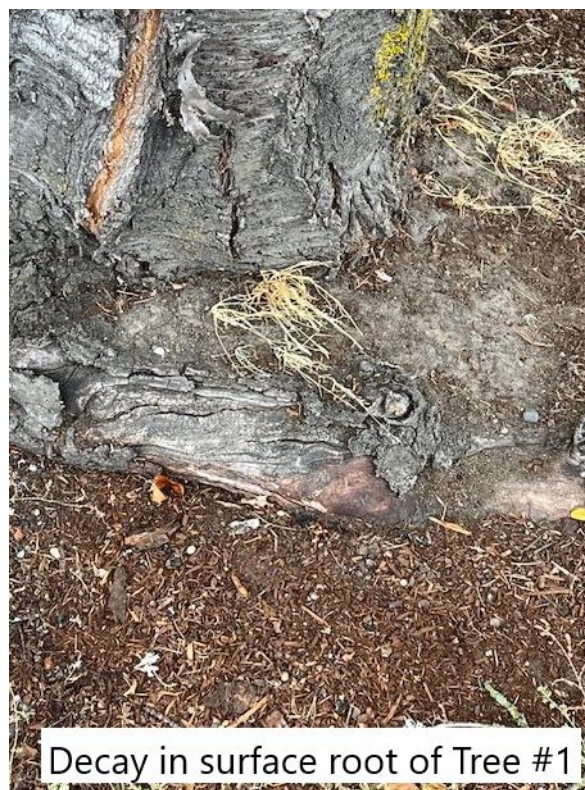
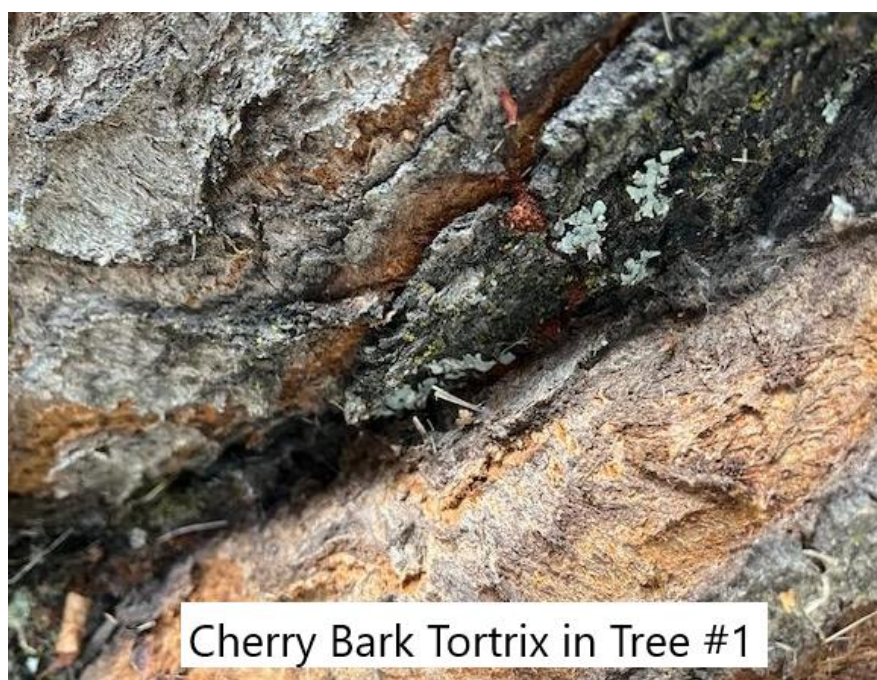
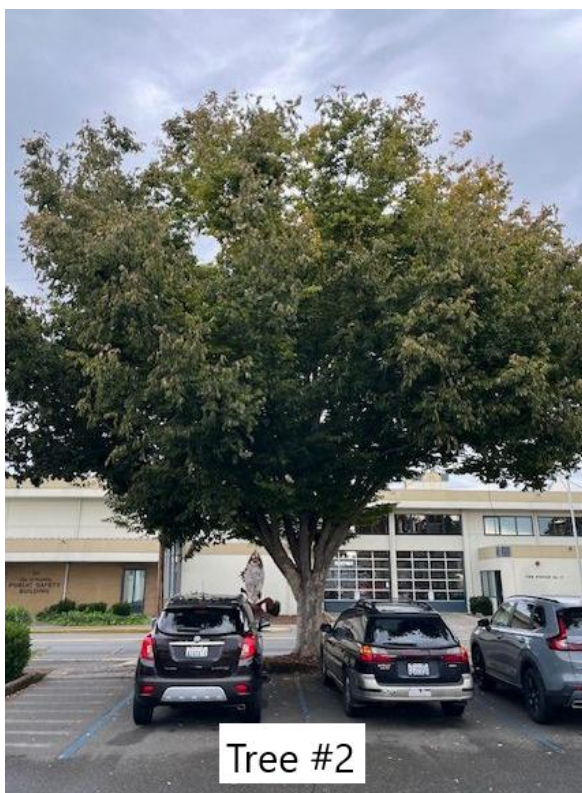
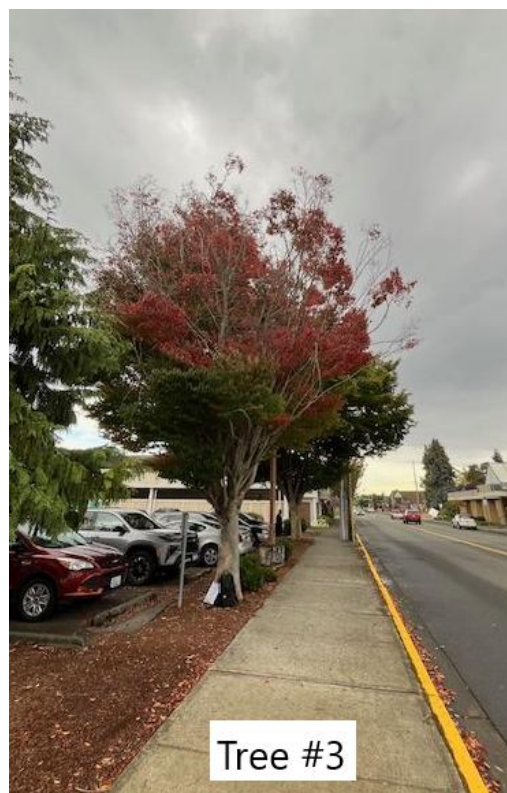
| ID# | Species | DBH<br>Height<br>Live<br>Canopy<br>Ratio | Current<br>Target(s) | Condition | Risk<br>Rating | Comments |
|---|---|---|---|---|---|---|
| 1 | Bird<br>Cherry | 26"<br>32'<br>25% | Powerlines<br>Alley<br>Parking<br>Fence | Poor | Moderate | Tree is infested with Cherry Bark Tortrix. Large scaffold branch torn off in the past. Previously topped at 20'. Trunk sounds did not indicate internal stem decay but decay was found in a large surface root. Roots are lifting the alley and parking lot asphalt. Most likely failure is a large branch in the area of the past topping wounds. |
| 2 | Zelkova | 21"<br>45'<br>35% | Powerlines<br>Sidewalk<br>Street<br>Parking | Good | Low | Trunk soundings did not indicate internal stem decay. Roots are lifting the parking lot asphalt and the sidewalk has been grinded. |
| 3 | Zelkova | 15"<br>42'<br>25% | Street<br>Sidewalk<br>Parking | Poor | Moderate | The upper third of the canopy is dead with 2"+ diameter dead branches. Trunk soundings did not indicate internal stem decay. The roots are lifting the nearby asphalt. Branch failure is the most likely risk. |
