Artz Site and Soil Evaluation

Parcel No. 0419095003, 5004 & 5022
Site Address 409, 427 and 433 43rd AV SW
Site Observations January 20, 2020

Introduction

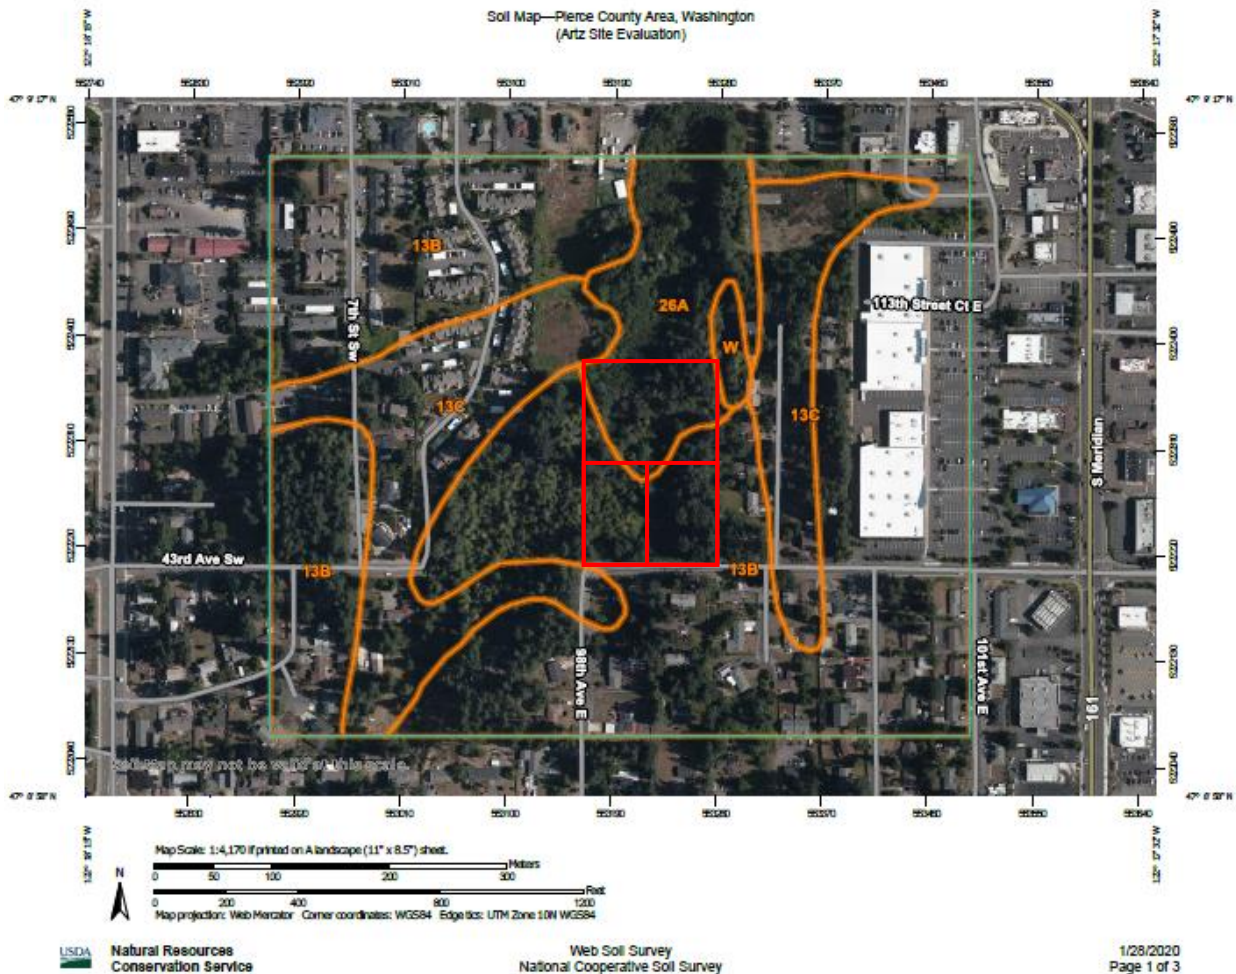
NRCS Soil Map

As discussed in the 'Published Information Accuracy' section above, on-site reconnaissance is necessary to verify soil conditions on specific properties. The NRCS identifies the soil on the two southern lots as Everett gravelly sandy loam (13B) In this case; test pits excavated north and east of the proposed structure as a

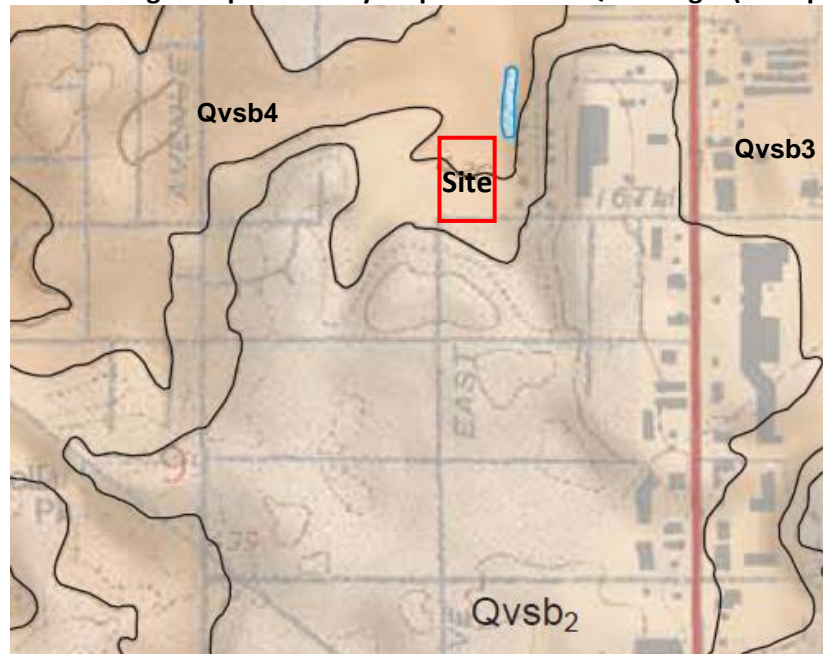
USGS Geologic Map of the Puyallup 7.5 Minute Quadrangle (Excerpt)

According to the USGS *Draft* Geologic Map of the Puyallup 7.5 Minute Quadrangle in Figure 2 below: this plateau region was formed by the gradual emplacement glacial drift stratigraphy; followed by the erosion of the previously emplaced glacial drift deposits by channelized glacial meltwater incision along the west side, and by ice lobe truncation within the Puyallup valley. The map shows that the slope section dipping to the northeast provides a depositional record of the pre-vashon mixed fine and coarse deposits, overlain by the Vashon advance outwash, overlain by the Vashon till, and finally overlain by the Vashon recessional outwash. The slope face represents the location where the much larger glacier within the valley truncated the slope face thus exposing a stratigraphic record of deposits. Figure 2 illustrates the site's position relative to the geology.
