**Re: *Fire Construction Permit Application
CUP Modification
Reuse of Storage Tank 3 for Used Oil***

Ecolube Recovery has petitioned for a minor modification under Conditional Use Permit No. P-18-0154 to allow for the repurposing of Tank 3 at the Ecolube Recovery terminal. Tank 3 will be used in Used Motor Oil storage in an identical fashion as Tanks 1, 2 & 4. The modification is being requested to allow for segregation of oil to differentiate blends according to product specifications and reduce overall transportation. ChemE Consulting (ChemE) is pleased to present this information on behalf of Ecolube Recovery in support of the Application for Fire Code - Construction Permit for repurposing Tank 3 for liquid storage and transfer operations located at 213 10th Street SE; Puyallup, WA 98731.

The proposed modification will add Tank 3 to the existing tanks located at the proposed site. Tank 3 was evaluated by a third party tank inspection firm Mistras to evaluate the condition of the tanks and found to be in satisfactory condition pending correction of mandatory recommendations.

TANK 3 ELEVATION NORTH DRAWING

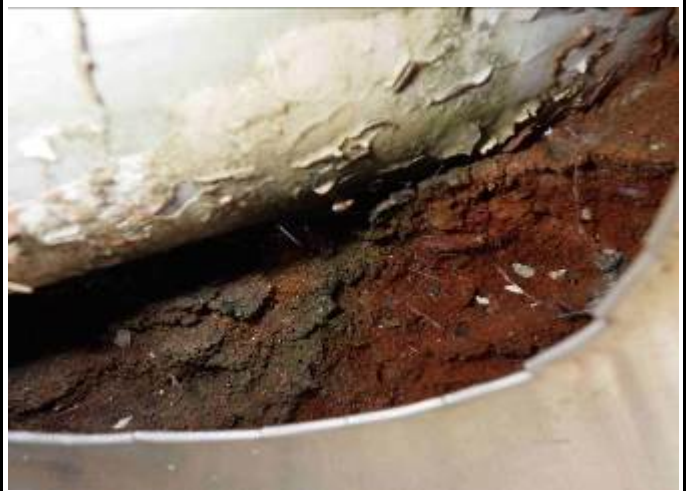
- 11) There were many suspect CUI (corrosion under insulation) areas throughout the exterior of the shell due to various openings and damage within the jacketing. Internal UT testing was performed on the shell interior of course 1 and 2 confirming that external metal loss up 0.06" has occurred in some locations. The external shell was also visible through UT ports that were installed during this inspection, and there appears to be a heavily degraded coating present in the upper courses of the tank. If the tank is to be re-used, the client should highly consider stripping sample areas of insulation at strategic locations to better evaluate the exterior condition of the tank shell.

Deteriorated Insulation at Nozzle Penetration.

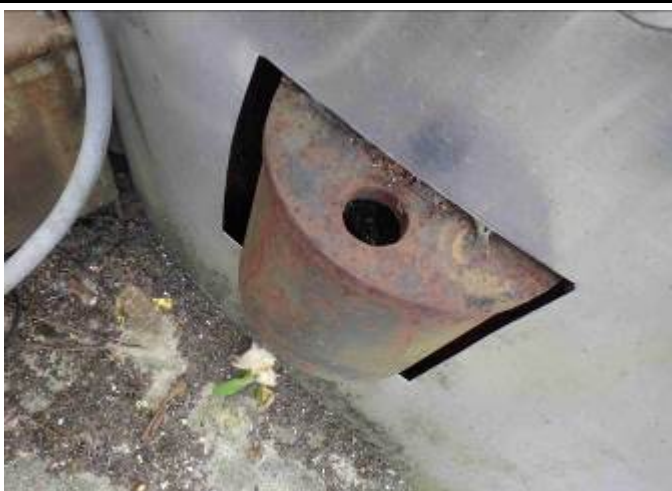
- 5) This tank contains seismic anchoring details. Inspection noted that there is currently 1 missing long bolt out of a total of 8. Due to the tank's dimensions, it is likely that all bolts are required. The customer should replace the missing bolt before recommissioning the tank.

2.3 Supports	Check for corrosion, paint failure, etc.	<input checked="" type="checkbox"/> Yes* <input type="checkbox"/> No <input type="checkbox"/> N/A	This tank contains seismic anchoring. There was 1 missing bolt noted.

Missing Anchor Bolt

- Install new 10” Emergency vent assembly on top of tank
- Replace existing 3” conservation vent with 3” gooseneck pipe vent
- Install one missing anchor bolt per recommendation (Hilti 1-1/4” HIT-RE-500V3) with Special Inspection
- Install level transmitter on existing 3” flange nozzle per dwg. P-101.
- Install Float High Level Switch (LSHH) on existing 3” flange nozzle per dwg. P-101.
- Change out all flange gaskets
- Hydraulic fill test to verify that tank is liquid tight
- Install 3” pipe from unloading manifold pipe to top of Tank 3
- Install 4” pipe from Tank 3 to loading manifold pipe
- Repair coating wear on caged ladder rungs

OK. REPLACEMENT ANCHOR
1 1/4" THRU. ROD IN FLOW ANCH 13" EMBED

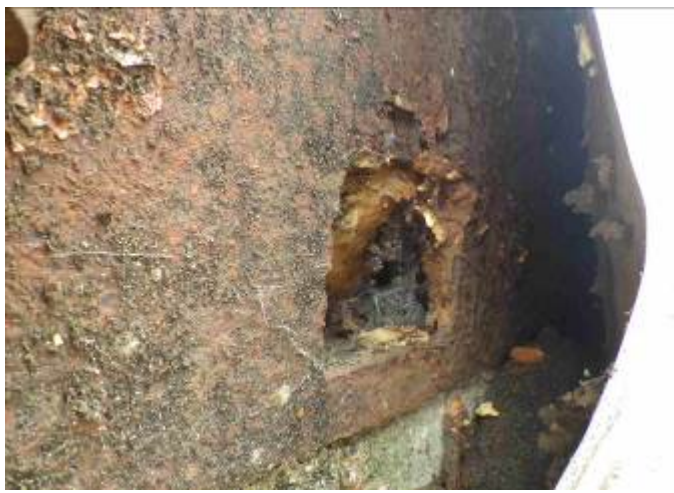
- 6) The dead space between the double floor has 3 visible 3" x 3" cutouts in the shell. The space appears to have been filled with a type of spray foam in effort to seal the area from any potential bottom leaks. This configuration is not ideal for typical leak detection. These cutouts should be closed up by welded inserts. The customer should also install a threaded coupling with a bull plug in the lower region of the space so that periodic leak monitoring can be performed. Note: There are likely more of these cutouts behind the insulation sheeting which aren't readily visible.

Dead Space Cut Out

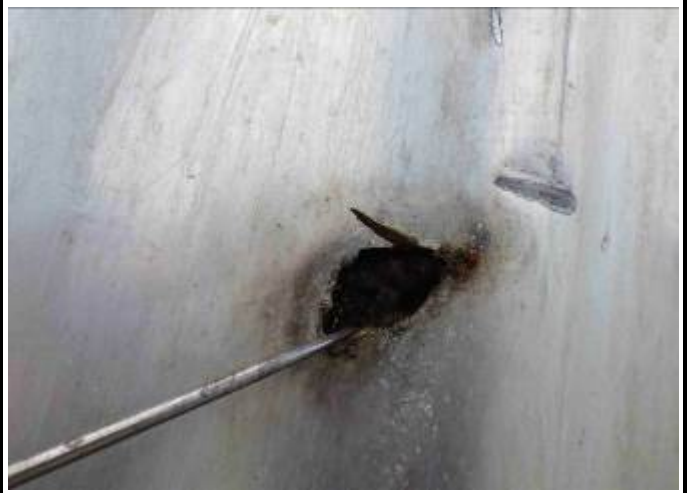
Shell Jacket Hole

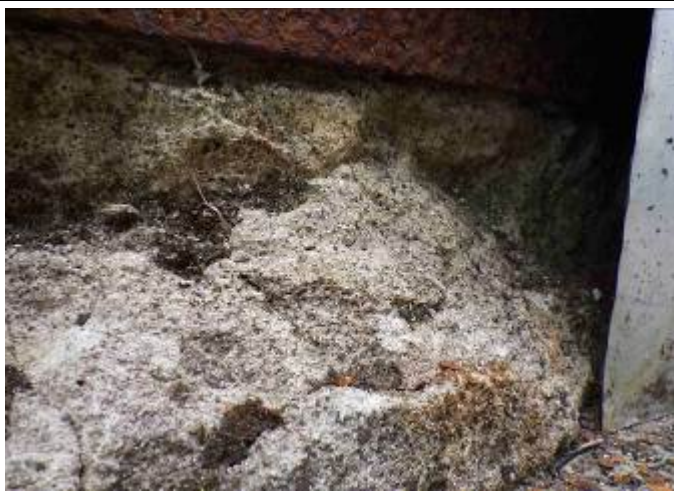
- 4) The tank rests on a 6" raised concrete pad. The viewable areas contained some moderate spalling and erosion. The customer should repair these areas in the future to mitigate further degradation.

2.2 Concrete pad or ring wall?	Cracking or spalling	<input checked="" type="checkbox"/> Yes* <input type="checkbox"/> No <input type="checkbox"/> N/A	The viewable areas contained some moderate spalling and erosion.

Edge of Foundation Pad

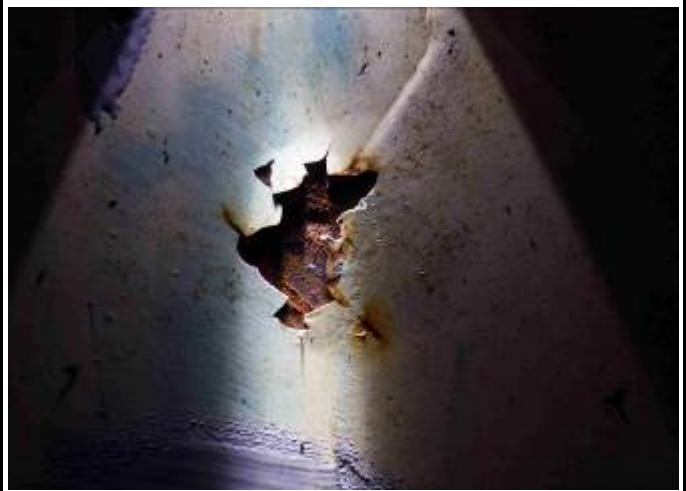
- 12) There are areas of heavy internal coating degradation present with scale buildup and non-measurable corrosion forming. The client should prep and recoat the affected area at the next opportunity. **Note: If an internal liner is required for the new intended service, this recommendation would be mandatory.**

Shell Internal Coating Failure

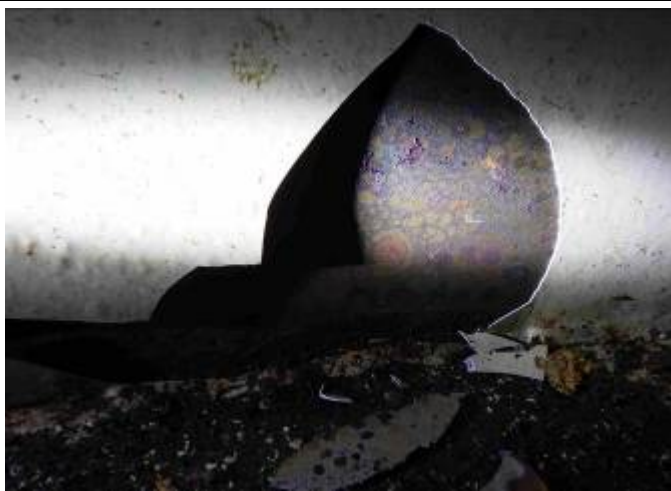
Lower Shell Large Coating Failure

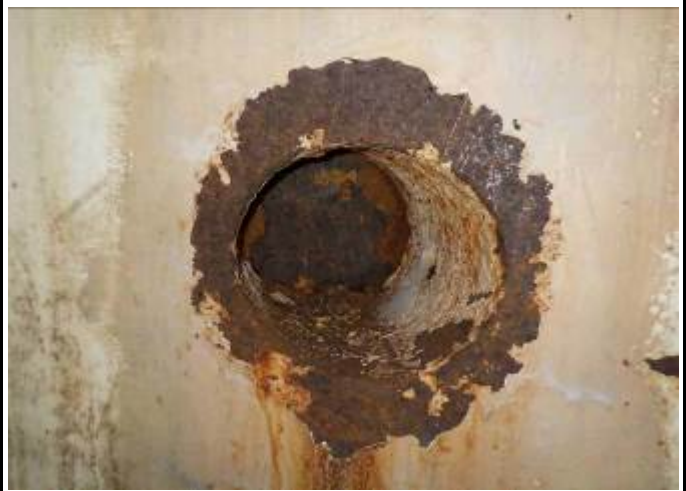
Nozzle G Interior. Note Coating Degradation

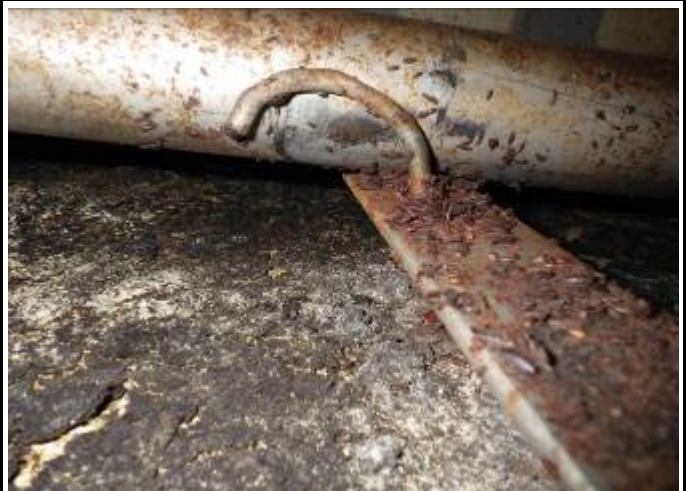
- 10) There are 2, 1.5" diameter stainless steel tube banks installed which were used for heating purposes. Visual inspection noted that many of the U-bolts which secure the piping to the supports, were broken or missing. If this component is to be used again in future service, all faulty hardware should be replaced.

Broken U Bolt

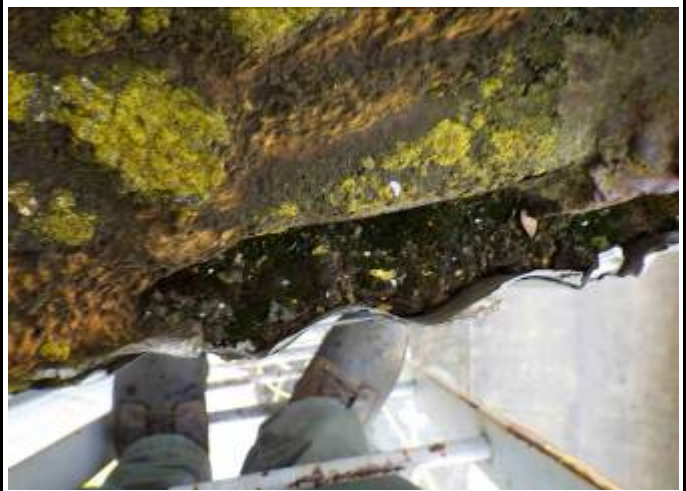
Shell Top Angle. Note Opening.
