**PHASE I ENVIRONMENTAL AUDIT**

Proposed Sunset Pointe Residential Plat  
East of Intersection of 21st St SE and 19th Ave SE  
Puyallup, Washington

**DESERT CREEK, LLC**

JN 24420

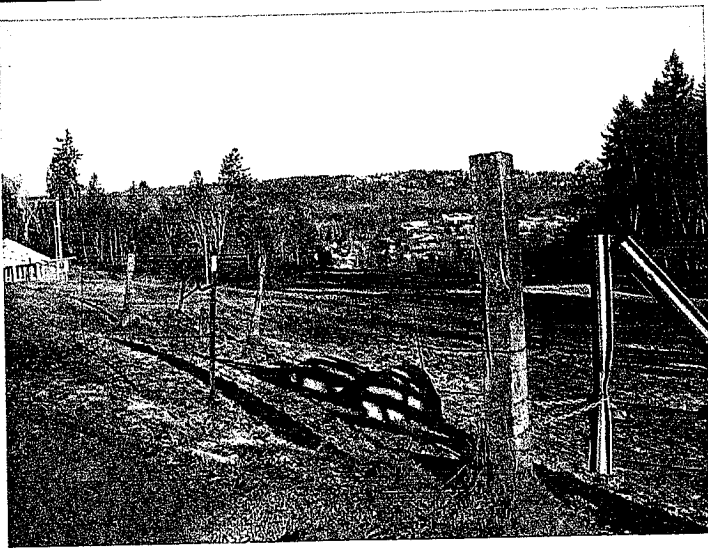
Photo 1: Pasture land on northern portion of the site, as viewed from subject property driveway.

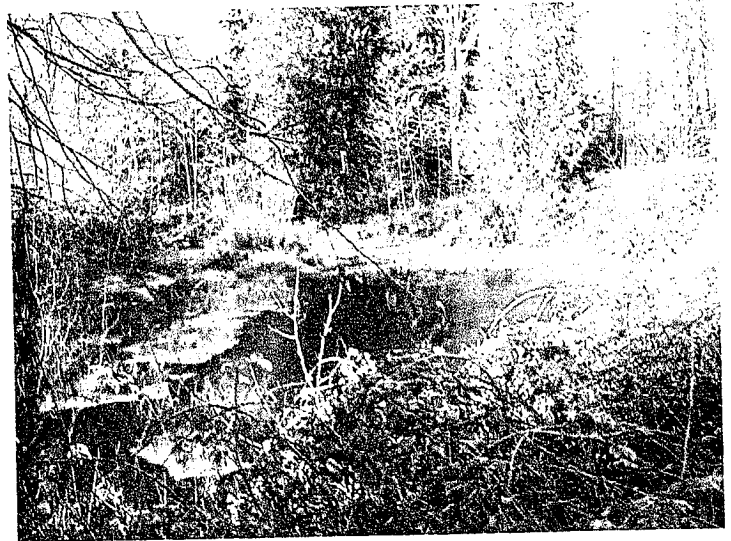
- A small pond was noted approximately halfway between the two onsite residences, on the southern side of the driveway. A soil retention wall consisting of battery casings was noted on the northern edge of this pond, at the area where the driveway crosses the ponds drainage conduit. According to Ms. Pat Tanner, property owner, these batteries were brought on the site approximately 40-years ago after being obtained from a local battery recycler (Kiby's Battery Company). Ms. Tanner stated that prior to purchasing the battery casings, Kiby's had removed the contents and cleaned the interiors of the casings. Onsite, the empty casings were then filled with soil and stacked in their present configuration adjacent to the roadway. More recently, Mr. Scholten of Desert Creek, LLC (potential purchaser of site) informed us (EAI) that in an attempt to independently evaluate environmental conditions, his company had collected a single soil sample from inside one of these battery casings. The sample was submitted by Desert Creek to Spectra Laboratories for Lead Toxicity Characteristic Leaching Potential (TCLP) and pH analyses. Analysis indicated the leachable lead concentrations to be 0.38-parts per million (ppm). The pH analysis indicated the soils to be slightly basic (7.5 pH units). As a basis for comparison of TCLP results to total concentrations, an unofficially adopted "rule of thumb" used by some regulators and investigators is that total concentration of a given metal in soils can be roughly estimated by multiplying the TCLP results by a factor of twenty. Using this calculation, an estimated

"total" concentration of lead in the tested soil would be roughly 7.6-ppm, a concentration below the median concentration of "total" lead in soils of the Puget Sound region, as detailed by the Washington State Department of Ecology, in "Natural Background Soil Metals Concentrations in Washington State" (publication #94-115). To the extent that the results of the sampling and analysis undertaken by Desert Creek are reflective of conditions at other locations near the wall, it would then be possible to conclude that the risk of environmental impacts relating to this battery casing wall would be relatively low.

Photo 2: Pond located on southern portion of site. Retaining wall constructed with battery casings is located on northern portion of pond, near location where photo taken from.

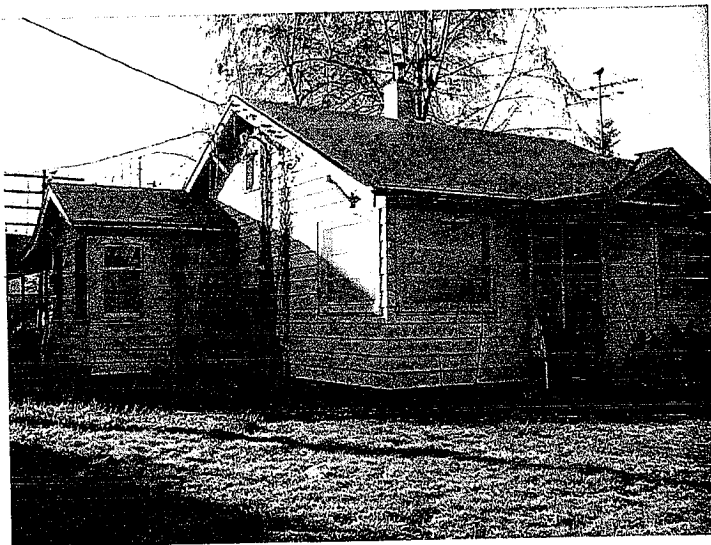
As discussed earlier, a positive qualitative reaction suggesting the likely presence of lead was observed during "Lead Check" testing of the painted wood exterior finishes on several of the buildings located on the southern portion of the property. On the basis of the positive indications, we conclude that lead is most likely present in these areas, and could conceivably be in other areas as well. All painted surfaces were in poor to fair condition. Additional sampling and testing would be required to quantify the concentration of lead and the extent of the lead-bearing paint.

Photo 2: Southern house on subject property. Wood window, door, and other trim painted with a lead containing finish. Siding is aluminum. Lead not detected on siding finish.

As with asbestos, workers who may have cause to disturb suspect lead-bearing surfaces in future activities as renovation, demolition, etc., should be formally advised of these findings so that they may take appropriate precautions in terms of exposure. Special handling and disposal requirements may apply in the event that lead-bearing painted surfaces are disturbed, removed, or demolished at this facility.

Alternative management approaches to resolve lead paint issues frequently include: (1) painting over paint layers containing lead with high density quality penetrating/sealing paint; or (2) removal of the paint under controlled conditions to prevent the release of lead-bearing paint into the atmosphere. Current thinking on this issue according to U.S. EPA Region 10, is to manage the material in-place until a structure is renovated or demolished.

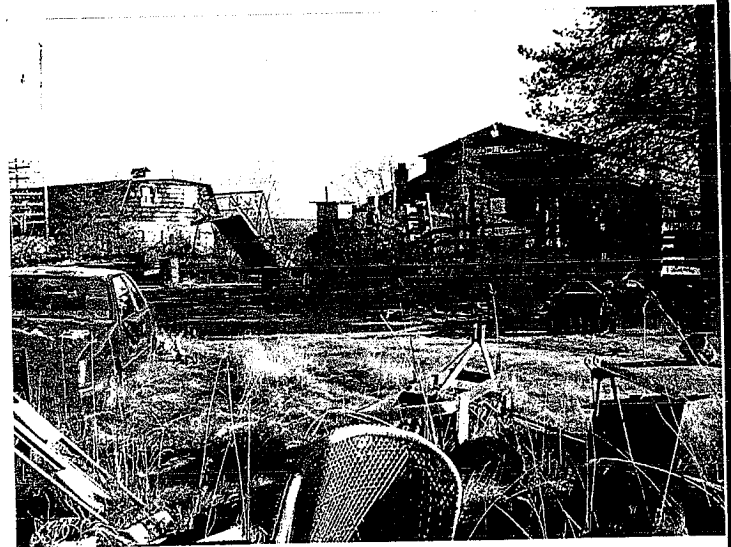
- Cultural debris such as lumber, furniture, fencing, appliances, and general household rubbish was noted in the vicinity of the buildings located on the southern portion of the site.

Photo 4: Example of barn/storage sheds located on southern portion of site as well as types of refuse accumulated in this area.

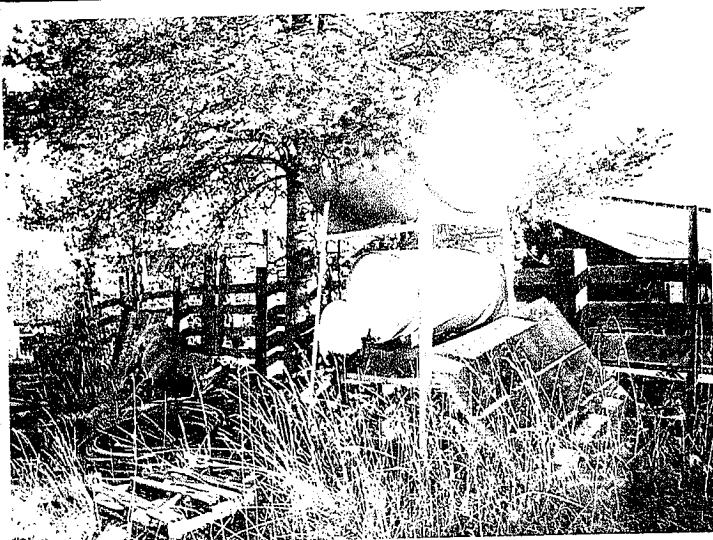
- A steel vertical rack containing three separate above ground tanks/drums was noted near the southern border of the subject property. Although the bottom of one of these tanks was rusted out, no odors, stained soil, or disturbed vegetation was noted in the vicinity of these tanks. According to Ms. Tanner, these tanks were used to store gasoline to refuel the gravel mining vehicles. Ms. Tanner did not report any spills or releases from these tanks.

Referring to Photo #1 on Plate 5 and as discussed briefly in earlier sections of the report, the current occupant of the site (Tanner) disclosed that gasoline was historically stored in and dispensed from multiple above-ground tanks located on the southern part of the property in support of vehicles associated with gravel mining operations. The bottom of one of the tanks was rusted out at the time of our site visit.

By virtue of the materials (motor fuel in substantial volume) stored at the subject site over a potentially extended period, in the context of the ASTM definition, such gasoline storage and dispensing operations appear to qualify as a "recognized environmental condition" for this property.

Photo 1: Steel rack containing multiple tanks/drums on southern portion of property. Bottom of lower left drum noted to be rusted out. No staining, odors, or disturbed vegetation noted under tanks.

If, for reasons of their own, the client, owner, lender, or other involved parties desire a higher degree of confidence than is afforded by the current level of knowledge, limited but statistically representative shallow subsurface sampling in areas proximal to the former fuel storage and dispensing area supported by appropriate laboratory analysis could be employed to confirm actual subsurface environmental conditions in that area. As strongly implied under section 4.5.3 of ASTM E-1527, decision-making authority in that regard clearly lies with the client and/or other involved parties, depending upon their individual risk tolerances.

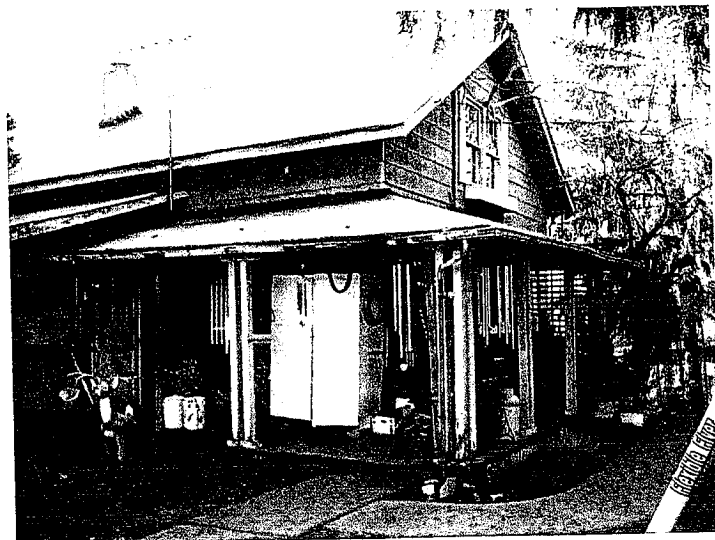
Photo 2: Northern house observed on subject site. Siding is asphaltic shingle material.

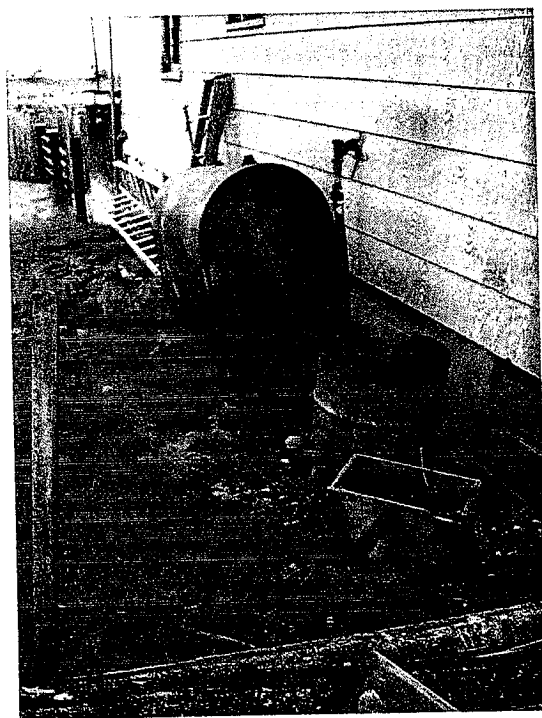
- Ceilings are painted drywall, or "popcorn" textured materials.
- A wood-fired stove is reported to be the sole current source of heat for the two residences. Referring to Photo #3 of Plate #5, an above-ground storage tank used to store heating oil was observed adjacent to the southern wall of the northern onsite residence. According to Ms. Tanner, use of this tank was discontinued approximately 20-years ago. No staining was noted near the base of this tank.

Photo 3: Heating oil tank observed adjacent to southern wall of northern house. Tank appeared to be in good condition.

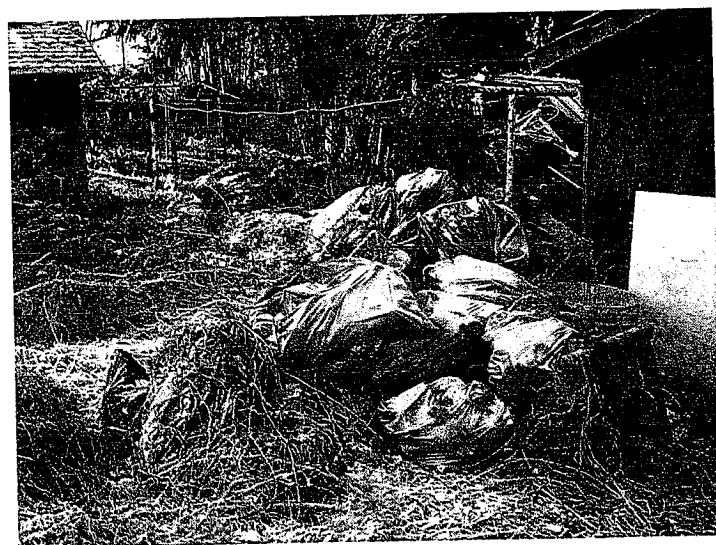
- An additional area of accumulated rubbish and household waste was noted in the vicinity of the northern house on the subject property.

Photo 4: Household refuse noted in the vicinity of northern house on site.
