LEROY SURVEYORS & ENGINEERS, INC.

Supplemental Geotechnical Report

Small Scale Pit Infiltration Test

LS&E Job No. 13298

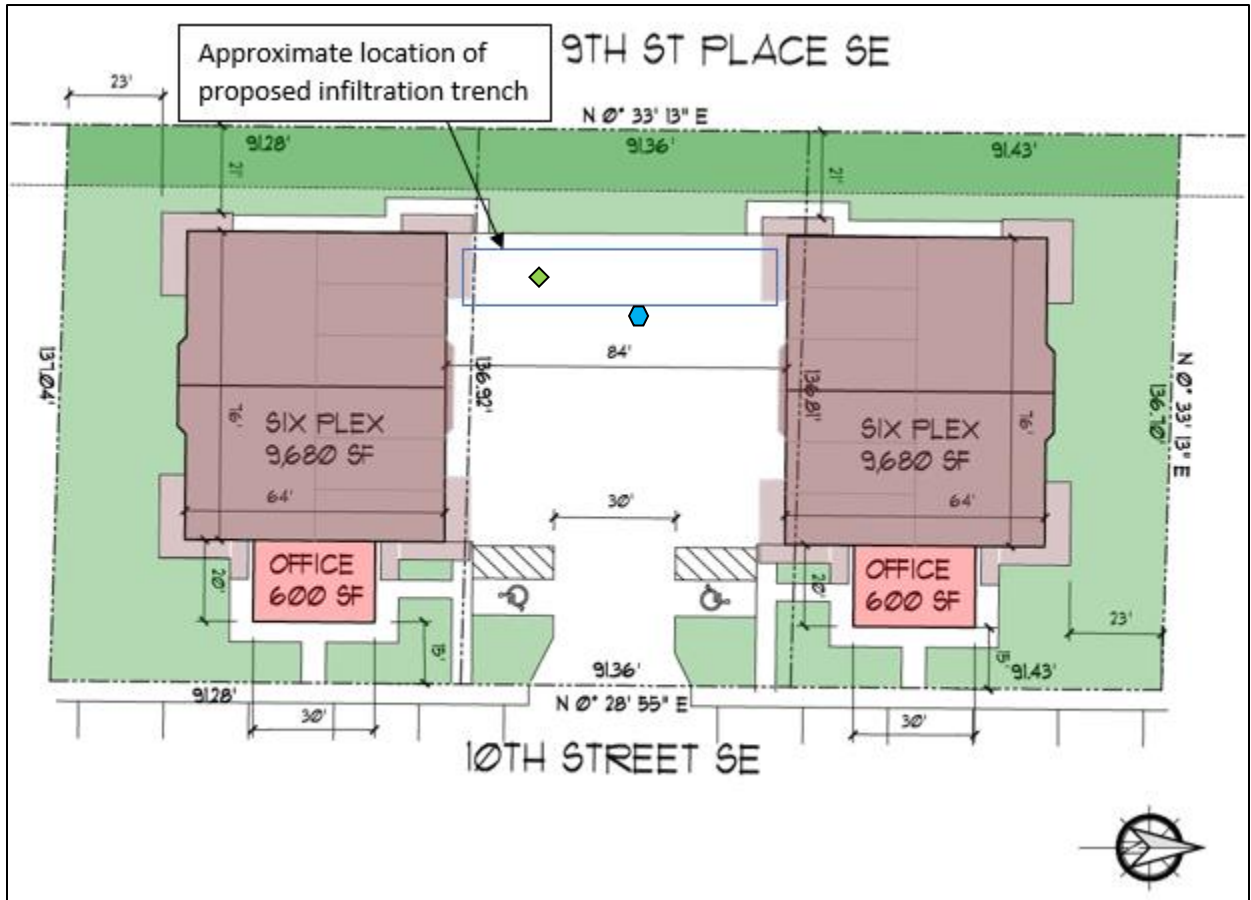
Figure 1: Infiltration Test (●) and Monitoring Port (◆) Locations

Figure 1 illustrates the test locations only. Our firm makes no assertion that the conceptual exhibit is the most current – it is the only plan provided to LS&E.
