LEROY SURVEYORS & ENGINEERS, INC.

Dos Lagos Asset, LLC
810 E. Pico Blvd, Unit B24
Los Angeles, CA. 90021
213-614-8887

August 6, 2020
Updated April 23, 2021

Geotechnical Soil Observation Report
Parcel No. 0419102118, 0419106024,
0419106025, 0419106026, 0419106028,
0419106030
Site Address – 405 39th Ave SE
LS&E Job No. 12896
Assessments Performed: 7/7/2020

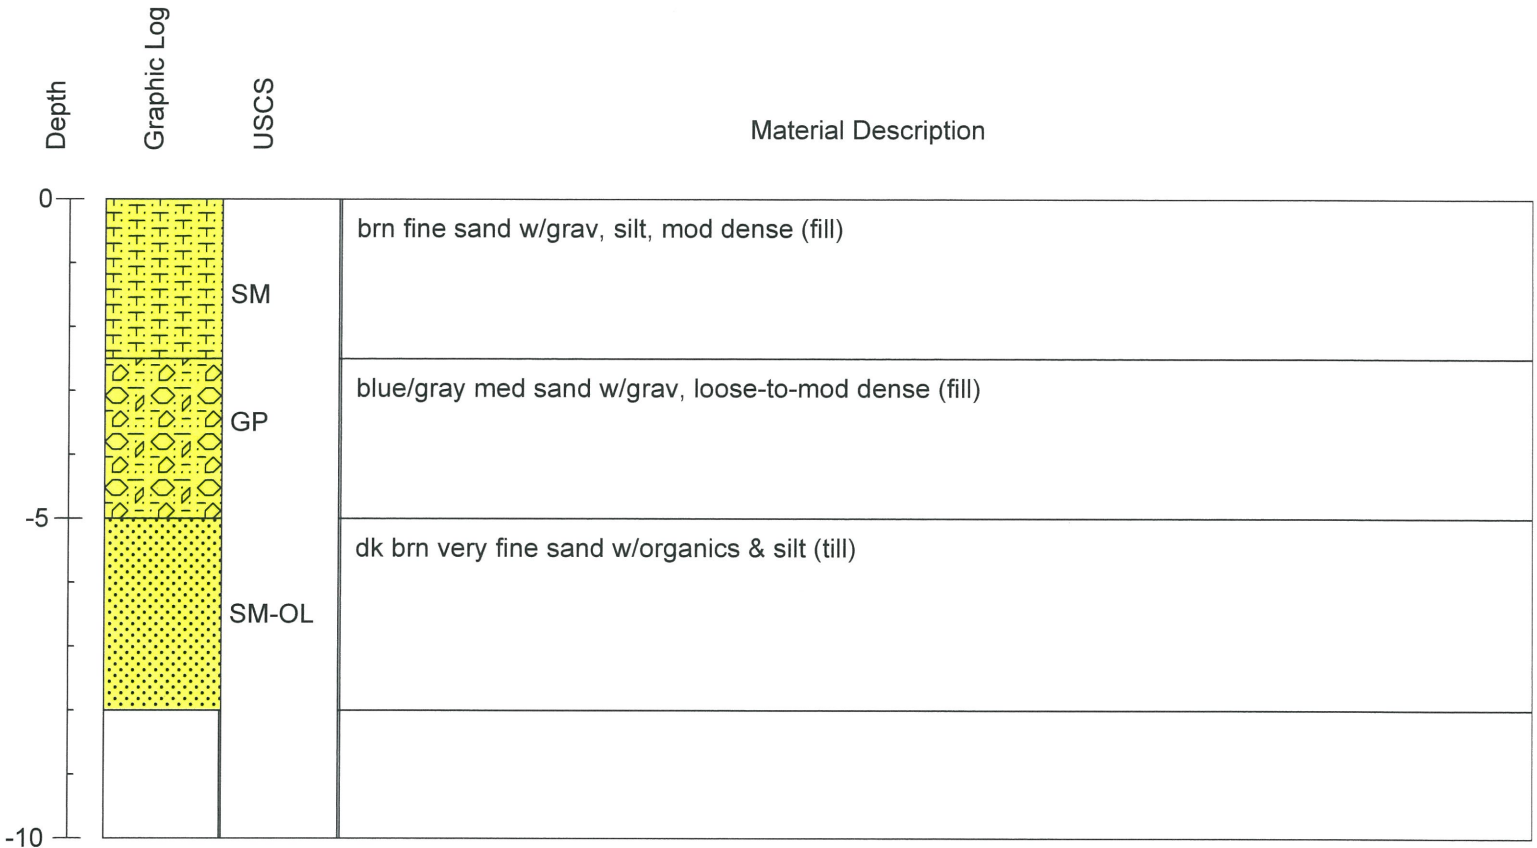
Test Pit Number: TP 1
 Project Name: Dos Lagos
 Ground Elevation: 438 Test Pit Size: 2x6
 Ground Water Levels:
 At Time of Excavation: None
 At End of Excavation: None
 Static Water Depth: None

Client: Dos Lagos Asset, LLC
 Job Number: 12896
 Date Started: 7/7/20
 Date Completed: 7/7/20
 Excavation Contractor: N/A
 Excavation Method: Track Mounted Excavator
 Logged By: JET Checked By: BC
 Notes: _____

Bottom of Test Pit at: 8.0 ft
 Ground Water/Seepage: None Observed
 Side Wall Caving: _____

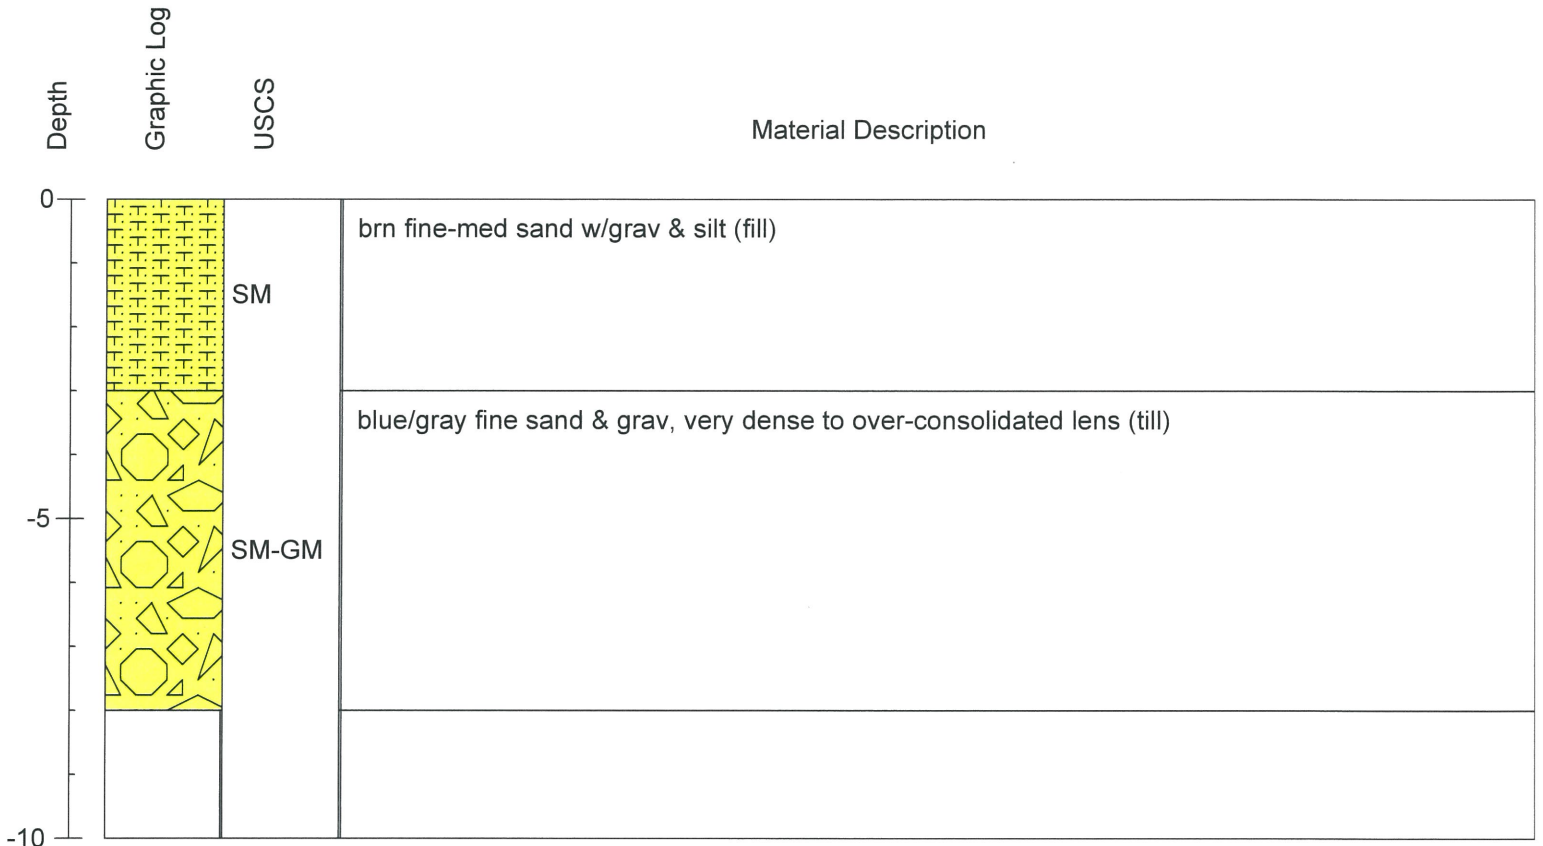
Test Pit Number: TP 2
 Project Name: Dos Lagos
 Ground Elevation: 440 Test Pit Size: 2x6
 Ground Water Levels:
 At Time of Excavation: None
 At End of Excavation: None
 Static Water Depth: None

Client: Dos Lagos Asset, LLC
 Job Number: 12896
 Date Started: 7/7/20
 Date Completed: 7/7/20
 Excavation Contractor: N/A
 Excavation Method: Track Mounted Excavator
 Logged By: JET Checked By: BC
 Notes: Significant fill present, no organics within, preloaded condition.
None

Bottom of Test Pit at: 8.0 ft
 Ground Water/Seepage: None Observed
 Side Wall Caving: None Observed

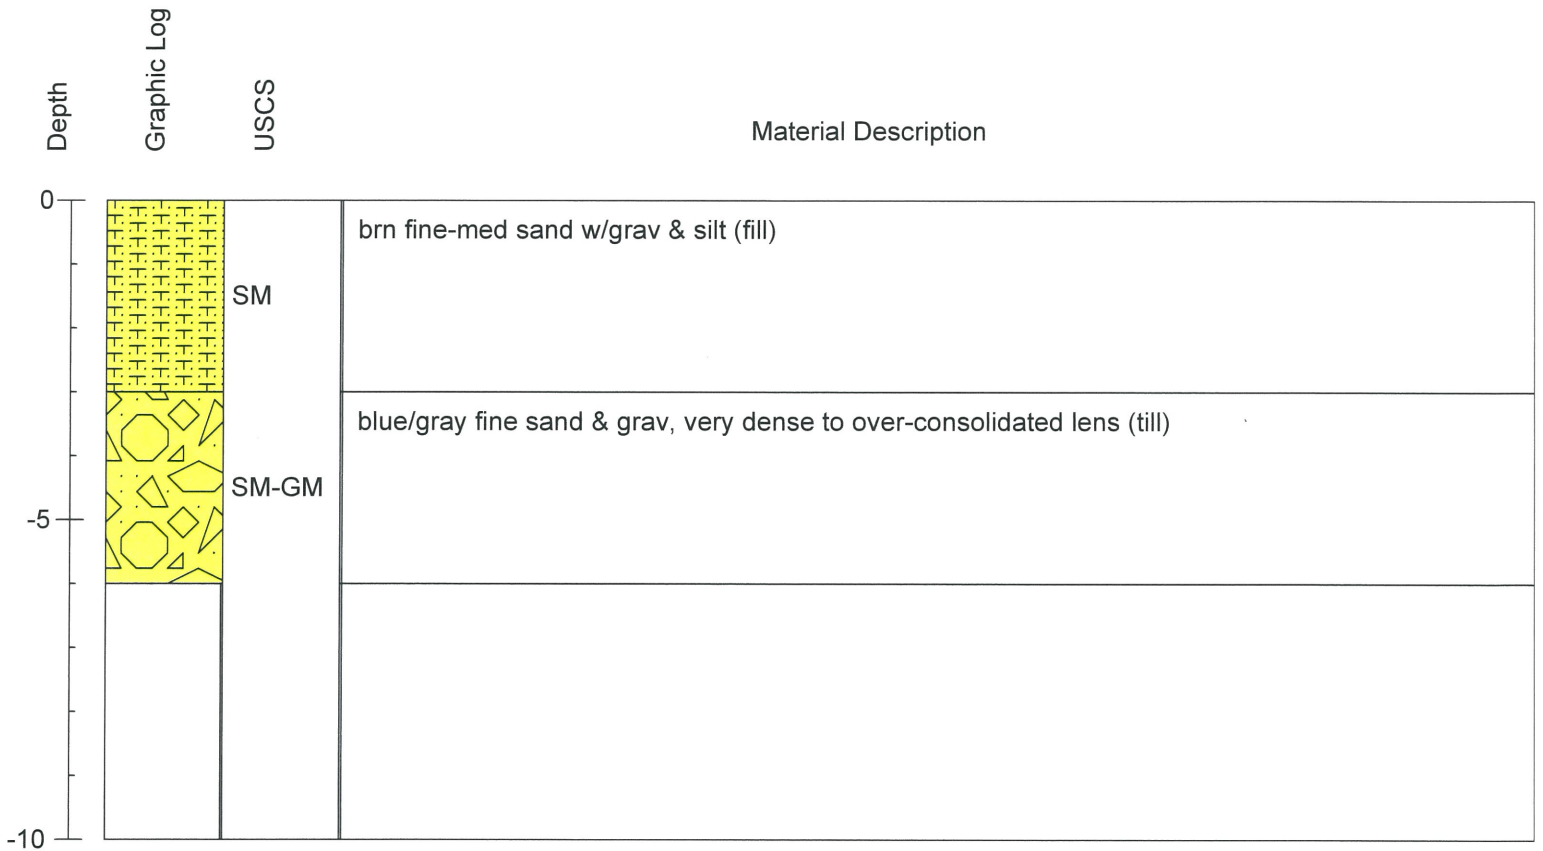
Test Pit Number: TP 3
 Project Name: Dos Lagos
 Ground Elevation: 440 Test Pit Size: 2x6
 Ground Water Levels:
 At Time of Excavation: None
 At End of Excavation: None
 Static Water Depth: None

Client: Dos Lagos Asset, LLC
 Job Number: 12896
 Date Started: 7/7/20
 Date Completed: 7/7/20
 Excavation Contractor: N/A
 Excavation Method: Track Mounted Excavator
 Logged By: JET Checked By: BC
 Notes: Significant fill present, no organics within, preloaded condition.
None

Bottom of Test Pit at: 6.0 ft
 Ground Water/Seepage: None Observed
 Side Wall Caving: None Observed

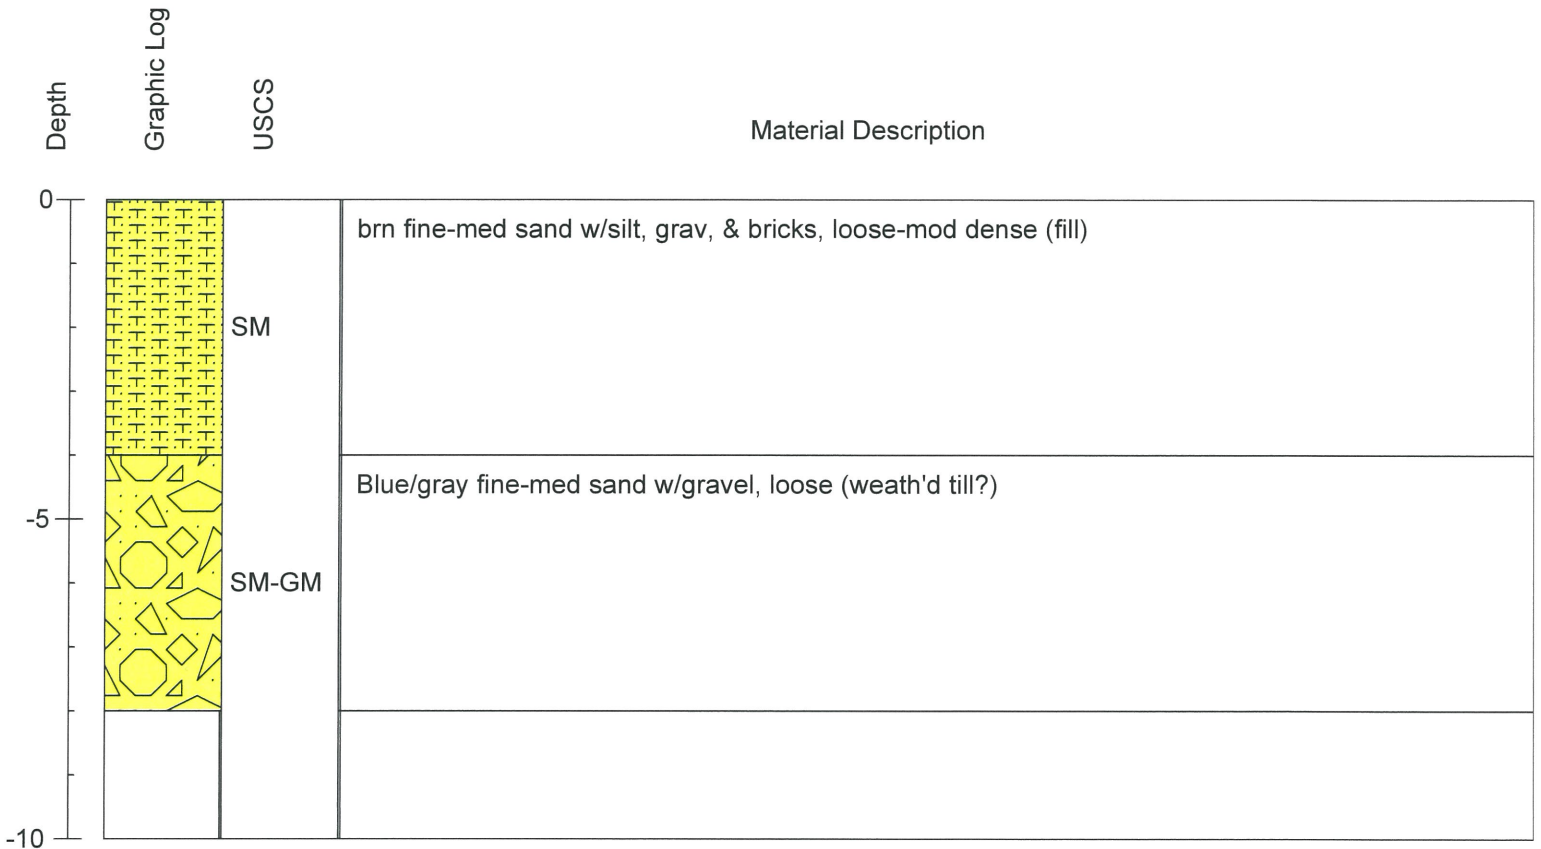
Test Pit Number: TP 4
 Project Name: Dos Lagos
 Ground Elevation: 438 Test Pit Size: 2x6
 Ground Water Levels:
 At Time of Excavation: None
 At End of Excavation: None
 Static Water Depth: None

Client: Dos Lagos Asset, LLC
 Job Number: 12896
 Date Started: 7/7/20
 Date Completed: 7/7/20
 Excavation Contractor: N/A
 Excavation Method: Track Mounted Excavator
 Logged By: JET Checked By: BC
 Notes: Significant fill present, no organics within, preloaded condition. Bricks found at depth.
None

Bottom of Test Pit at: 8.0 ft
 Ground Water/Seepage: None Observed
 Side Wall Caving: None Observed

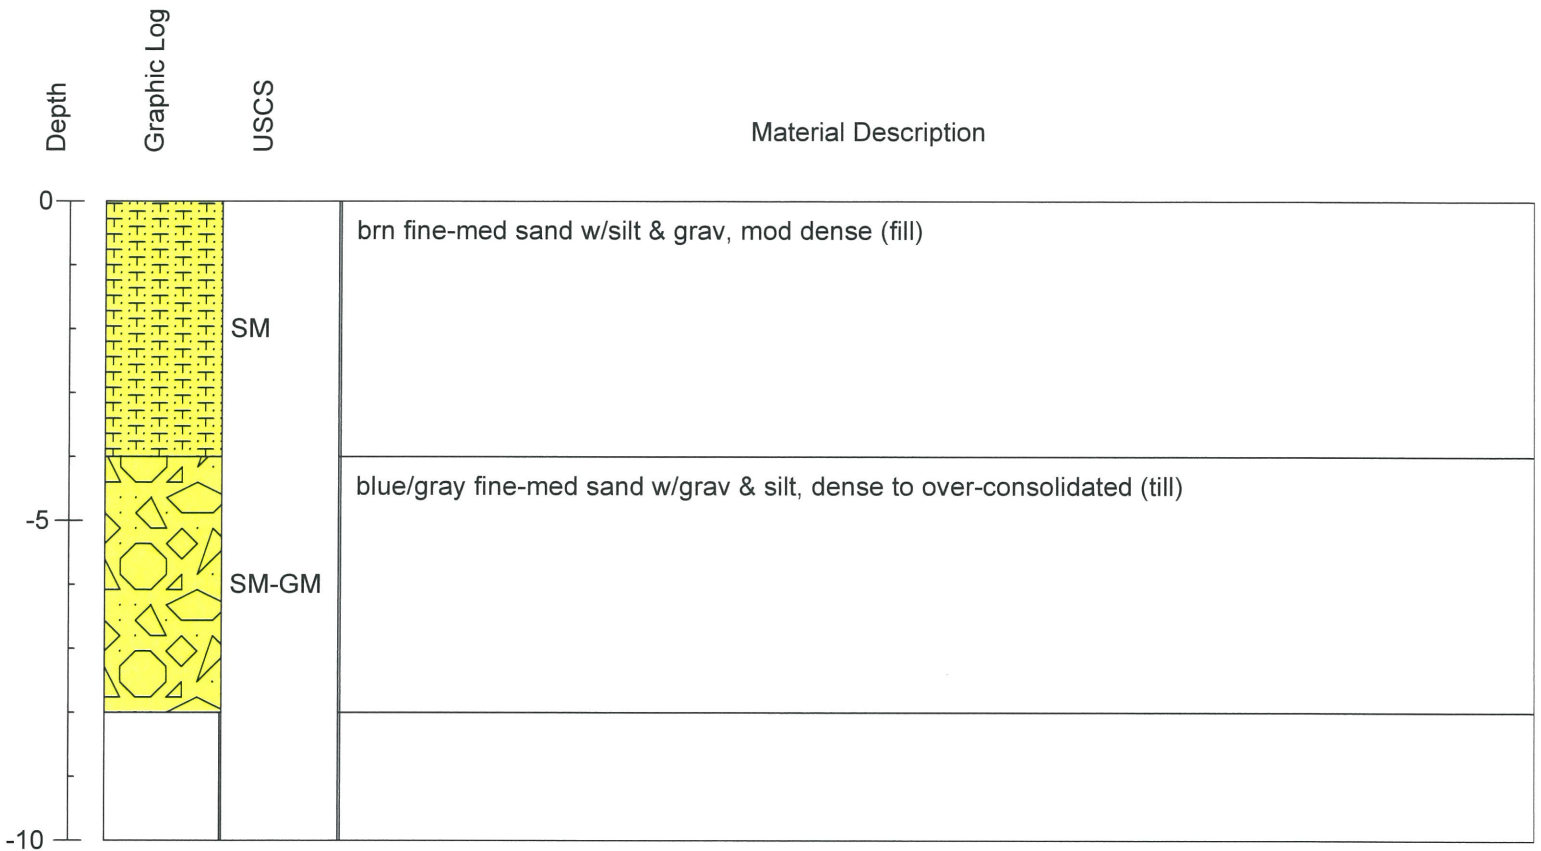
Test Pit Number: TP 6
 Project Name: Dos Lagos
 Ground Elevation: 438 Test Pit Size: 2x6
 Ground Water Levels:
 At Time of Excavation: None
 At End of Excavation: None
 Static Water Depth: None

Client: Dos Lagos Asset, LLC
 Job Number: 12896
 Date Started: 7/7/20
 Date Completed: 7/7/20
 Excavation Contractor: N/A
 Excavation Method: Track Mounted Excavator
 Logged By: JET Checked By: BC
 Notes: Significant fill present, no organics within, preloaded condition.
None

Bottom of Test Pit at: 8.0 ft
 Ground Water/Seepage: None Observed
 Side Wall Caving: None Observed

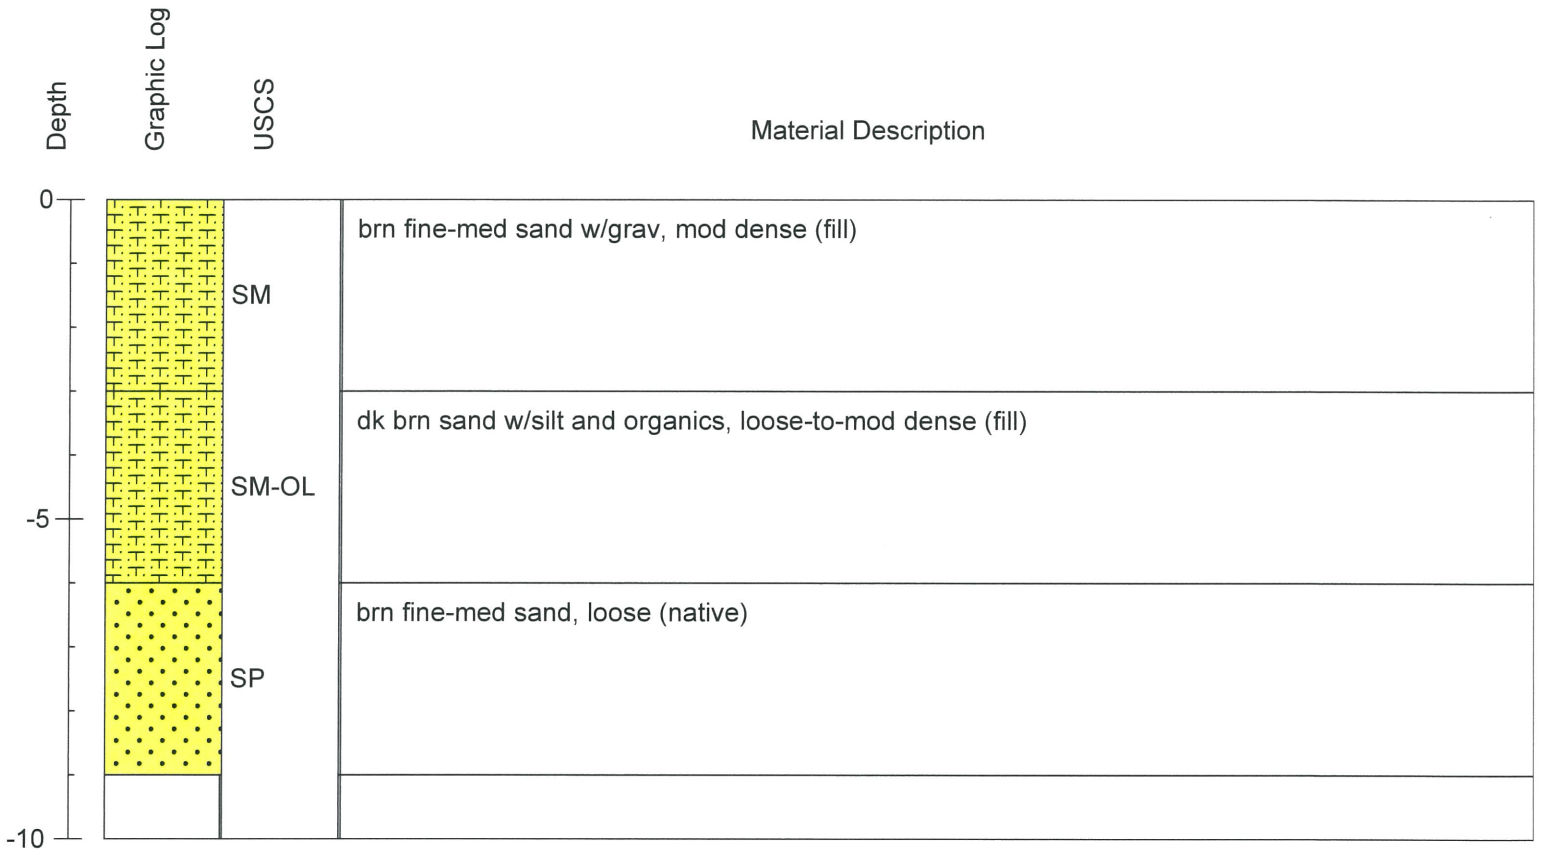
Test Pit Number: TP 8
 Project Name: Dos Lagos
 Ground Elevation: 444 Test Pit Size: 2x6
 Ground Water Levels:
 At Time of Excavation: None
 At End of Excavation: None
 Static Water Depth: None

Client: Dos Lagos Asset, LLC
 Job Number: 12896
 Date Started: 7/7/20
 Date Completed: 7/7/20
 Excavation Contractor: N/A
 Excavation Method: Track Mounted Excavator
 Logged By: JET Checked By: BC
 Notes: Significant fill present, no organics within, preloaded condition.
None

Bottom of Test Pit at: 9.0 ft
 Ground Water/Seepage: None Observed
 Side Wall Caving: None Observed
