PROPOSAL FOR MERIDIAN POINTE

2022 Removals / Meridian Pointe / Palladium

Proposal ID: 265751

Address: 407 Valley Ave NE, Puyallup, WA 98372

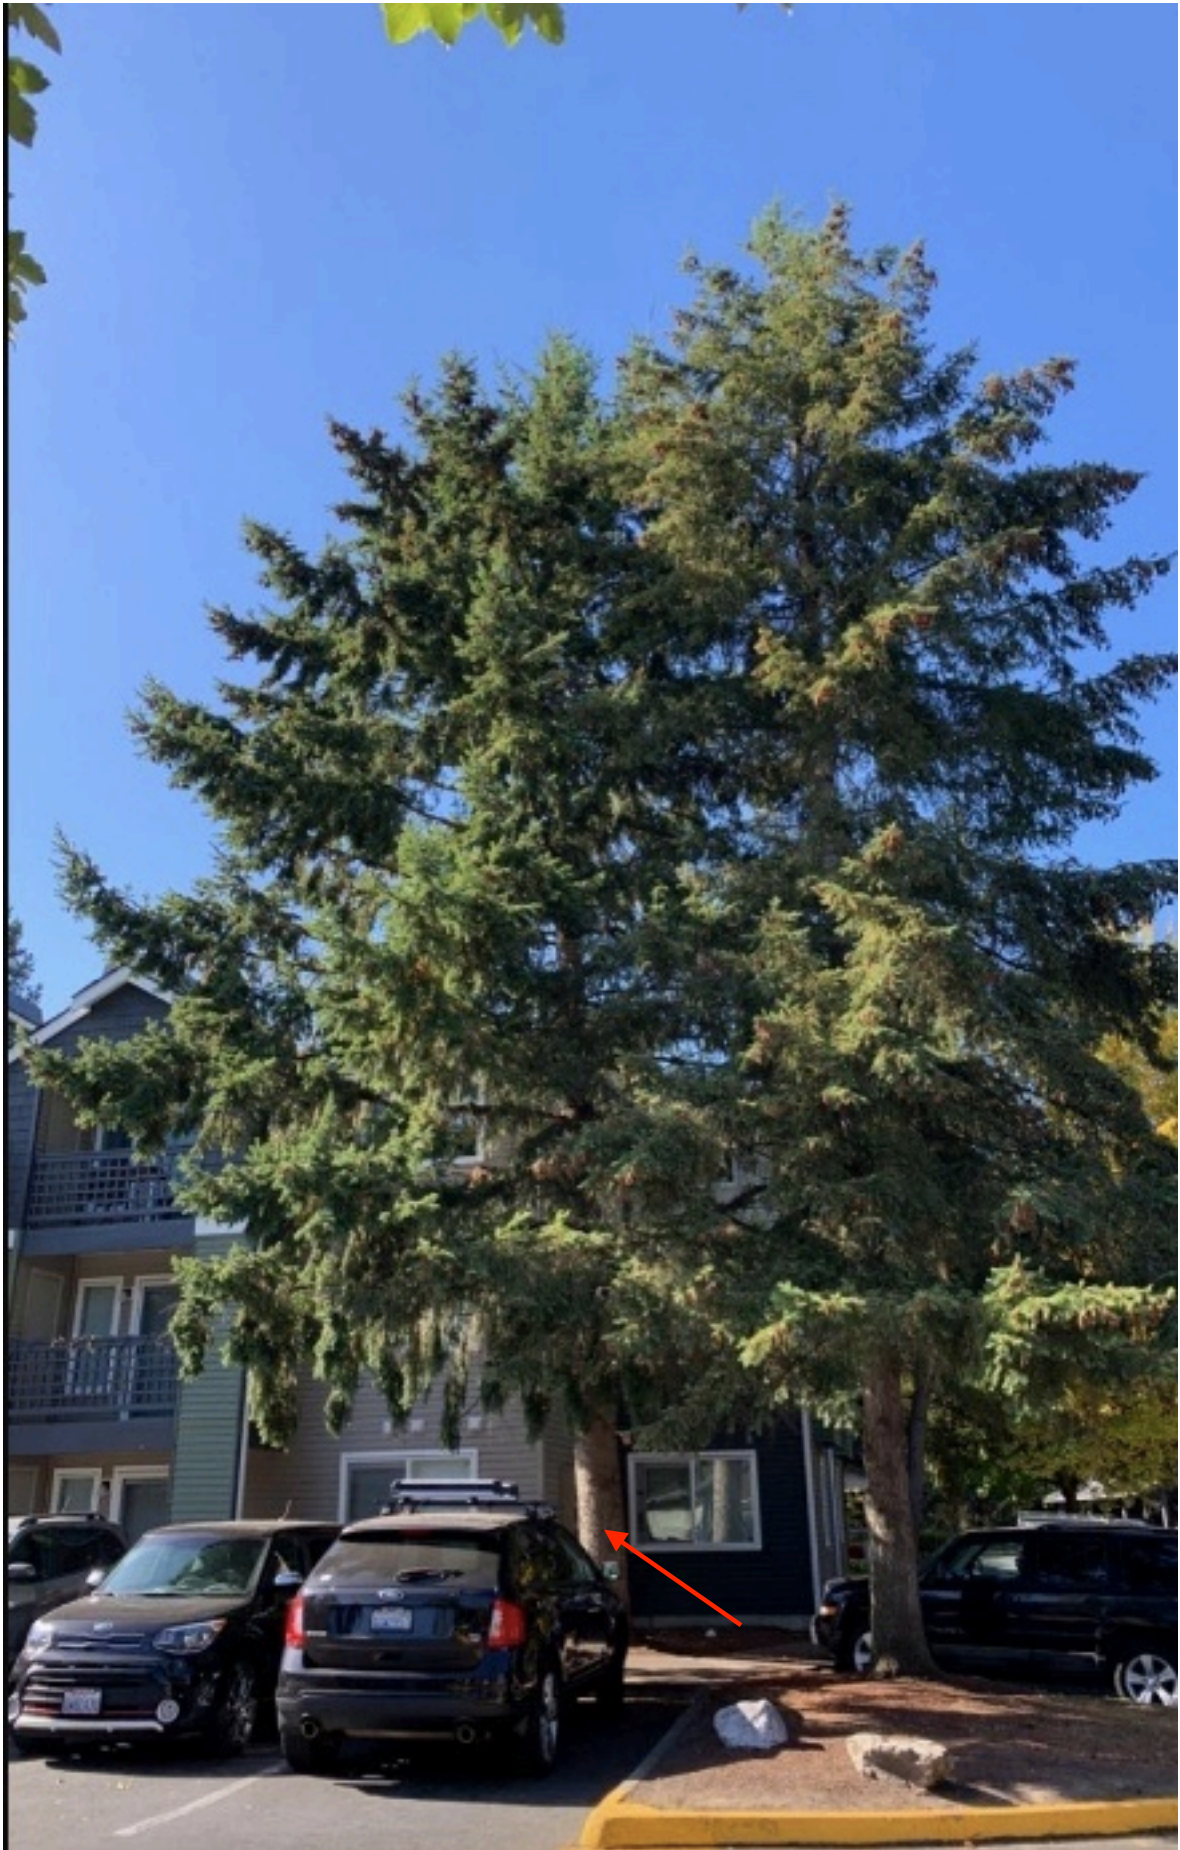
Tree 4

4	Douglas Fir (Pseudotsuga menziesii) [1000860237] 19.4" DBH. Fair. M building Lifting and damaging adjacent walk. Walk has been ground previously. Root pruning not recommended due to proximity to walk, size of tree, surrounding targets & potential damage from root failure. Root pruning would remove significant portion.	Removal

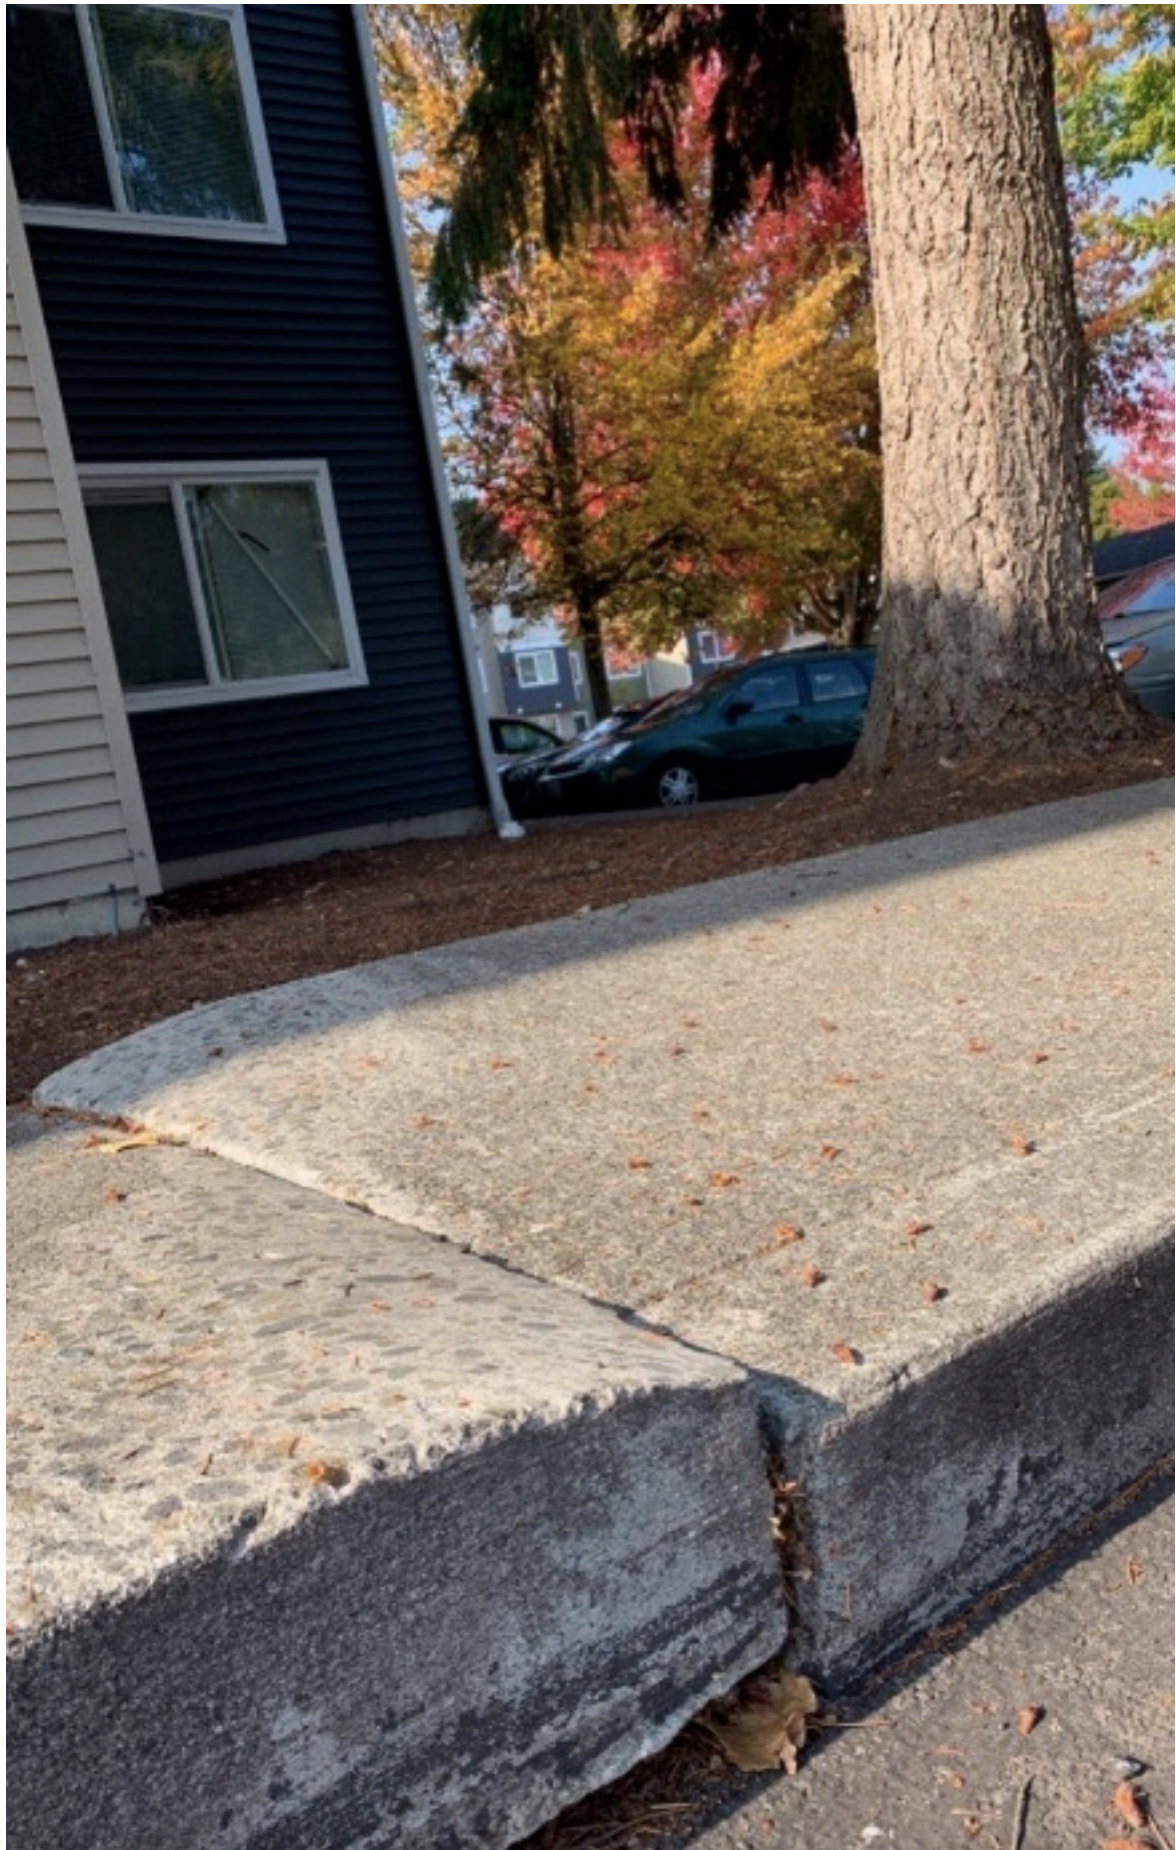
Tree 4: Walk damage & previous surface grinding

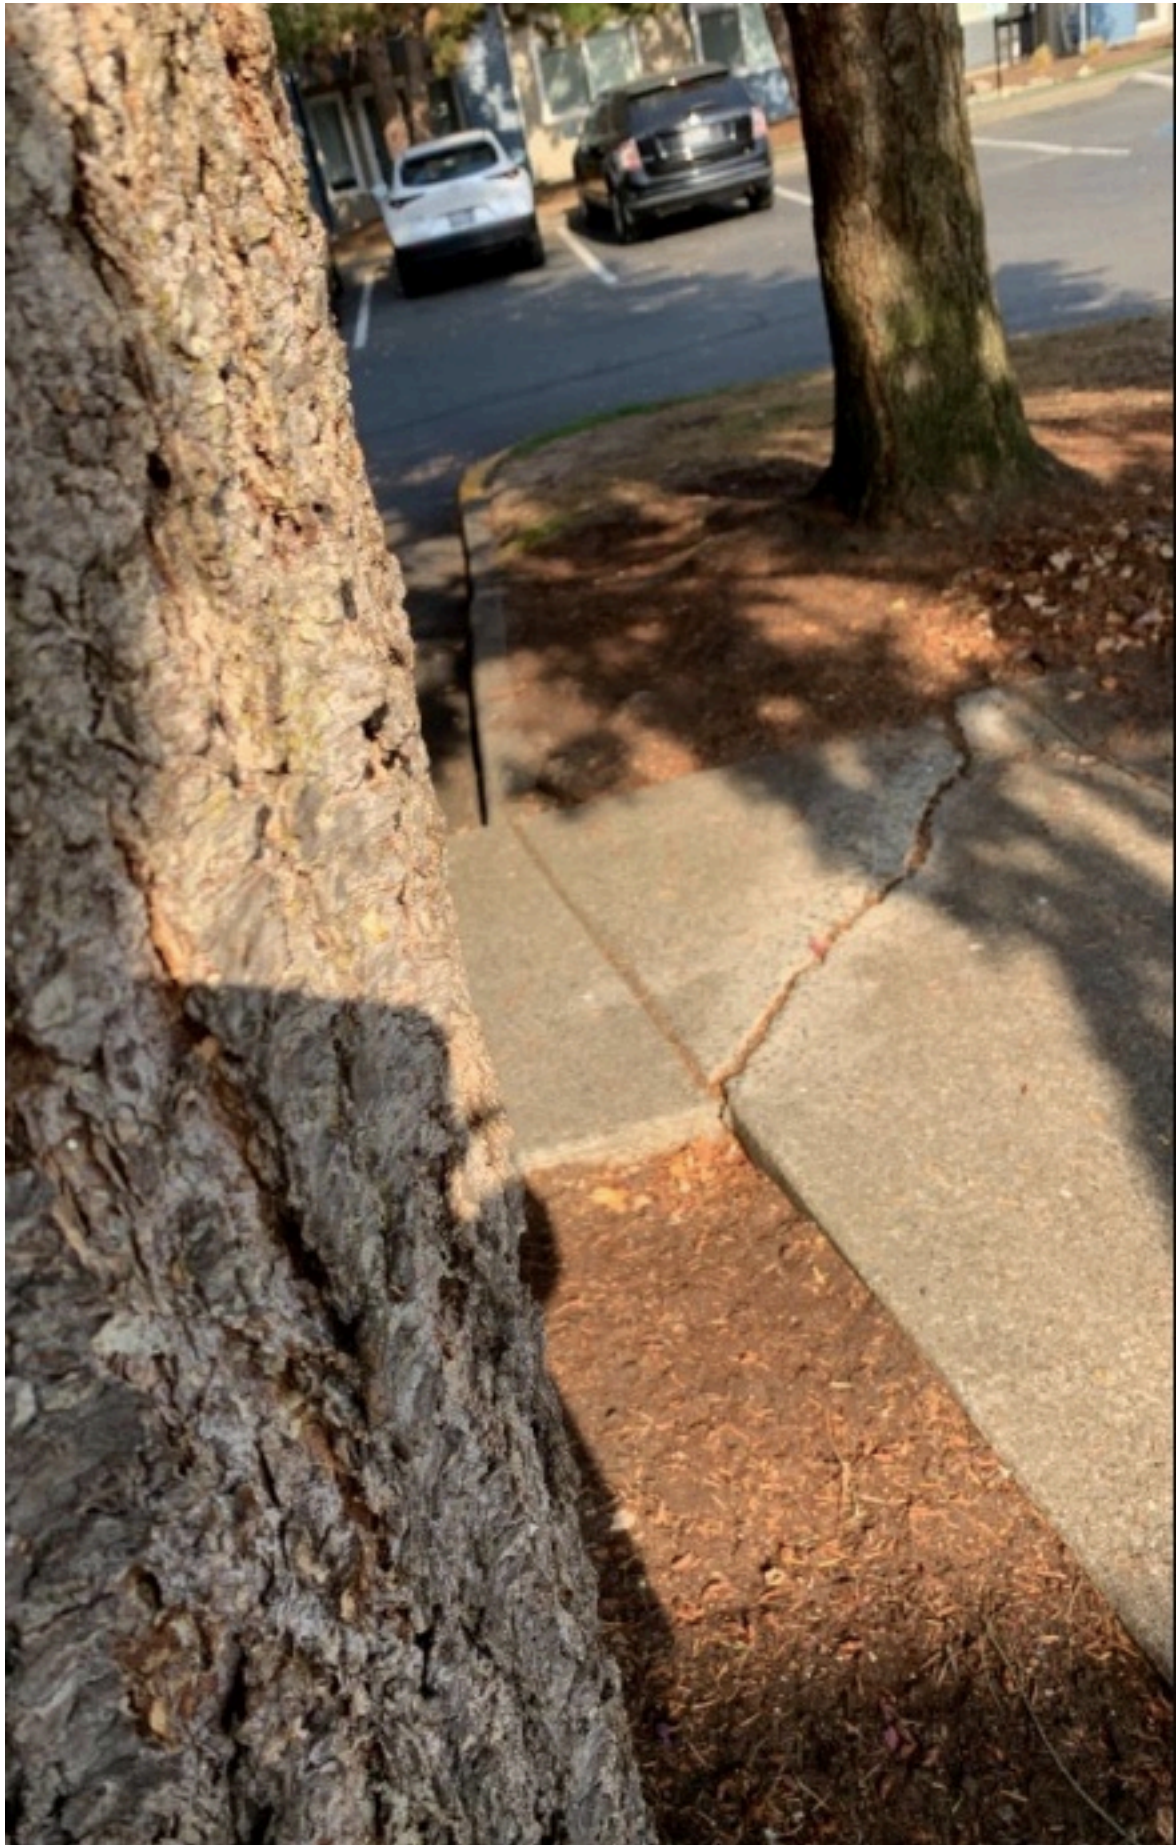
Tree 4: Adjacent walk damage & previous surface grinding

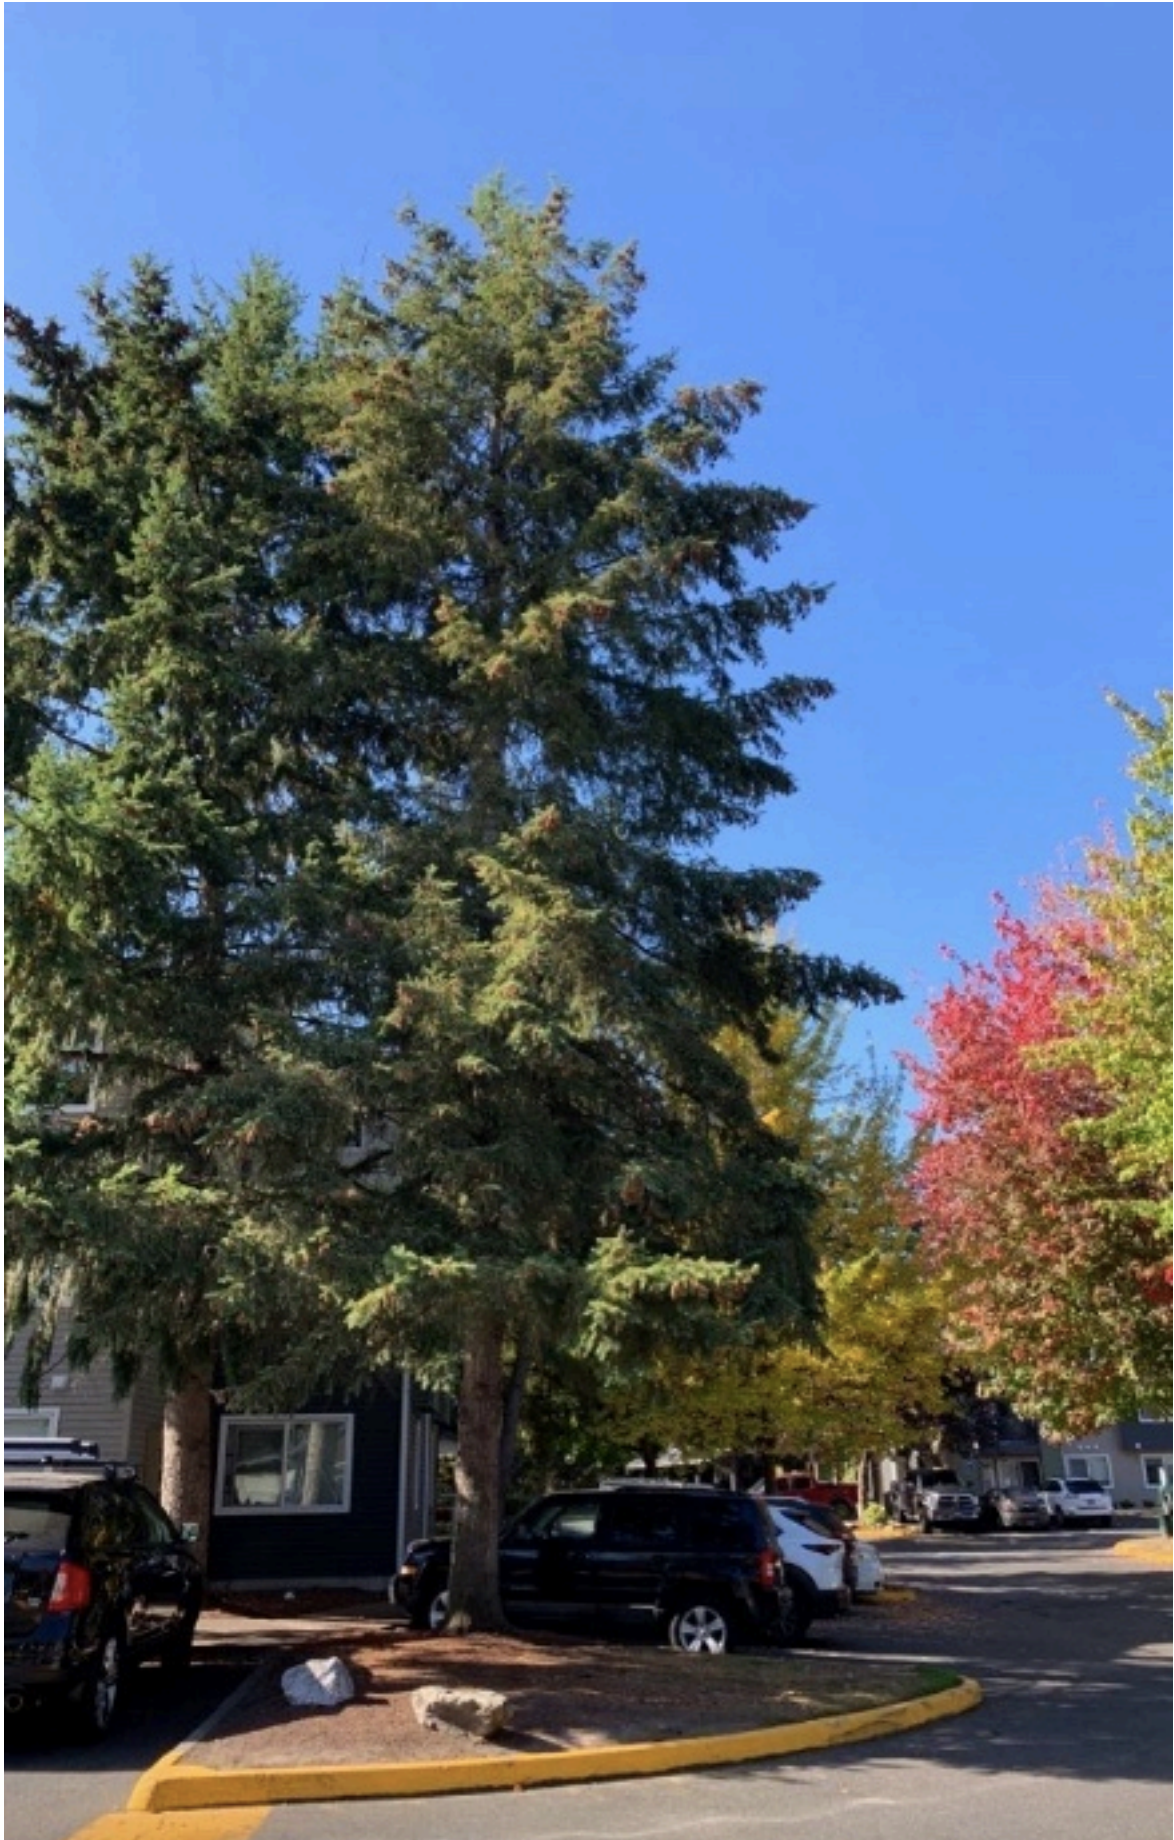
Tree 5

5	Douglas Fir (Pseudotsuga menziesii) [1000860238] 16.5" DBH. Fair. M Building Tree has lifted curb & damaging asphalt in adjacent parking area creating a trip hazard. Root pruning not recommended due to proximity, size of tree, limited soil conditions for root development, targets & potential damage from root failure. Root pruning would remove potential anchor/scaffold roots near the base of the tree.	Removal

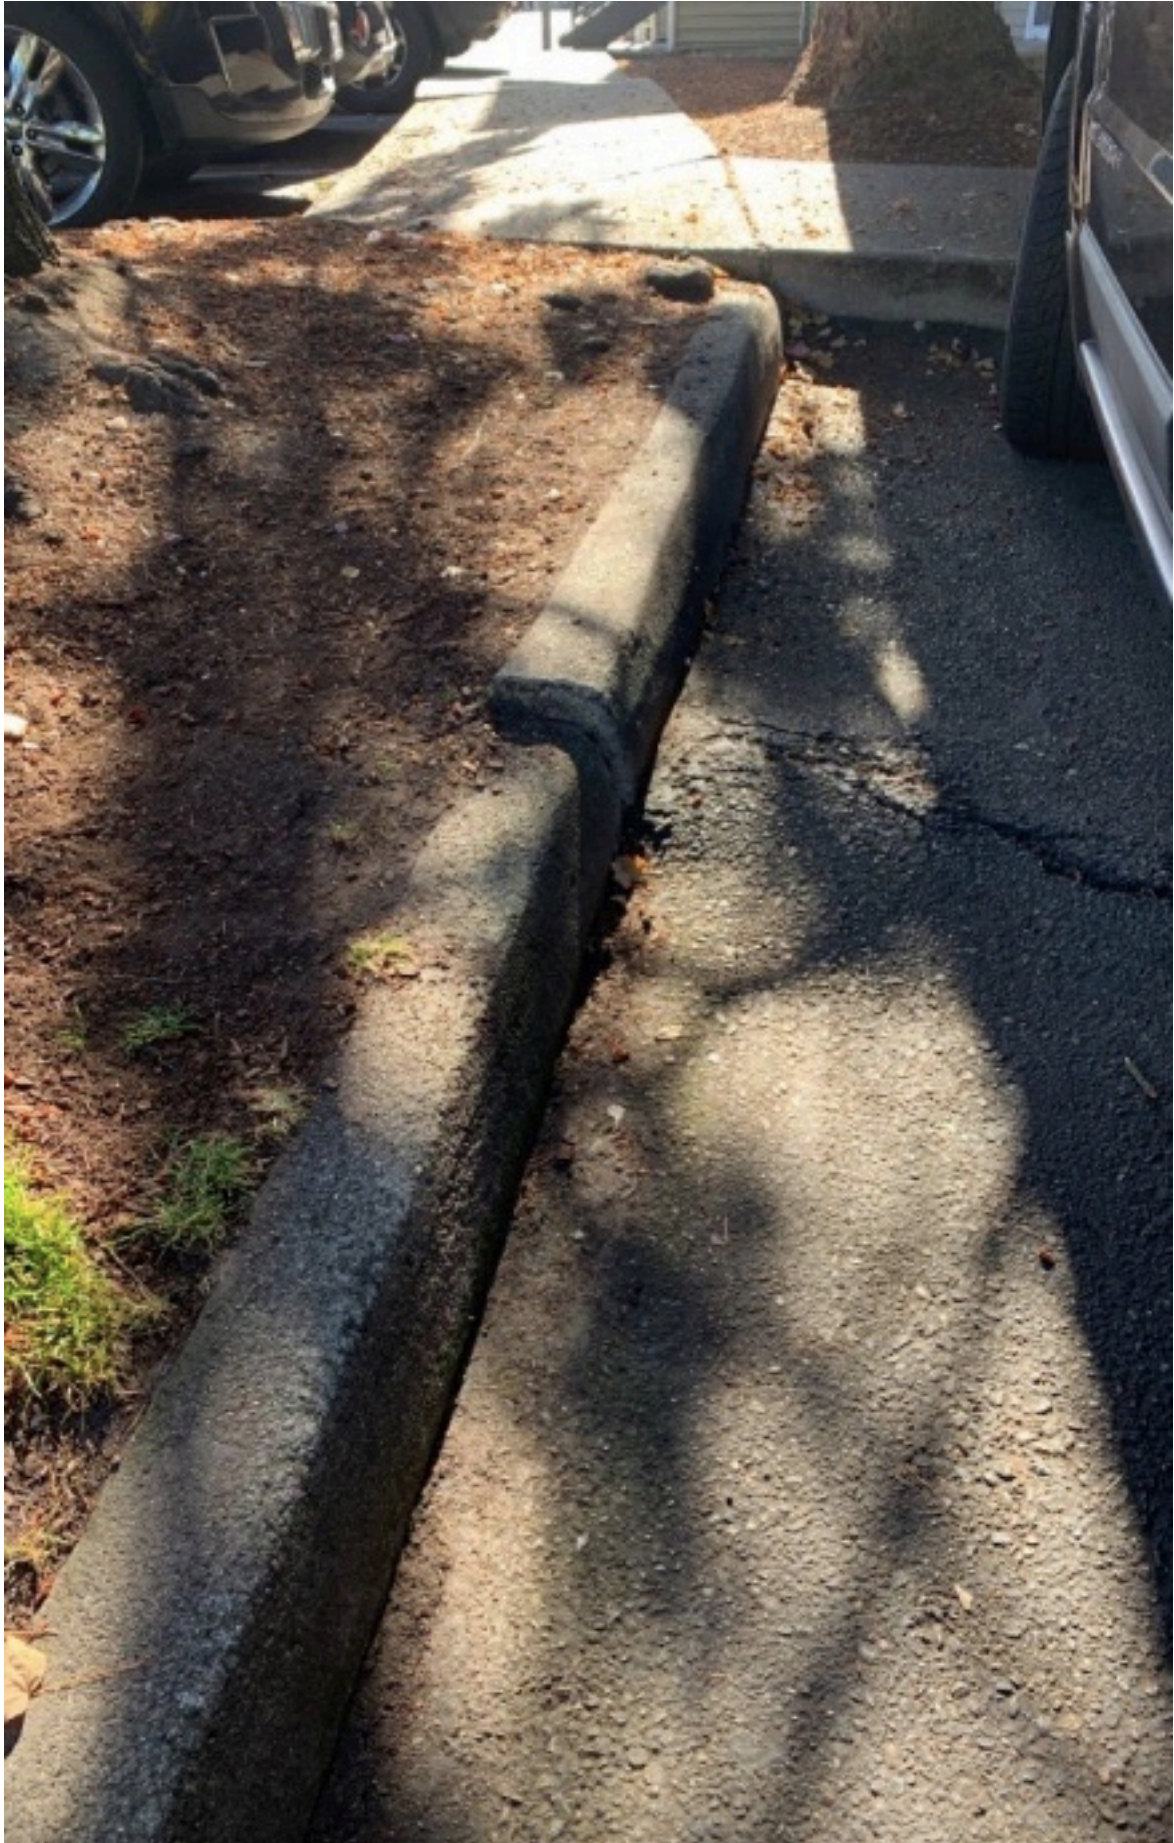
Tree 5: Curb & asphalt damage

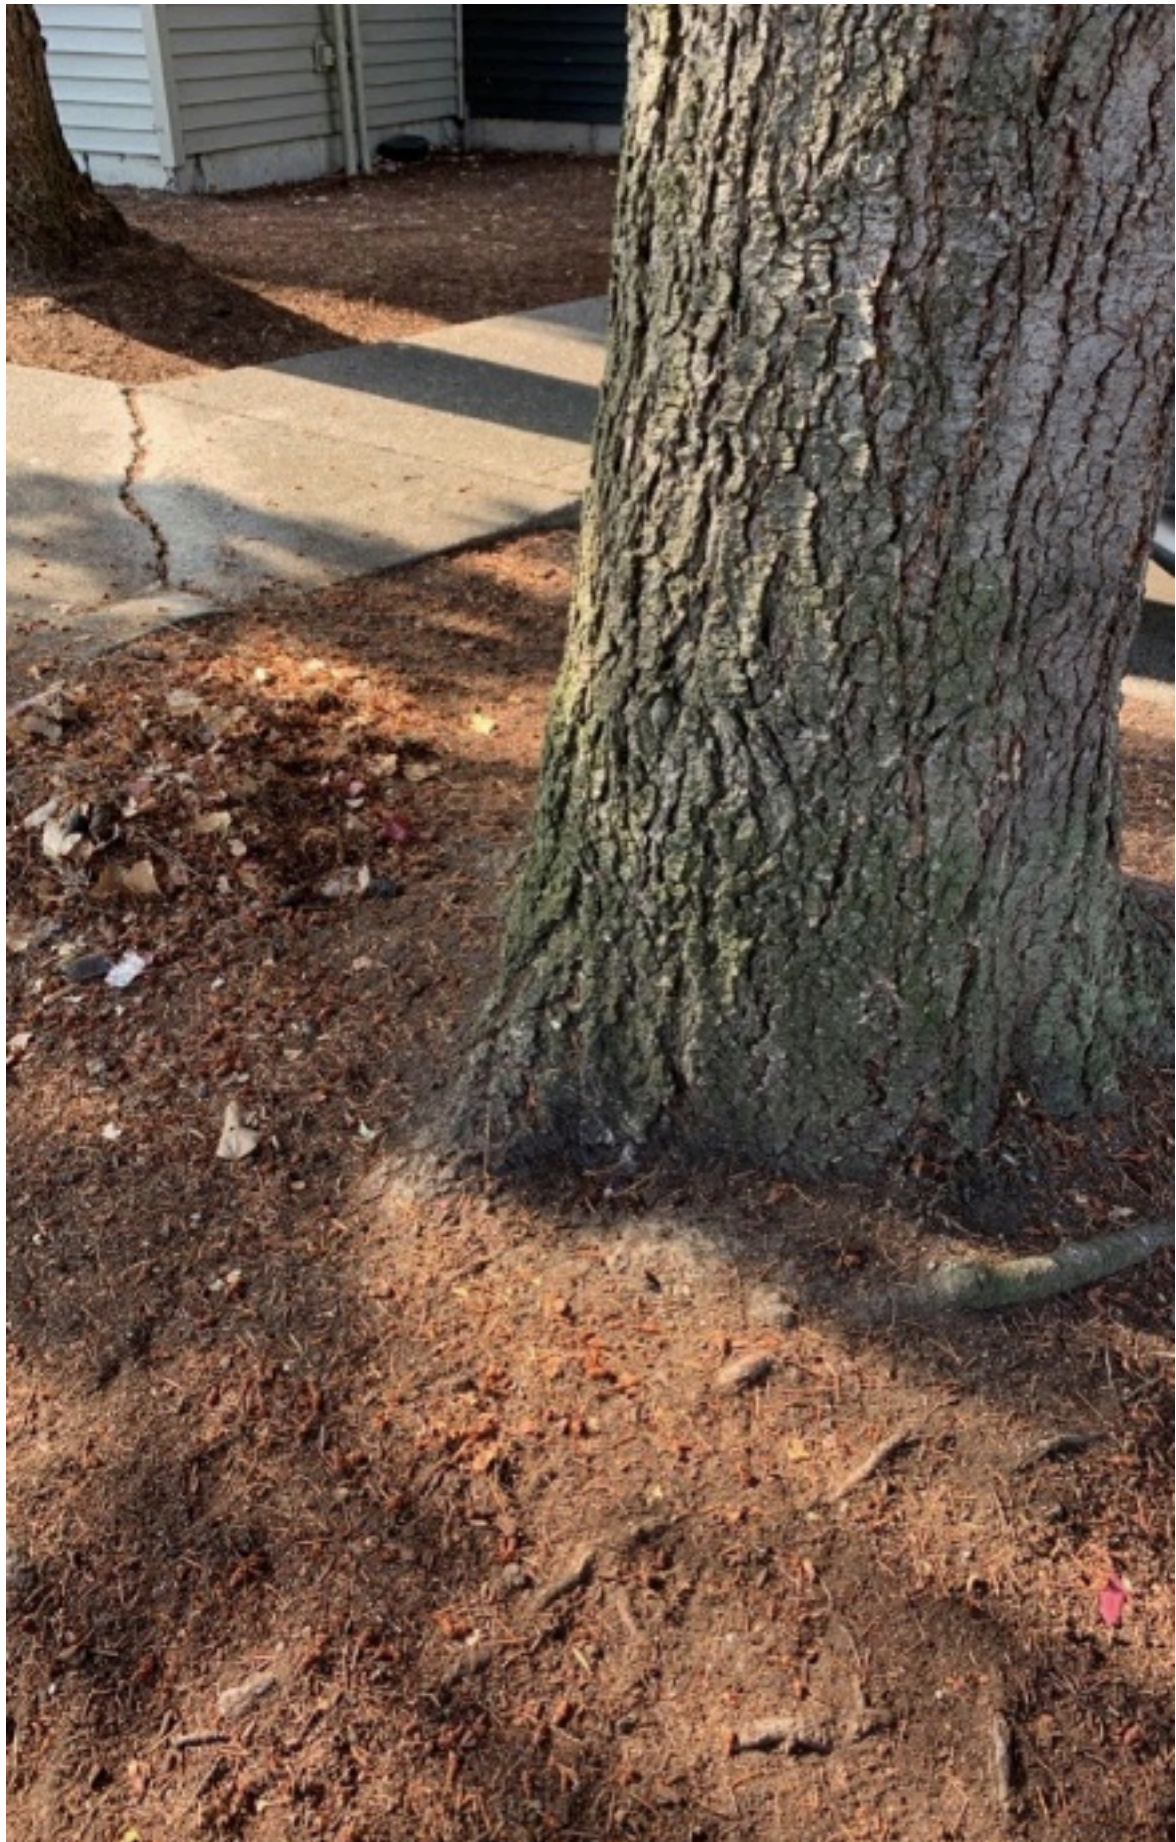
Tree 5: Adjacent walk damage

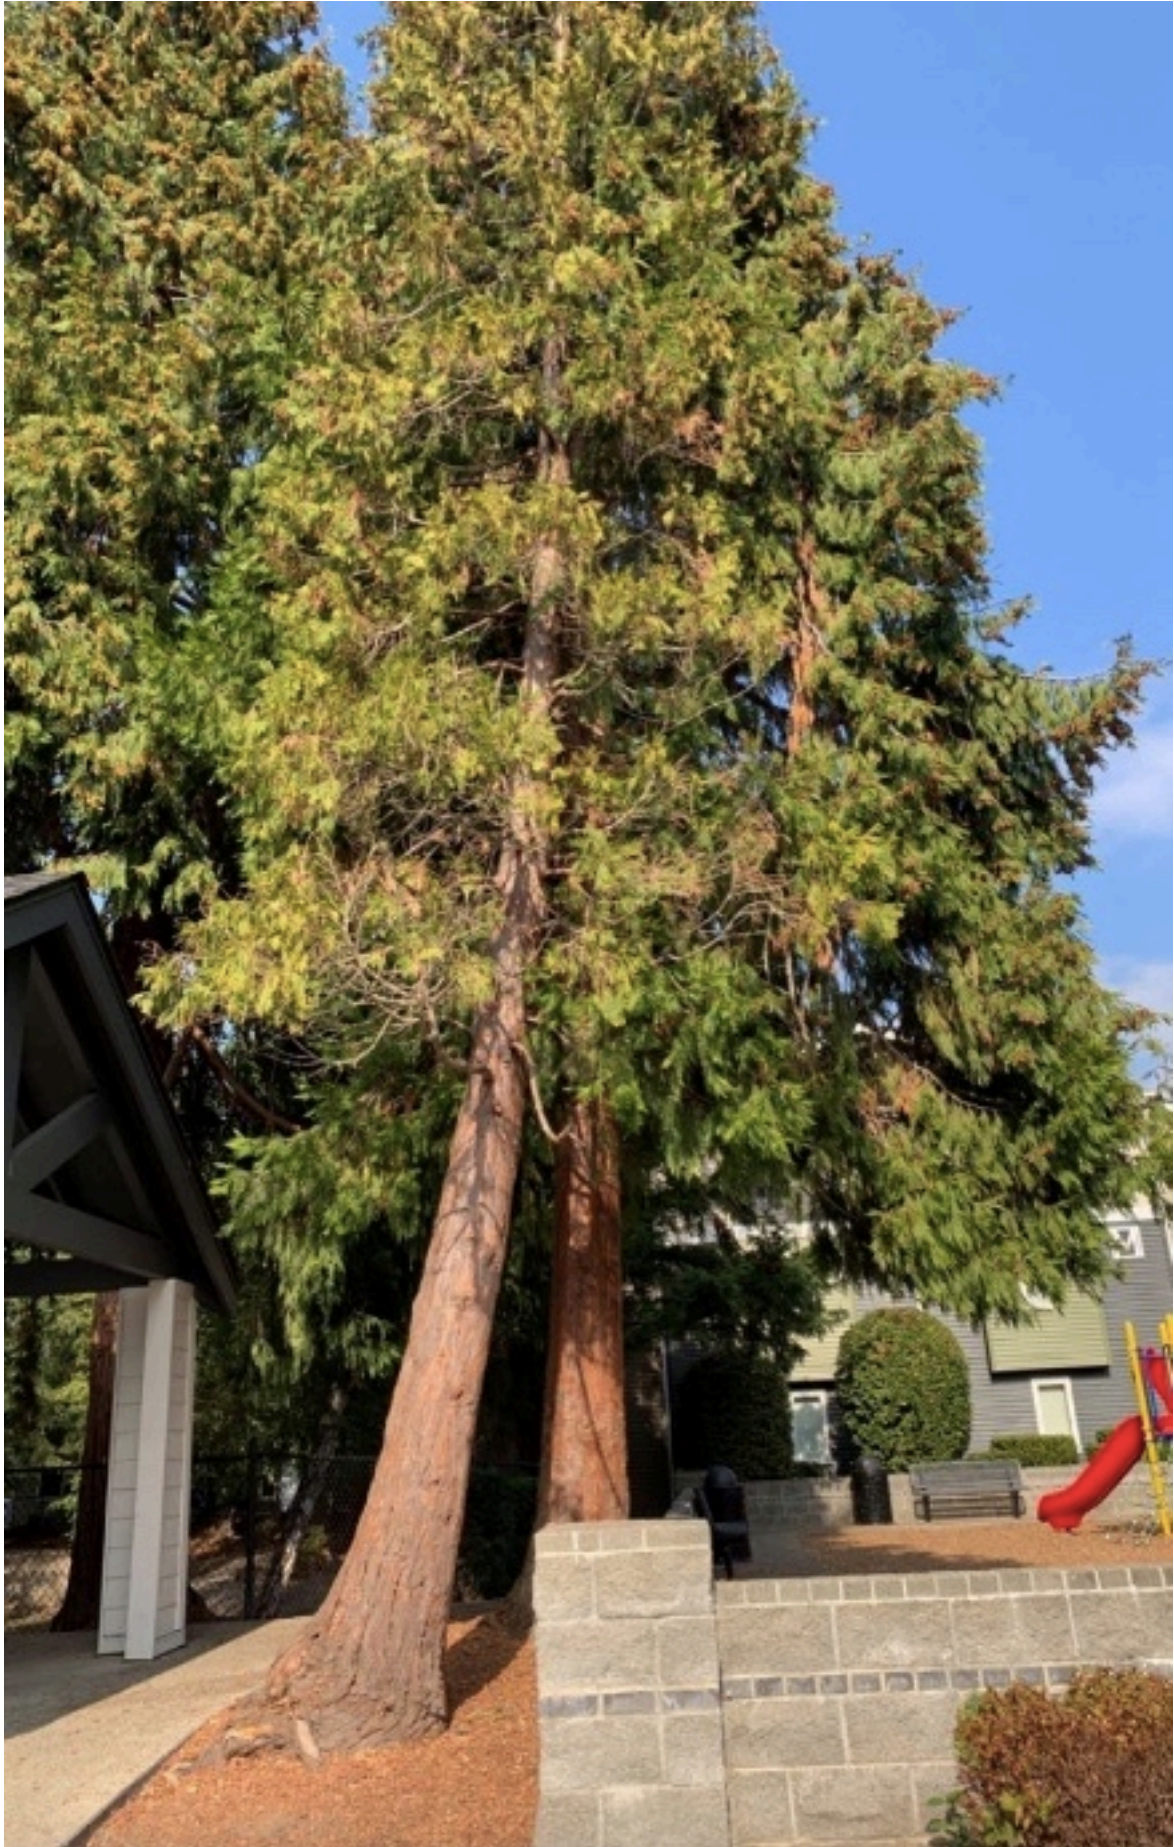
Tree 6

6	Incense Cedar (Calocedrus decurrens) [1000860202] 16.7" DBH. Fair. Roots lifting & cracking adjacent walk. Unsustainable location due to proximity to hardscape. Roots previously cut near the concrete. Tree has corrected lean towards play area. Root pruning not a viable option.	Removal

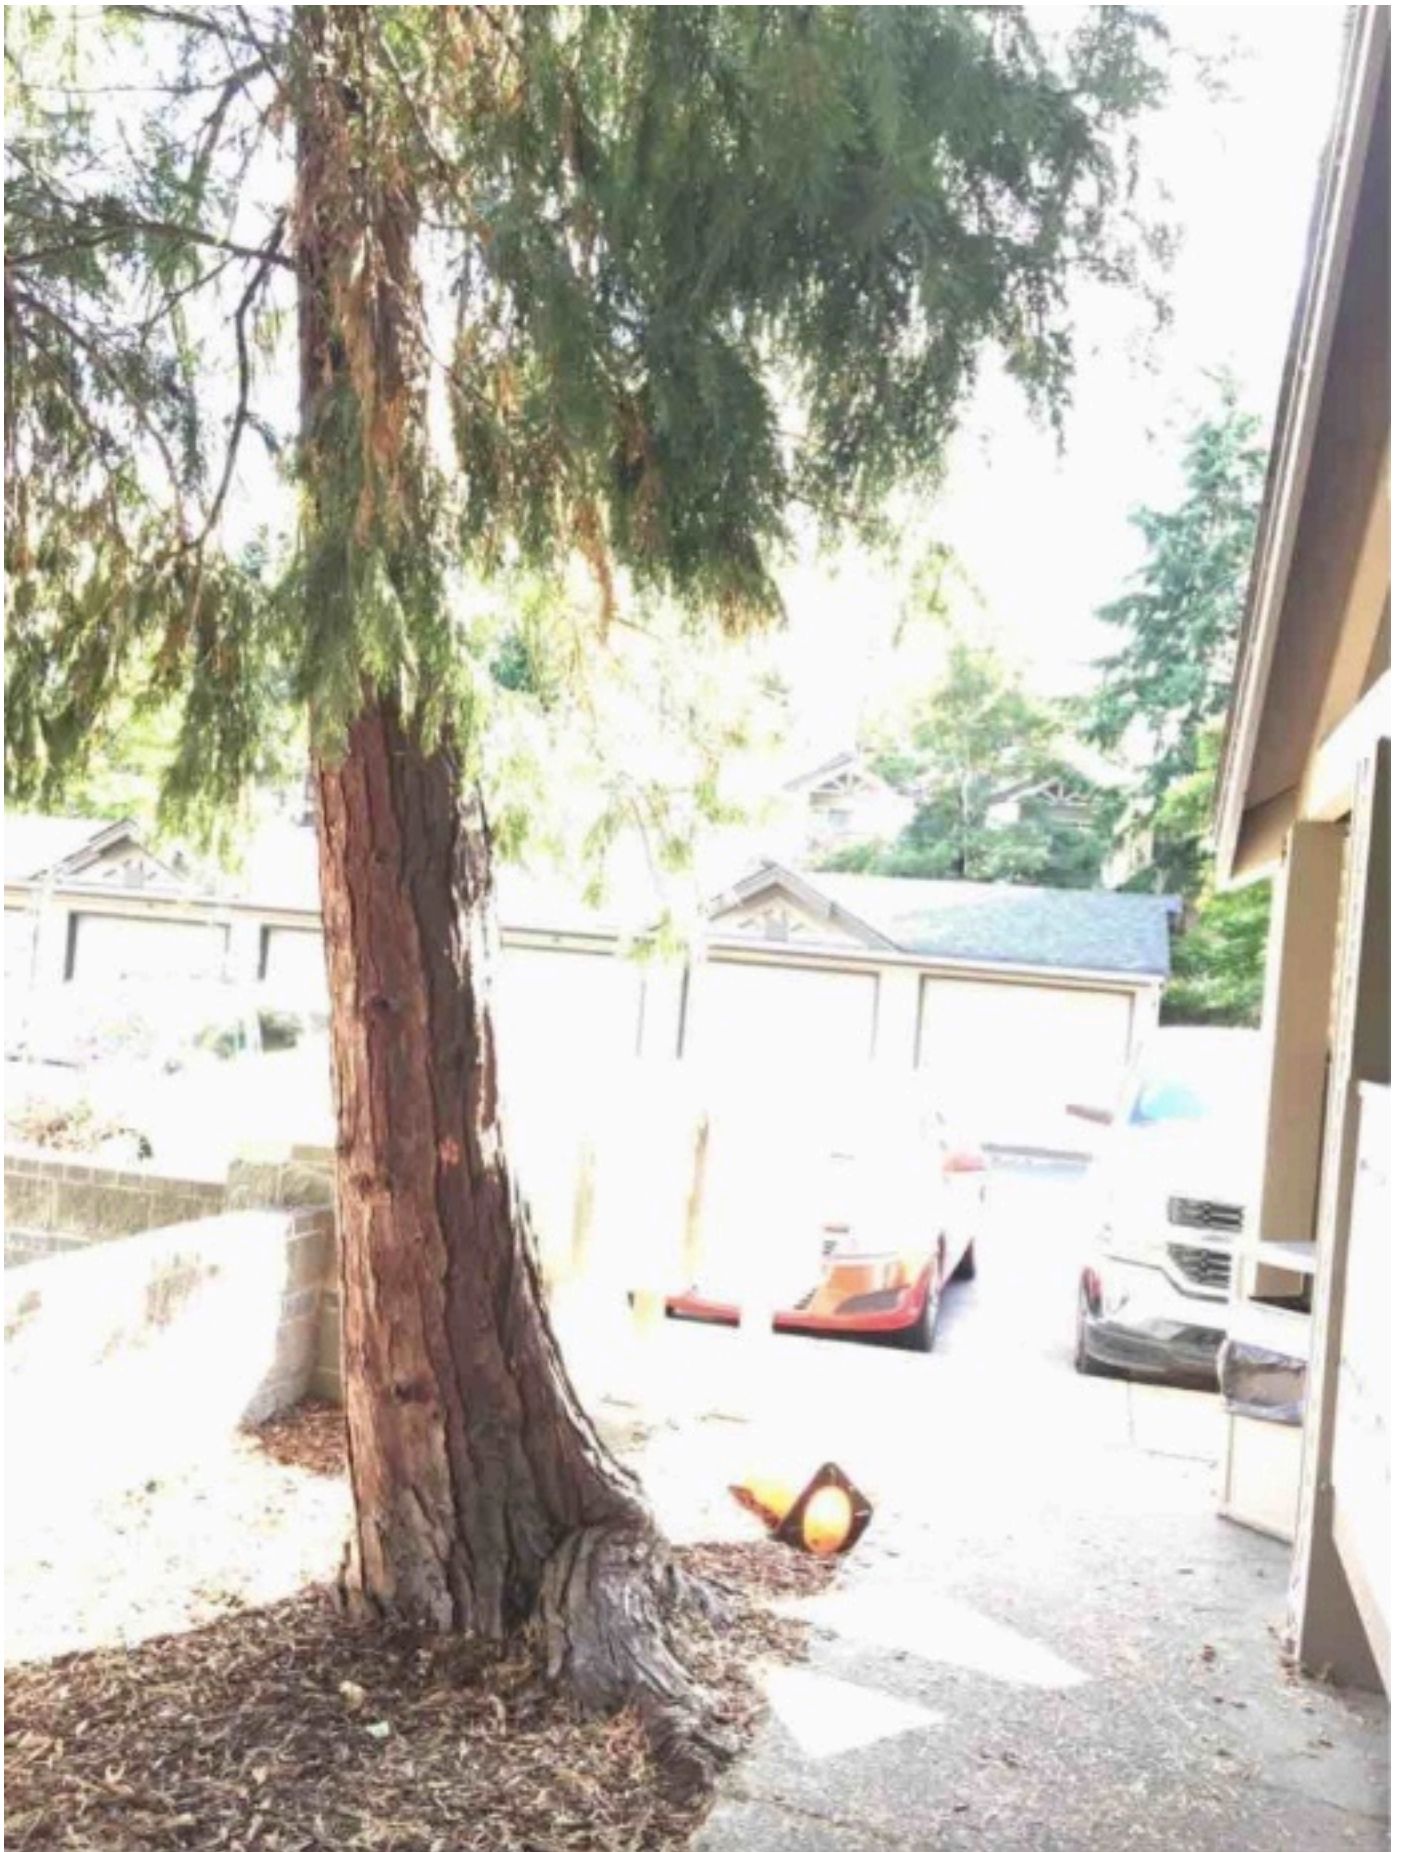
Tree 6: Proximity to walk, tension-side response growth & scaffold roots

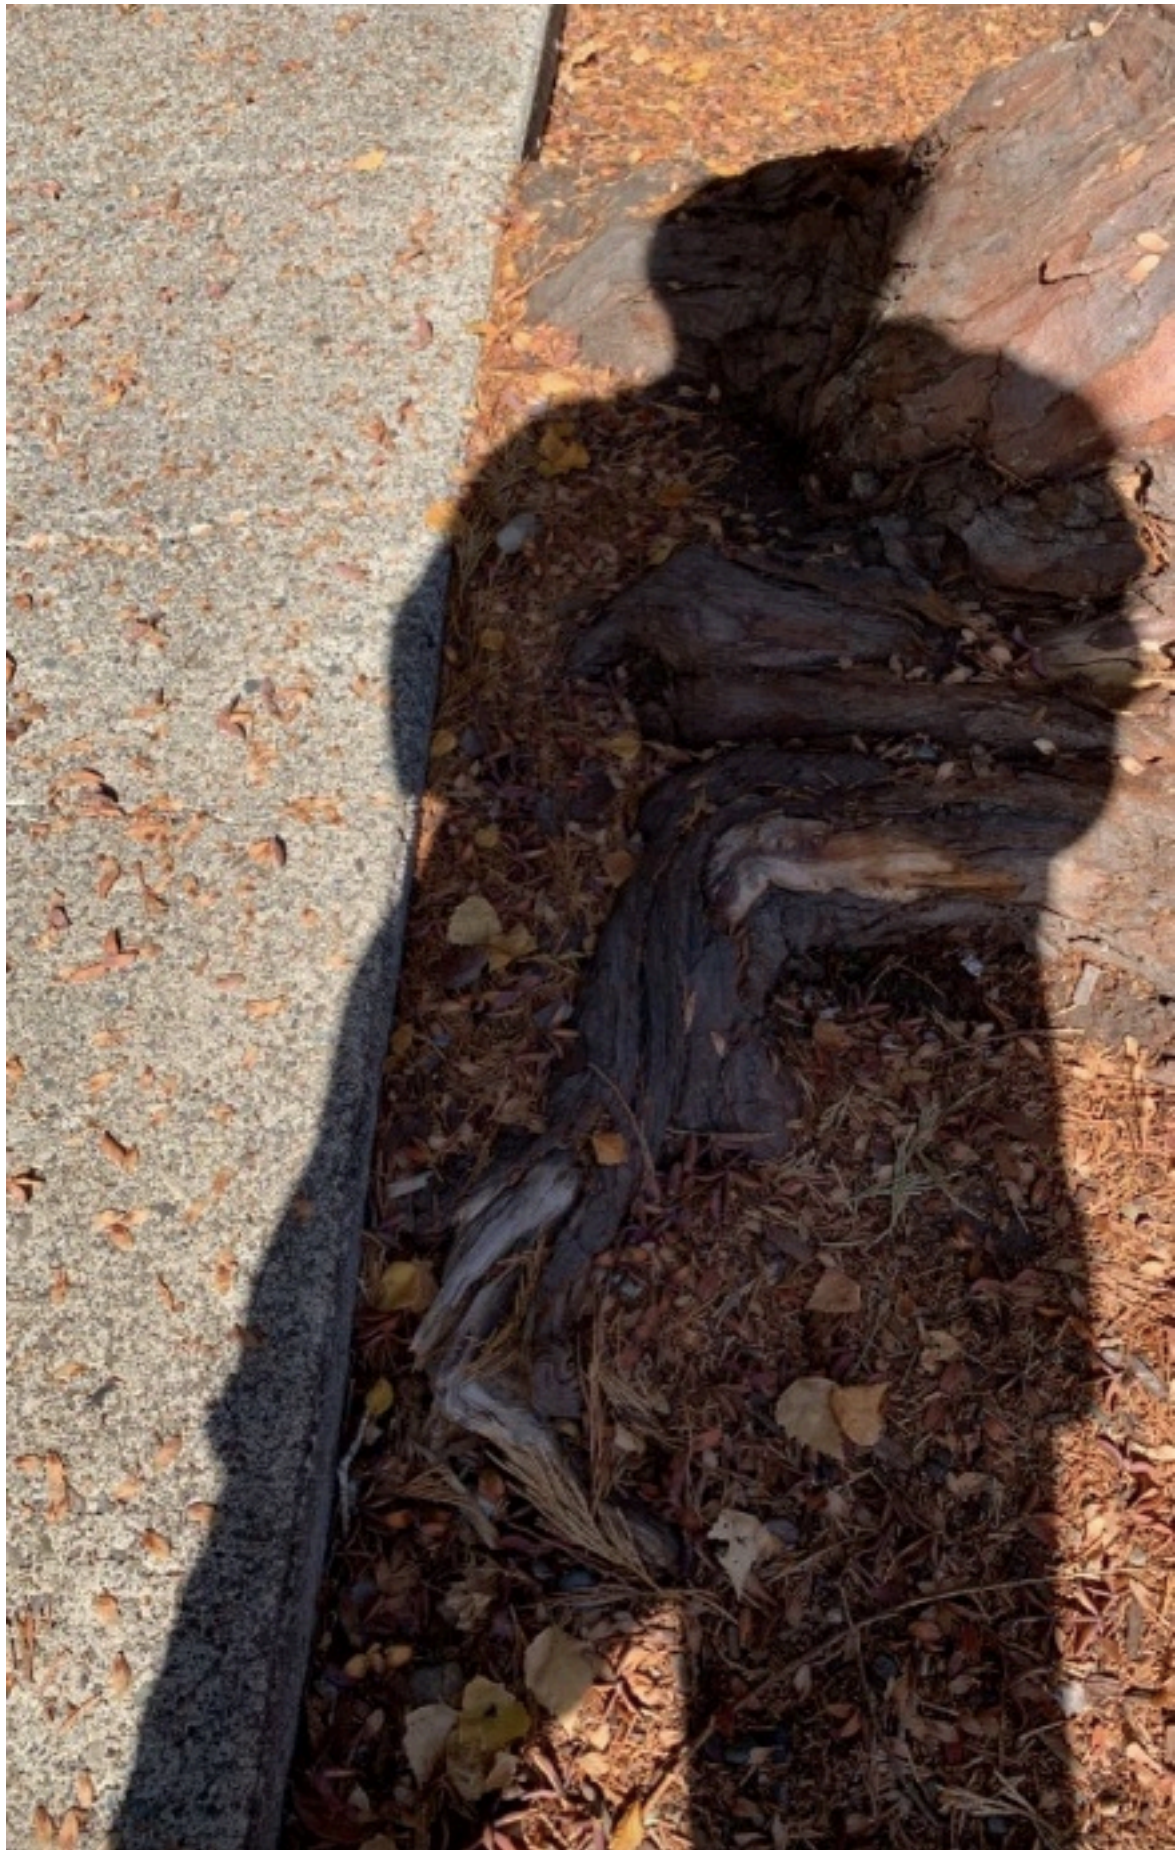
Tree 6: Previous surface root pruning wounds
