**SUF**  
**SOUND URBAN FORESTRY, LLC**

10/13/2025

RE: 204 4<sup>th</sup> St SW/Bell Place Tree Risk Assessment

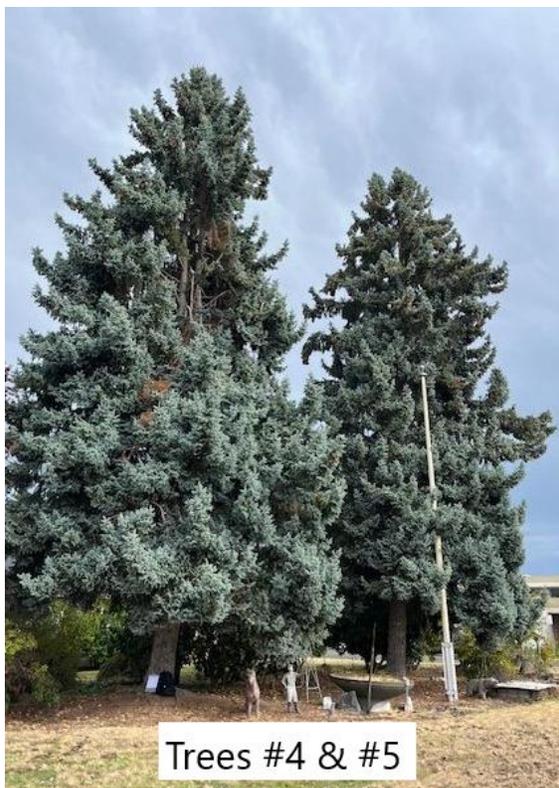
Trees #4 & #5

ID#	Species	DBH Height Live Canopy Ratio	Current Target(s)	Condition	Risk Rating	Comments
5	Colorado Blue Spruce	23" 62' 40%	House Sidewalk Street	Poor	Moderate	Past main stem failure at 50'. Co-dominant stems at that point with 3' of inclusion.
6	Purple Plum	17" 20' 10%	House	Poor	Moderate	Previously topped at 10'. Extensive decay found within the main stem and scaffold branches. Grows at an angle toward the house.

The risk ratings assigned to the assessed trees reflect their current conditions and targets. I would recommend the removal of all six trees.

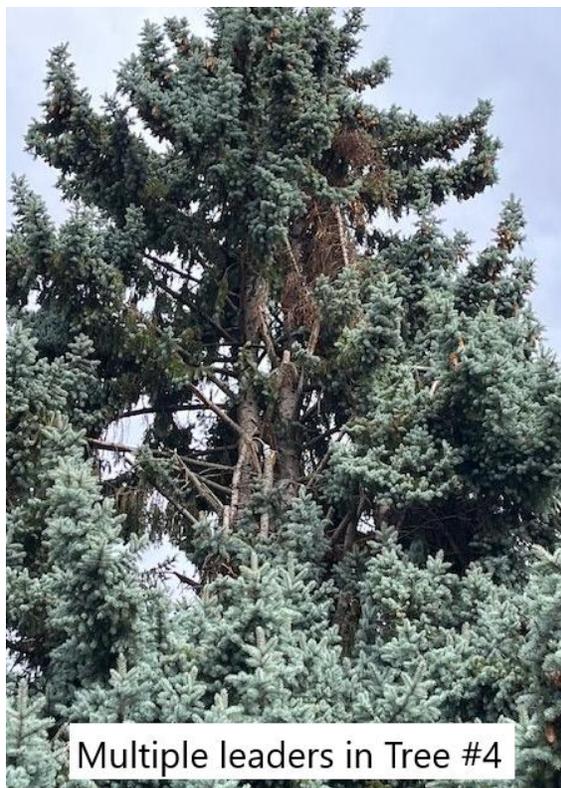
Multiple leaders in Tree #4

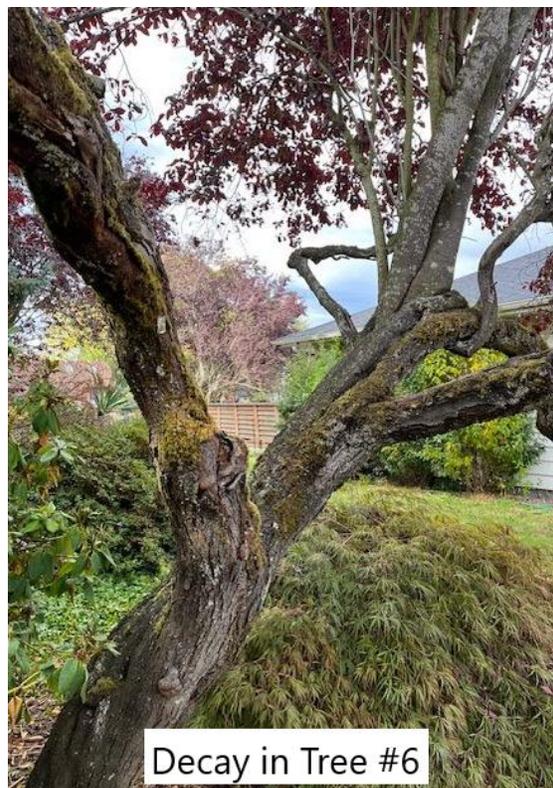
Decay in Tree #6
