## Arborist Report

**Date: December 21, 2023**

**Re: Arborist Report**

**5<sup>th</sup> Street Southeast – 2525 5<sup>th</sup> Street Southeast, Puyallup, Washington 98372**

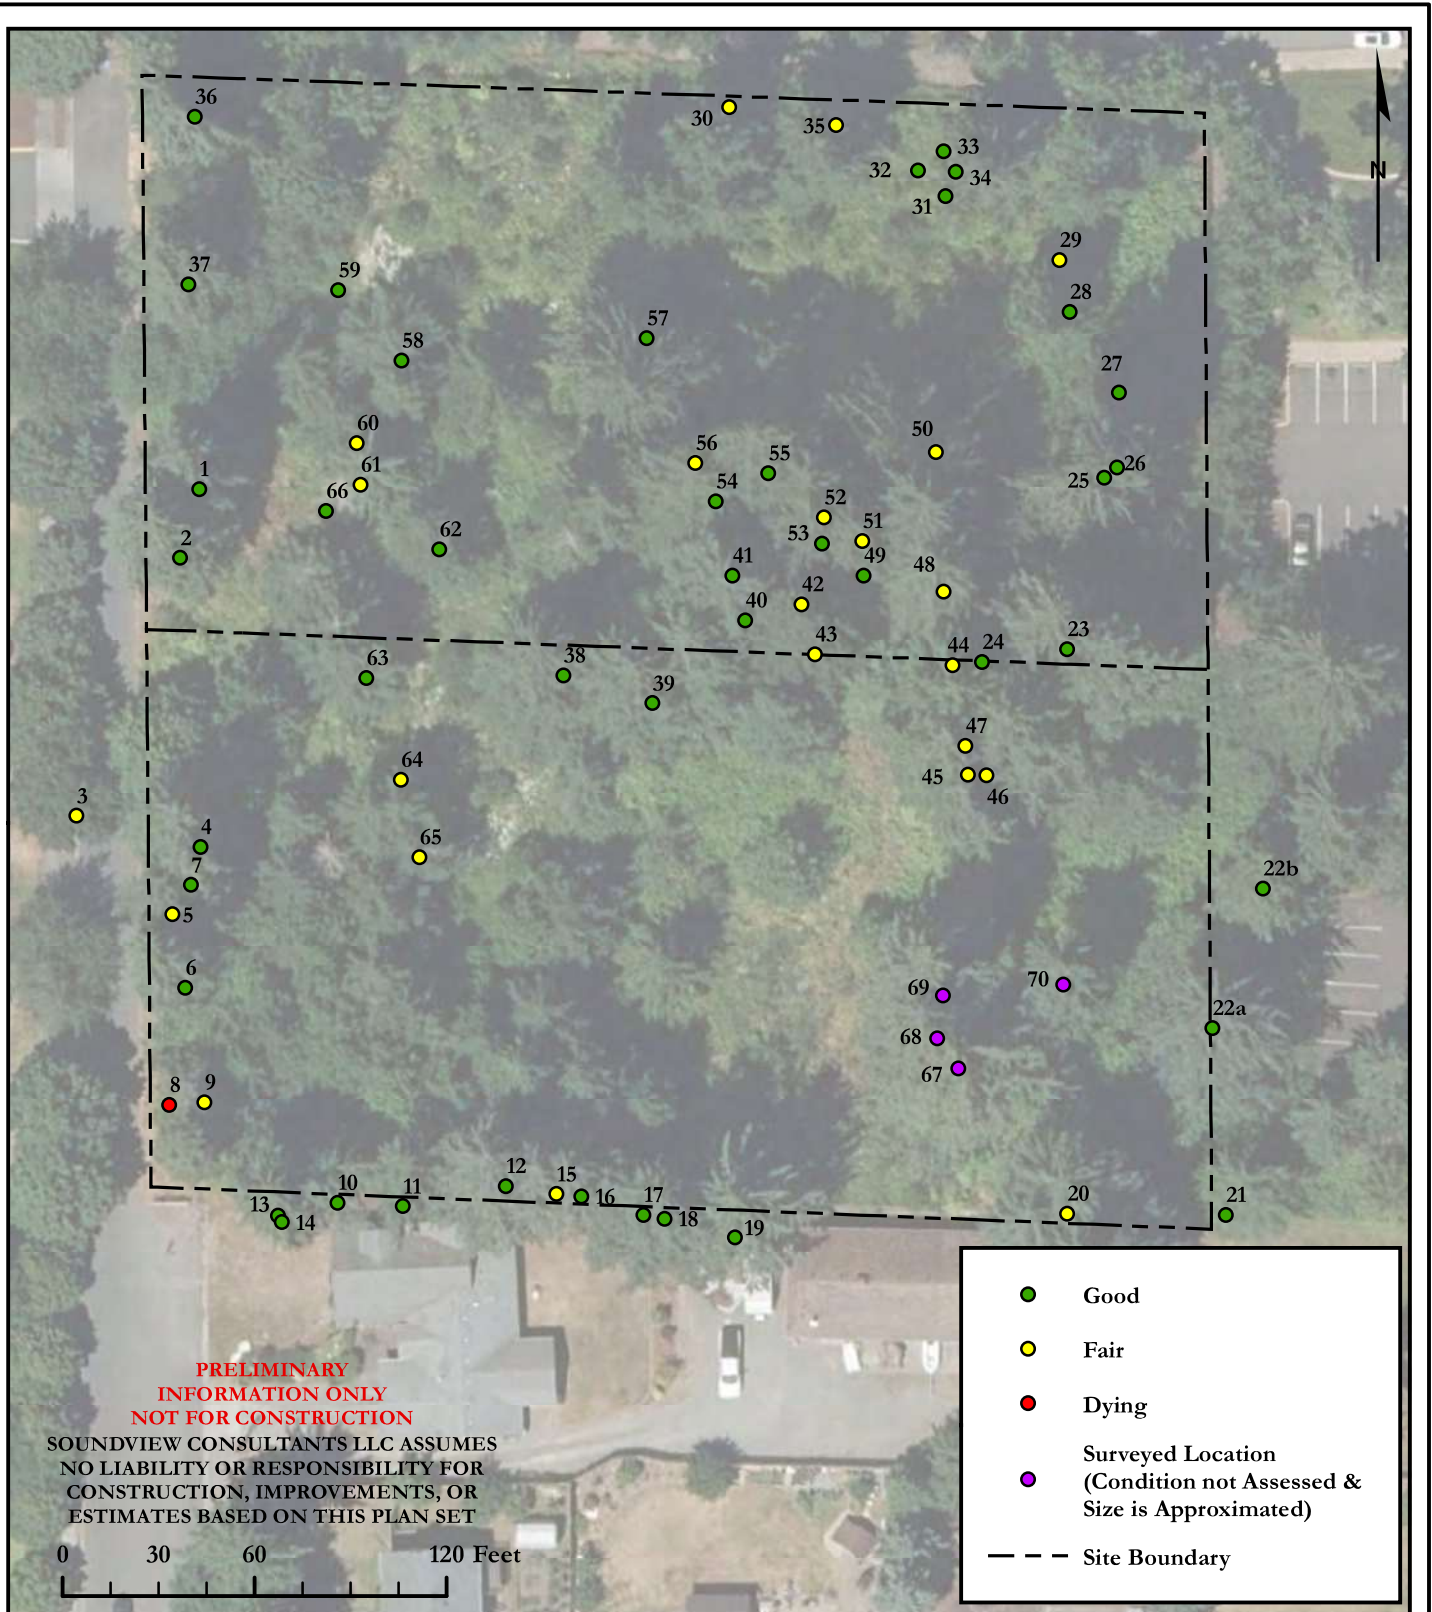
# TREE INVENTORY MAP

A total of 67 trees ( $\geq 15''$  DBH) were assessed, flagged and given a unique identification number. Four additional significant Douglas fir trees were collected by survey but not assessed by SVC (T-67 to T-70) but are included in the mapping and associated data for a total of 71 trees; however, the DBH, health, and overall condition of these trees cannot be confirmed. Refer to Attachment B for the Tree Inventory Exhibit and Data. The assessed/collected trees were comprised of 68 Douglas fir (*Pseudotsuga menziesii*), one dying western red cedar (*Thuja plicata*), one Deodar cedar (*Cedrus deodara*), and one multi-stemmed bigleaf maple (*Acer macrophyllum*). DBH of assessed trees ranged from 15 inches to 39 inches, of which 24 were large mature fir trees with trunk diameters in excess of 30 inches DBH. All but one tree was in good or fair condition.

Data was collected on trees directly adjacent to the property boundaries as aerial and rooting space allotment should be taken into consideration when determining the clearing limits for the site, as their CRZ will need to be protected from construction impacts. The assessed Deodar cedar (T-21) was located on the parcel boundary, however, survey did not collect this tree, as such, we are assuming it is offsite. Additionally, the location, approximate DBH, and condition were collected on an offsite Douglas fir (T-22) to the east. Along the southern property boundary, 4 unflagged trees were determined to be onsite and 7 unflagged trees were confirmed to be offsite after confirming their surveyed locations. In total, there were 61 onsite significant trees, 9 offsite significant trees, and 1 dying tree of significant size assessed.

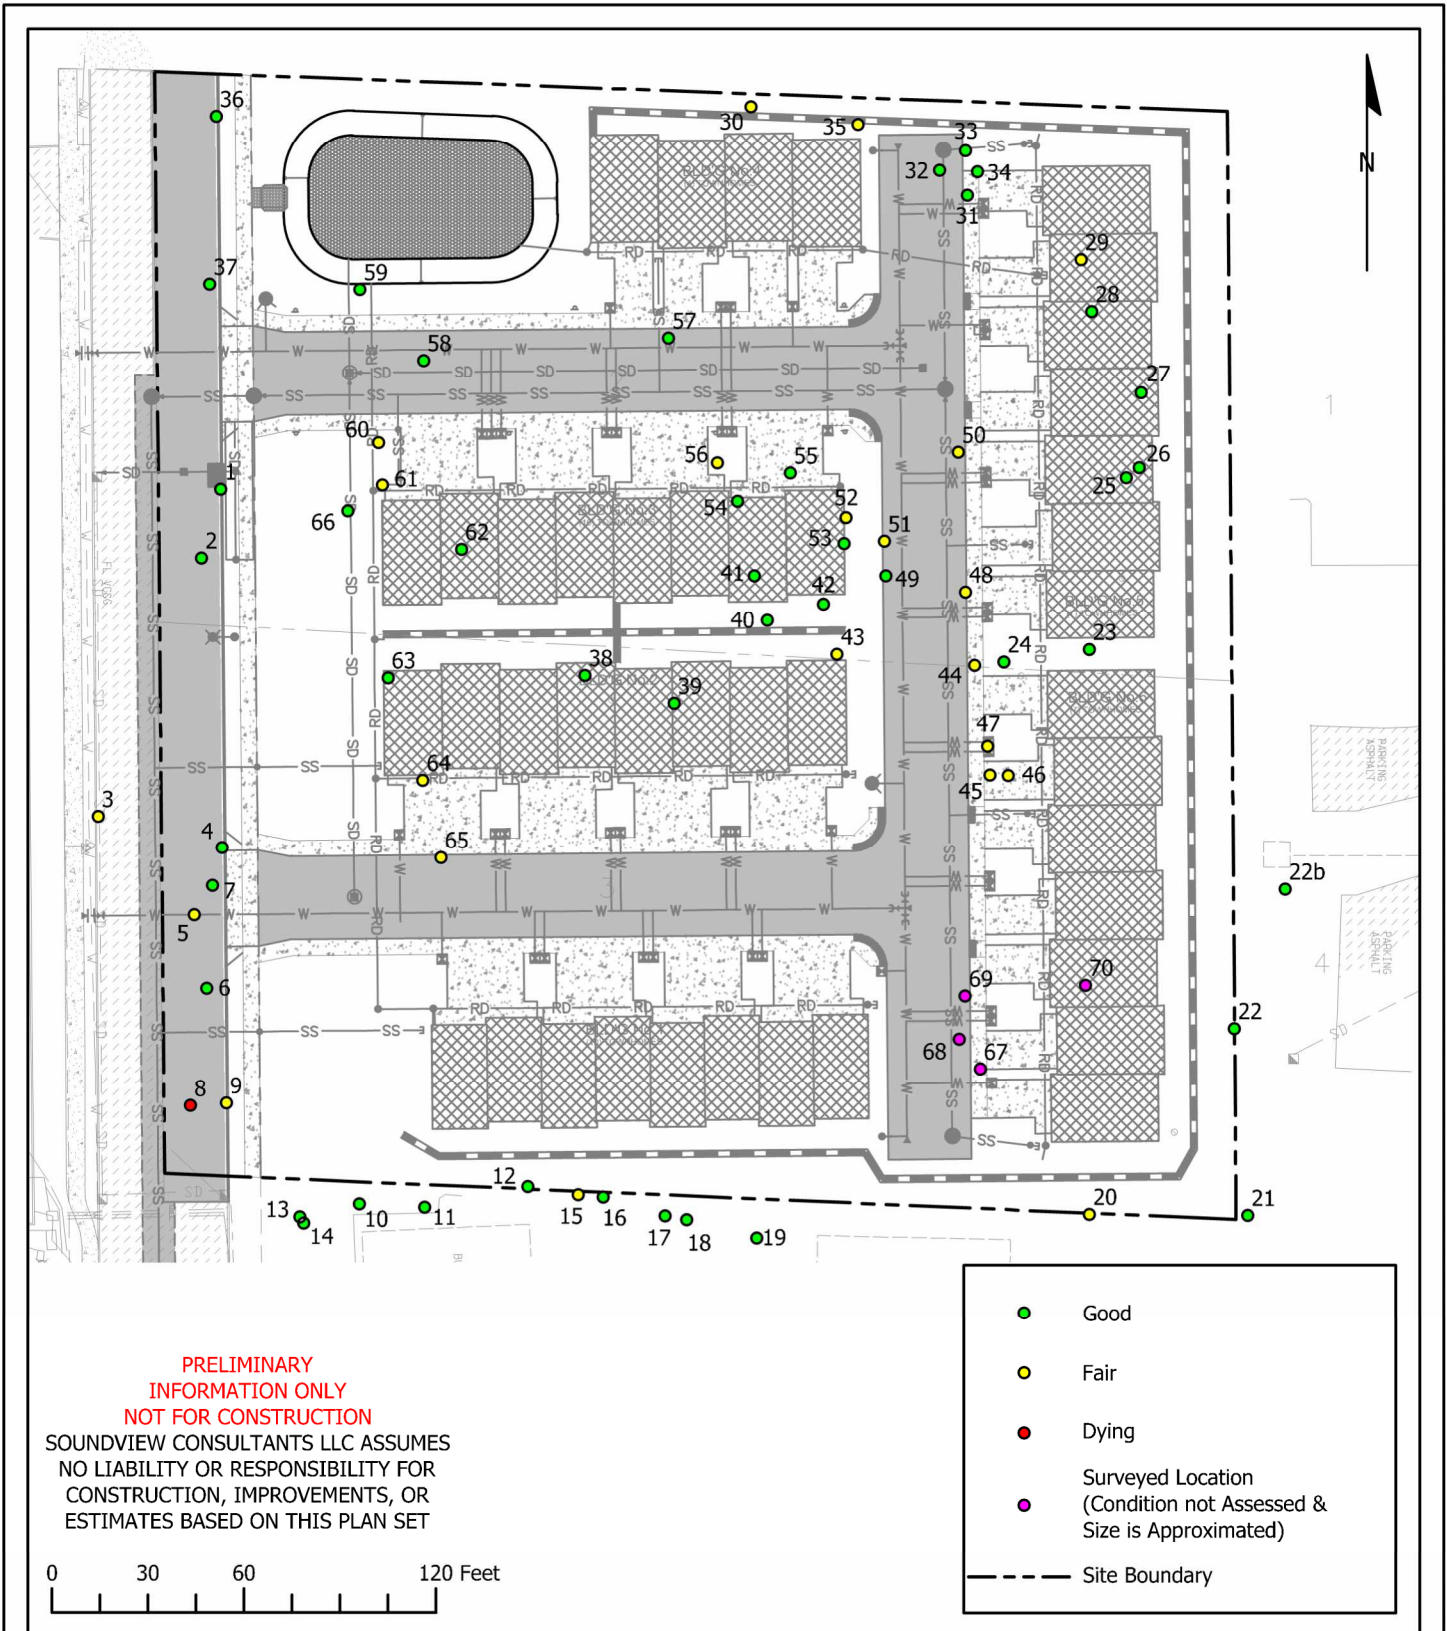
# TREE INVENTORY MAP (PROPOSED CONDITION)

Street SE right-of-way along the western side of the site. Trees numbered 1 through 9, 37 and 38 are all located either in the ROW expansion area or within the required sidewalk area immediately adjacent to the road. Second, the site will be lowered to a grade of 3 to 8 feet below its current elevation. A retaining wall is proposed to be erected around three-fourths of the project site. The structural rooting zone of trees 30 and 35 are located within a few feet of the northern retaining wall. Likewise, tree 23 is located in an area that will see an approximate 7-foot change in elevation per grading plan and its CRZ would be significantly encumbered by the proximity to the building foundation of the townhouse unit to the north. Due to the proposed grade changes around and beneath these trees, there is not sufficient rooting space to retain these trees. Trees 31 through 34 are in an interior area, south of the retaining wall and are anticipated to be graded down approximately 6 feet from the current grade. They are also located within the northern portion of the road turnaround, sidewalk or driveway entrance to the northeastern-most townhouse unit.

The third area compromised by the new site plan and grading limits is the western interior area where trees 59 and 66 are located. Here, the grade is anticipated to be lowered by two to three feet from the existing grade. Additionally, utility trenching for a storm drain continues south to north, cutting directly beneath the primary structural roots of trees 59 and 66. As such, creating a tree protection zone “island” for an individual tree or trees would be potentially plausible, but would disrupt the continuity of the overall project and would likely result in the retention of unhealthy, not windfirm trees over time. Redesigning the storm pond to accommodate tree 66 will still not address the 2-foot elevation change. Isolated trees retained from a forested stand with significantly altered rooting and climactic environments are less likely to thrive and be good candidates for retention.

Trees along the southern property boundary are primarily located offsite on the neighboring parcel. Yet, four trees, numbered 12, 15, 16 and 20 are onsite and would be good candidates for retention. Cutting, clearing, and grading for the retention wall north of the trees will compromise their full critical root zones, potentially more than the 50 to 75 percent maximum allowable amount to be removed. The City of Puyallup defines the required critical root protection zone (CRPZ) as tree diameter (in inches) x 2, converted into feet. The trunk diameters of these trees are T-12 (30 inches DBH), T-15 (24 inches DBH), T-16 (32 inches DBH) and T-20 (24 inches DBH). All four trees are heritage-sized, Douglas fir trees in good or fair condition at or just inside the fence line. According to the City’s CRPZ, the largest 30-inch DBH Douglas fir tree would require a CRPZ of 60 feet. Prior to final grading limits, a maximum distance of 15 feet from trunk to retaining wall may be achievable. This is far less than the minimum of 75 percent of the CRZ that must be preserved at natural grade per VMP 10.1.A.(3)i, yet the structural roots largely responsible for tree stability will be preserved as will the root zone to the west, south and east of the tree. SVC’s arborist recommends retaining these trees and having a Certified Arborist present to monitor these four trees during cutting and excavation of soil and/or roots within the CRZ during construction. To reduce the inevitable degree of environmentally altered stress experienced by many trees post-construction, after care including temporary irrigation and woodchip mulch are recommended based on the degree of vegetation clearing and other impacts to the tree’s root zones. As such, four trees are proposed to be retained onsite.

Due to the proximity to the subject property, the CRPZ of nine offsite trees (T-10, 11, 13, 14, 17-19, 21, 22b) have the potential to encroach into the proposed project clearing limits yet are required to be protected from construction impacts. The DBH of adjacent, offsite trees ranges from 16 inches to 33 inches and therefore the CRPZ may extend onsite based on the specifications outlined in the Methods section. It should be noted that they were intentionally not tagged or flagged in the field due to their

The purpose of this Arborist Report is to evaluate the proposed project according to the tree retention and replanting requirements of the City's VMS and the development standards of PMC 20.58. It is proposed that 4 significant trees will be retained onsite if proper care is provided during and after construction. No other significant trees are to be retained on the subject property due to the amount of grading and right-of-way/utility work required to develop the site. Additionally, the CRZ of 9 offsite significant trees are required to be protected based on the criteria provided in the Offsite Tree Protection section of this report.
