# TERRA ASSOCIATES, Inc.

May 22, 2023  
Project No. T-5915-3

Subject: Response to Comments  
Geotechnical Report Addendum  
Wesley Homes Expansion  
Puyallup, Washington

Reference: Geotechnical Report Addendum, Wesley Homes Expansion, Puyallup, Washington, Project No. T-5915-3, prepared by Terra Associates, Inc., dated December 29, 2022

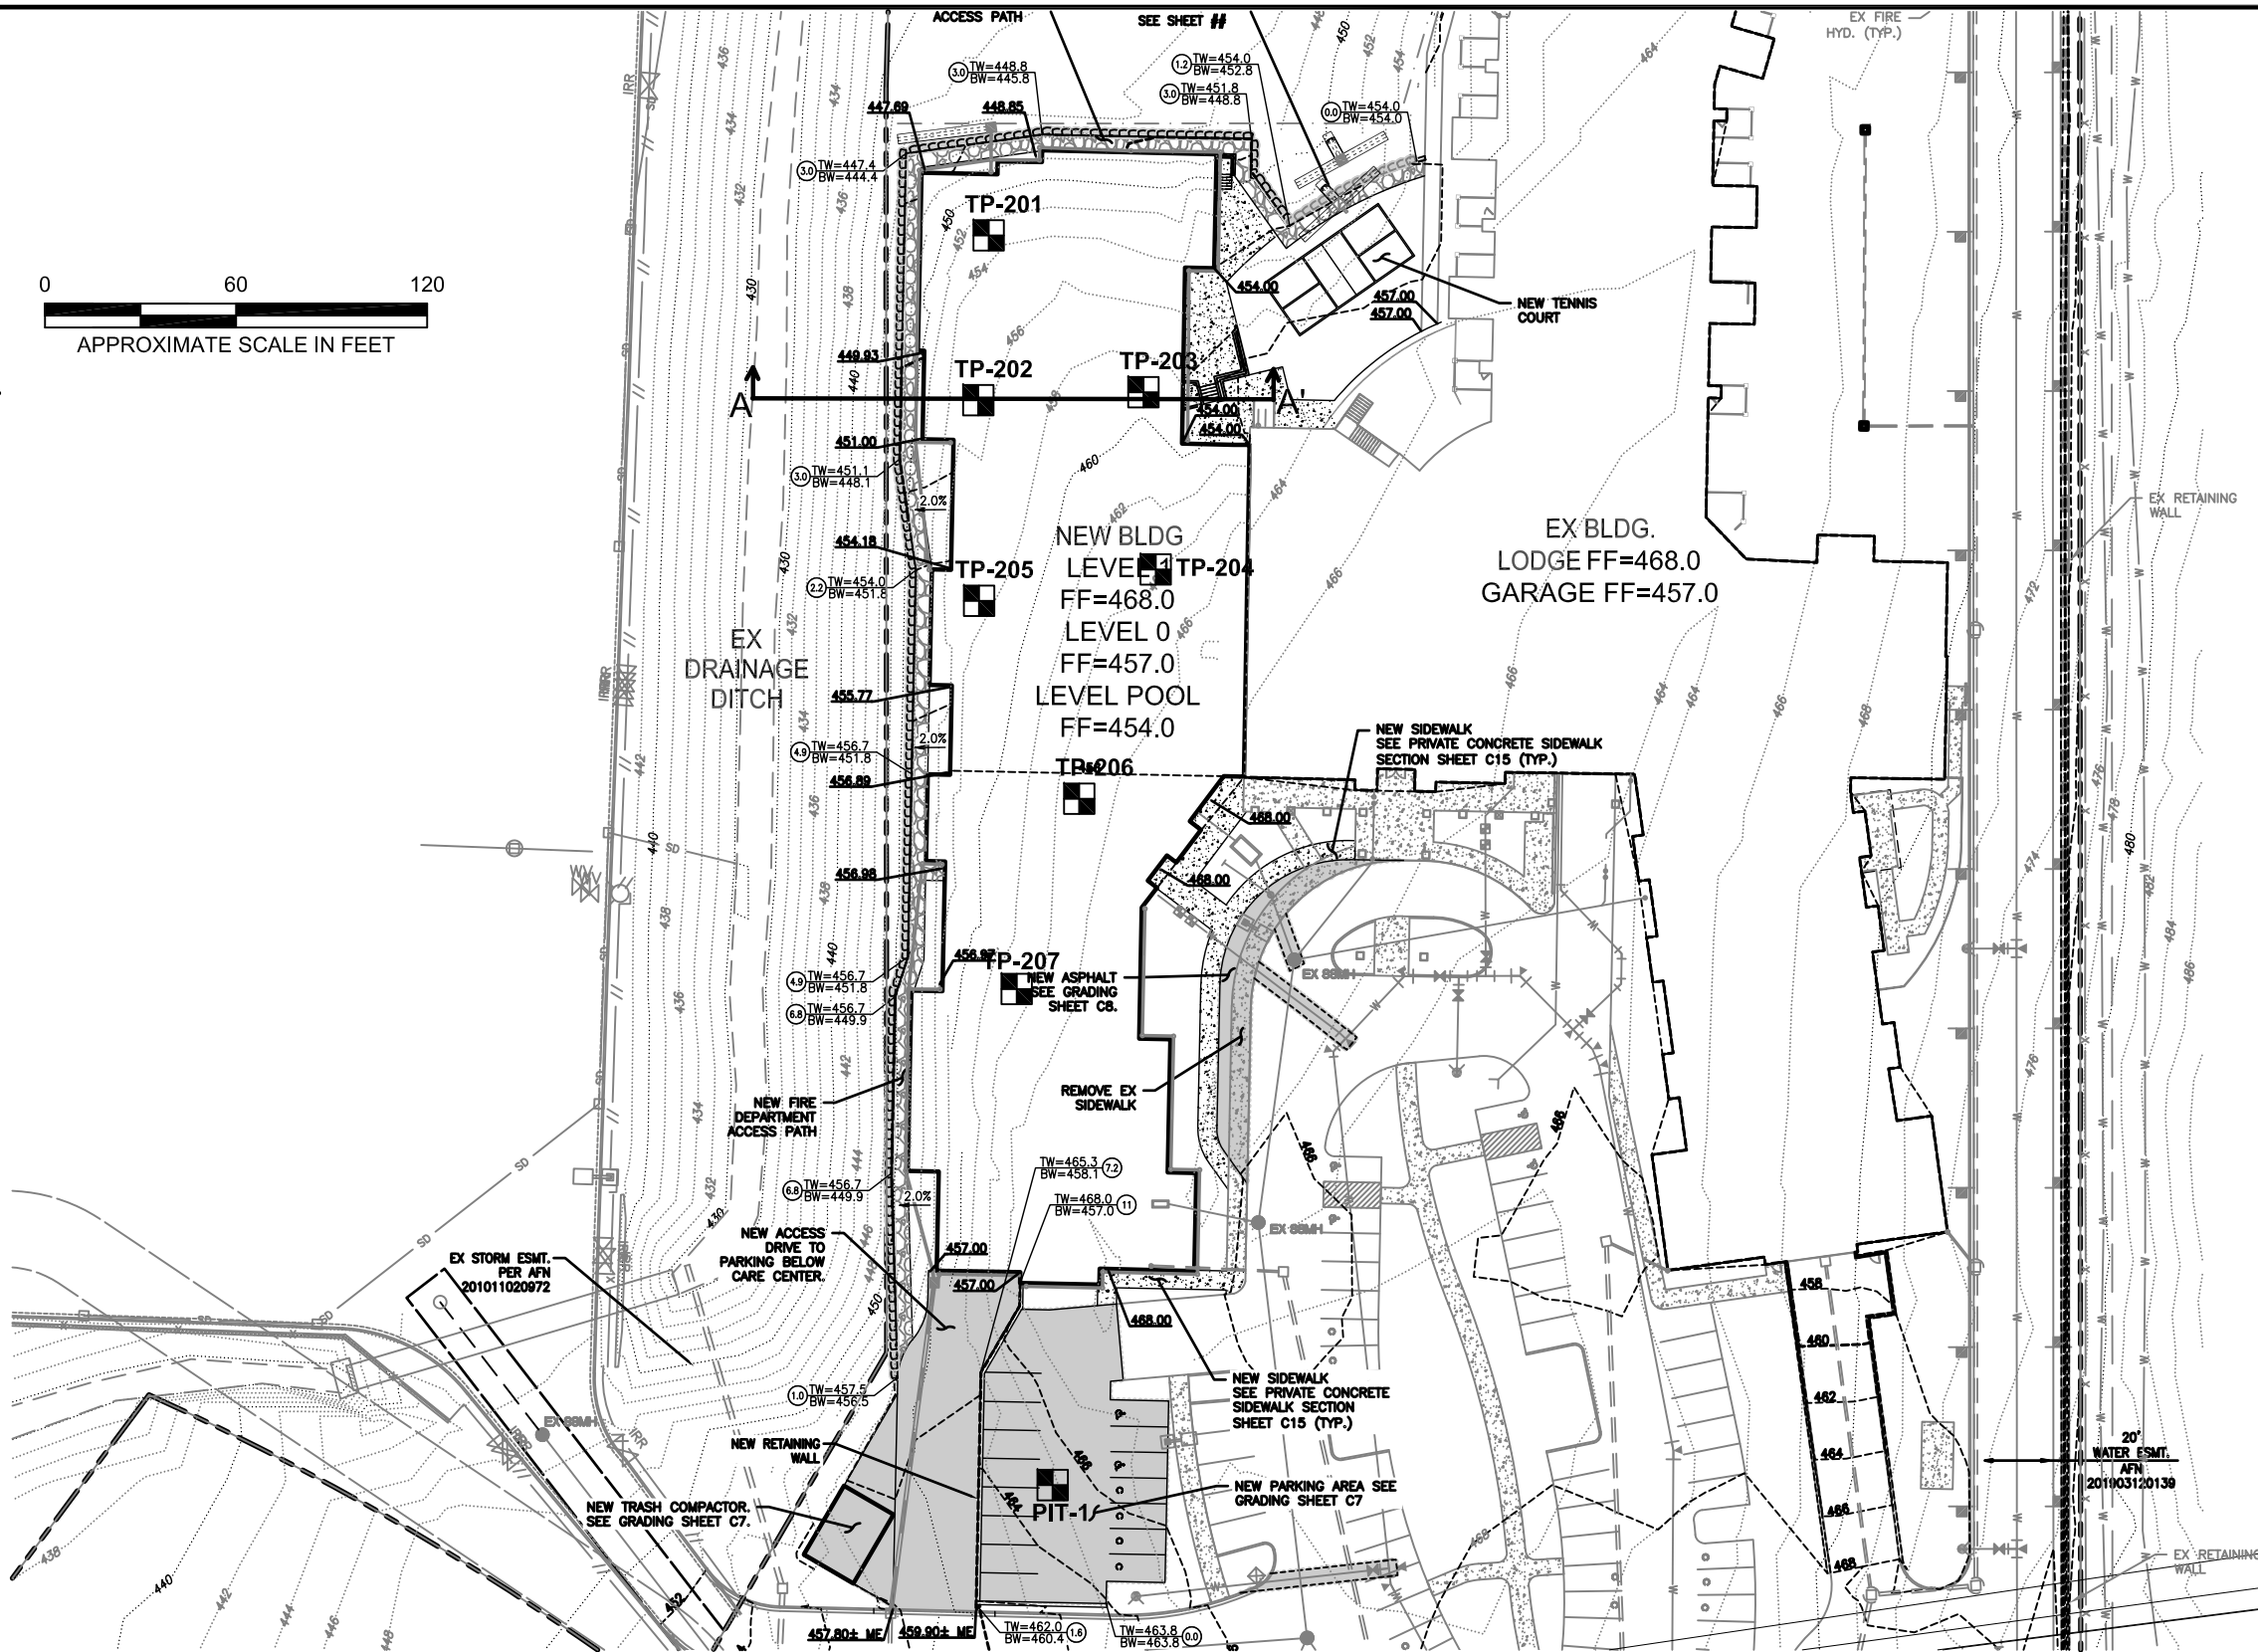
Proj. No. T-5915-3    Date MAY 2023    Figure 1

This section of the PMC requires that the proposed development in a landslide hazard area not decrease the factor of safety for landslide occurrences below 1.5 for static conditions and 1.2 for dynamic (seismic) conditions. To address this comment, we completed a stability analysis of a representative cross section of the slope that included grading and application of building loading from the proposed development. We also completed additional subsurface exploration to better define the limits of the unsuitable existing fill soils and underlying competent native soils. Supplemental test pit locations and test pit logs are attached as Figures 1 through 9. The location of the cross section analyzed is also shown on Figure 1.

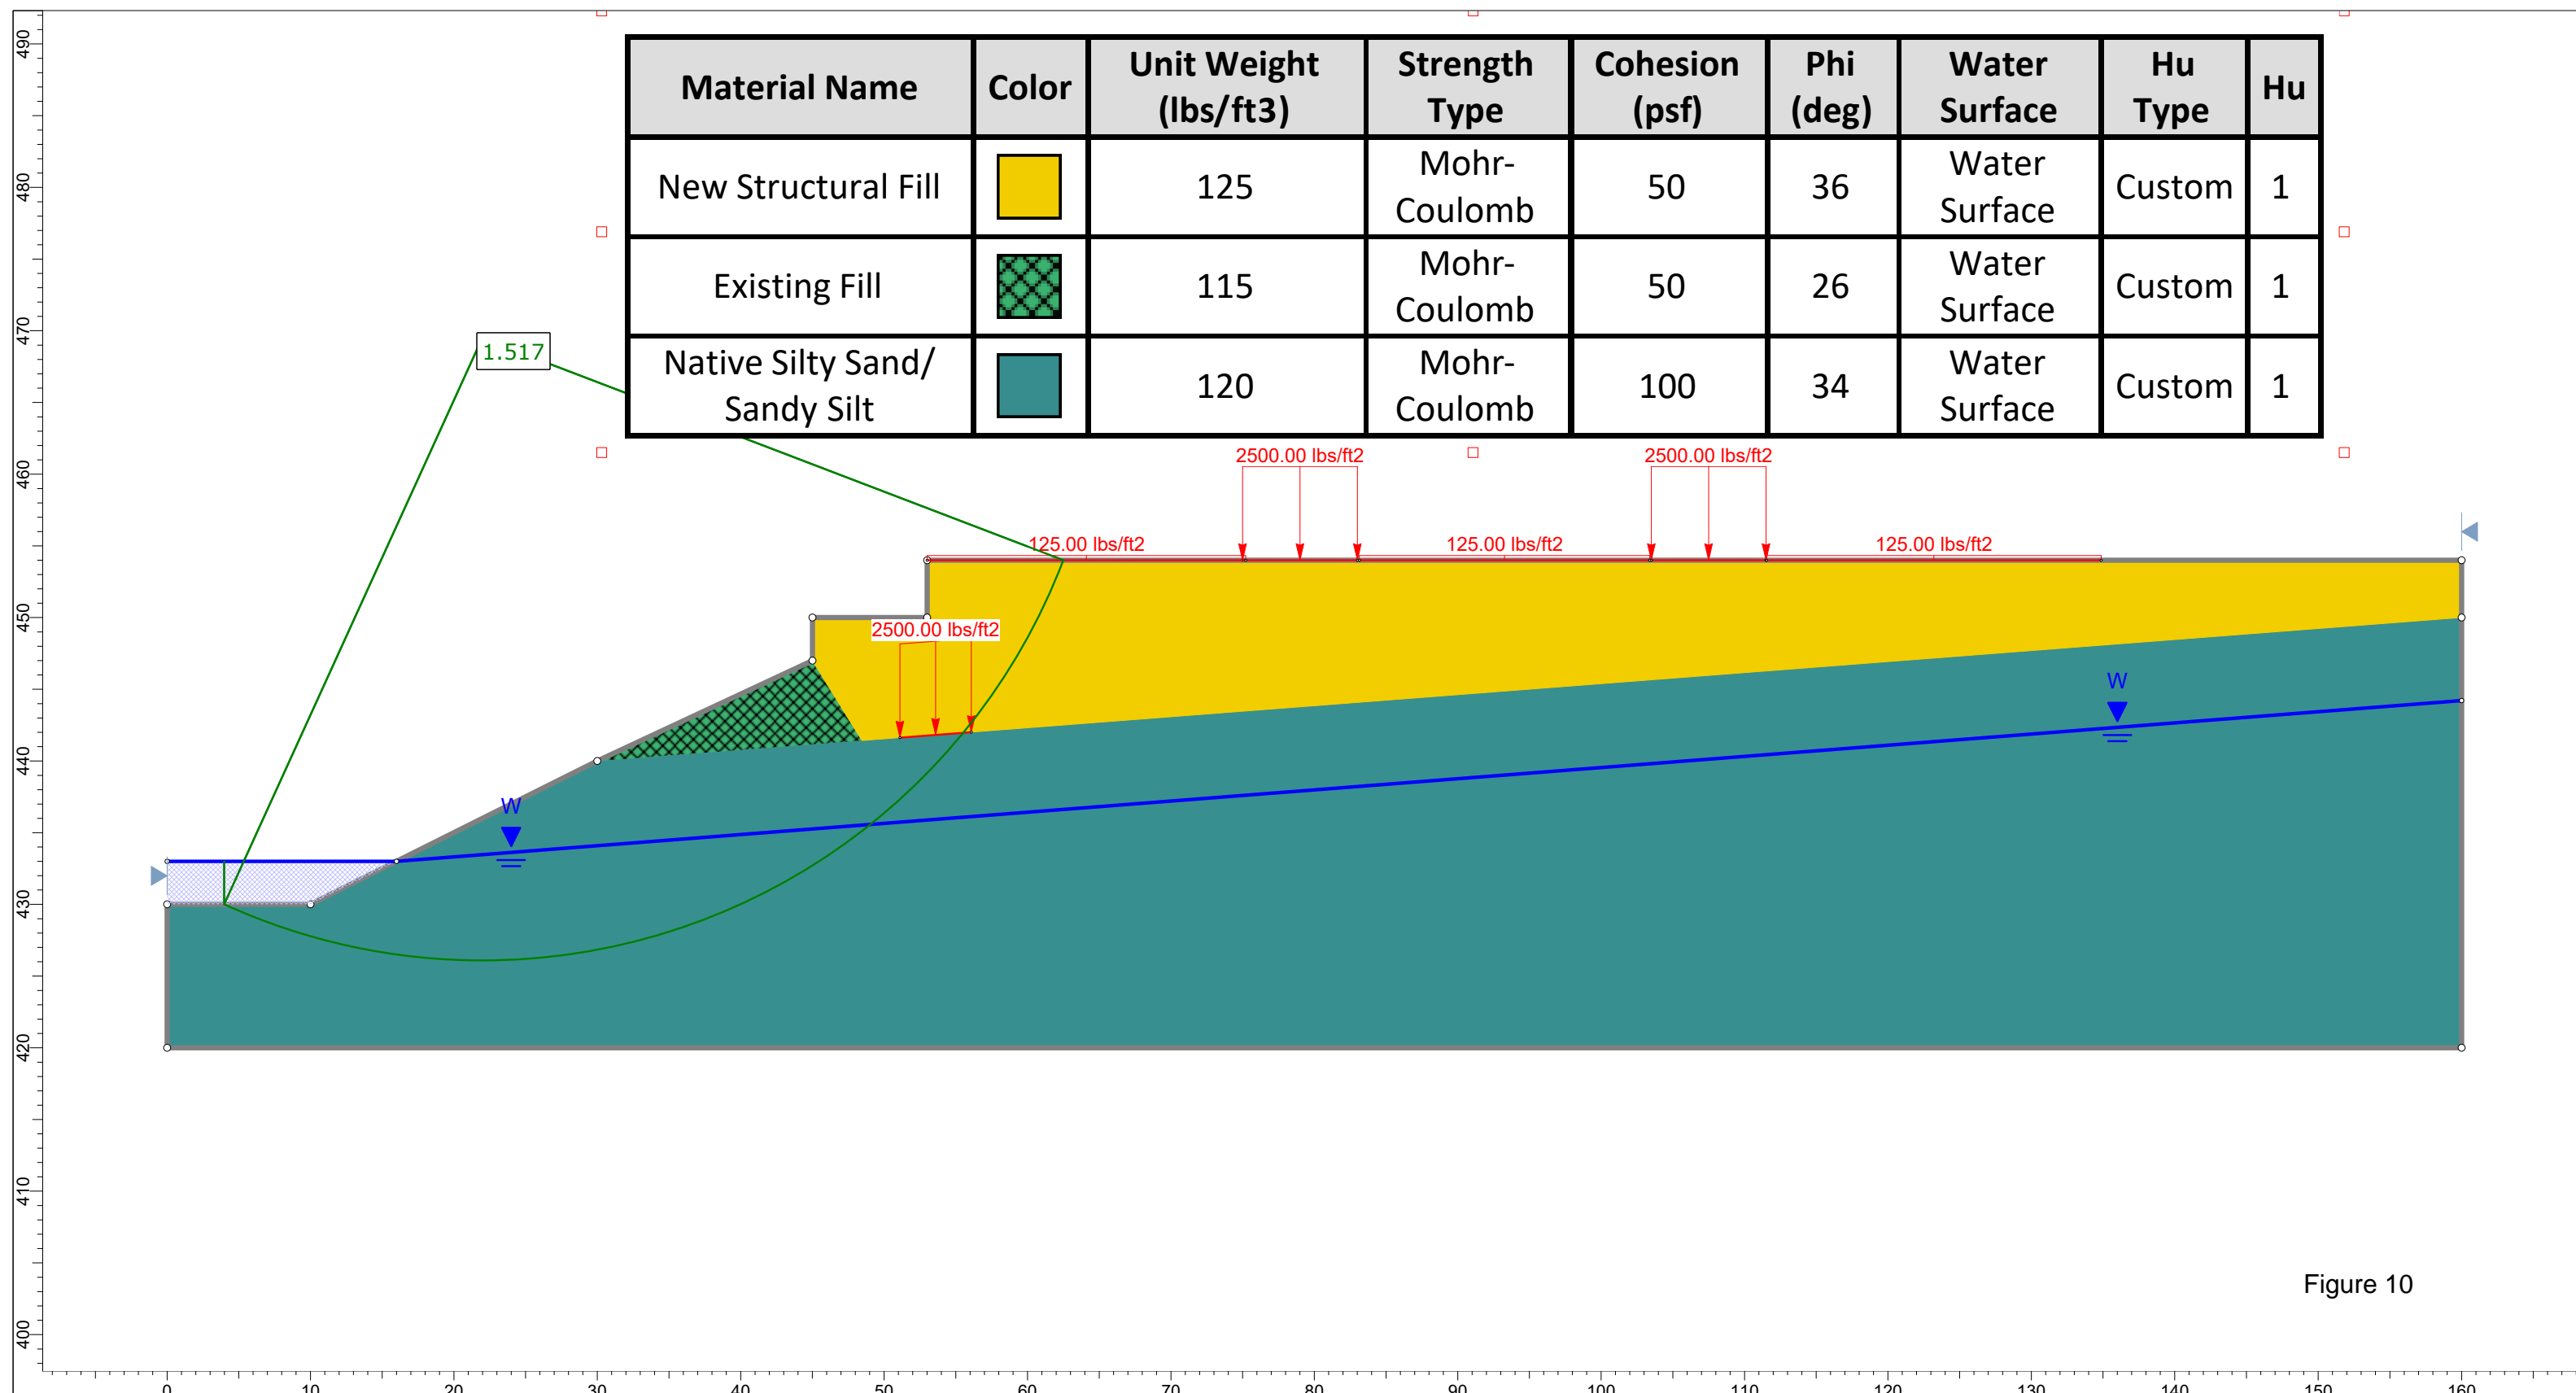
Figure 10

We completed the stability analysis using the SLIDE2 computer program published by RocScience. Results of the analysis indicate that with the exiting unsuitable fill soils removed and replaced with structural fill placed and compacted in accordance with recommendations in our geotechnical report, the minimum safety factor under static conditions of 1.5 or greater would be met. A graphic of the cross section showing these results along with soil parameters used in the analysis is attached as Figure 10.

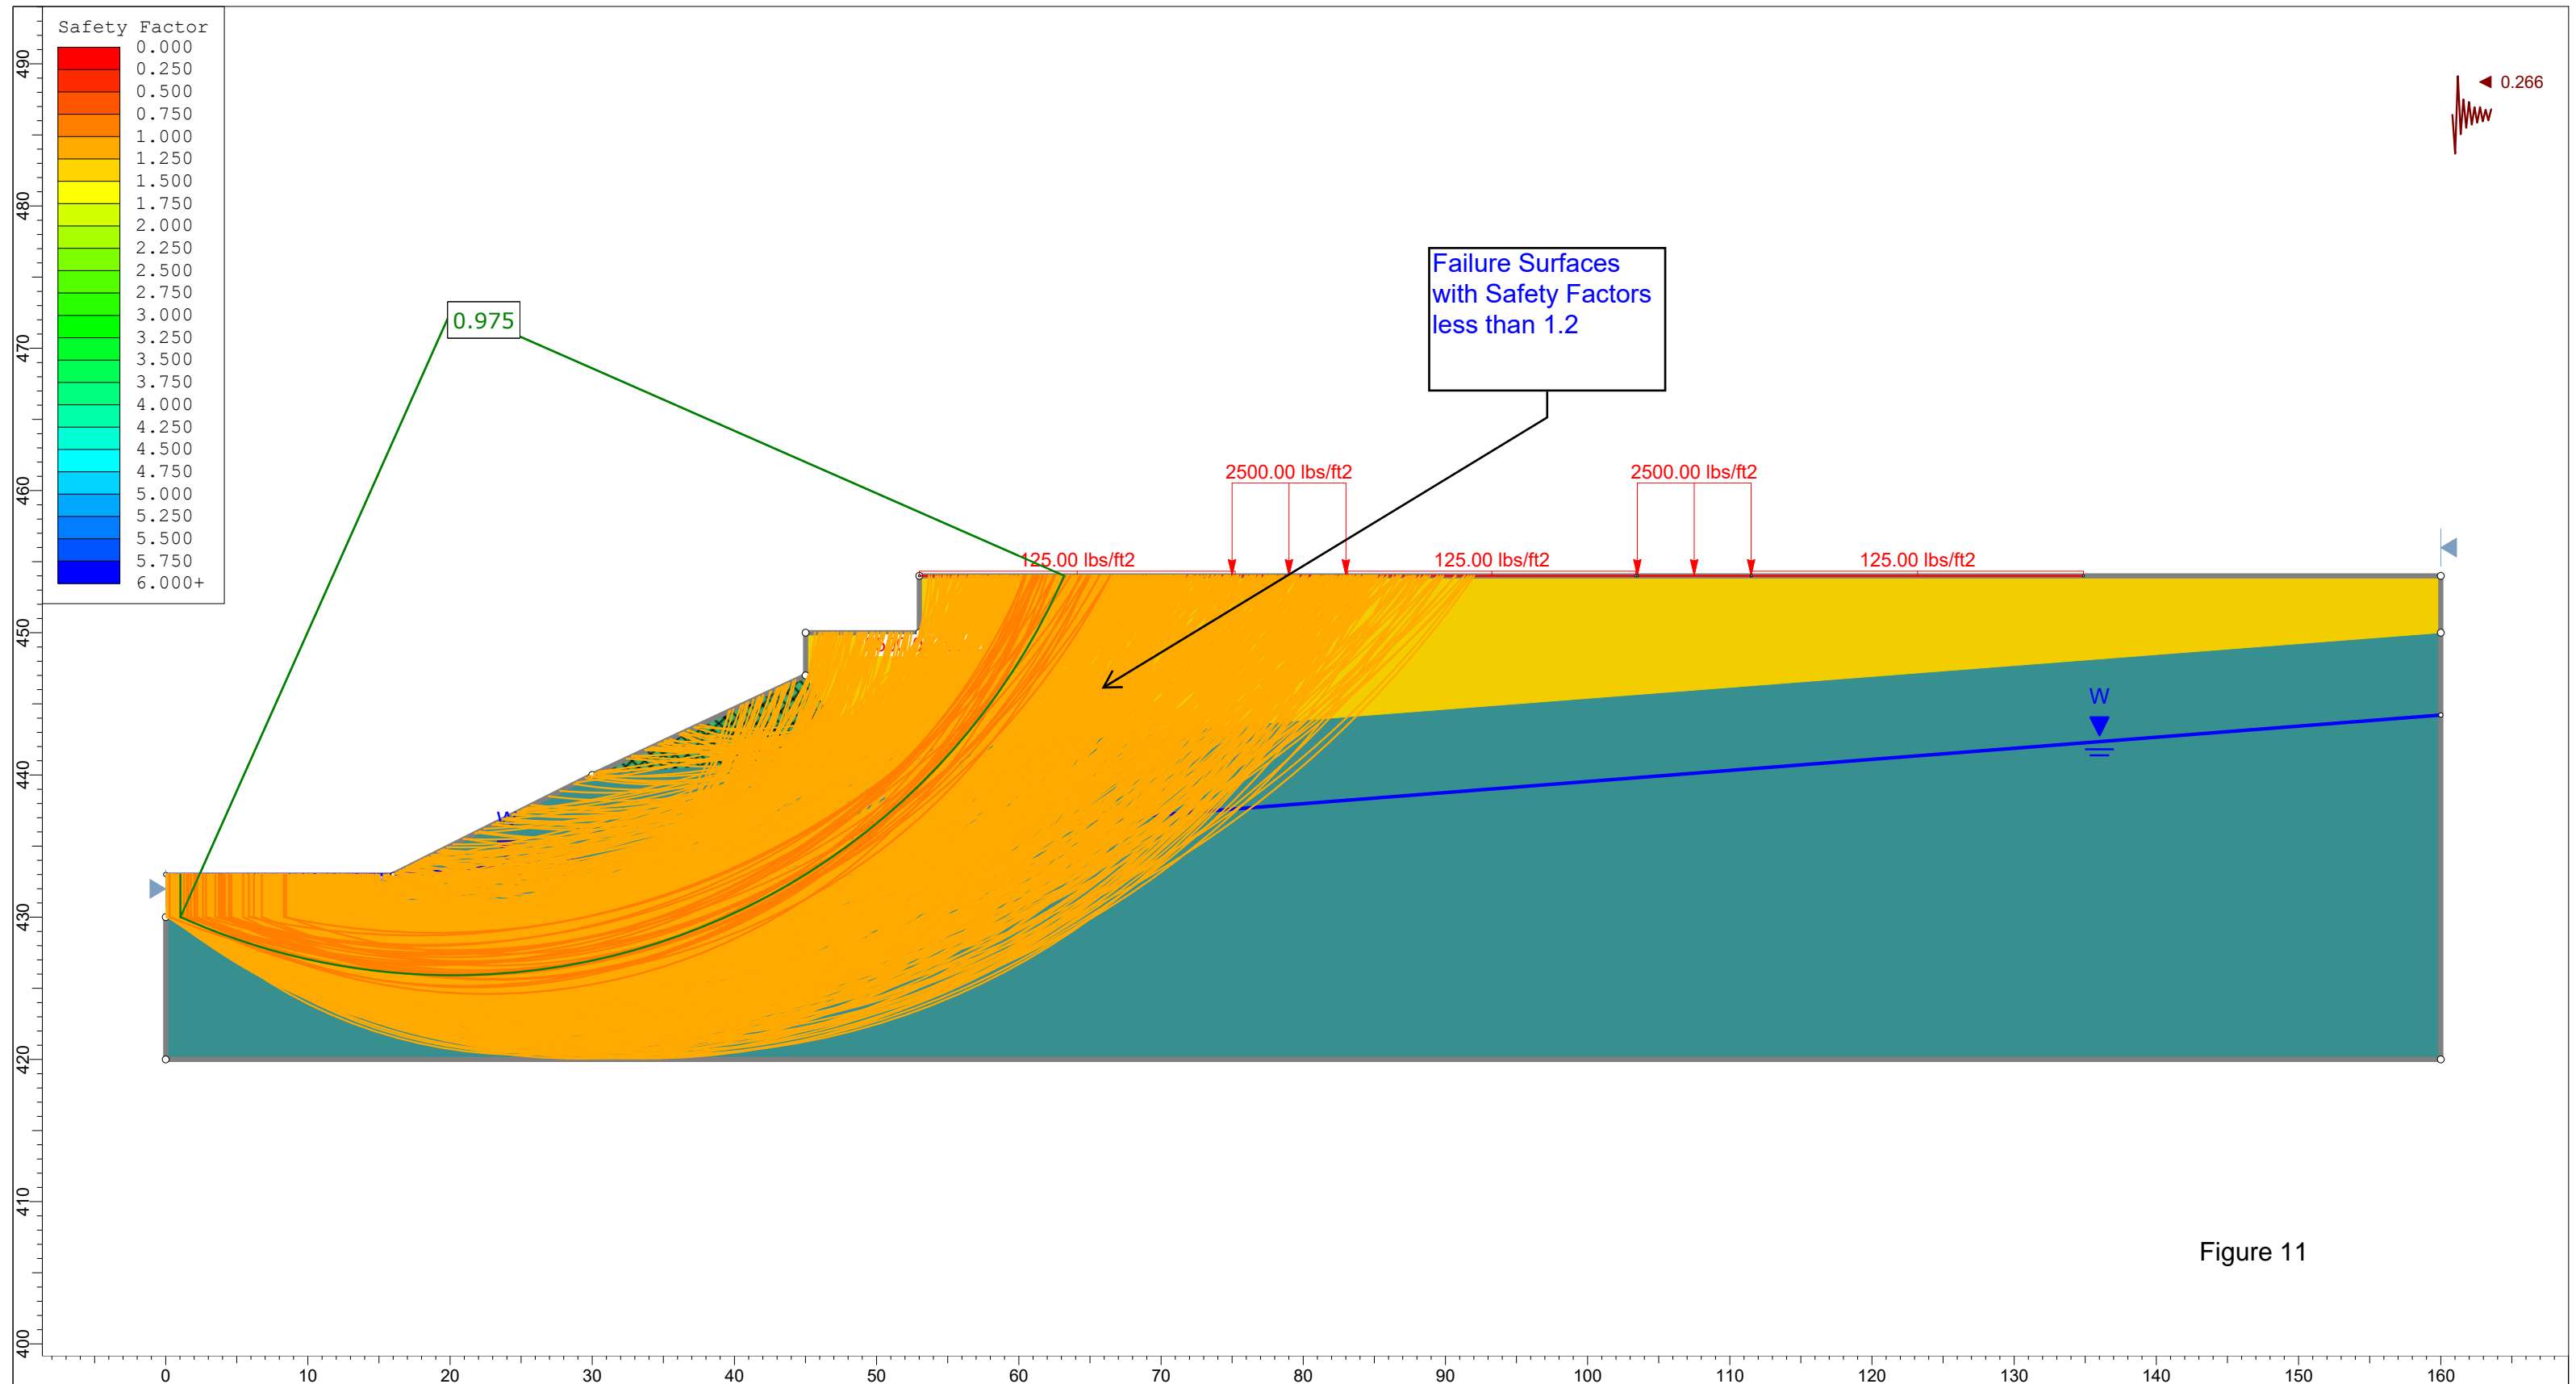
Figure 11

Seismic (Pseudostatic) analysis was then completed along this section. The acceleration input into the analysis was the Peak Ground Acceleration (PGA) for the maximum considered event (MCE) as defined by the current International Building Code (IBC). This value represents an earthquake with a 2 percent chance of exceedance in 50 years ( 1 in 2500 years). This acceleration was adjusted for sloping conditions. The results of this analysis indicate safety factors less than the required 1.2 minimum would be present. These results are shown on attached Figure 11.

In our opinion, provided the owner is willing to accept the risk of building damage caused by minimal downslope displacement following a design level earthquake, no design measures need to be implemented to mitigate this movement. However, if the owner is not willing to accept this risk, then the western half of the building paralleling the crest of the slope should be supported on pile foundations.

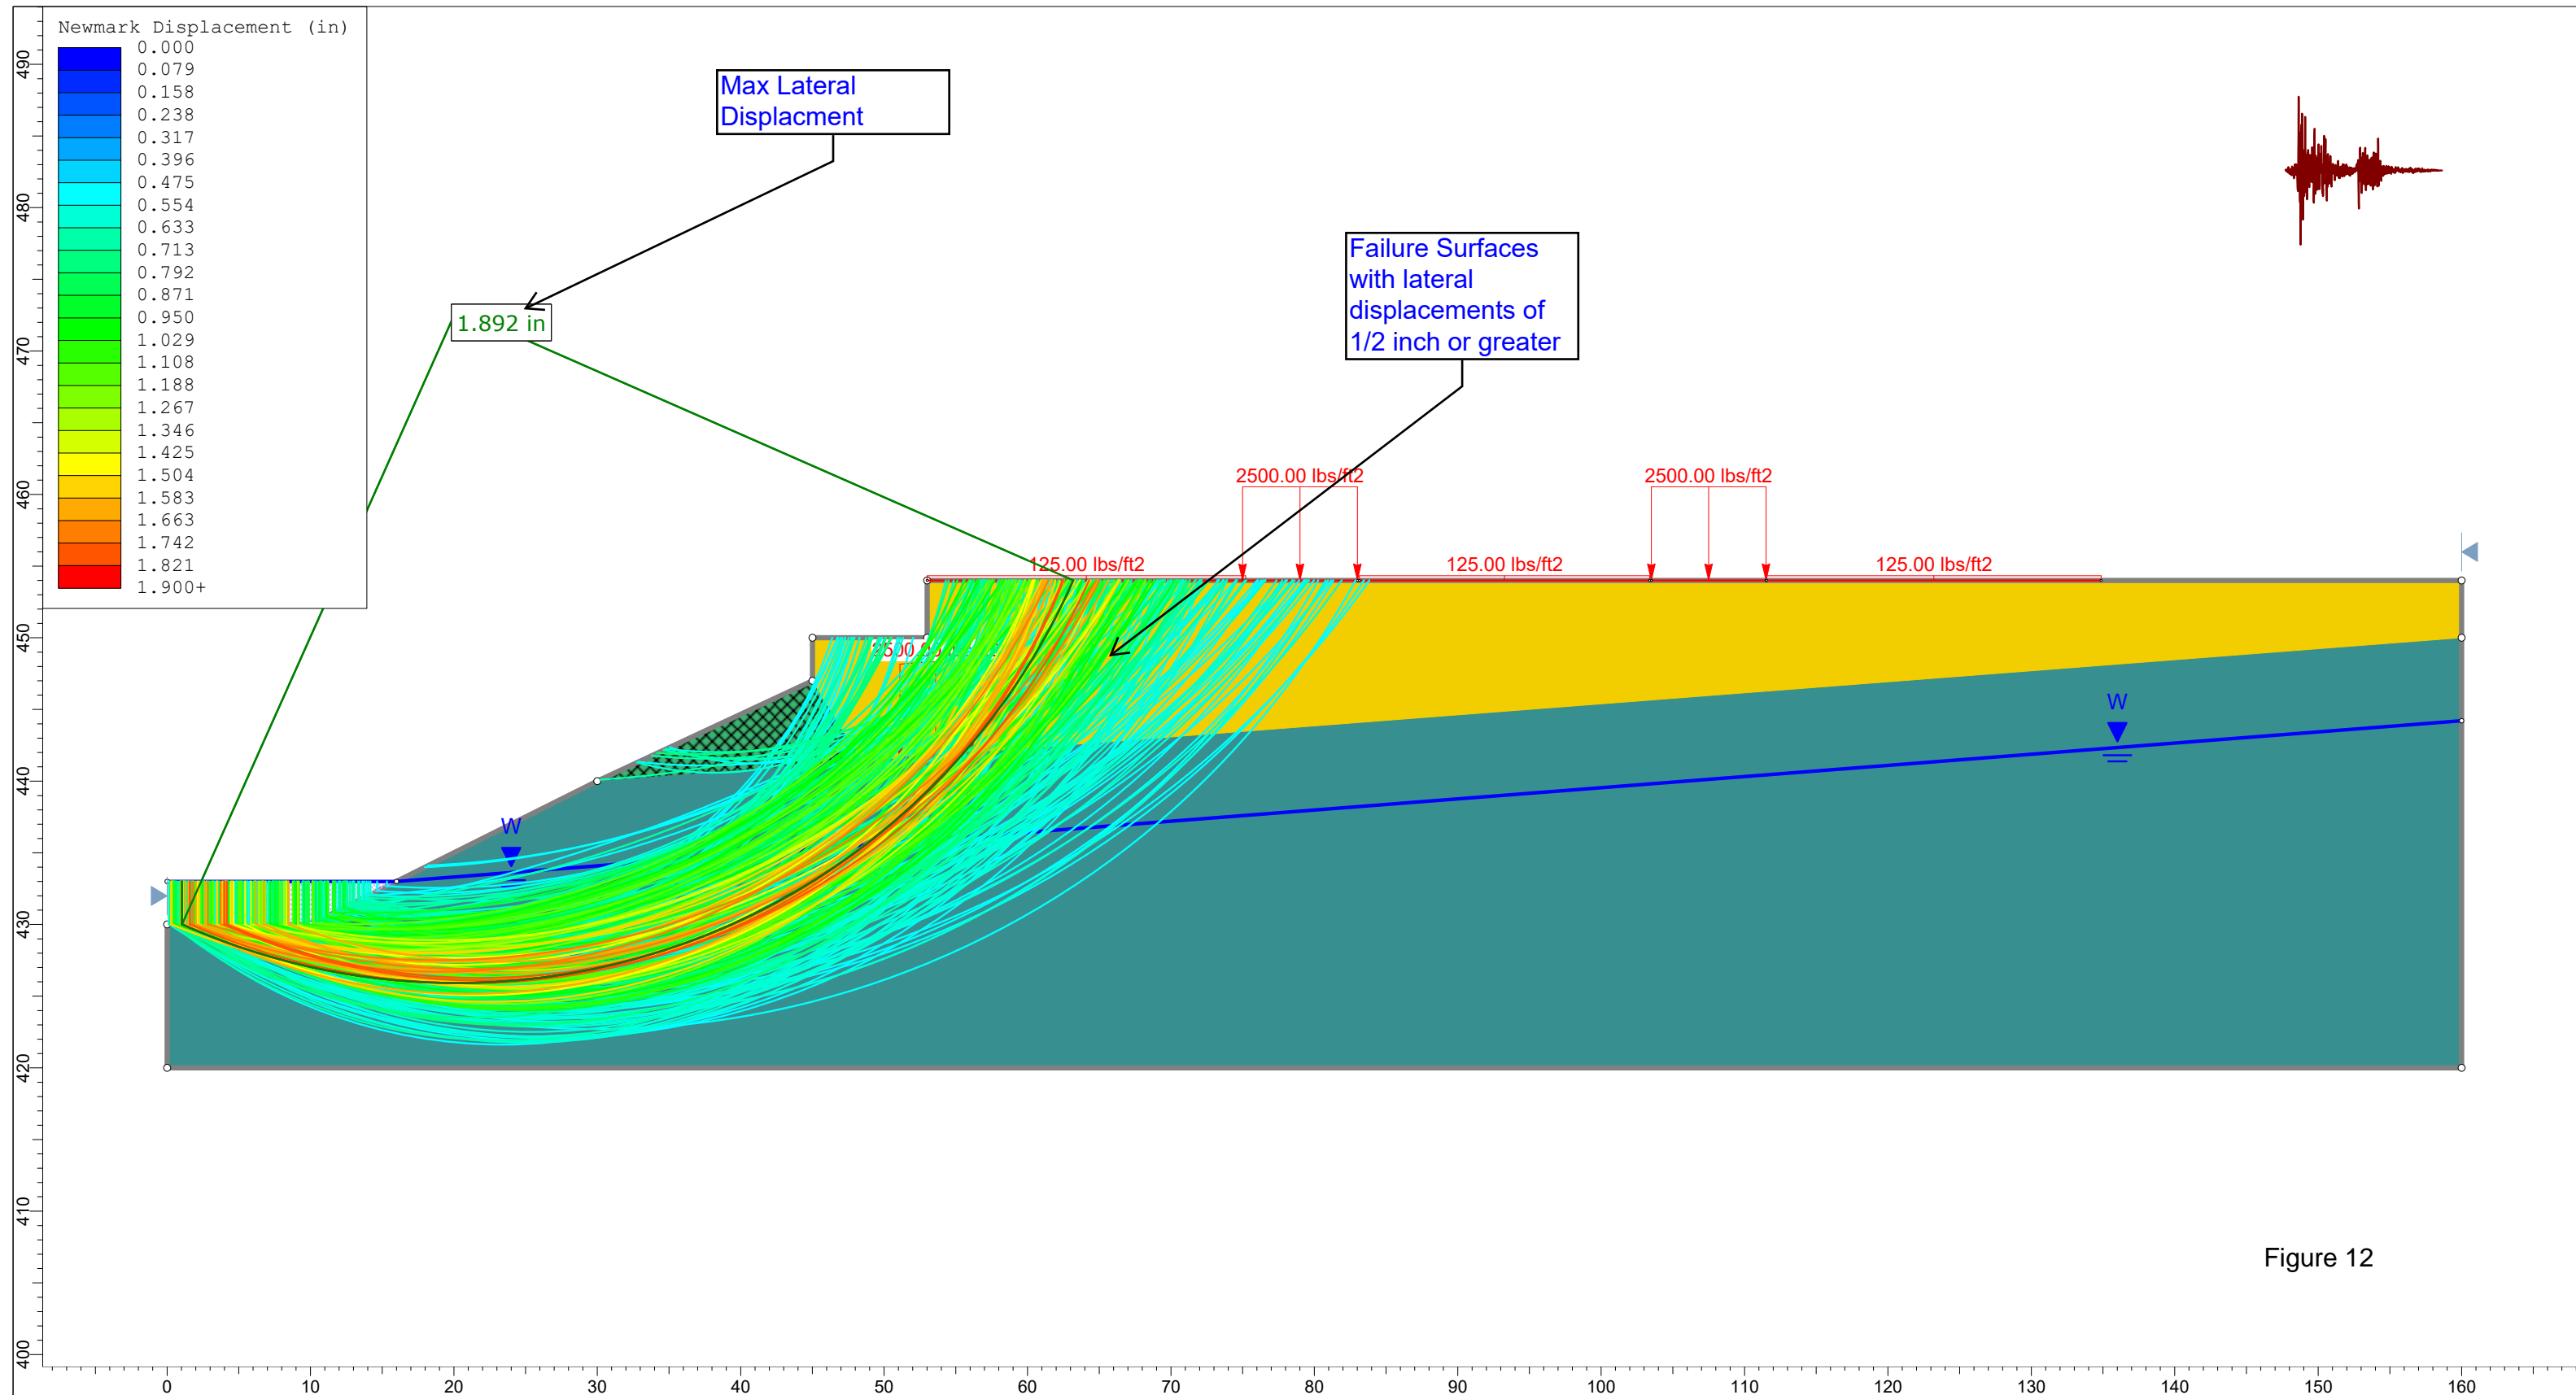
Figure 12

We would note that pseudostatic safety factors of less than 1 (one) do not necessarily reflect that a slope failure or a landslide would occur. The ground shaking may cause the slope to displace downgradient, but the amount of displacement may not be significant or sufficient to cause damage to the facility that would be considered a life safety issue. To evaluate this condition, we completed additional dynamic analysis of the slope section to evaluate potential lateral downslope displacements (Newmark Analysis). The earthquake record used in this analysis was a Cape Mendocino event that had a PGA of .59 which is similar to this sites PGA. This analysis indicates that the maximum displacement along the western side of the building would be less than two-inches with displacements diminishing to less than one-half-inch towards the mid-point of the structure. This amount of movement would not be categorized as a slope failure or landslide. Damage to the building would occur, however, this amount of lateral movement would cause damage of a cosmetic nature and would not be a life safety issue that would require design which would mitigate the displacement, in our opinion. Results of this analysis are shown on attached Figure 12.
