# TERRA ASSOCIATES, Inc.

May 22, 2023  
Project No. T-5915-3

Subject: Response to Comments  
Geotechnical Report Addendum  
Wesley Homes Expansion  
Puyallup, Washington

Reference: Geotechnical Report Addendum, Wesley Homes Expansion, Puyallup, Washington, Project No. T-5915-3, prepared by Terra Associates, Inc., dated December 29, 2022

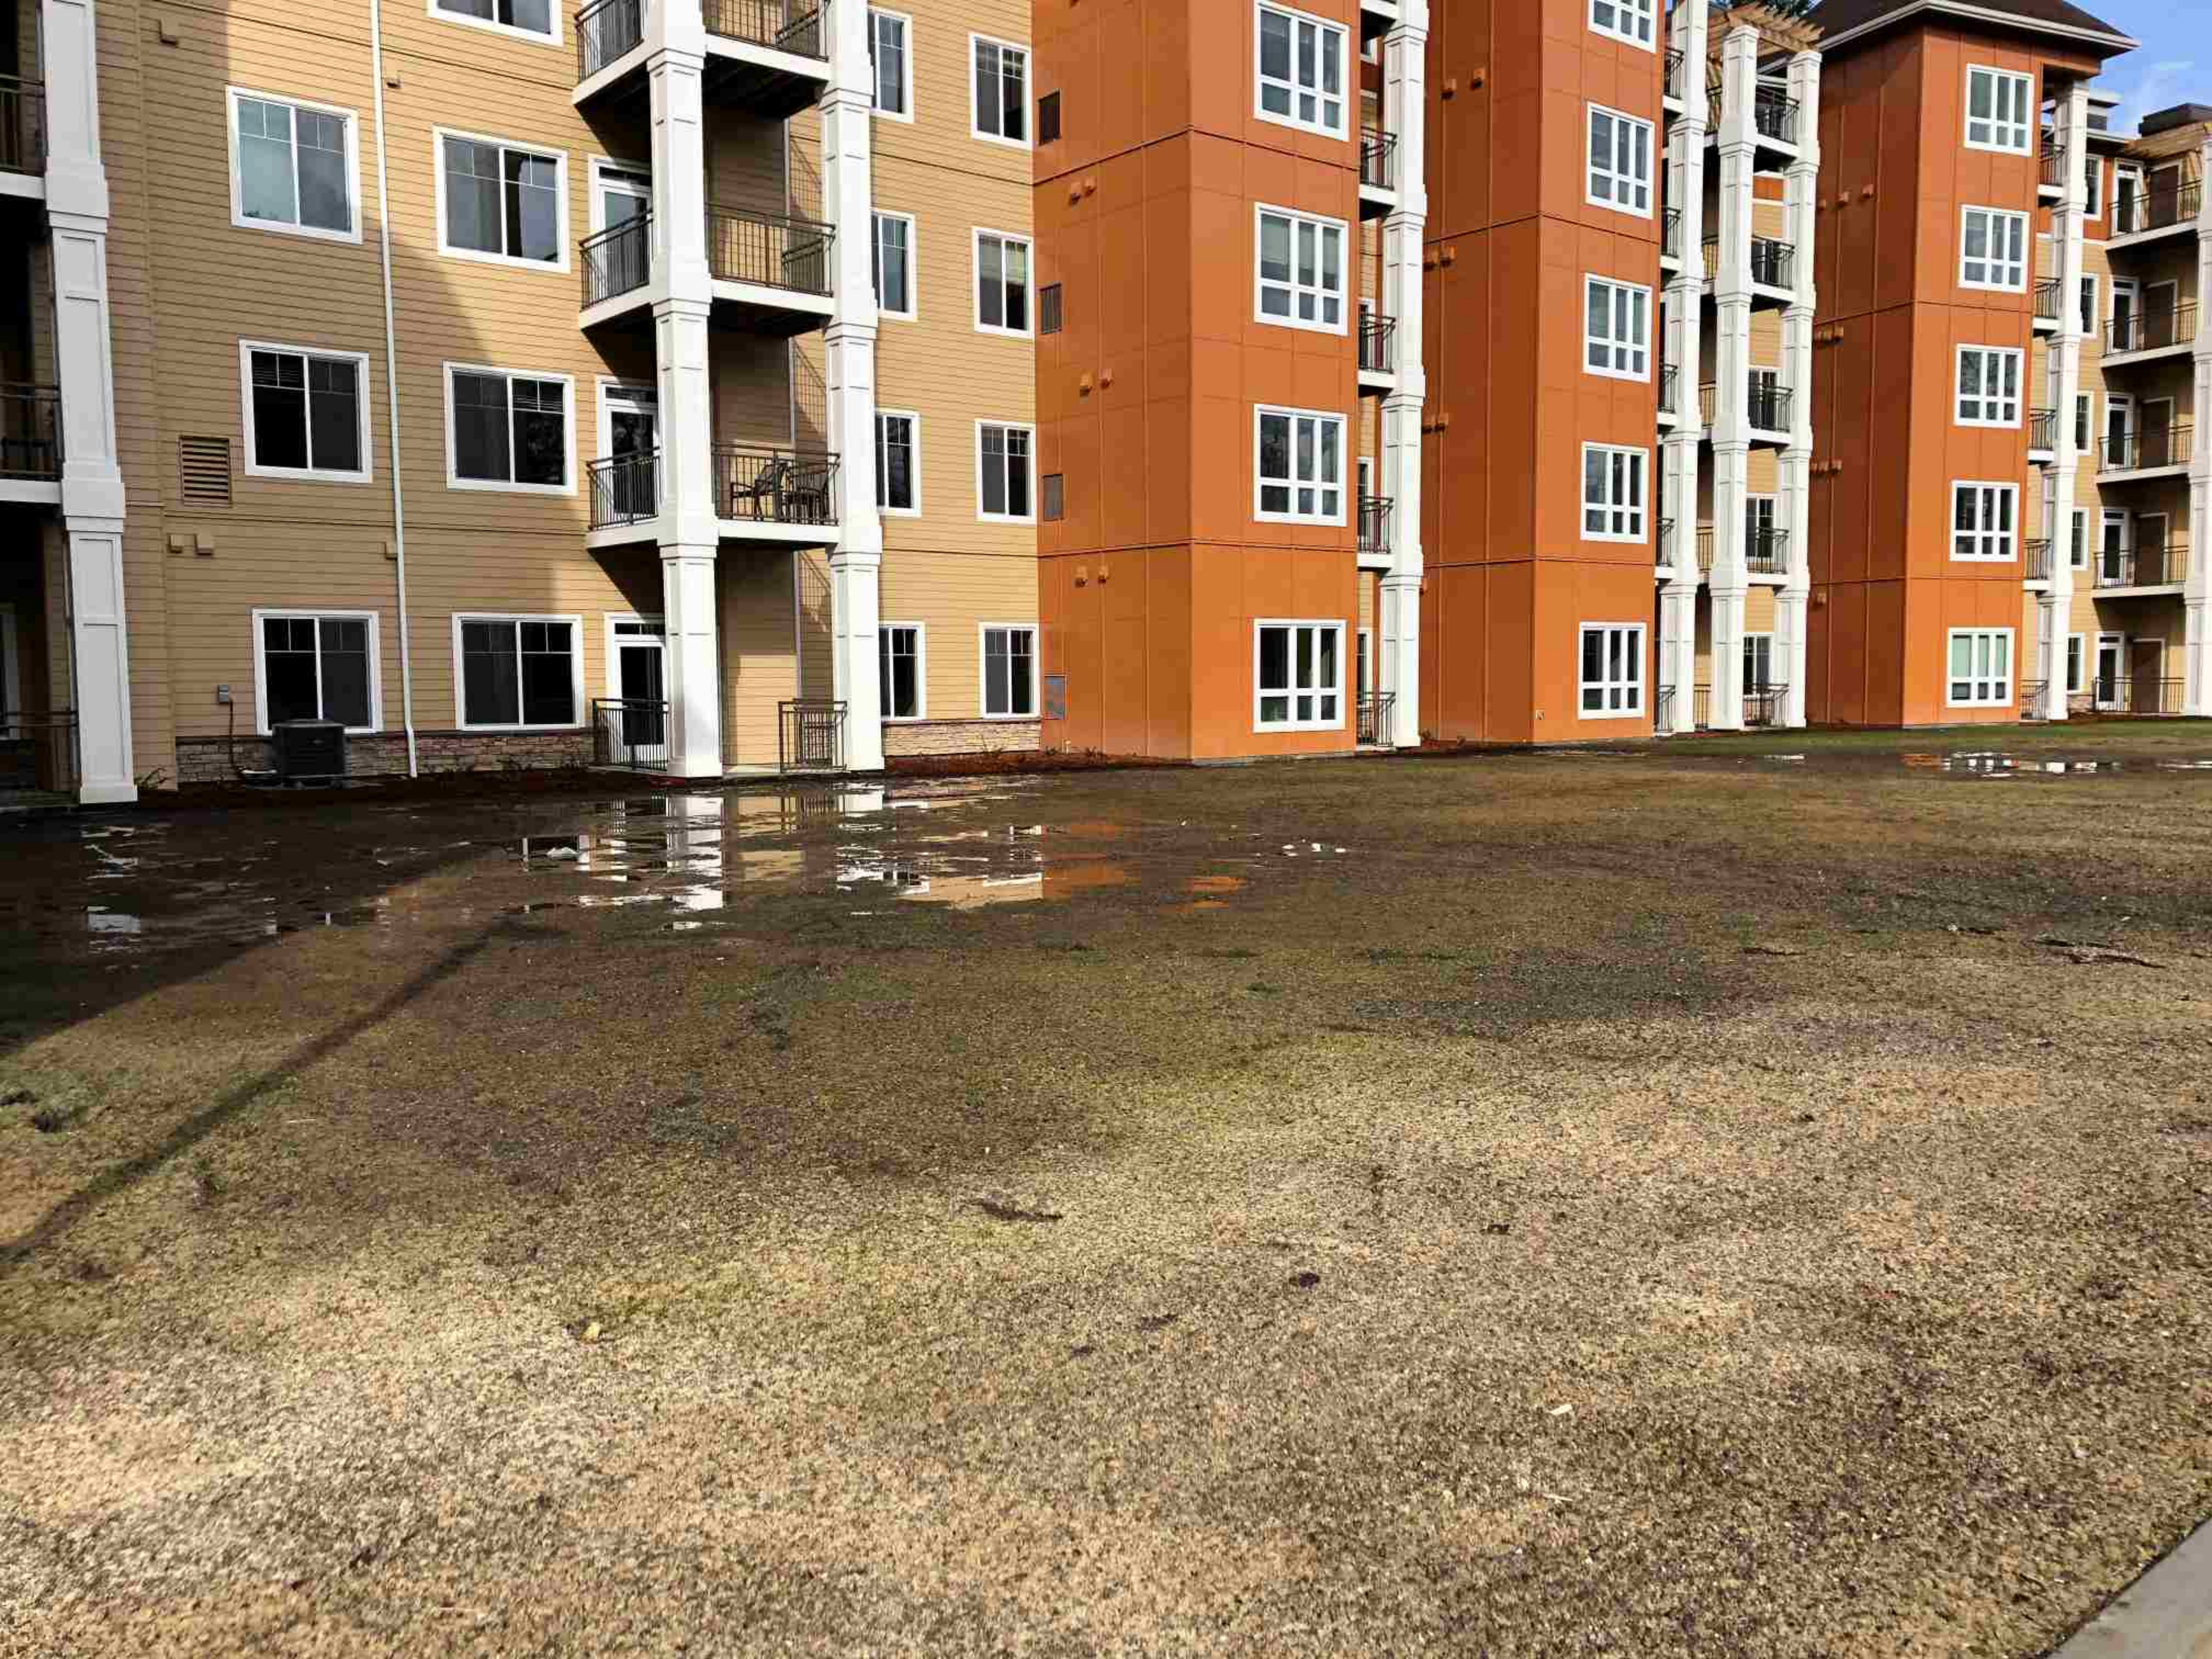
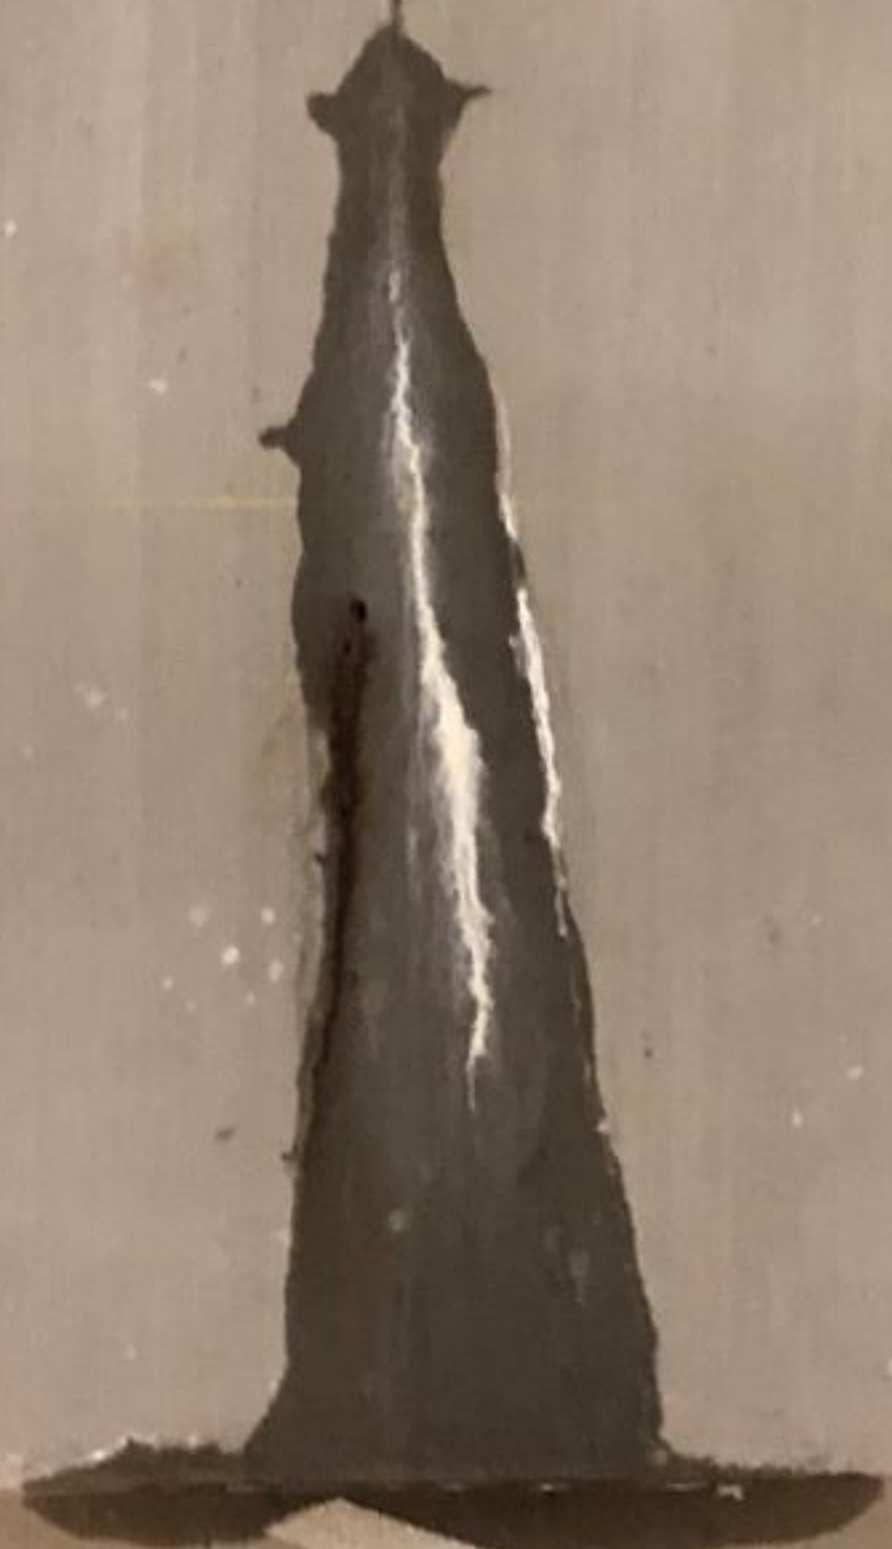
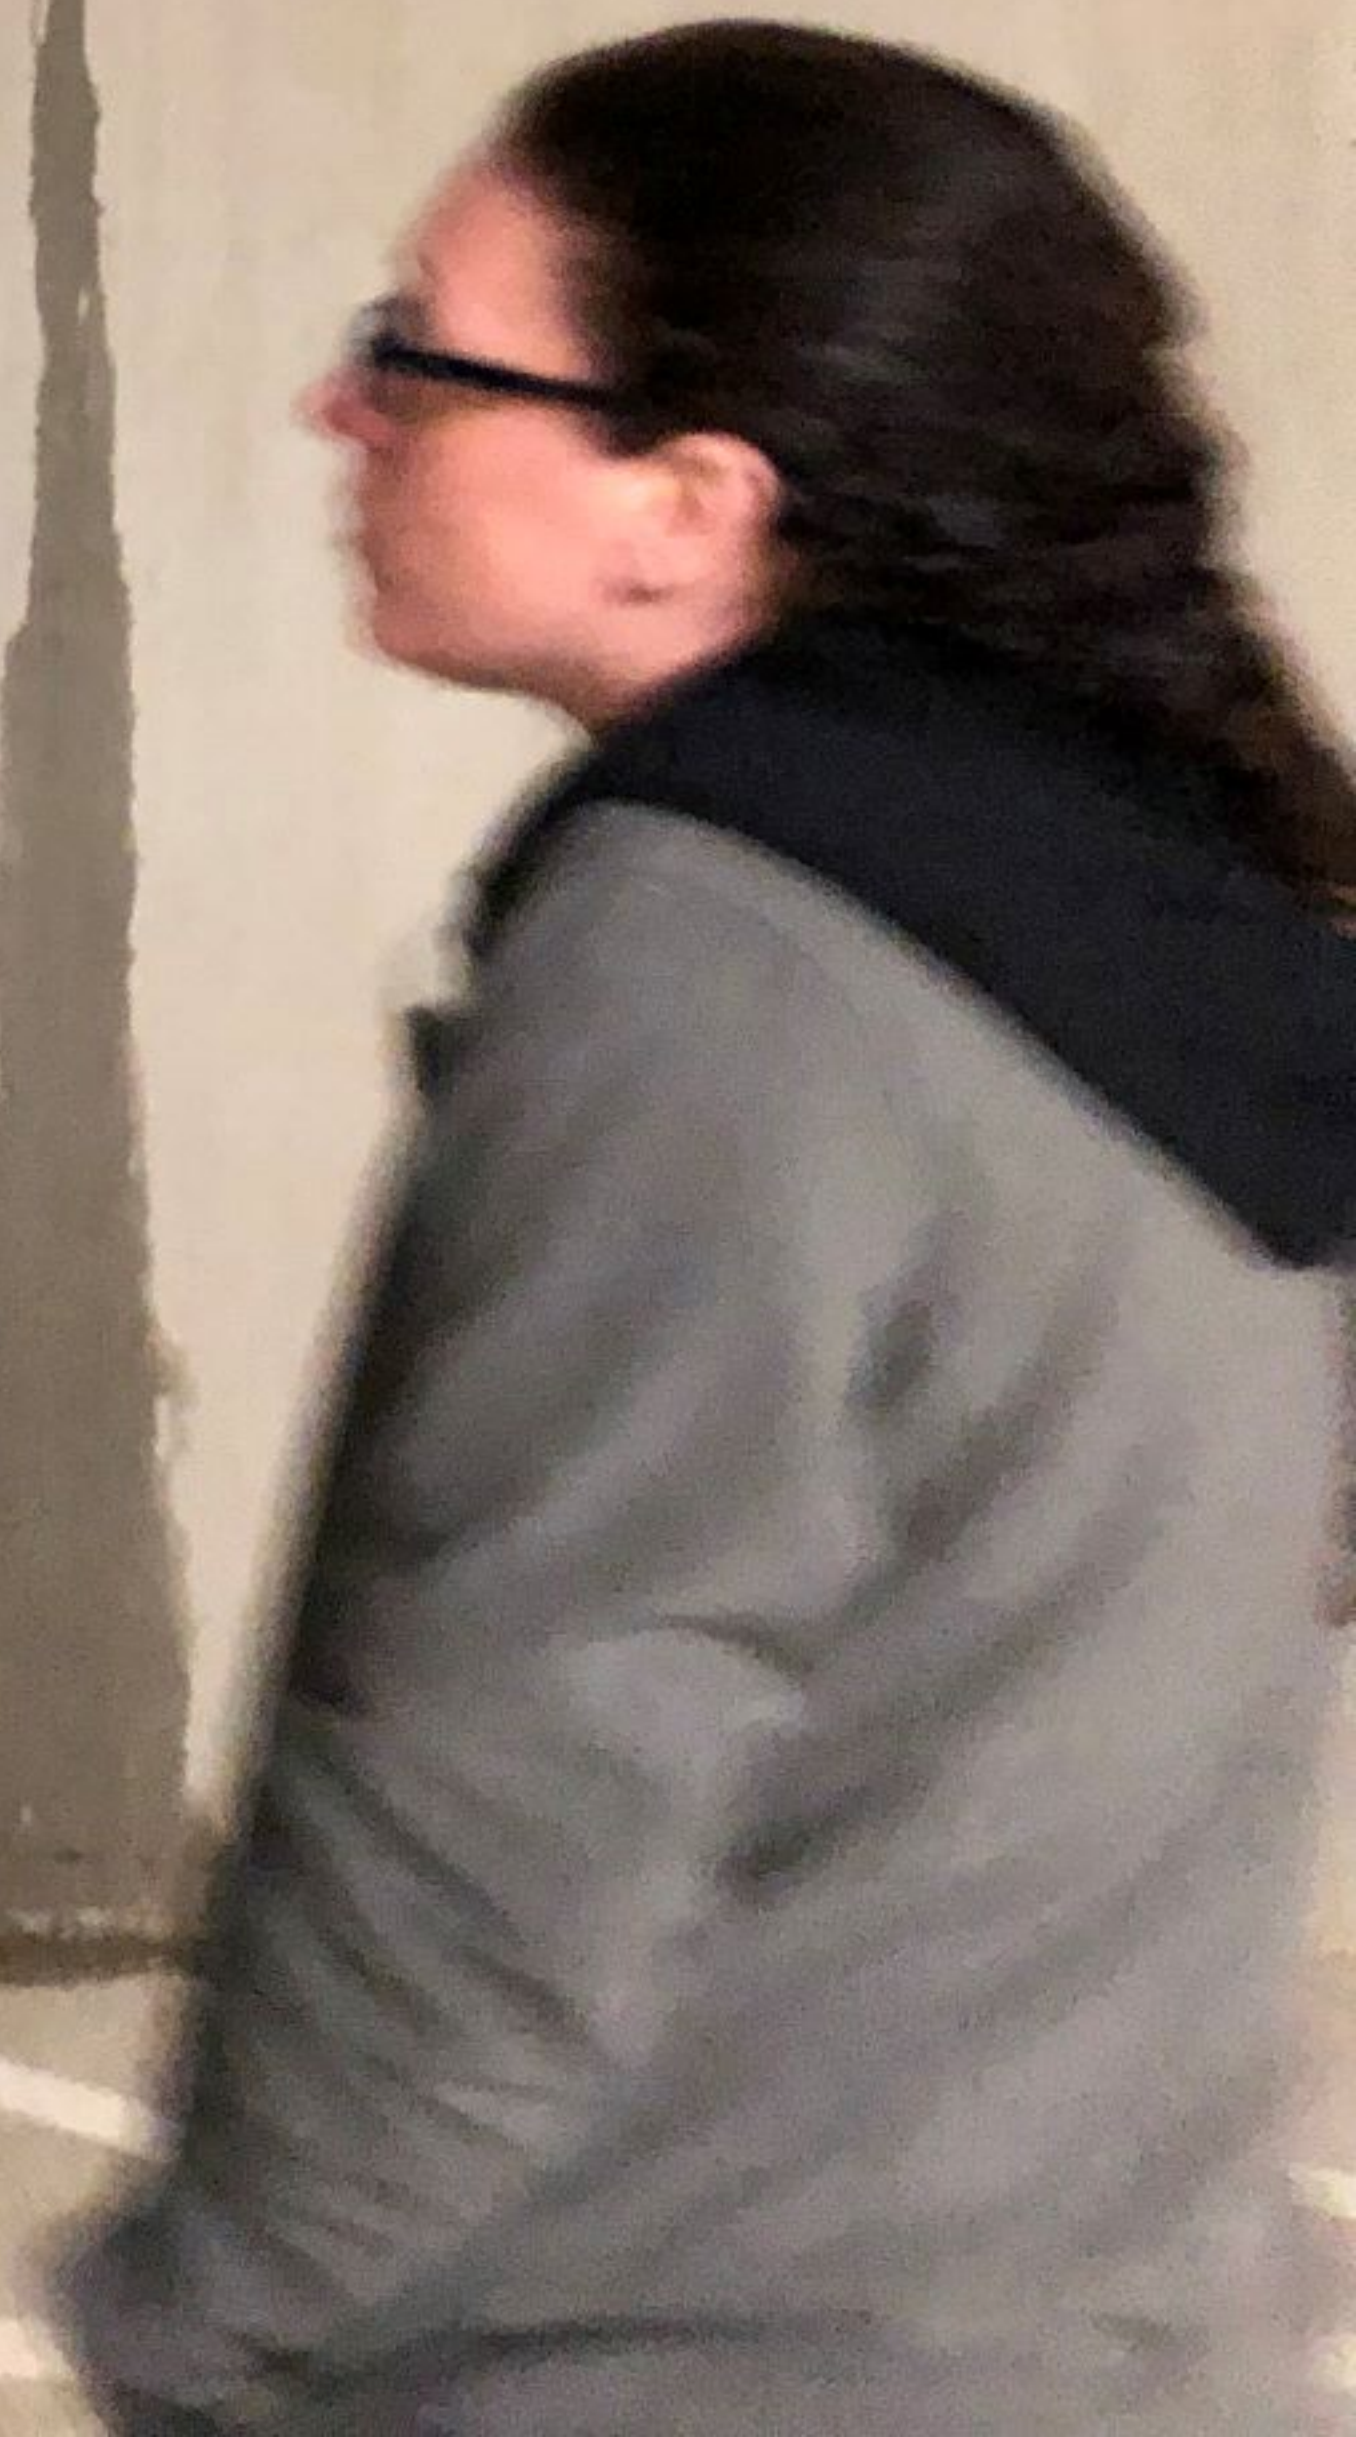
The site seepage mentioned in the referenced addendum took place on the east and south sides of the existing Lodge building. Flat grades along these sides of the building along with relatively low permeable fill soils resulted in ponding water areas that eventually seeped into the Lodge lower-level garage. Photographs documenting conditions observed in April 2019 are attached for reference.

This condition clearly demonstrates that infiltration of stormwater using low impact development elements such as permeable pavement would not be feasible at the site. To further demonstrate this, in addition to excavating the supplemental test pits, we performed a small-scale pilot infiltration test (PIT) in the proposed pavement area south of the new building. This PIT location is shown on Figure 1. Approximately 50 gallons of water was introduced into the test pit at a depth 2.5 feet. This resulted in a head of about six inches. After two hours, no reduction in the head occurred demonstrating the fill soils do not infiltrate. The log for the PIT along with testing comments is included with the test pit logs.
