## Arborist Report

**Date: December 21, 2023**

**Re: Arborist Report**

**5<sup>th</sup> Street Southeast – 2525 5<sup>th</sup> Street Southeast, Puyallup, Washington 98372**

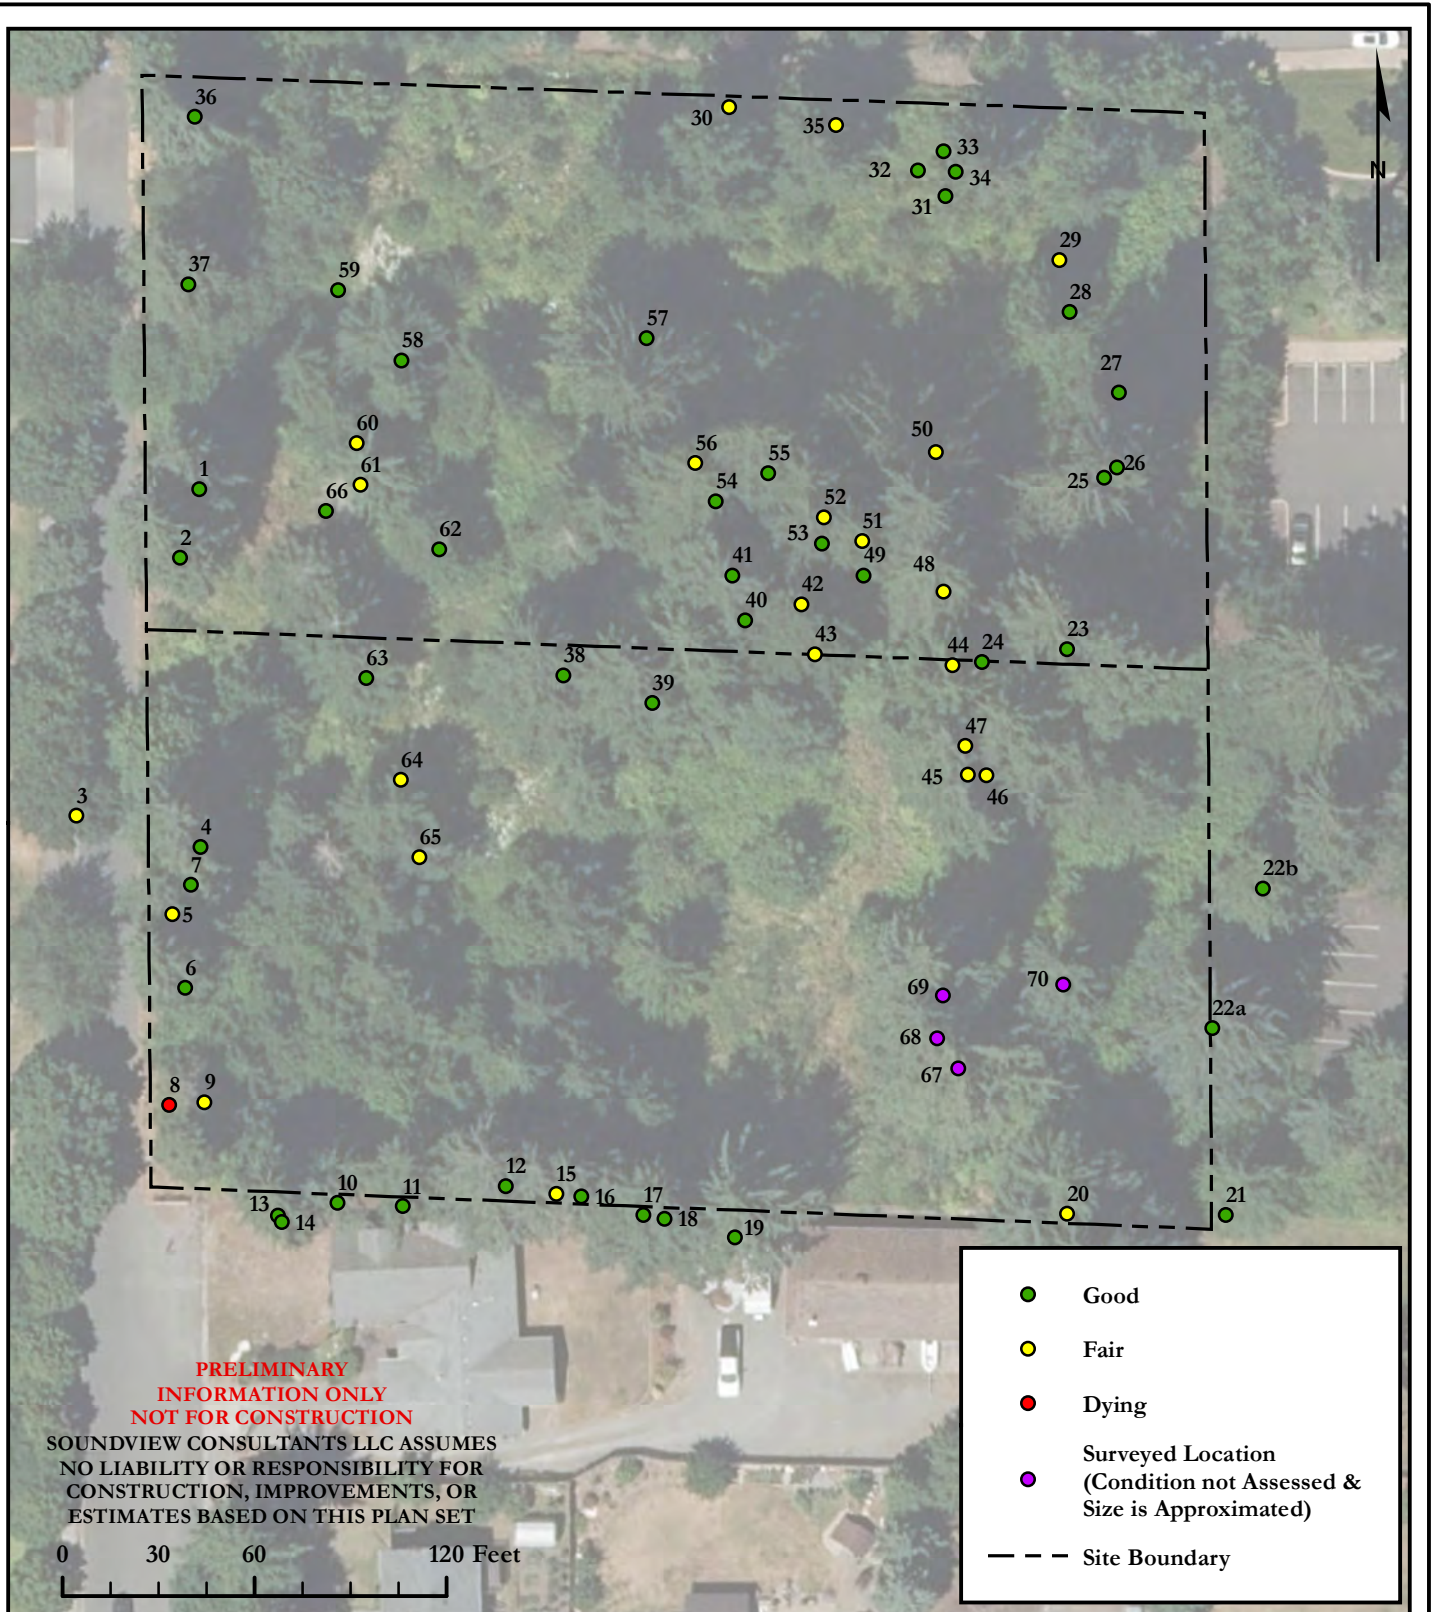
# TREE INVENTORY MAP

A total of 67 trees ( $\geq 15''$  DBH) were assessed, flagged and given a unique identification number. Four additional significant Douglas fir trees were collected by survey but not assessed by SVC (T-67 to T-70) but are included in the mapping and associated data for a total of 71 trees; however, the DBH, health, and overall condition of these trees cannot be confirmed. Refer to Attachment B for the Tree Inventory Exhibit and Data. The assessed/collected trees were comprised of 68 Douglas fir (*Pseudotsuga menziesii*), one dying western red cedar (*Thuja plicata*), one Deodar cedar (*Cedrus deodara*), and one multi-stemmed bigleaf maple (*Acer macrophyllum*). DBH of assessed trees ranged from 15 inches to 39 inches, of which 24 were large mature fir trees with trunk diameters in excess of 30 inches DBH. All but one tree was in good or fair condition.

Data was collected on trees directly adjacent to the property boundaries as aerial and rooting space allotment should be taken into consideration when determining the clearing limits for the site, as their CRZ will need to be protected from construction impacts. The assessed Deodar cedar (T-21) was located on the parcel boundary, however, survey did not collect this tree, as such, we are assuming it is offsite. Additionally, the location, approximate DBH, and condition were collected on an offsite Douglas fir (T-22) to the east. Along the southern property boundary, 4 unflagged trees were determined to be onsite and 7 unflagged trees were confirmed to be offsite after confirming their surveyed locations. In total, there were 61 onsite significant trees, 9 offsite significant trees, and 1 dying tree of significant size assessed.

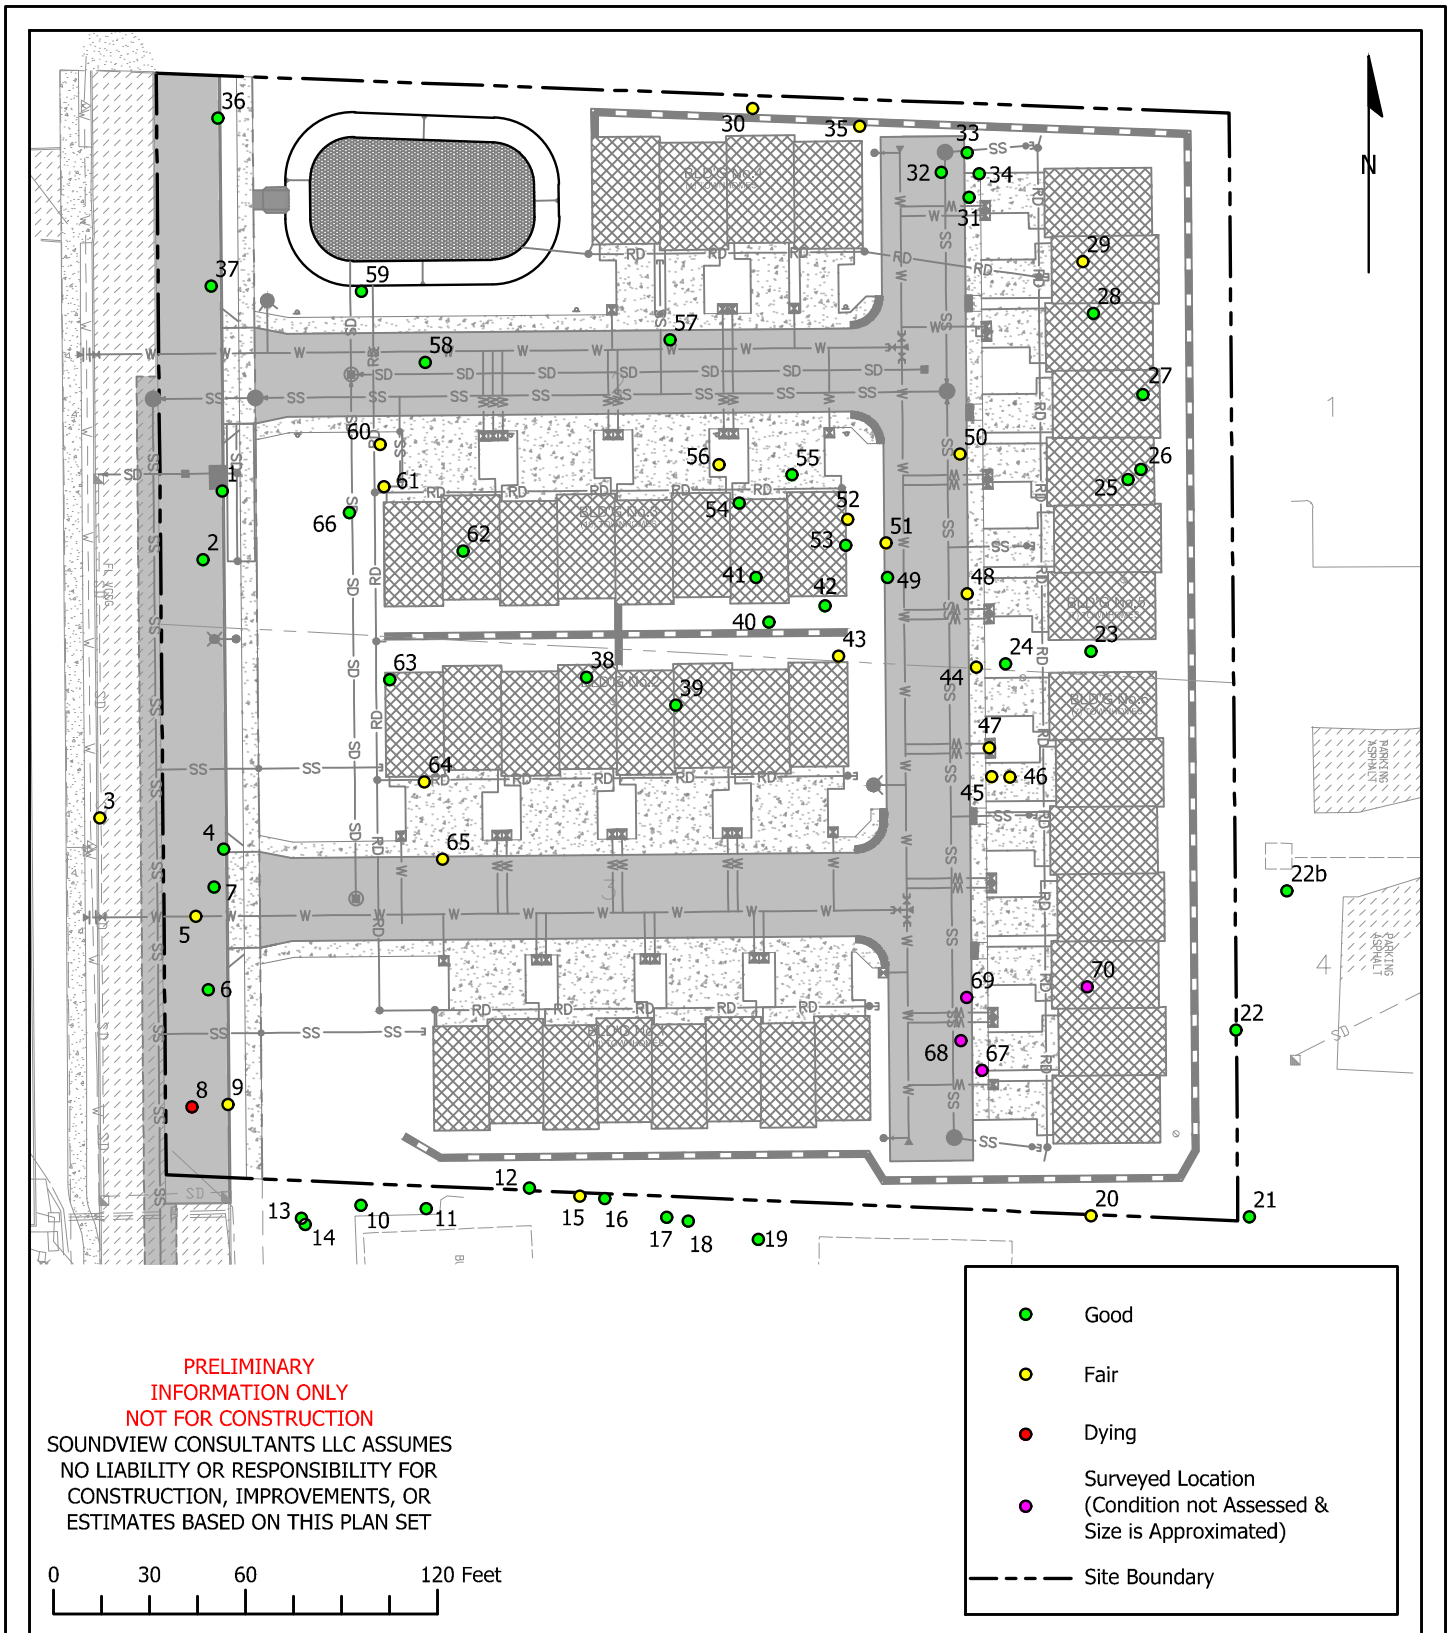
# TREE INVENTORY MAP (PROPOSED CONDITION)

Multiple site plan revisions have been made to shift project elements and avoid the removal of all identified significant trees as indicated in the previous Arborist Report, submitted prior to final site layout. However, three site elements prevent the retention of most of the trees recommended for retention by the City of Puyallup and WDFW. First, the City requires road improvements to the 5<sup>th</sup>

Street SE right-of-way along the western side of the site. Trees numbered 1 through 9, 37 and 38 are all located either in the ROW expansion area or within the required sidewalk area immediately adjacent to the road. Second, the site will be lowered to a grade of 3 to 8 feet below its current elevation. A retaining wall is proposed to be erected around three-fourths of the project site. The structural rooting zone of trees 30 and 35 are located within a few feet of the northern retaining wall. Likewise, tree 23 is located in an area that will see an approximate 7-foot change in elevation per grading plan and its CRZ would be significantly encumbered by the proximity to the building foundation of the townhouse unit to the north. Due to the proposed grade changes around and beneath these trees, there is not sufficient rooting space to retain these trees. Trees 31 through 34 are in an interior area, south of the retaining wall and are anticipated to be graded down approximately 6 feet from the current grade. They are also located within the northern portion of the road turnaround, sidewalk or driveway entrance to the northeastern-most townhouse unit.

The third area compromised by the new site plan and grading limits is the western interior area where trees 59 and 66 are located. Here, the grade is anticipated to be lowered by two to three feet from the existing grade. Additionally, utility trenching for a storm drain continues south to north, cutting directly beneath the primary structural roots of trees 59 and 66. As such, creating a tree protection zone “island” for an individual tree or trees would be potentially plausible, but would disrupt the continuity of the overall project and would likely result in the retention of unhealthy, not windfirm trees over time. Redesigning the storm pond to accommodate tree 66 will still not address the 2-foot elevation change. Isolated trees retained from a forested stand with significantly altered rooting and climactic environments are less likely to thrive and be good candidates for retention.

Trees along the southern property boundary are primarily located offsite on the neighboring parcel. Yet, four trees, numbered 12, 15, 16 and 20 are onsite and would be good candidates for retention. Cutting, clearing, and grading for the retention wall north of the trees will compromise their full critical root zones, potentially more than the 50 to 75 percent maximum allowable amount to be removed. The City of Puyallup defines the required critical root protection zone (CRPZ) as tree diameter (in inches) x 2, converted into feet. The trunk diameters of these trees are T-12 (30 inches DBH), T-15 (24 inches DBH), T-16 (32 inches DBH) and T-20 (24 inches DBH). All four trees are heritage-sized, Douglas fir trees in good or fair condition at or just inside the fence line. According to the City’s CRPZ, the largest 30-inch DBH Douglas fir tree would require a CRPZ of 60 feet. Prior to final grading limits, a maximum distance of 15 feet from trunk to retaining wall may be achievable. This is far less than the minimum of 75 percent of the CRZ that must be preserved at natural grade per VMP 10.1.A.(3)i, yet the structural roots largely responsible for tree stability will be preserved as will the root zone to the west, south and east of the tree. SVC’s arborist recommends retaining these trees and having a Certified Arborist present to monitor these four trees during cutting and excavation of soil and/or roots within the CRZ during construction. To reduce the inevitable degree of environmentally altered stress experienced by many trees post-construction, after care including temporary irrigation and woodchip mulch are recommended based on the degree of vegetation clearing and other impacts to the tree’s root zones. As such, four trees are proposed to be retained onsite.

Due to the proximity to the subject property, the CRPZ of nine offsite trees (T-10, 11, 13, 14, 17-19, 21, 22b) have the potential to encroach into the proposed project clearing limits yet are required to be protected from construction impacts. The DBH of adjacent, offsite trees ranges from 16 inches to 33 inches and therefore the CRPZ may extend onsite based on the specifications outlined in the Methods section. It should be noted that they were intentionally not tagged or flagged in the field due to their
