- Preliminary Tree Protection Plan -

43rd AVENUE MULTI-FAMILY

701 43rd Avenue SW
Puyallup, WA

Report Date: August 29, 2024

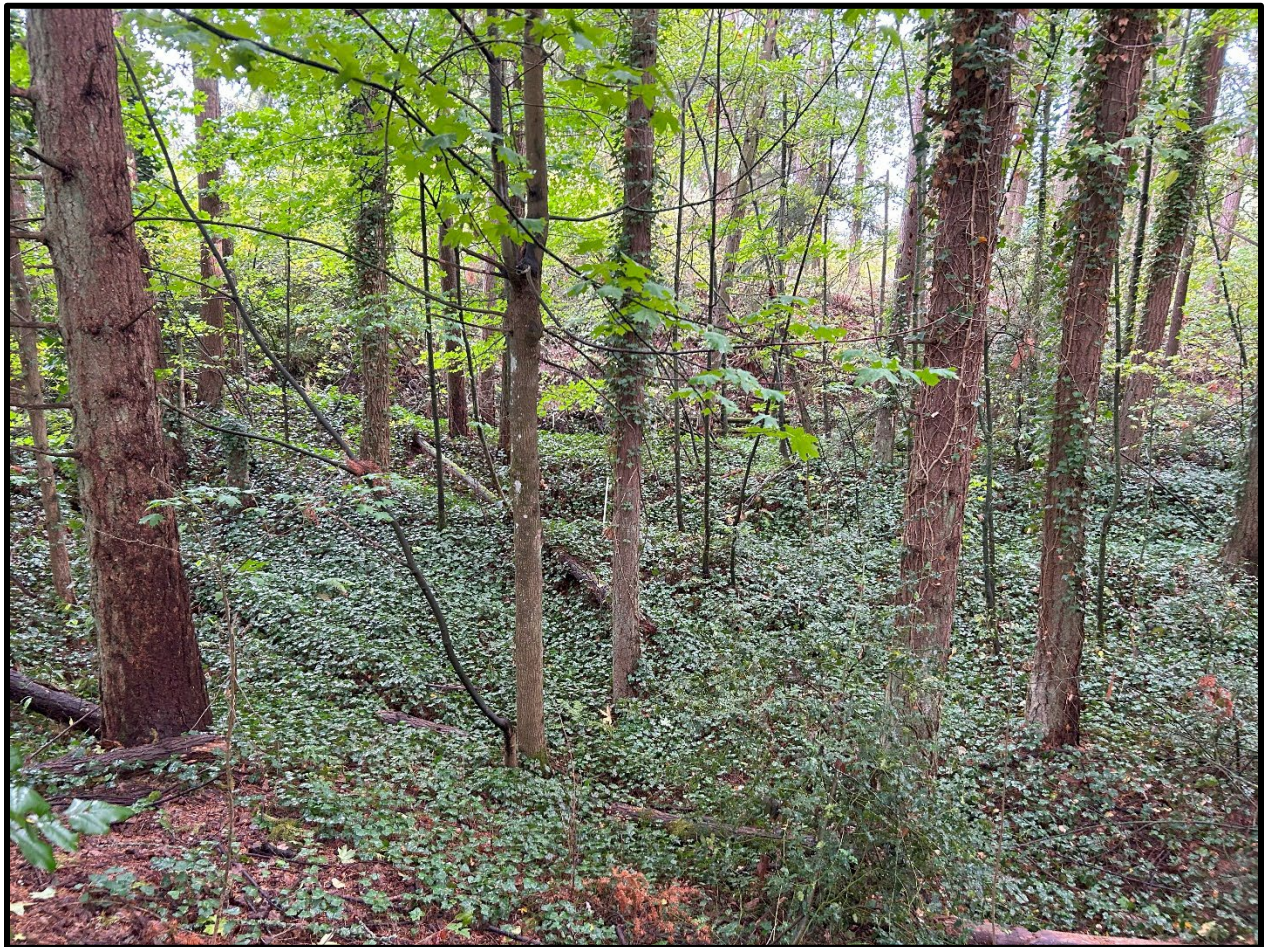
Type I. -- This 1.67-acre type covers the entire project area. There are 136 significant trees in the type. All the significant trees are Douglas-fir (*Pseudotsuga menziesii*) between 15- and 38-inches diameter at breast height (DBH). A stand summary report is in Attachment 3. All the trees were classified as sound, healthy, long-term trees. Non-significant trees in the type include black cottonwood (*Populus trichocarpa*) and small diameter bigleaf maple (*Acer macrophyllum*).

Photo 1. View of trees in Type I of the 43rd Avenue Multi-family site.

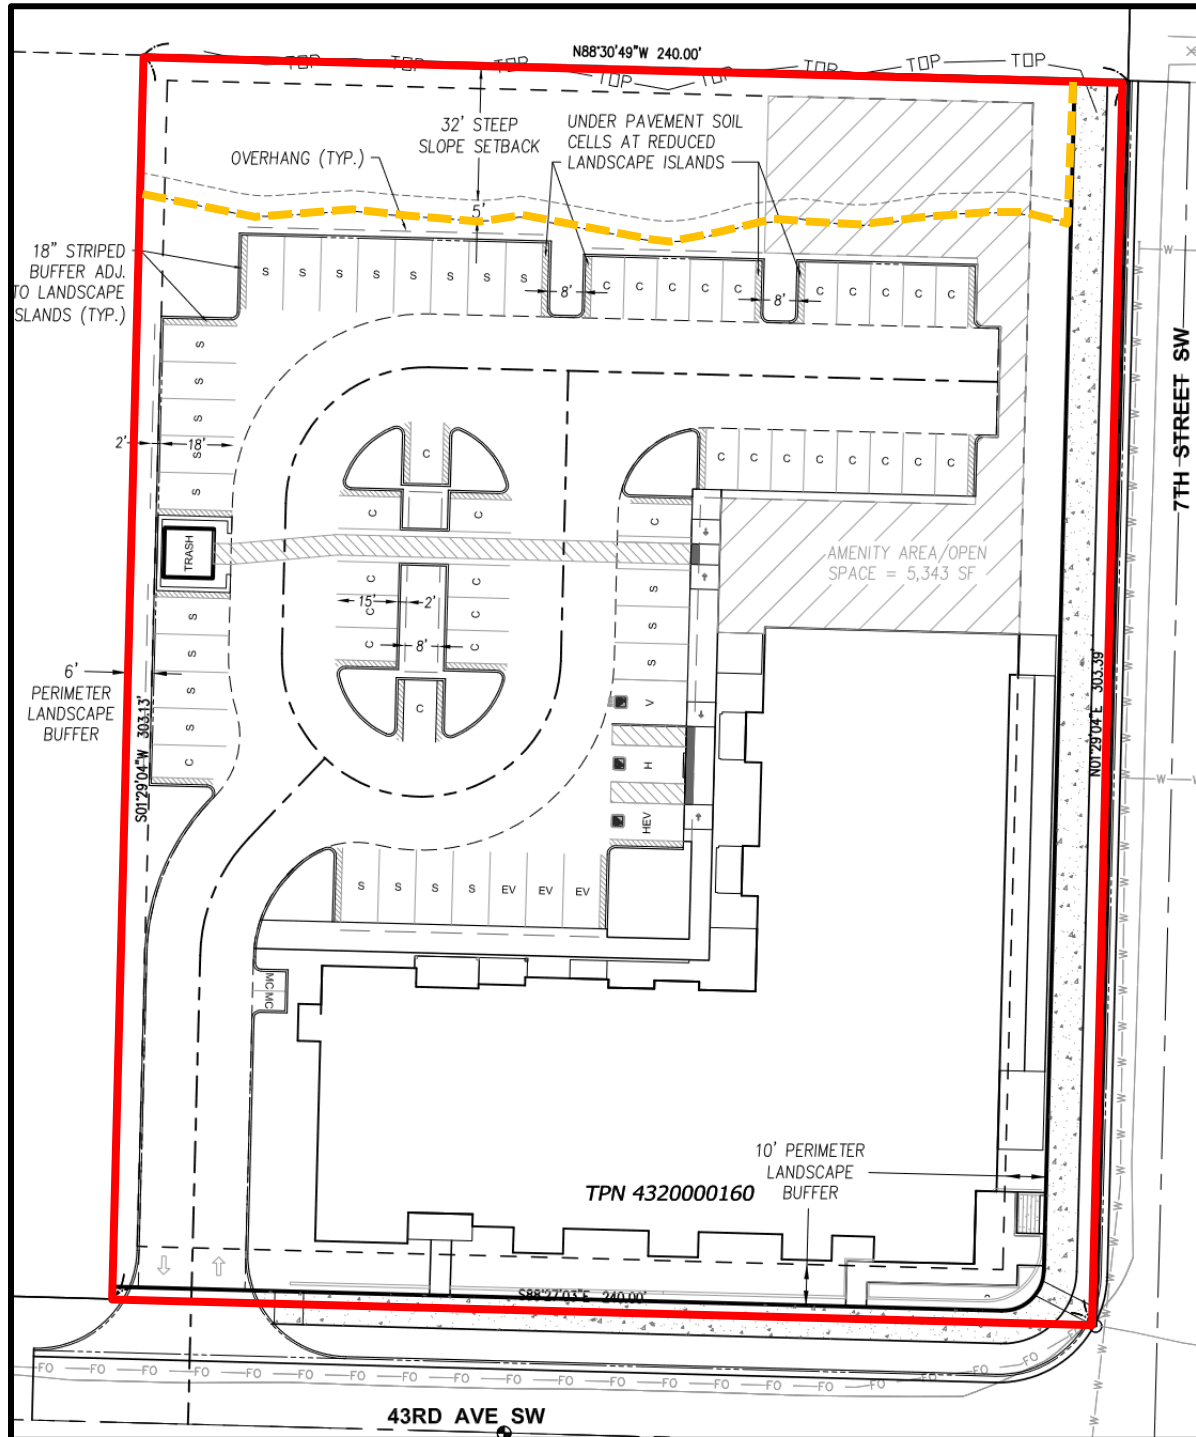
Attachment #2. 43rd Avenue Multi-family Site Plan

The provided site plan shows a tree retention area on the northern property line. There were no property corners or lines located in the field to determine the limits of the retention area. Vegetation in this area has few significant trees and is mostly small diameter trees including vine maple (*Acer circinatum*) and bird cherry (*Prunus avium*). The tree tract boundaries and grading plan are needed to establish a final count of trees to be retained.

Most of the 136 significant trees onsite will be removed to complete the construction of the project. The tree retention tract and property lines need to be staked and a grading plan provided to verify the number of trees being retained.
