SITE ASSESSMENT REPORT

219 N. Levee Road

Underground Oil Storage Tank Removal Project

March 2nd, 2023

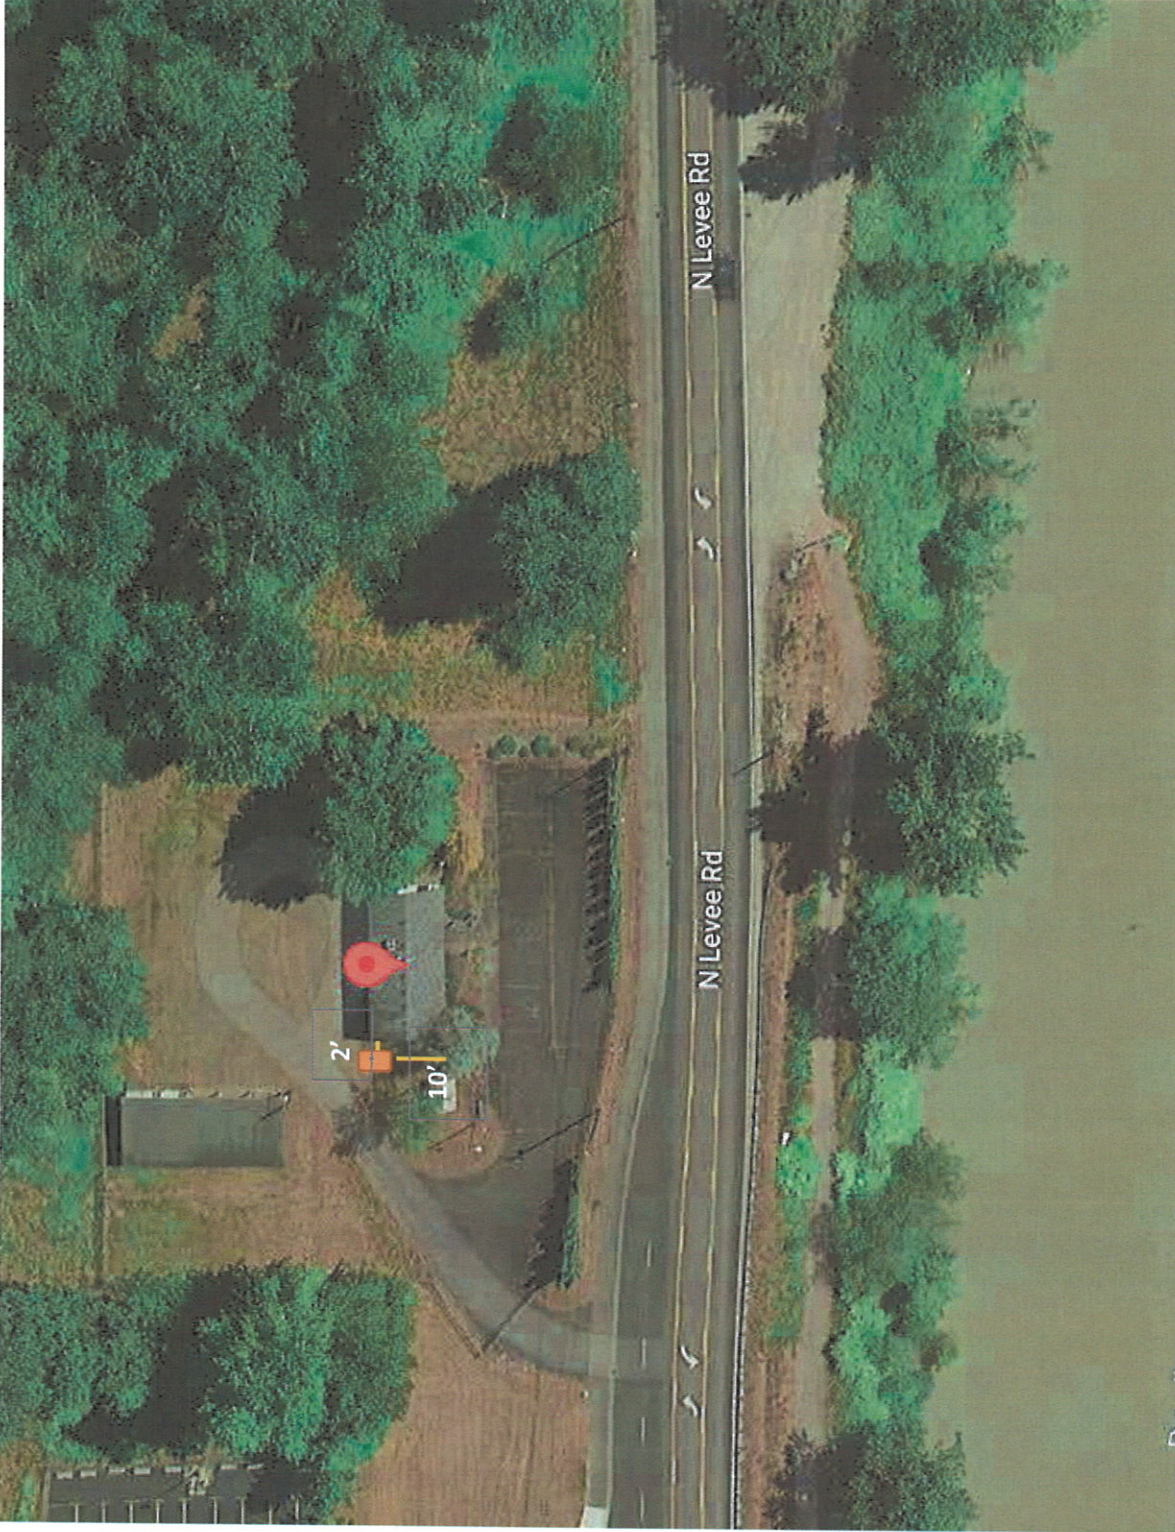
Pierce County Parcel No: 0420214063

300-Gallons Underground Heating Oil
Storage Tank to be Removed

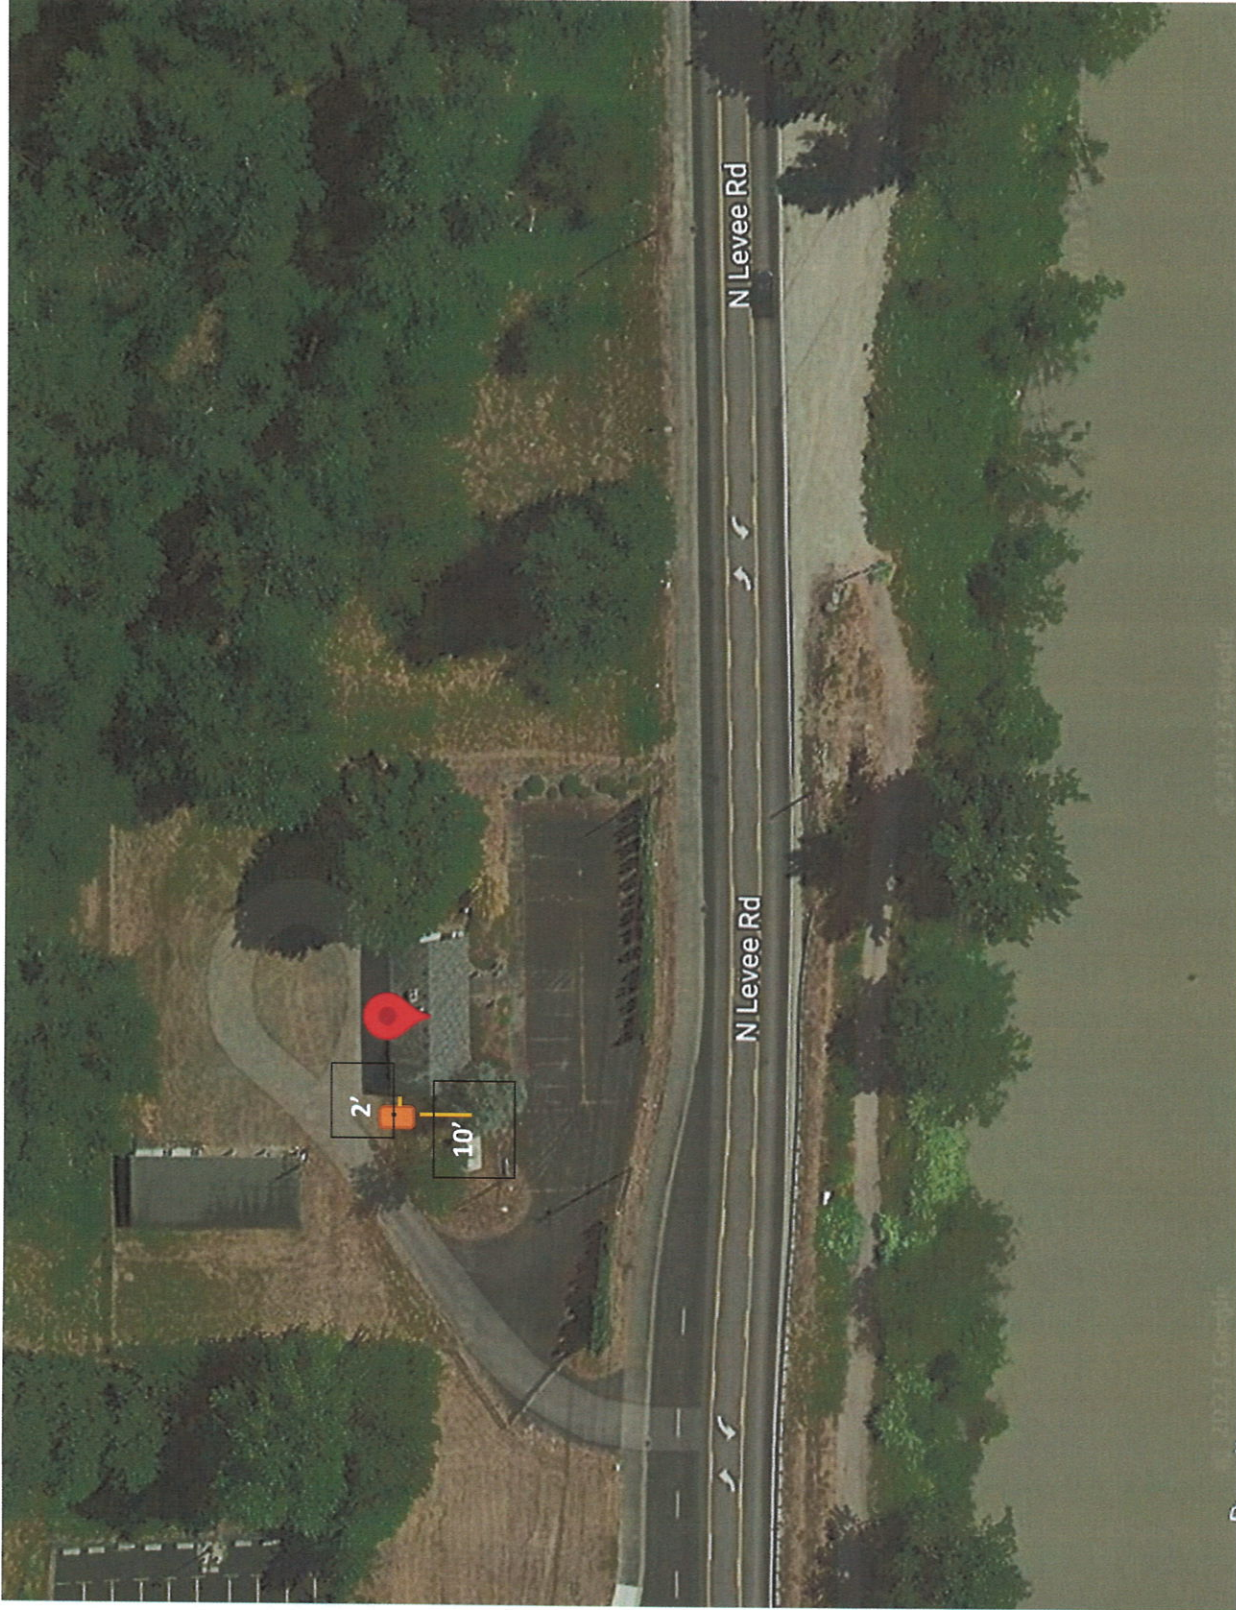
Pierce County Parcel No: 0420214063

300-Gallons Underground Heating Oil Storage Tank to be Removed
Soil Sample was taken at 8.5 feet

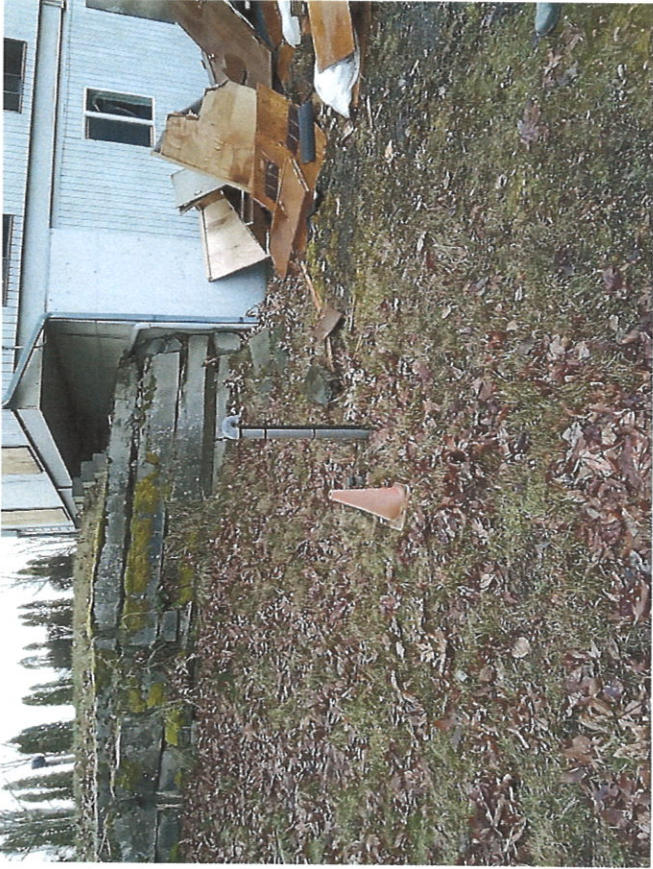
The Underground Heating Oil Storage Tank was located on the west side of the building. Sita Enterprises cleared area to remove the UST.

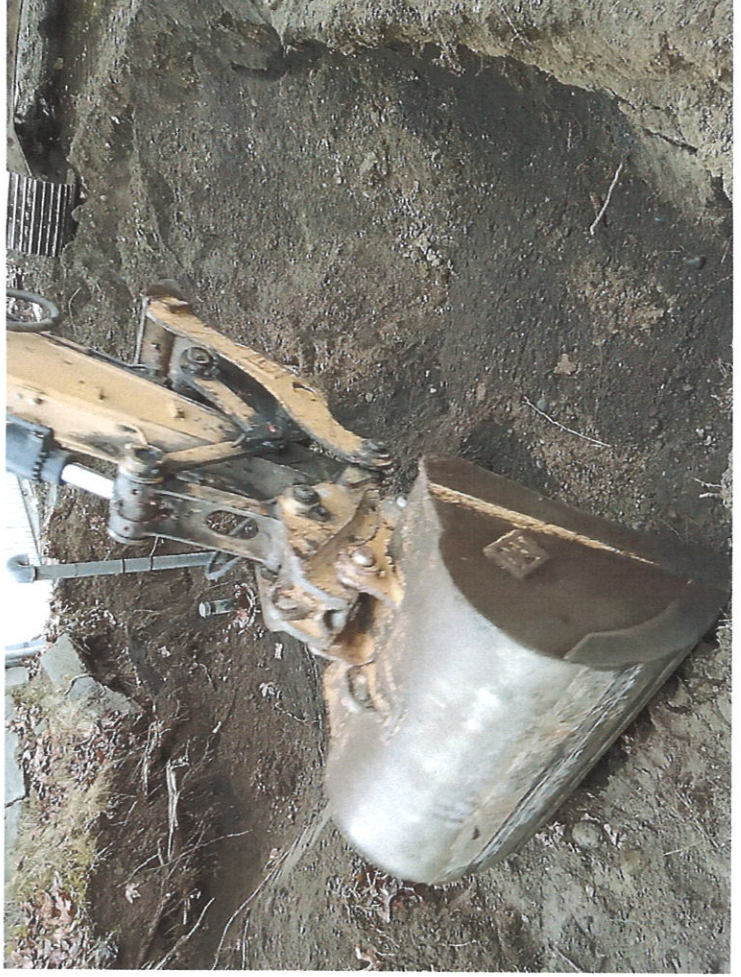
Sita Enterprises used an excavator to dig out pit area. The pit area was 12'x 12'. Utilities were in pit area, water line broke.

Tank was located under 44" of native soil. Underground Storage Tank was 45.5" x 6'L (500-Gallons). There was no visible holes in tank.

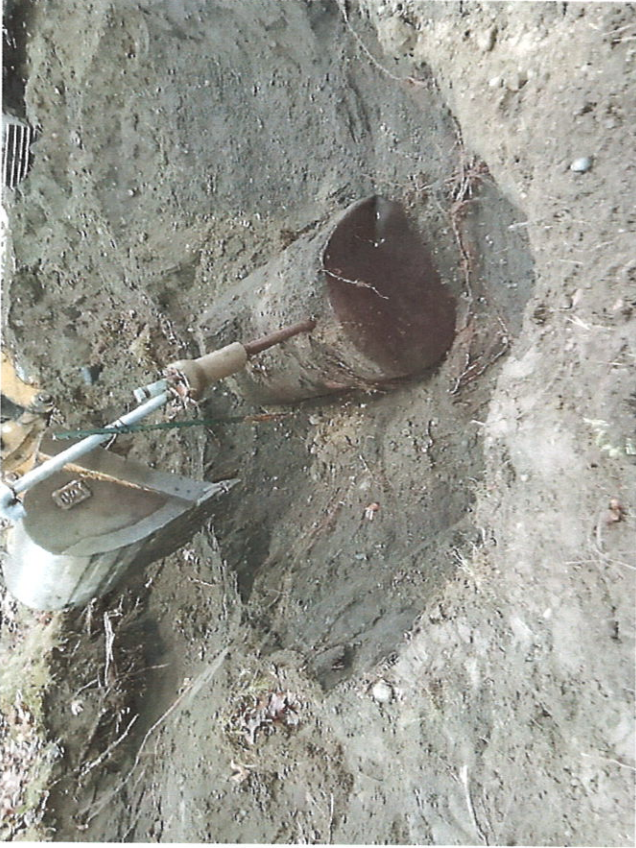
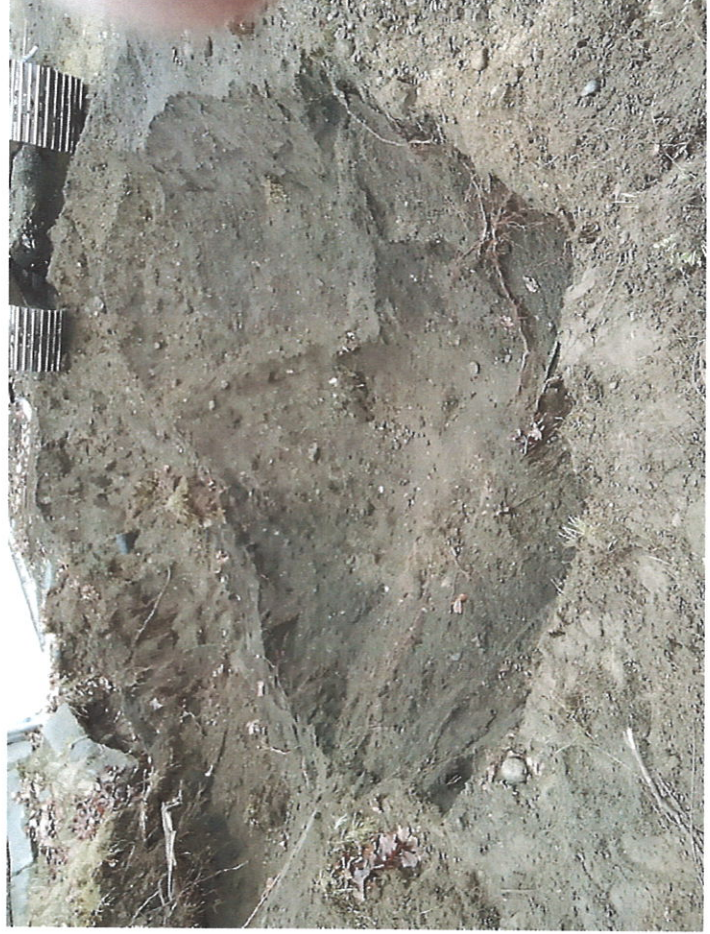
After the tank was removed by Sita Enterprises, a soil sample was taken in pit are at 8.5'. Then sent to Libby Environmental for lab analysis.

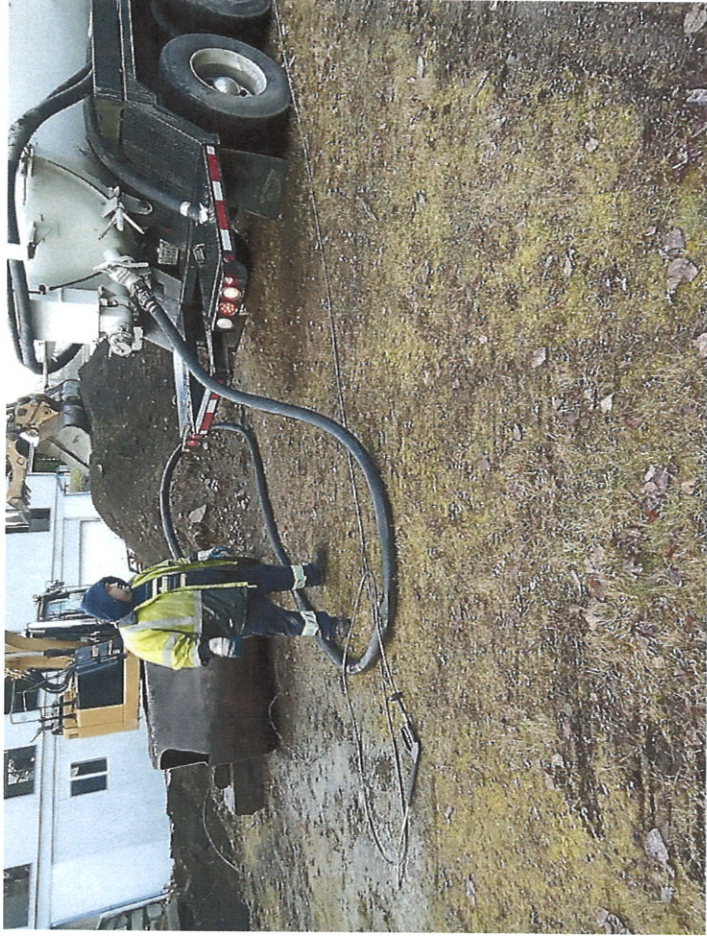
Northern Environmental LLC employee triple rinsed the tank for any residual oil. Tank must be properly cleaned to dispose of.

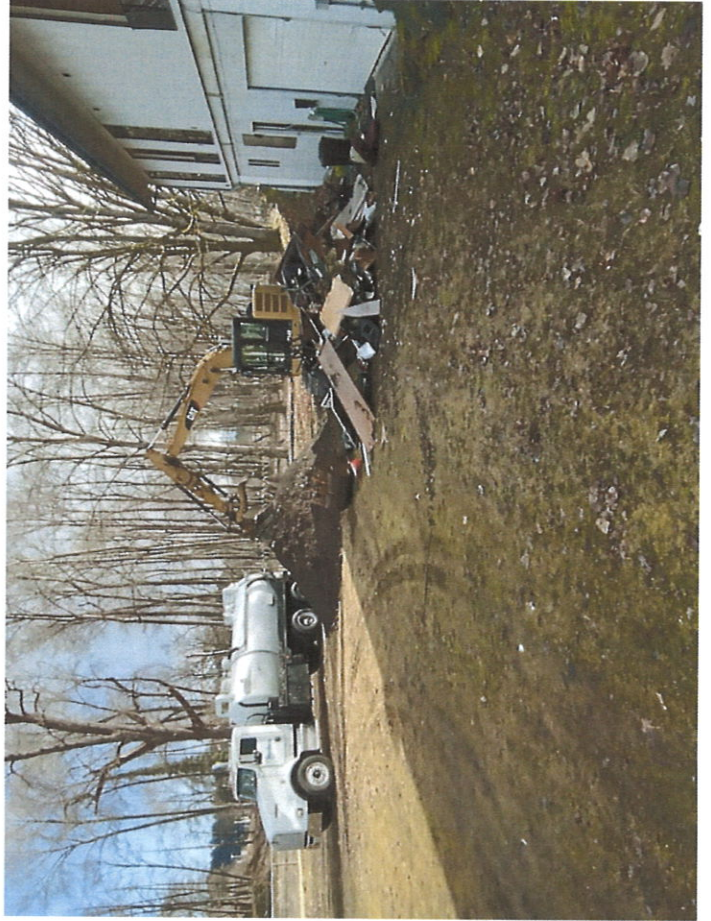
Sita Enterprises backfilled pit area, and disposed of tank by Washington State Guidelines.
