Stormwater Site Plan

Pierce College Puyallup
Campus Parking Expansion
Puyallup, WA
2200718.12

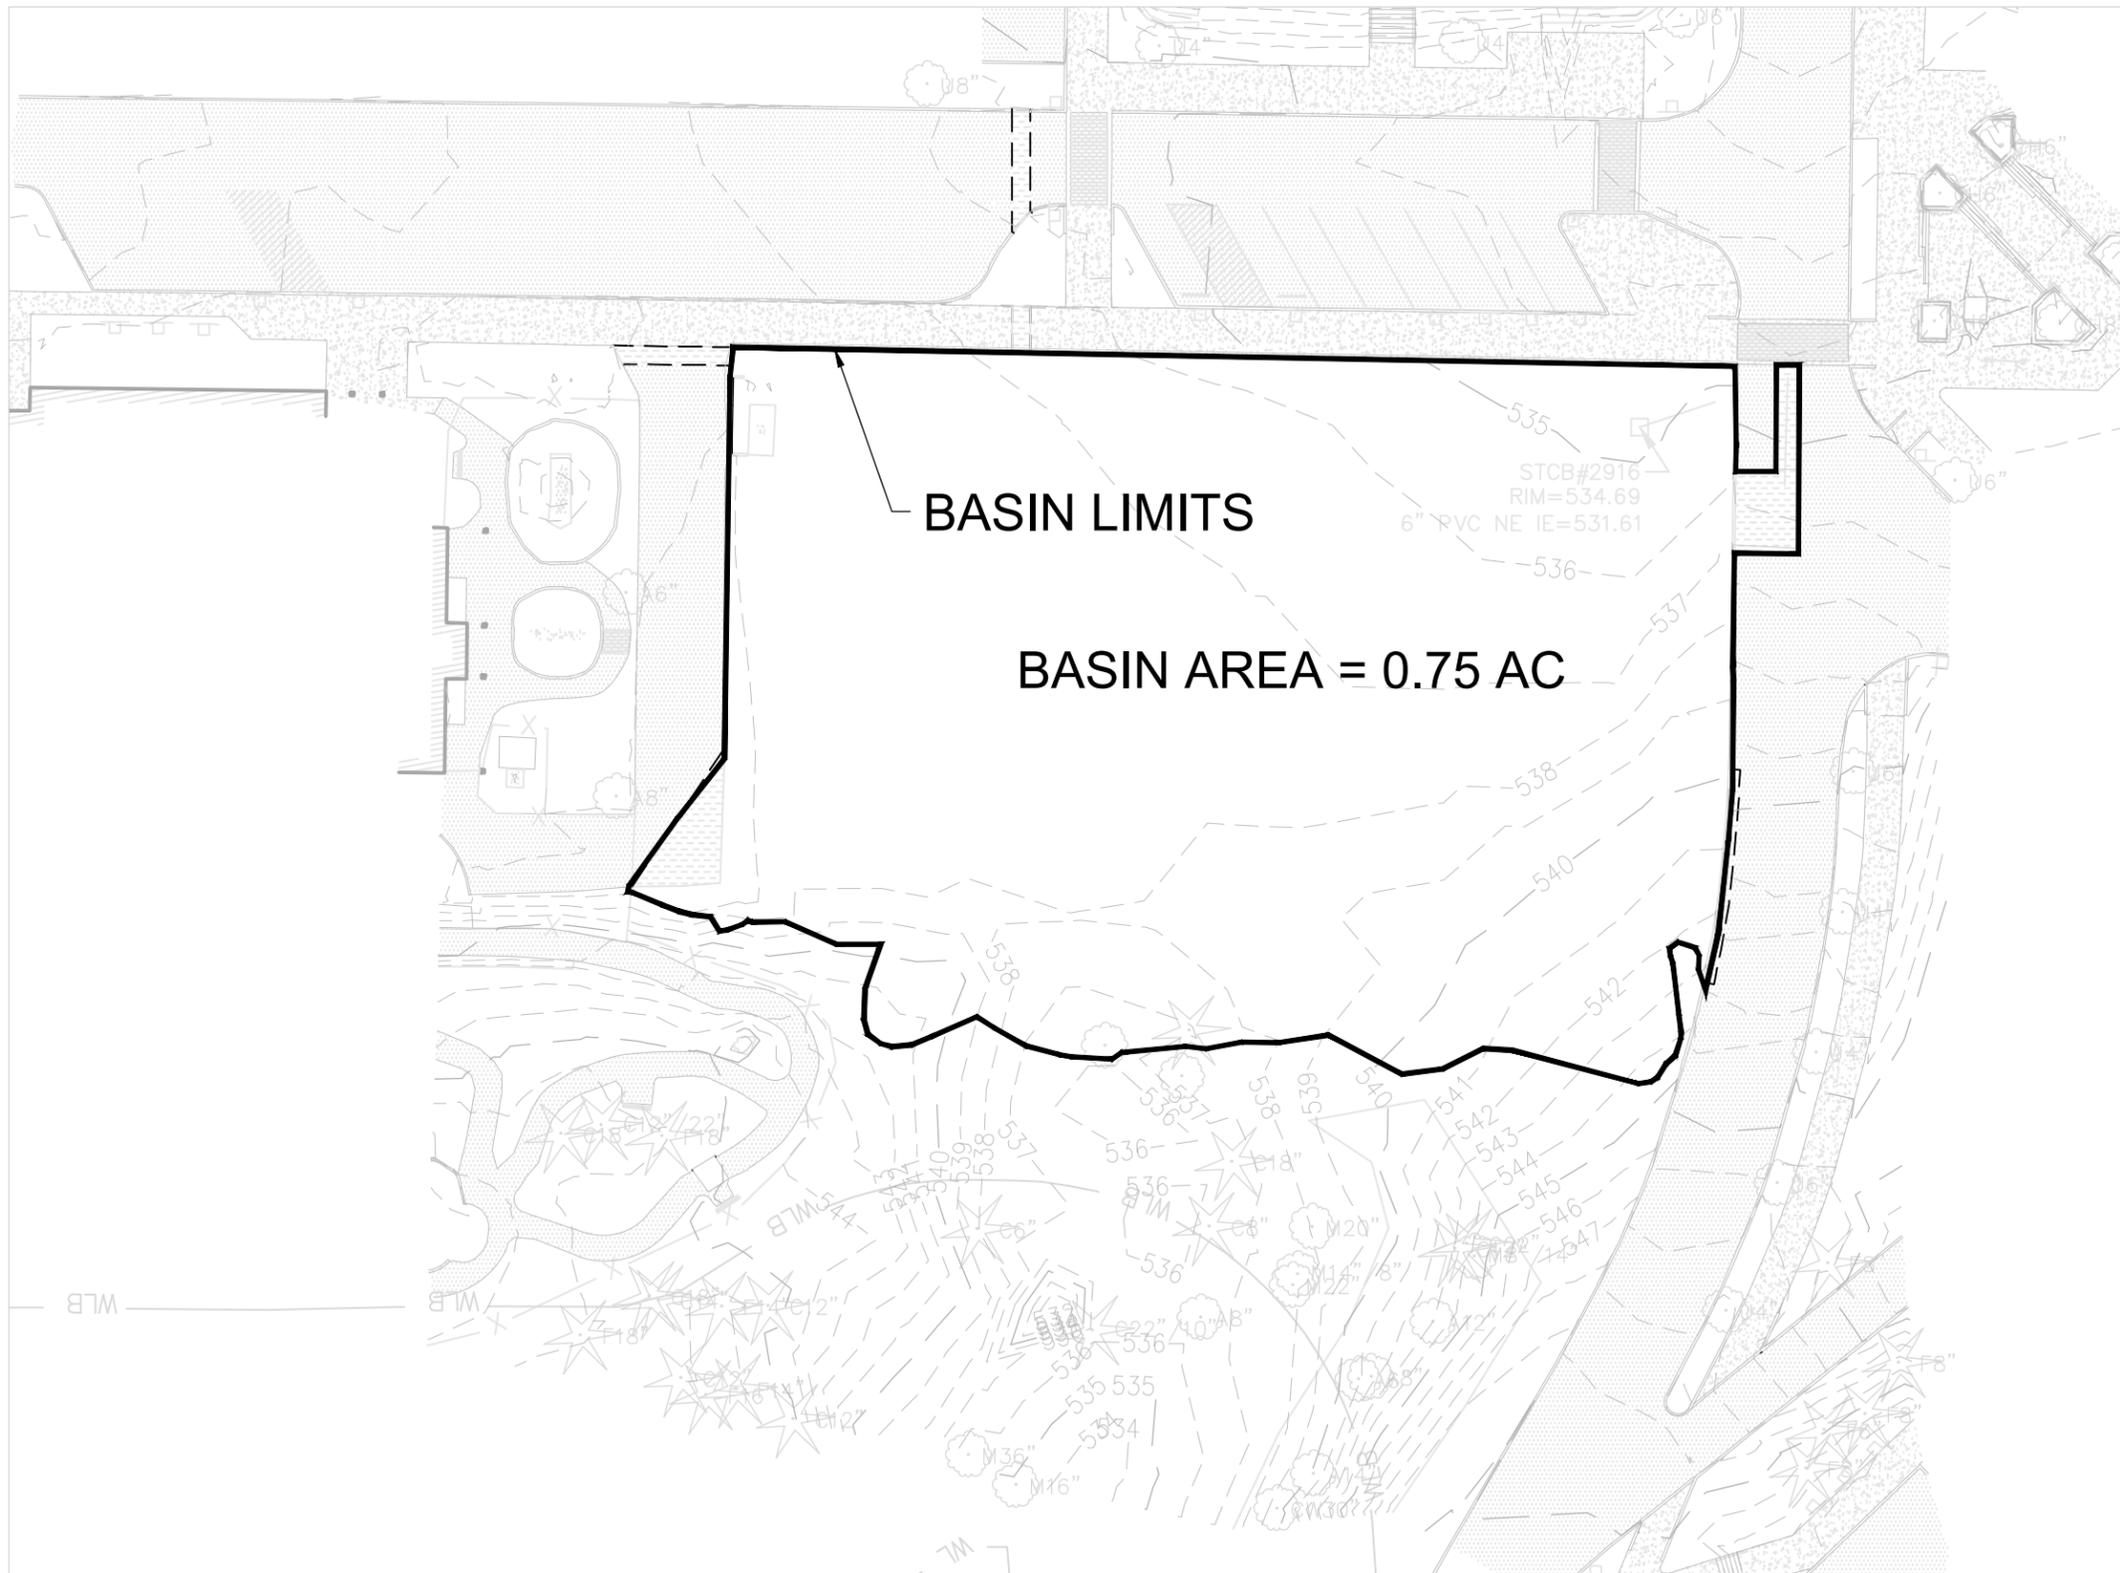
EX-A2.1

PIERCE COLLEGE PUYALLUP
 CAMPUS PARKING EXPANSION
**EXISTING BASIN MAP
 PARKING LOT B**

basin does drain to the adjacent wetland in the existing condition. Refer to Appendix A-2.1, Existing Conditions Map for more information on the Parking Lot B existing basin. Refer to Appendix A-7, Parking Lot B Wetland Basin Exchange Map for more information on the portion of the basin tributary to the wetland.

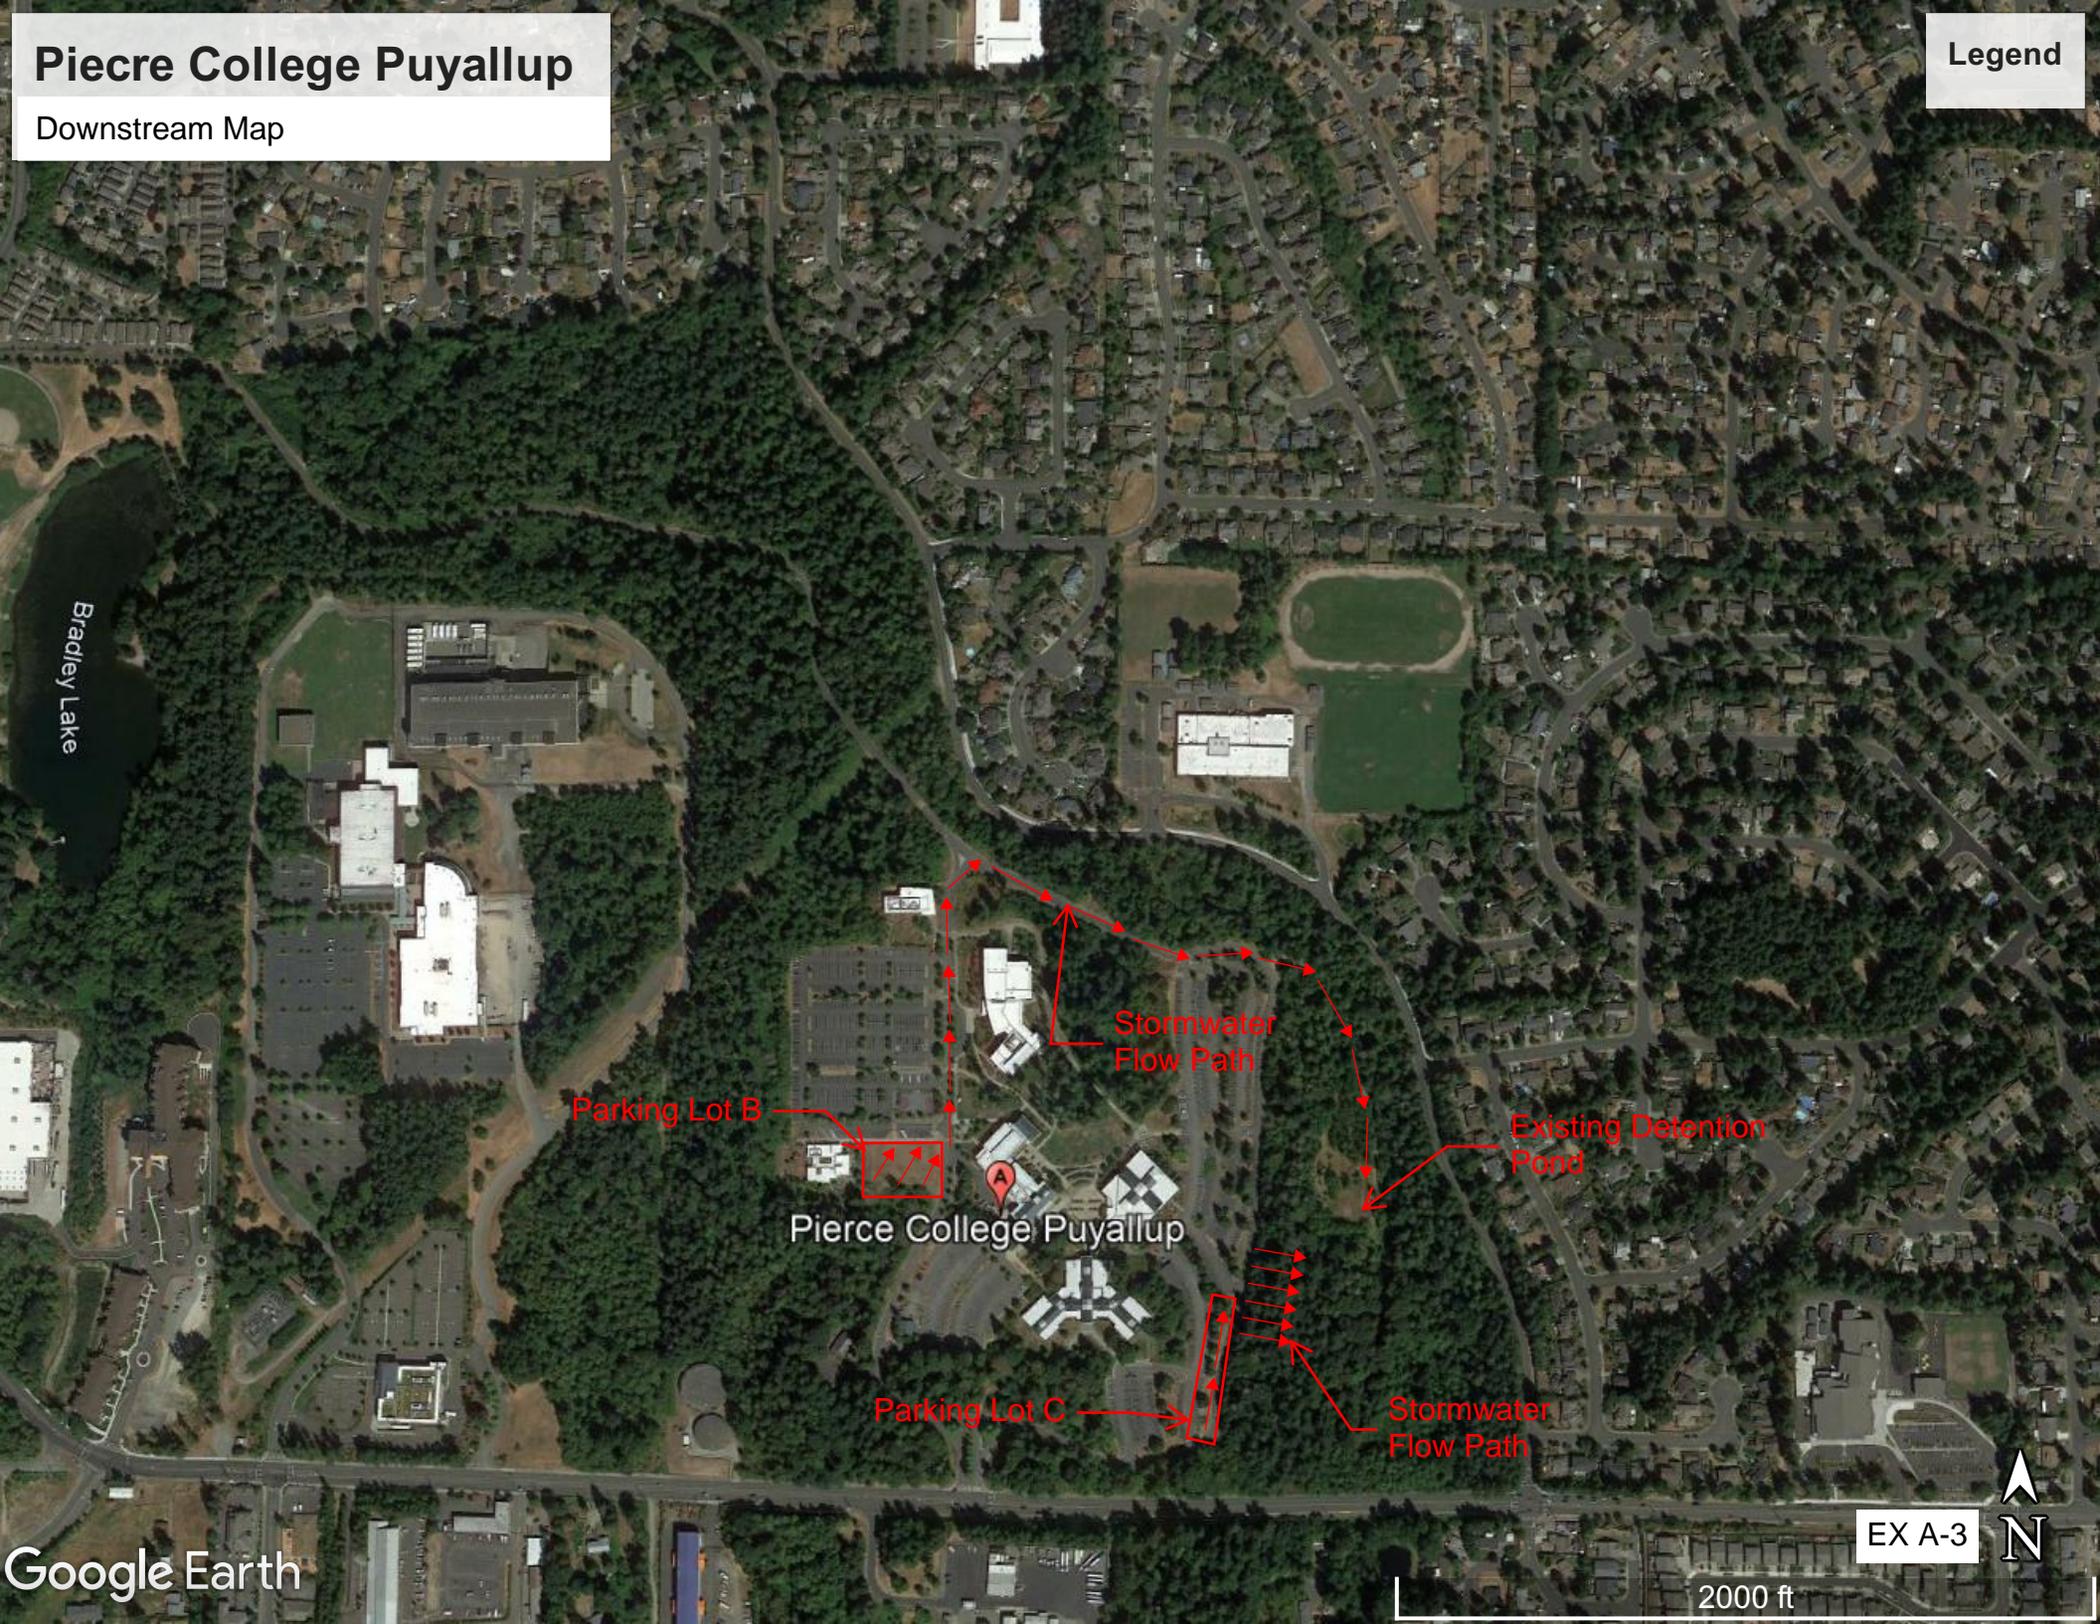
Downstream Map

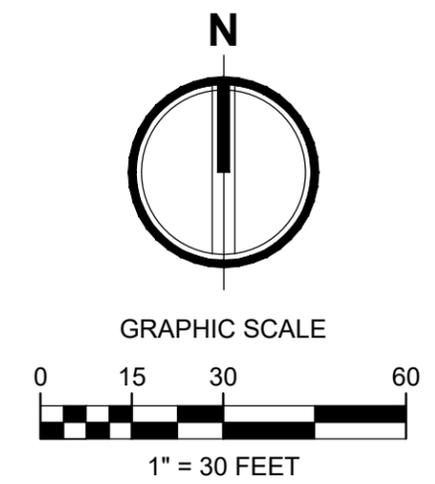
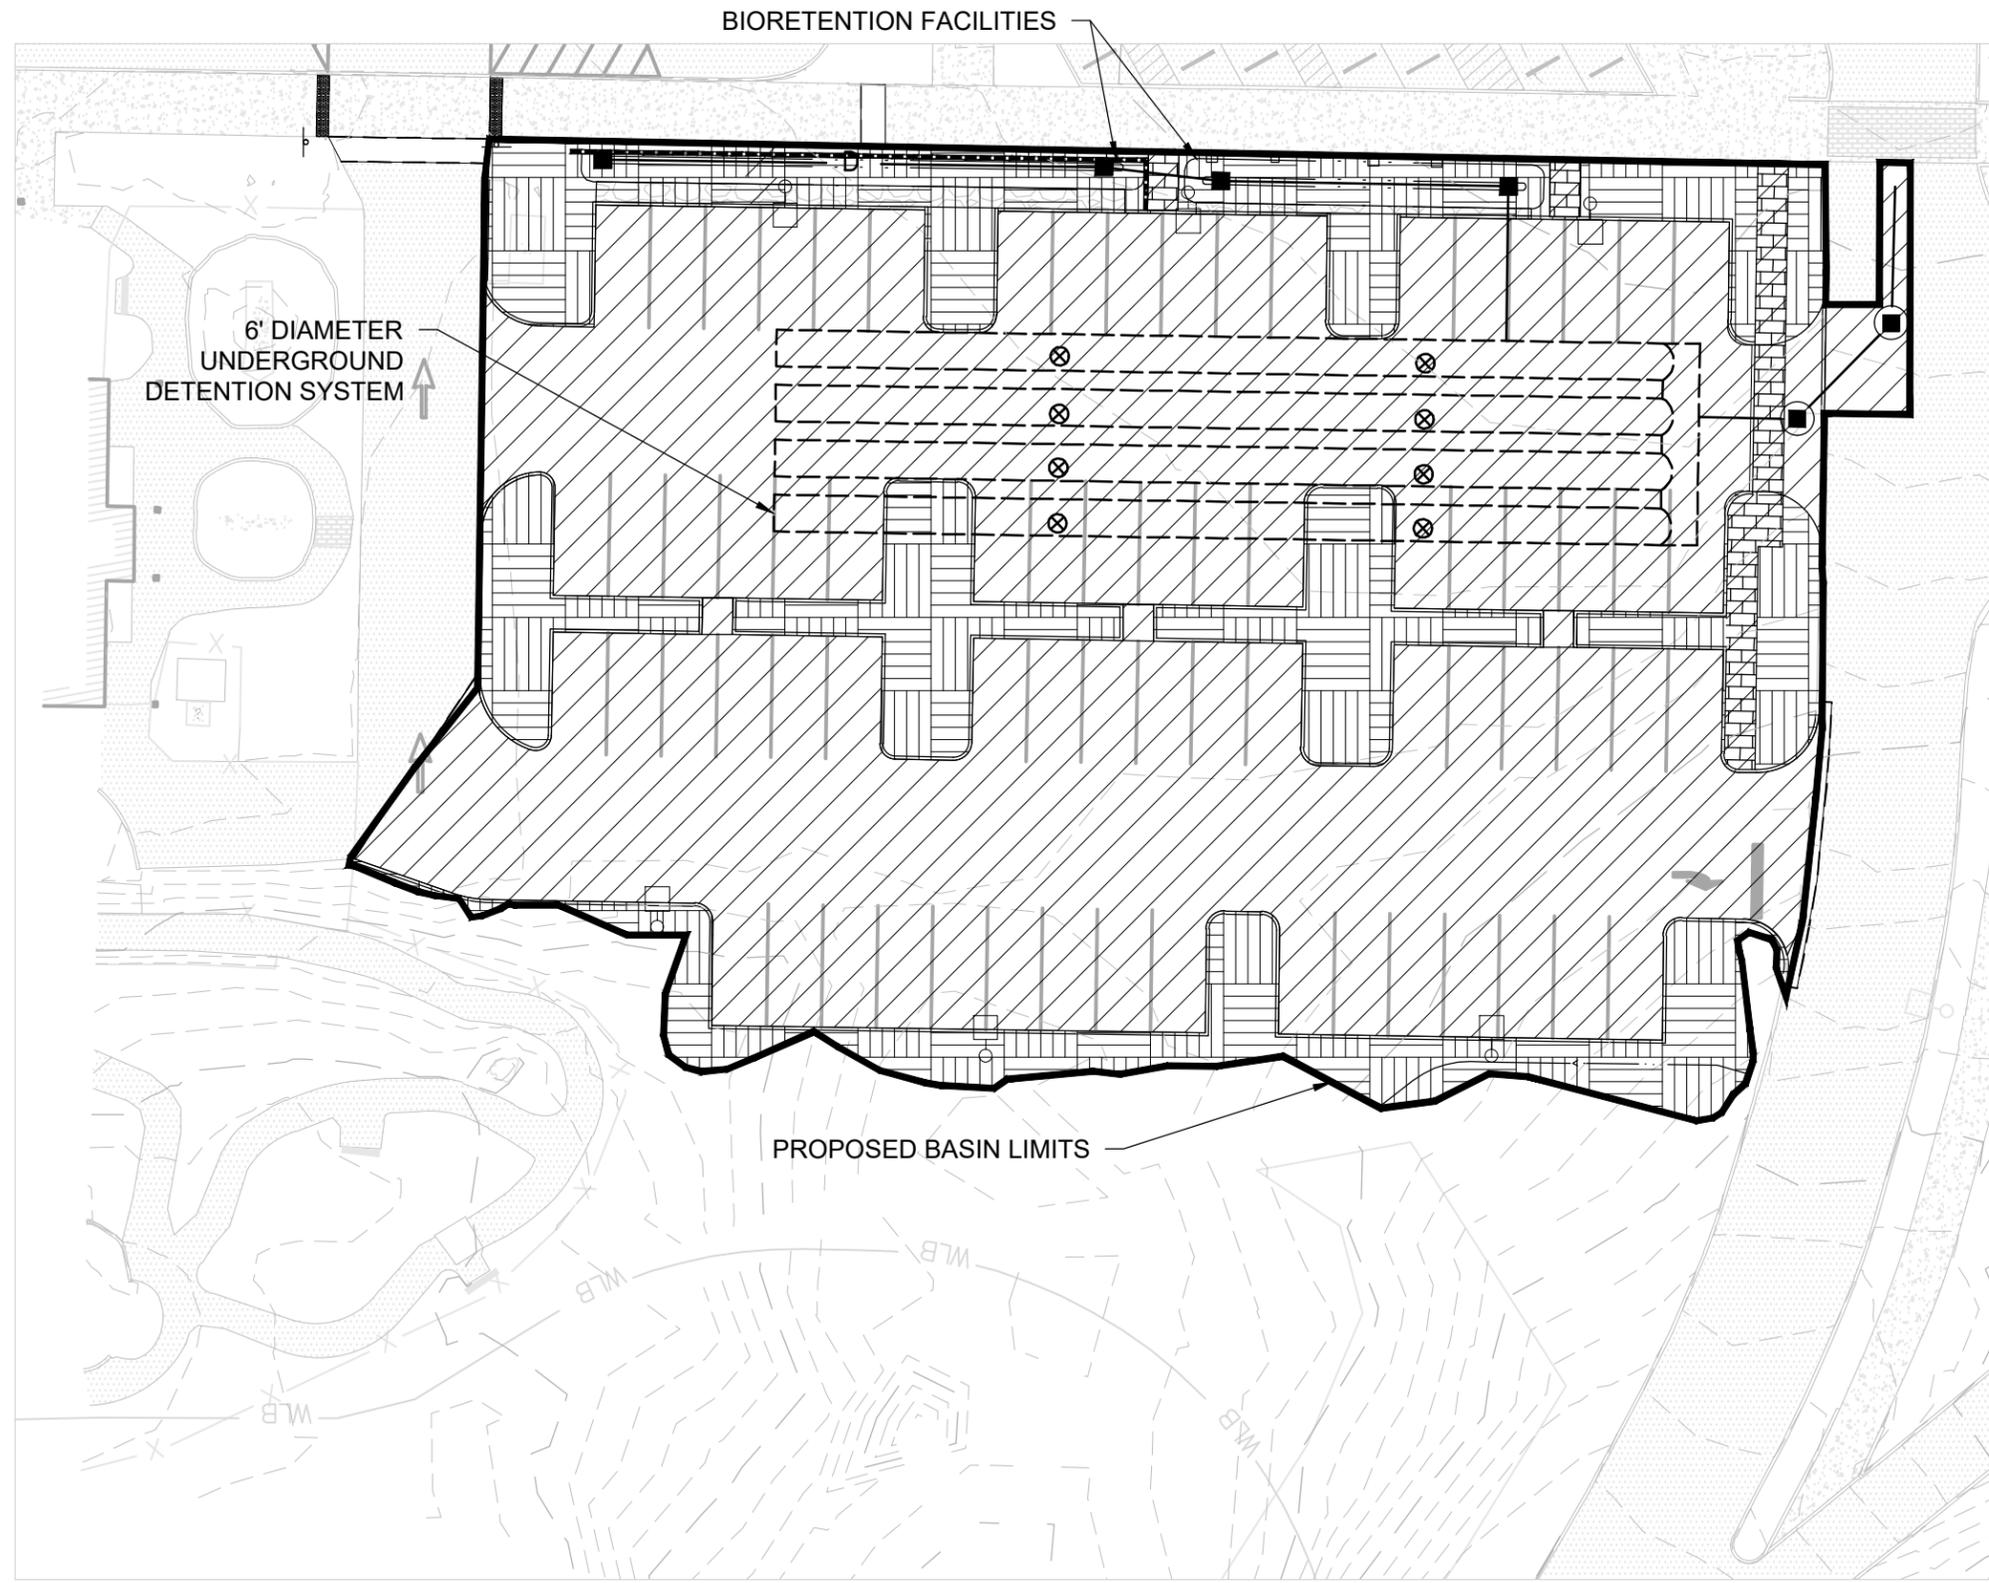
EX-A4.1

LANDSCAPE	IMPERVIOUS	TOTAL
0.20 AC	0.55 AC	0.75 AC

PIERCE COLLEGE PUYALLUP
 CAMPUS PARKING EXPANSION
**DEVELOPED BASIN MAP
 PARKING LOT B**

The project proposes two separate parking lots: Parking Lot B and Parking Lot C. Improvements include asphalt paving, concrete paving, and stormwater management. Refer to Appendices A-4.1 and A-4.2 for Developed Conditions Maps for more information. Underground detention pipes are proposed for stormwater flow control for proposed impervious surfaces. Bioretention facilities will be used upstream of the proposed flow control facilities for stormwater quality treatment for pollution generating impervious surfaces (PGIS).

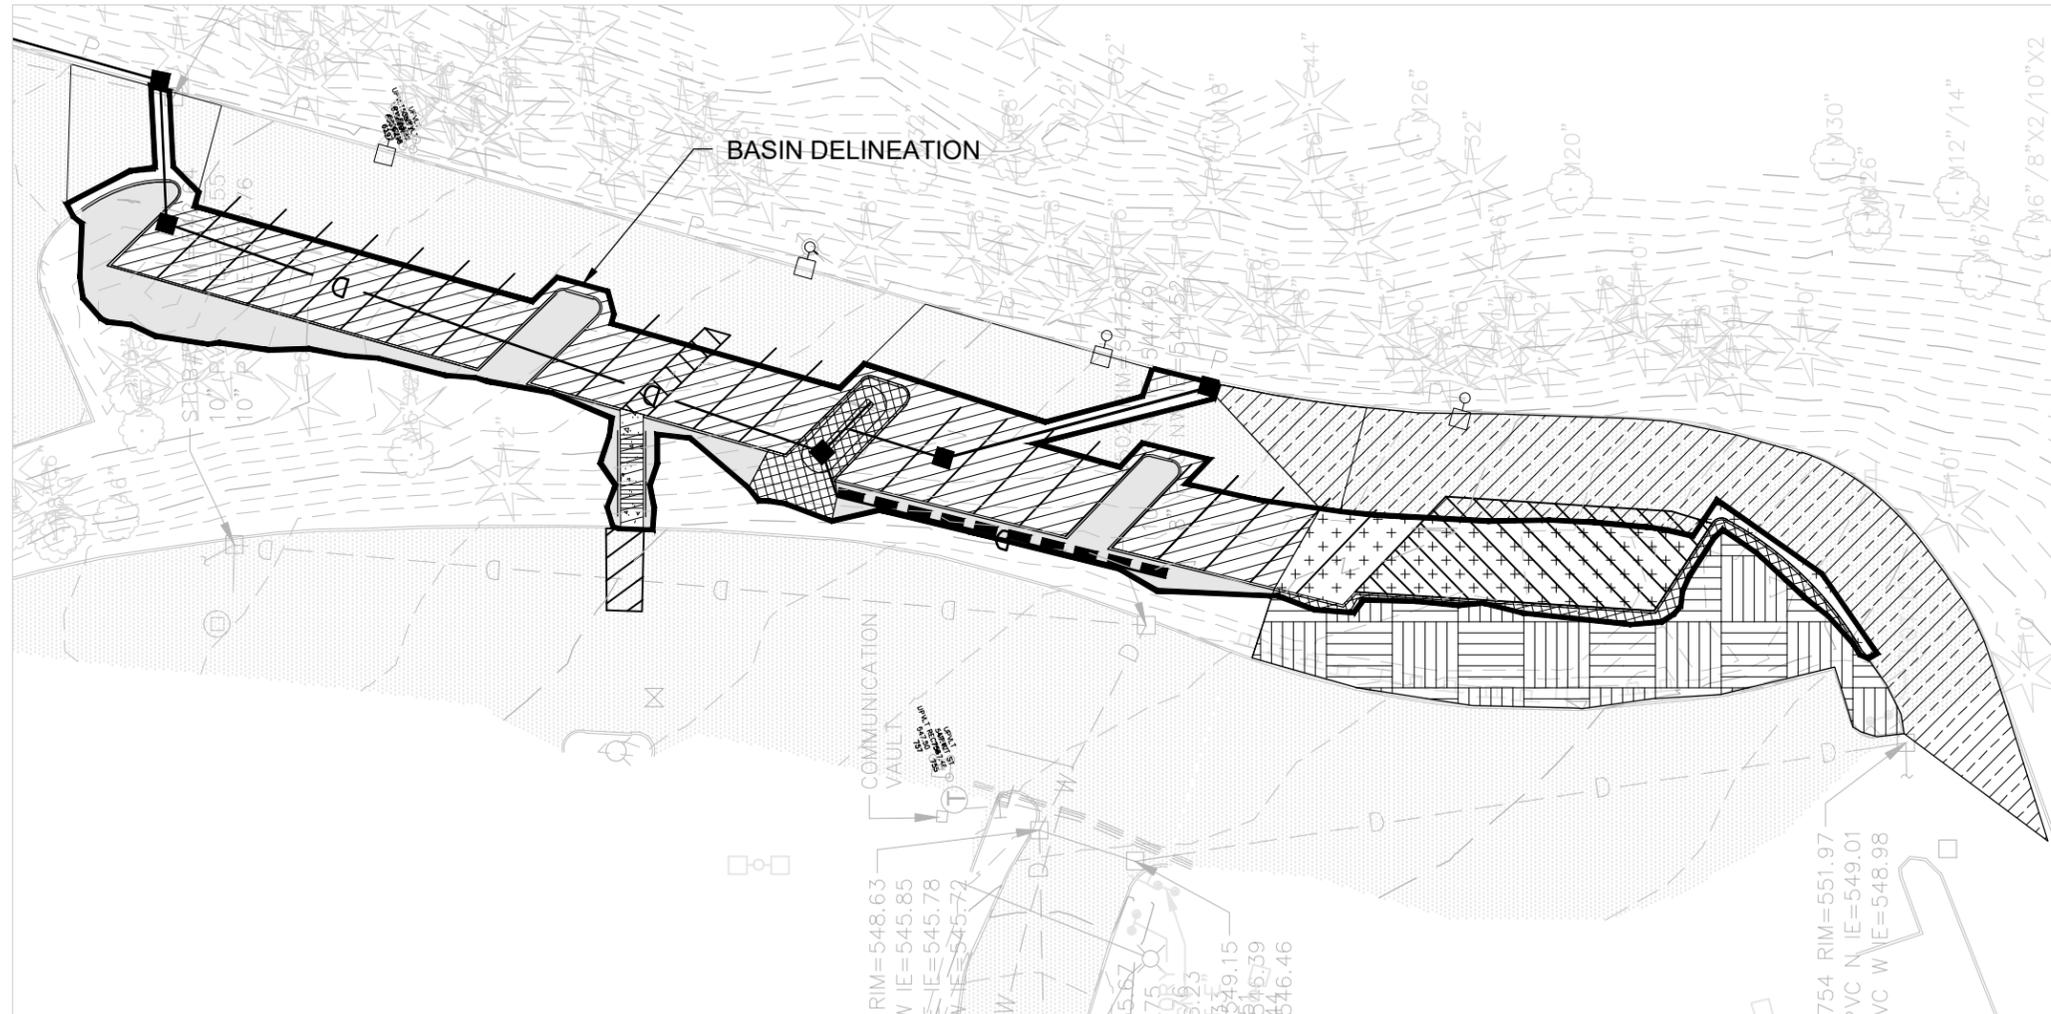
EX-A5

PIERCE COLLEGE PUYALLUP
 CAMPUS PARKING EXPANSION
**BASIN EXCHANGE MAP
 PARKING LOT C**

Due to the topography, not all of the new and replaced PGIS in Parking Lot C can be directed to the bioretention facility; therefore, a treatment trade is proposed. Stormwater will be collected from non-target PGIS that are outside of the project limits in exchange for target PGIS within the project limits that cannot be collected due to topography. Refer to Appendix A-5 for an exhibit outlining the treatment trade.

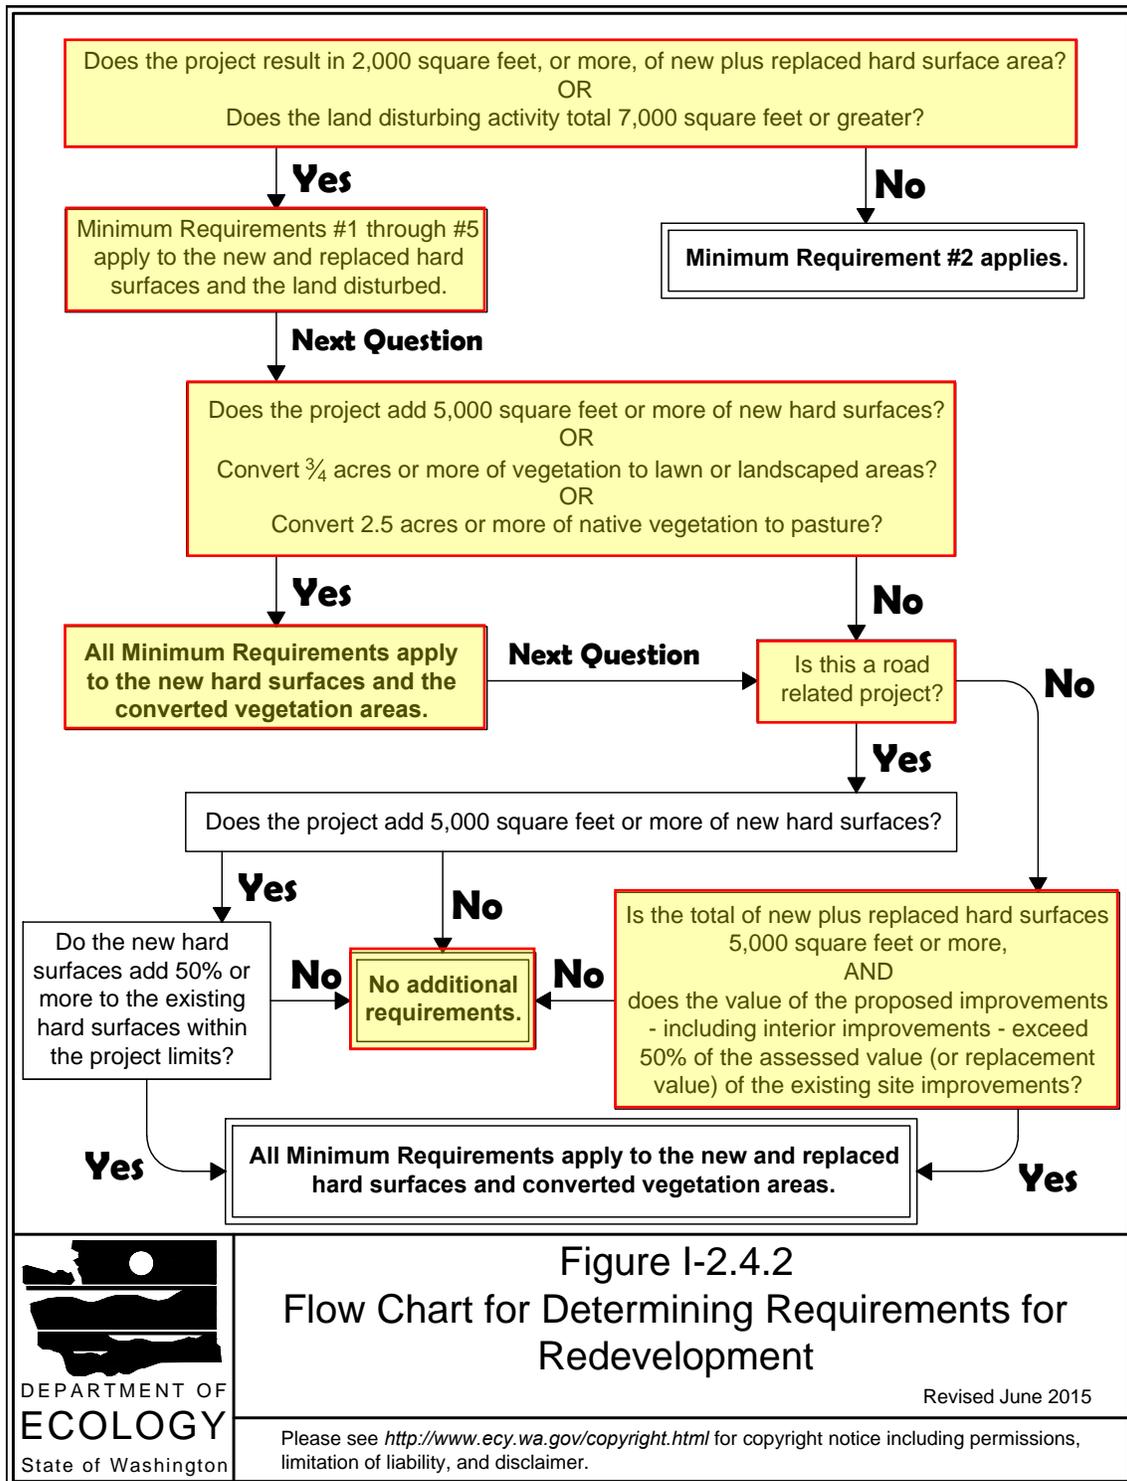
Figure I-2.4.2 Flow Chart for Determining Requirements for Redevelopment

As outlined in *SWMMWW* Figure I-2.4.2, the project results in over 5,000 square feet of new plus replaced hard surfaces. Therefore, the project is subject to MRs 1 through 9 and List 2, as outlined in *SWMMWW* Section I-3.4.5.

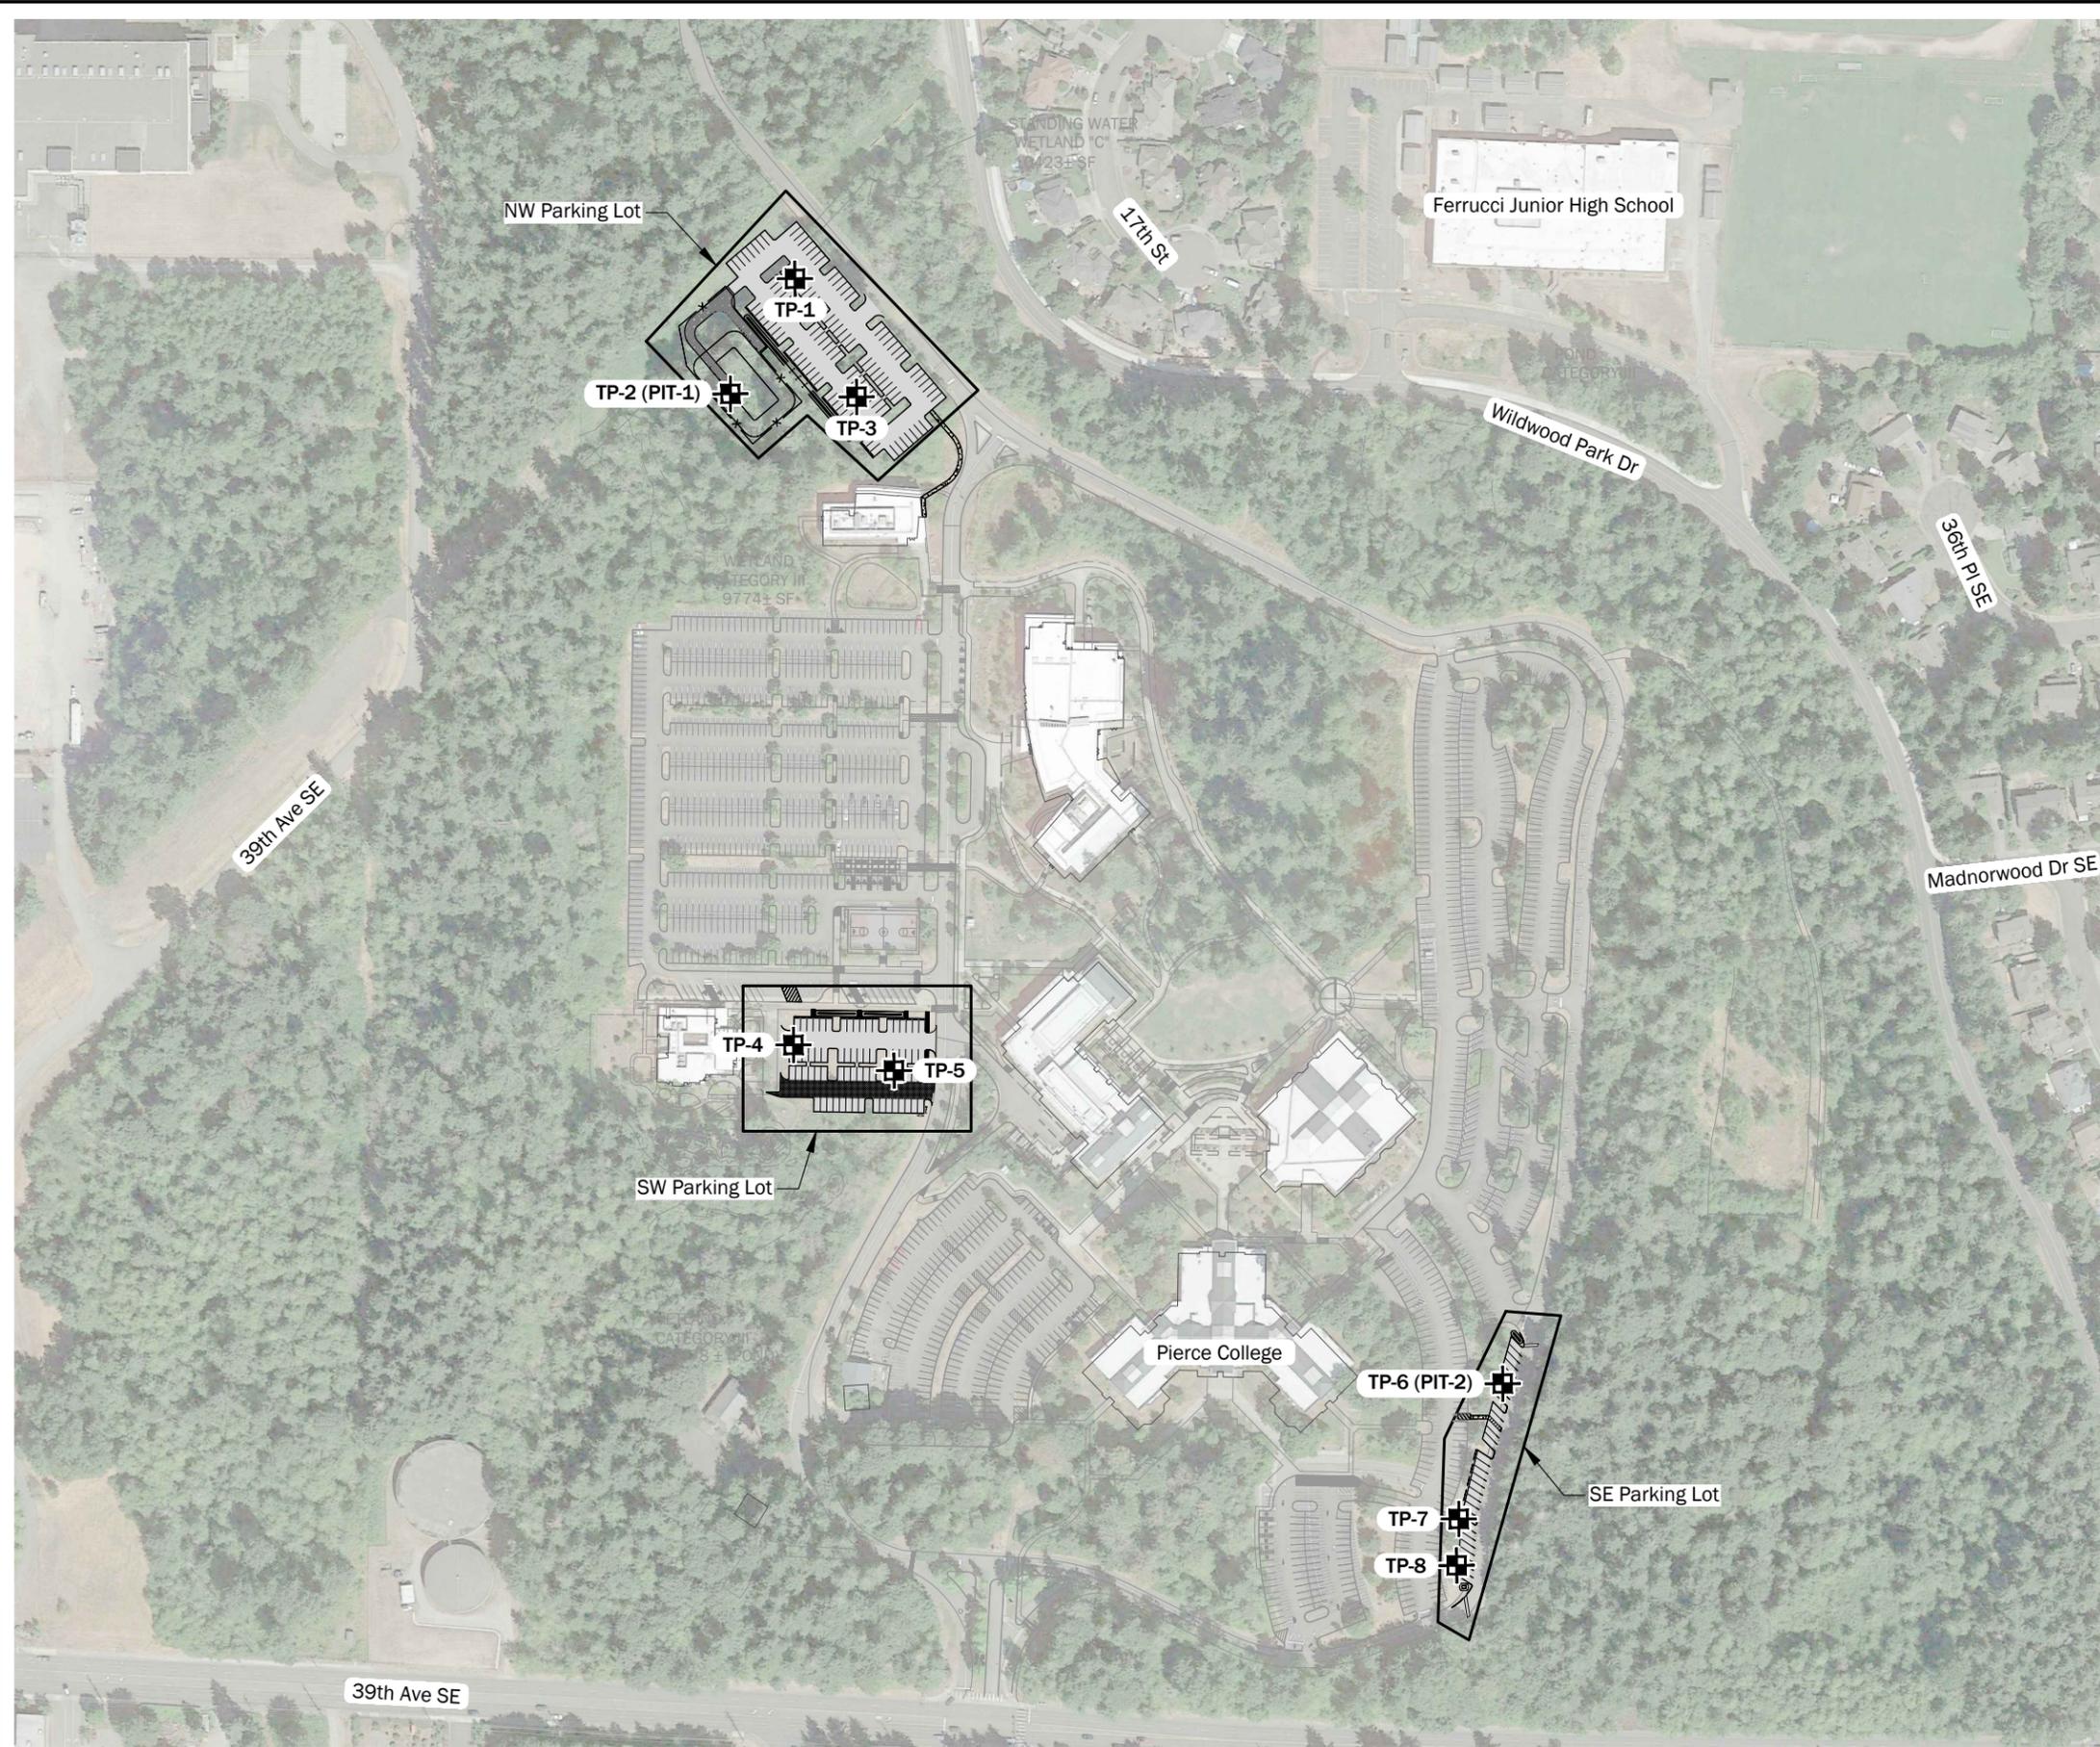
Vicinity Map	
Pierce College Puyallup - Parking Lot Additions Puyallup, Washington	
	Figure 1

This report presents the results of our geotechnical engineering services for the Pierce College Puyallup – Parking Lot Additions project. The project site is located at 1601 39th Avenue SE in Puyallup, Washington, as shown on the Vicinity Map, Figure 1. This report is preceded by a draft report dated August 16, 2021.

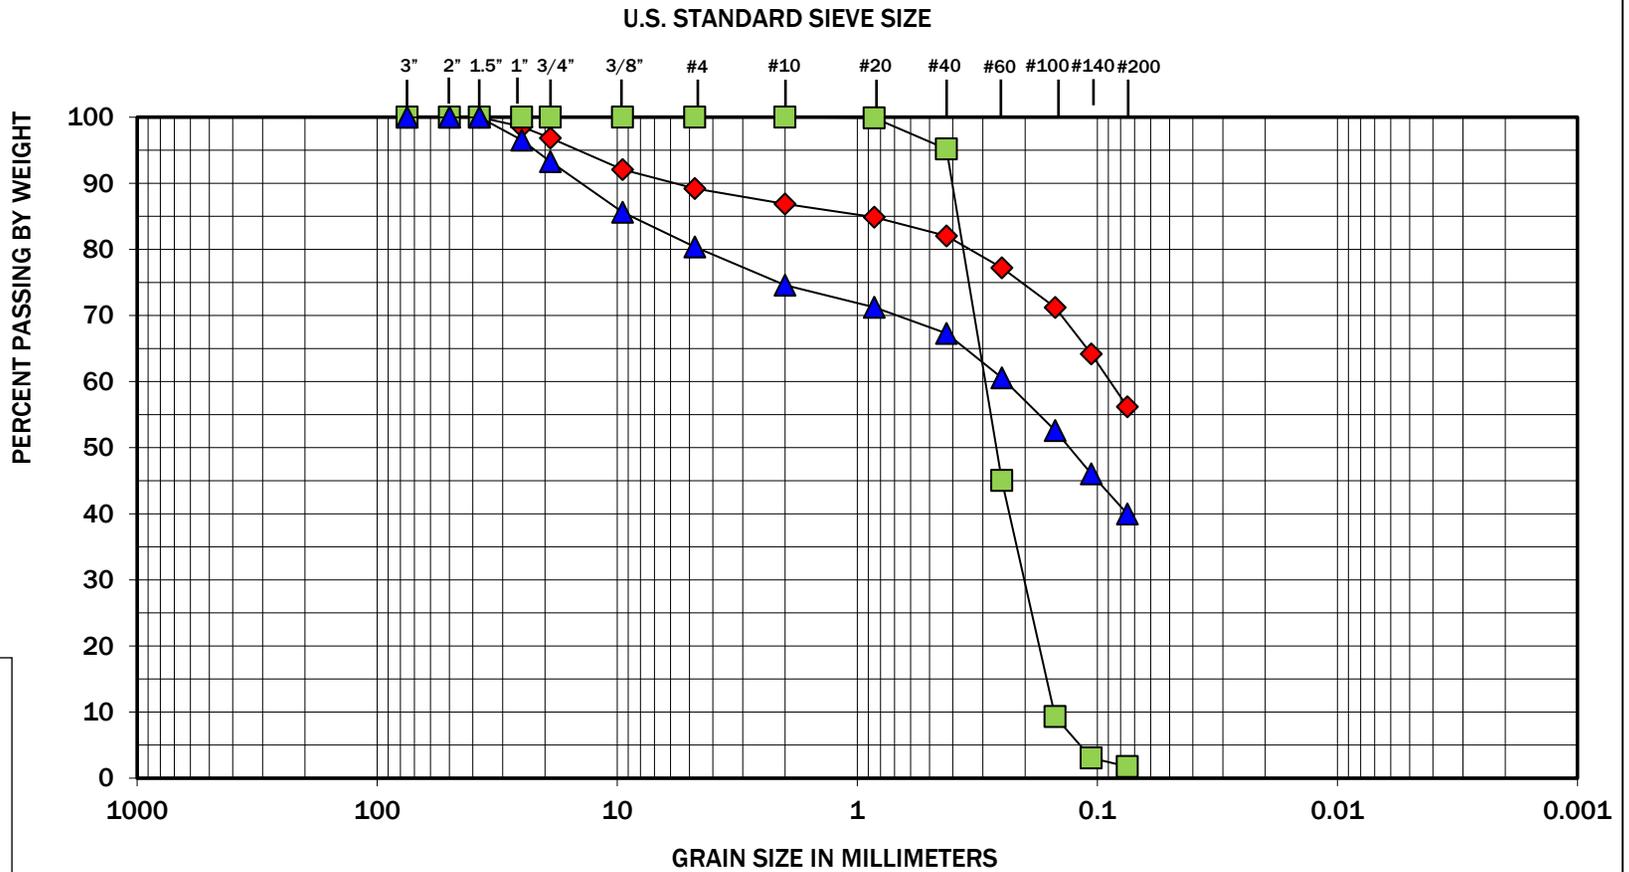
Figure A-9
Sheet 1 of 1

Symbol	Test Pit Number	Depth (feet)	Moisture (%)	Soil Description
◆	TP-2	11	18	Sandy silt (ML)
■	TP-5	9	22	Poorly graded sand (SP)
▲	TP-6	4	19	Silty sand with gravel (SM)
