Stormwater Site Plan

Pierce College Puyallup
Campus Parking Expansion
Puyallup, WA
2200718.12

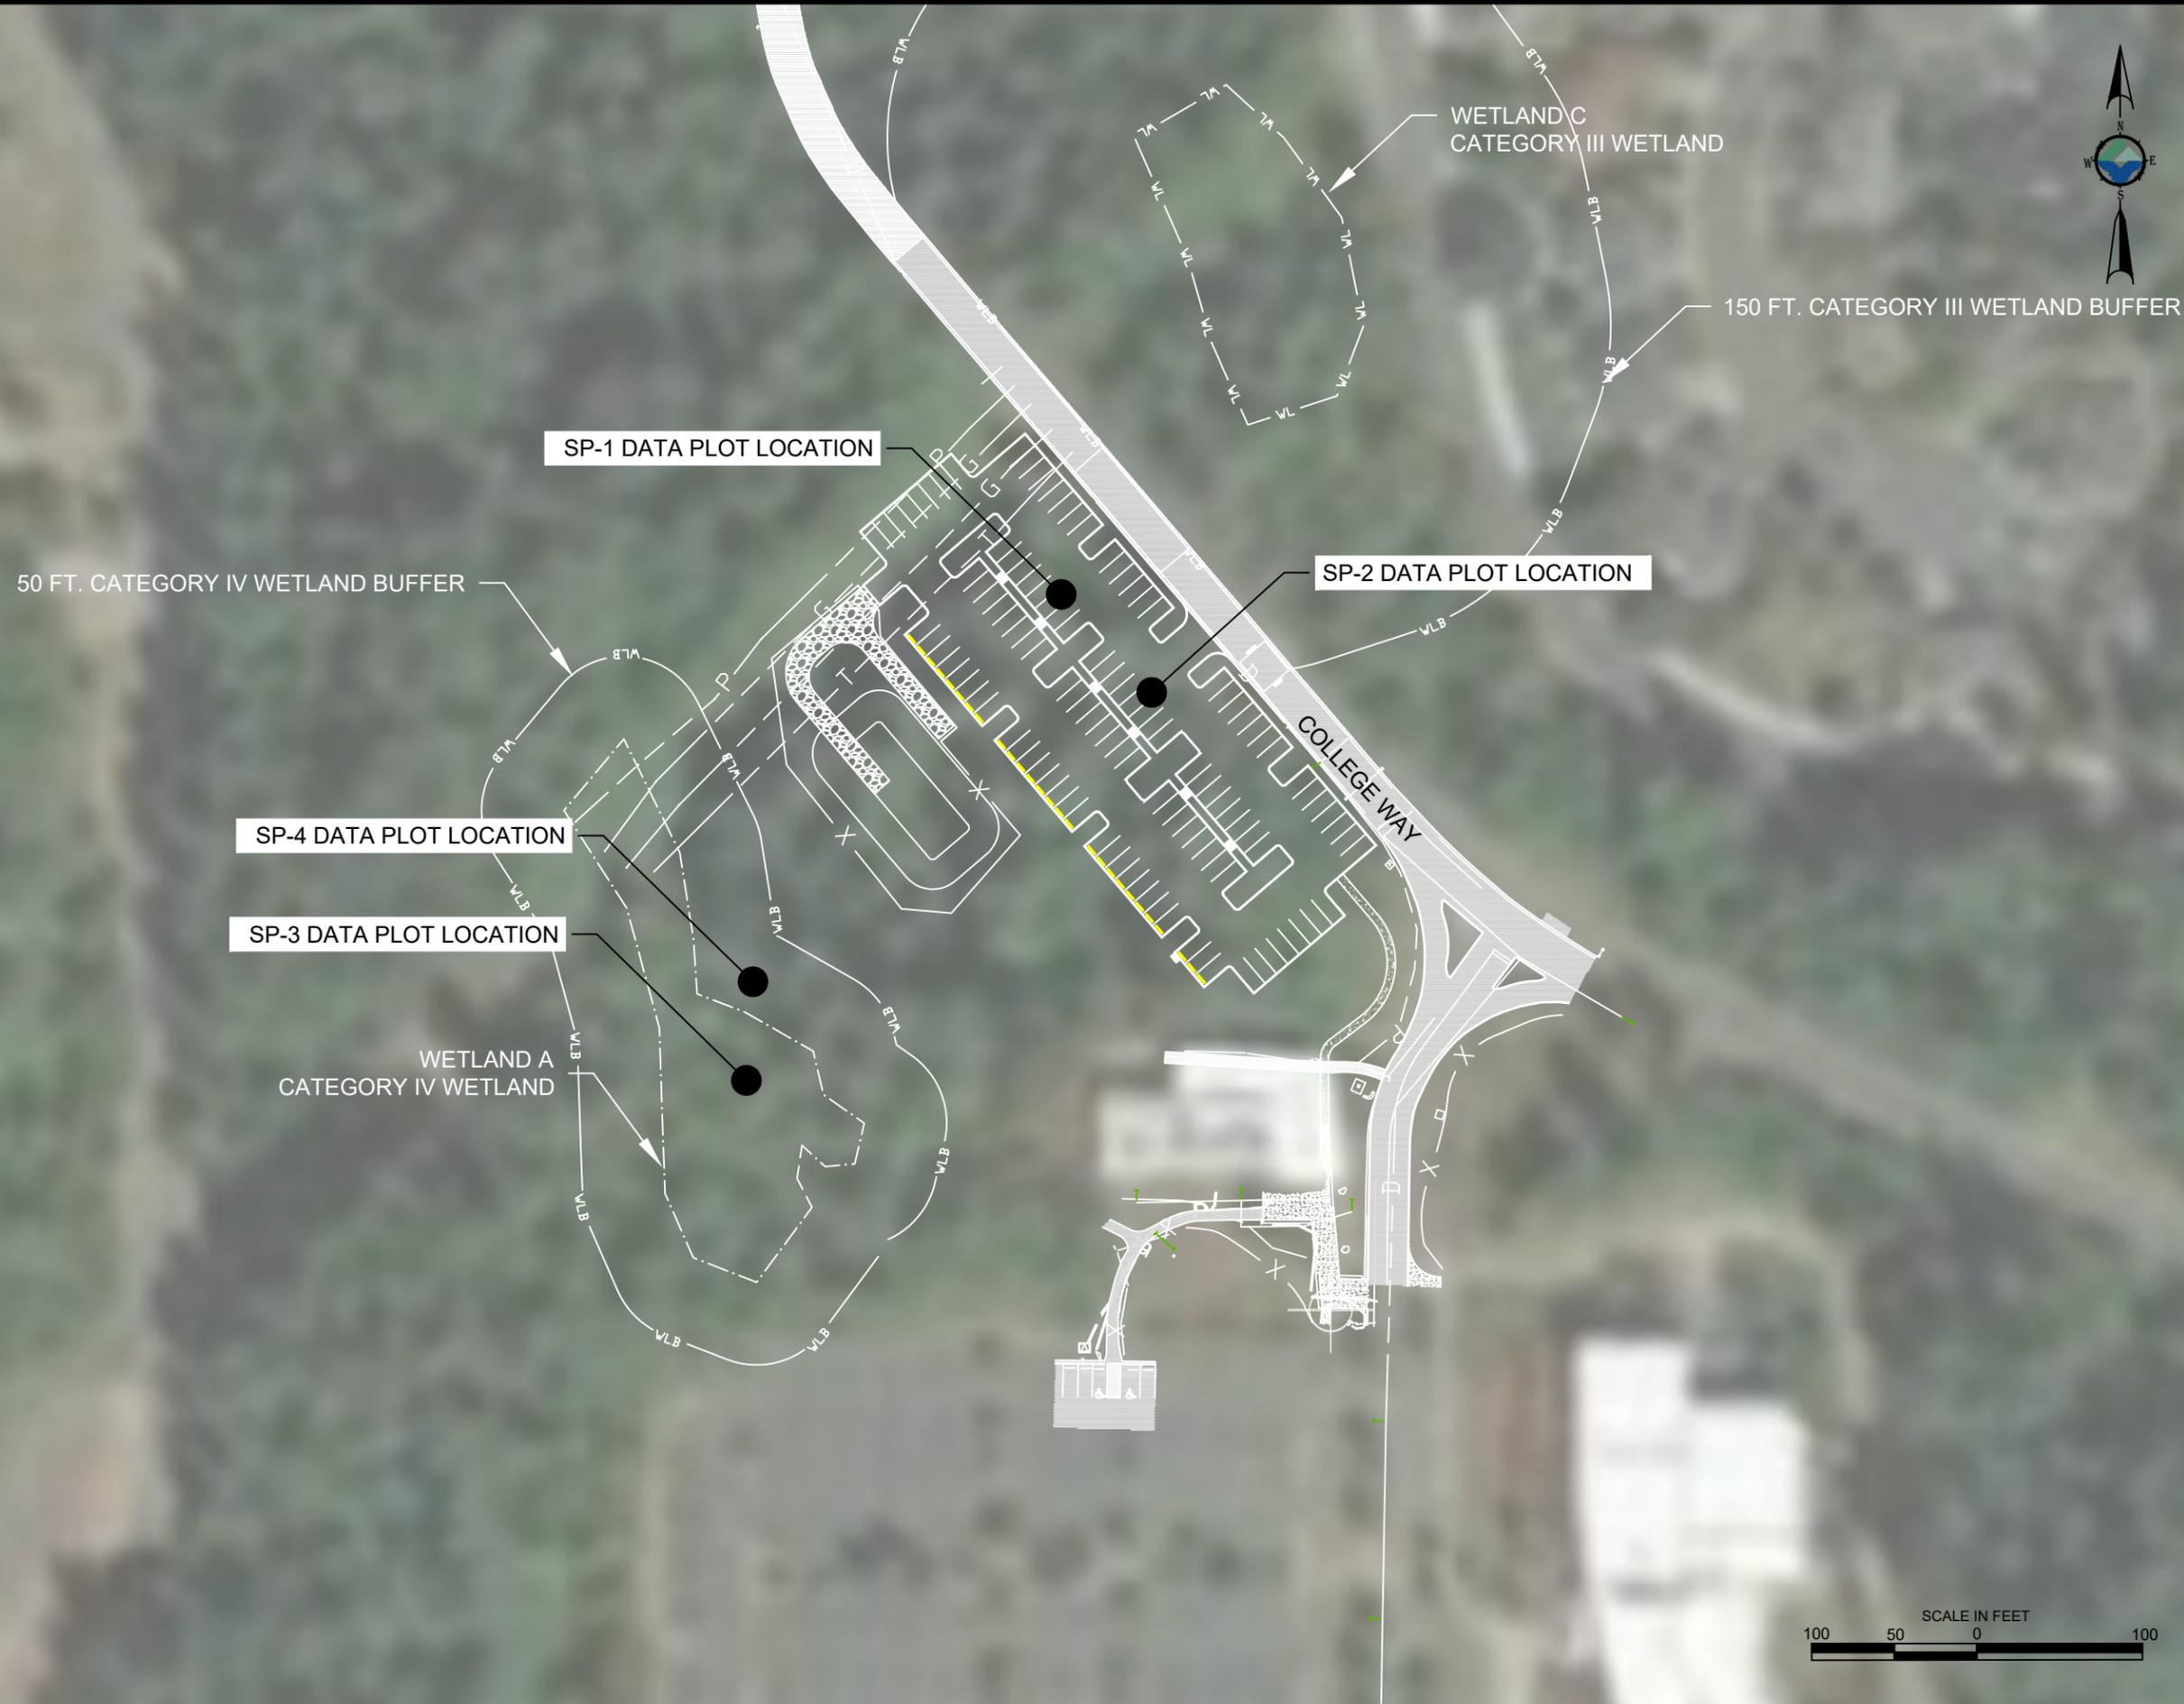
SHEET 1
 OF 3

APPENDIX A: WETLAND DELINEATION MAP

Parking Lot B improvements are adjacent to Wetland B which is sperate from the wetland the project outfalls to. Wetland B is considered a Category III wetland with a habitat score of 5 points and an 80-foot buffer. It is located approximately 110 feet from improvements at Parking Lot B. A small portion of the existing basin does drain to the adjacent wetland in the existing condition. A portion of the area tributary to the wetland will drain to the wetland in the proposed condition. However, a basin exchange is proposed to maintain the area tributary to the existing wetland. Therefore, Wetland B will not be impacted by the proposed work. Refer to Appendix A-2.1, Existing Conditions Map for more information on the Parking Lot B existing basin. Refer to Appendix A-7, Parking Lot B Wetland Basin Exchange Map for more information on the portion of the basin tributary to the wetland.

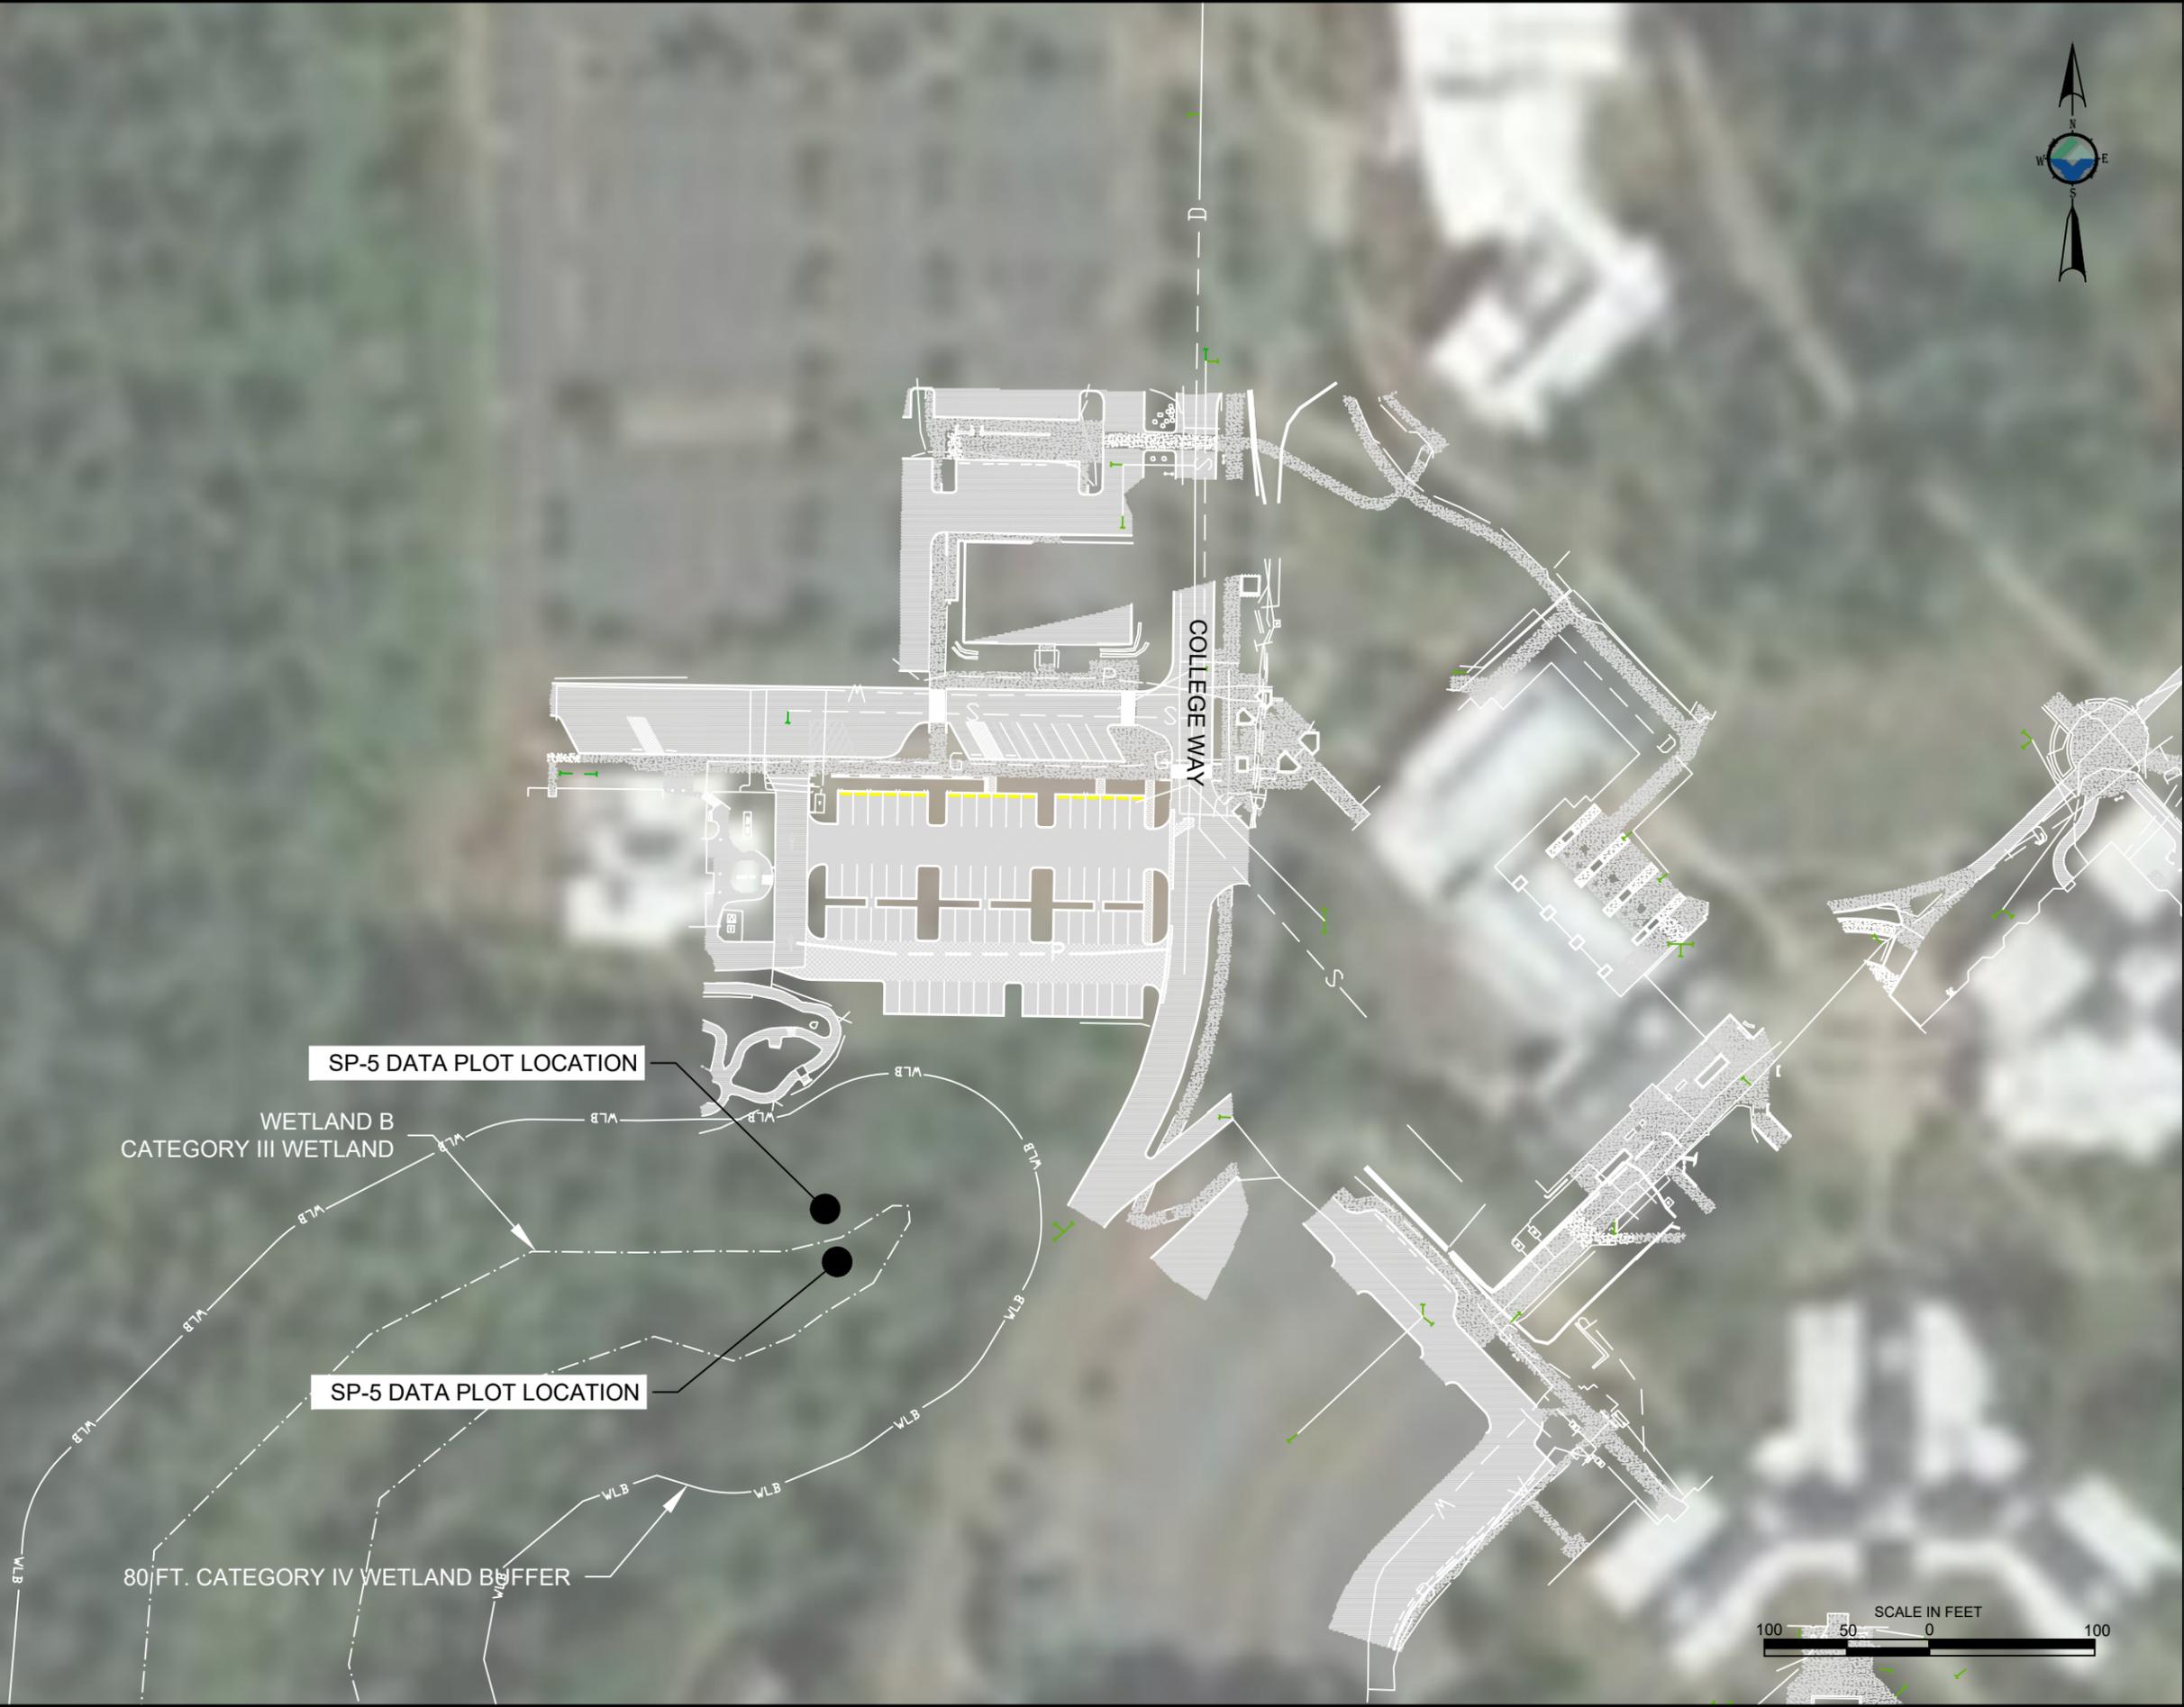
WETLAND DELINEATION MAP

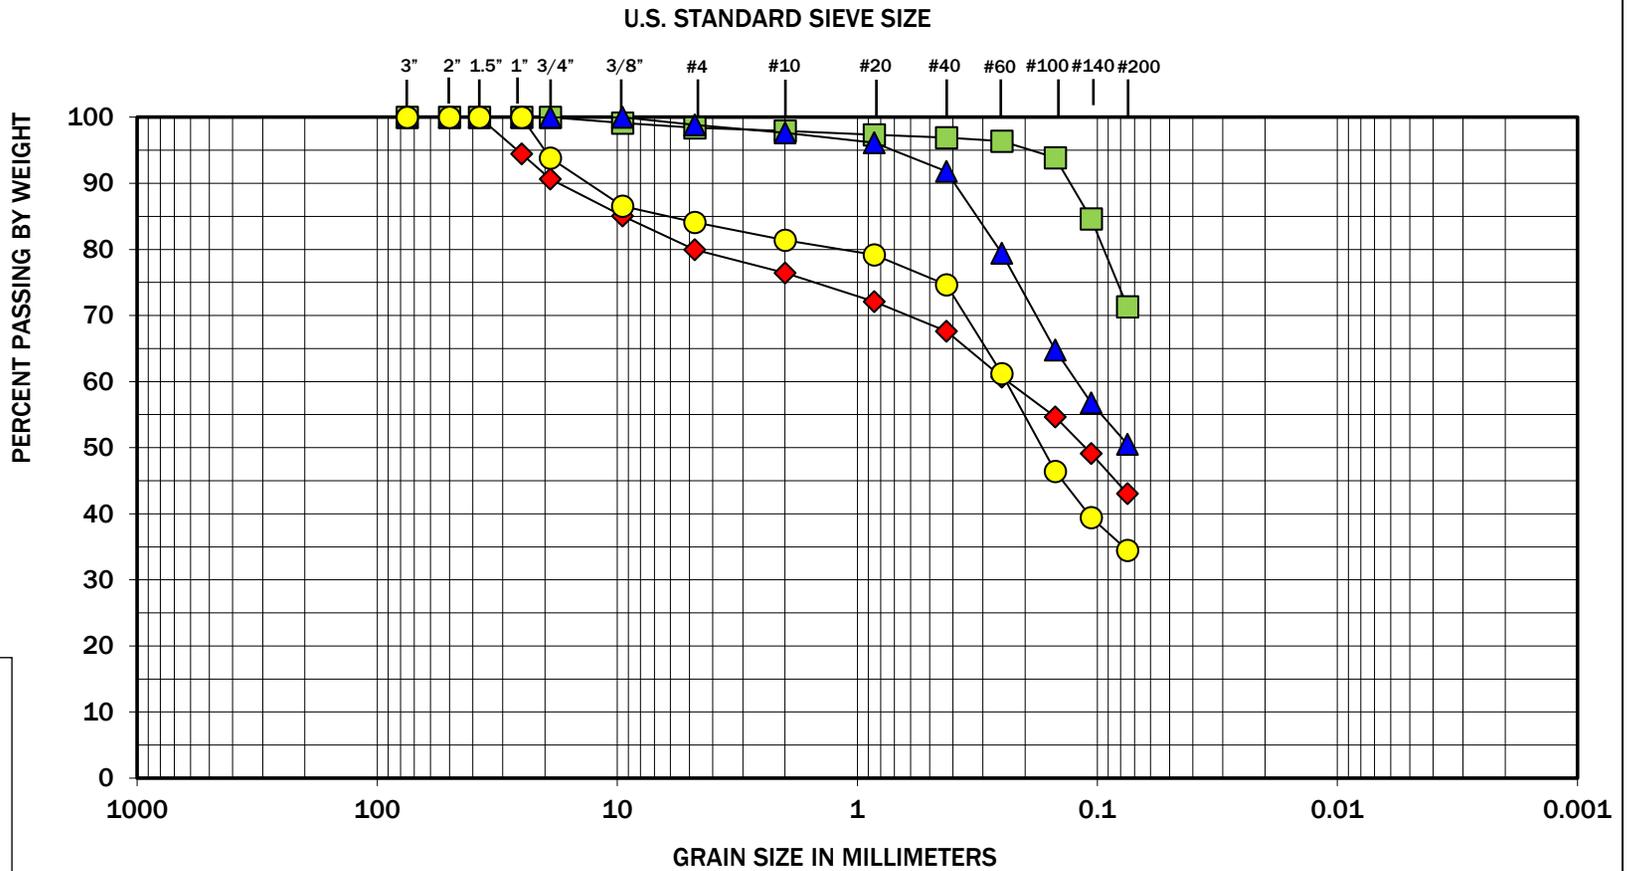
Key to Exploration Logs

Symbol	Boring Number	Depth (feet)	Moisture (%)	Soil Description
Red Diamond	MW-1	7.5	12	Silty sand with gravel (SM)
Green Square	MW-1	10	17	Silt with sand (ML)
Blue Triangle	MW-1	15	19	Sandy silt (ML)
Yellow Circle	MW-1	20	15	Silty sand with gravel (SM)

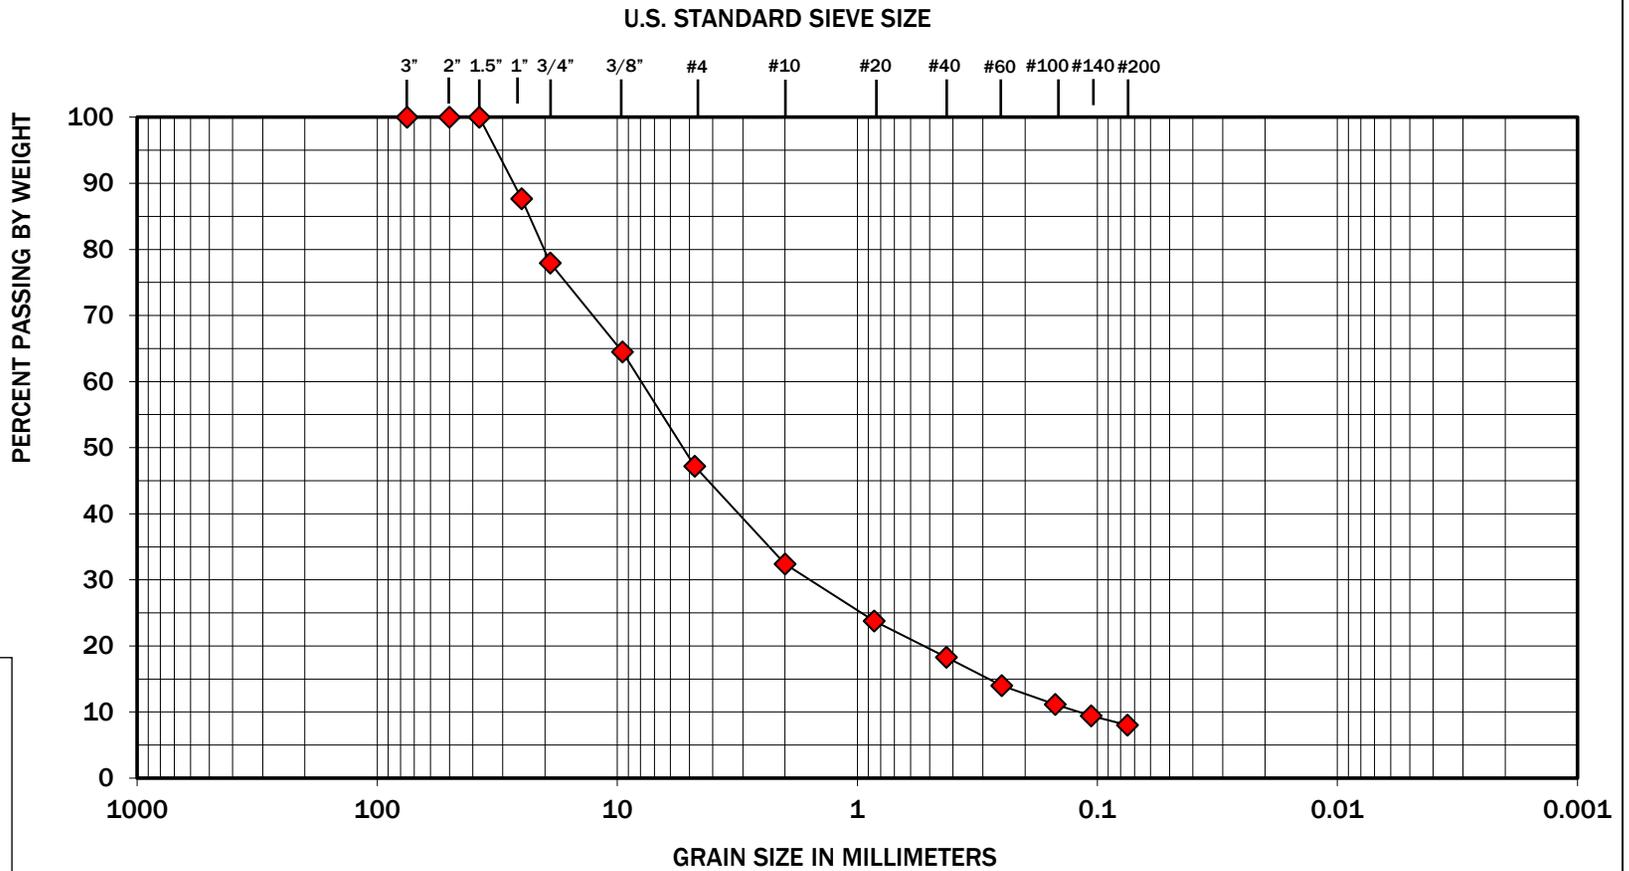
Sieve Analysis Results

Symbol	Boring Number	Depth (feet)	Moisture (%)	Soil Description
◆	MW-1	25	8	Well-graded gravel with silt and sand (GW-GM)

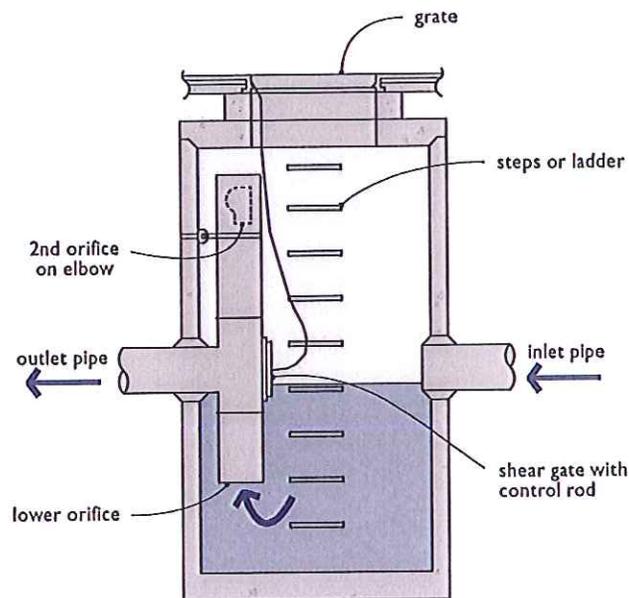
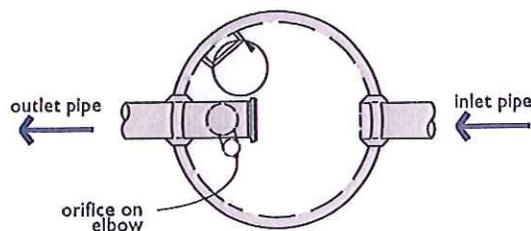
Control structures/flow restrictors are located on the outlet pipe of a detention system. The control structure is typically a Type 2 concrete catch basin (see Section 3.5 for catch basin description) with a riser (vertical pipe). The control structure reduces the discharge rate of stormwater from a detention facility. The flow is regulated by a combination of orifices (holes with specifically sized diameters) and weirs (plates with rectangular or vee shaped notch). Lack of maintenance of the control structure can result in the plugging of an orifice. This can result in flooding of the stormwater system and/or an increase in the rate of discharge from the site potentially damaging downstream property.

BIRD'S-EYE VIEW

SECTION PROFILE

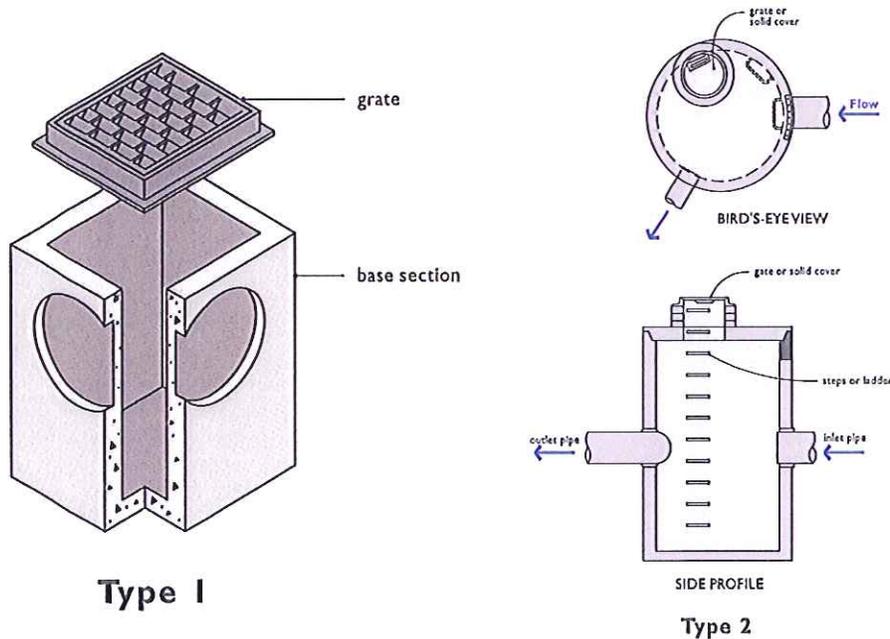
The most common cleaning method for catch basins is to utilize a truck with a tank and vacuum hose (vactor truck) to remove sediment and debris from the sump. Catch basins may be an enclosed space where harmful chemicals and vapors can accumulate. Therefore, if the inspection and maintenance requires entering a catch basin, it should be conducted by an individual with training and certification in working in hazardous confined spaces.

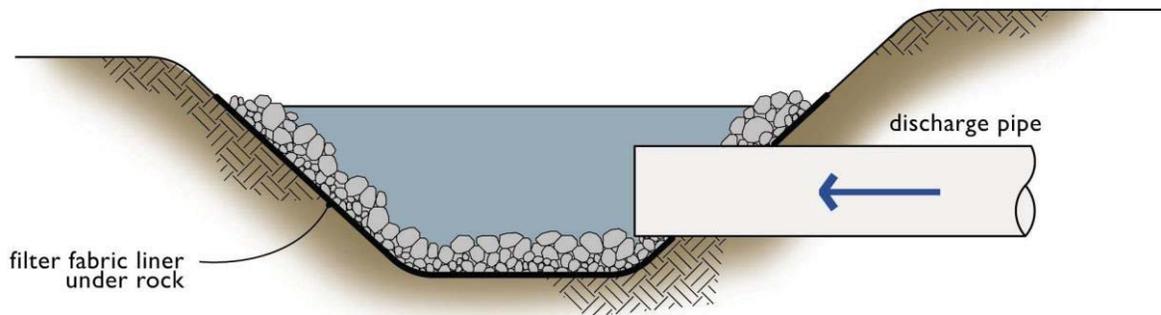
Energy dissipaters are provided on the inlet and outlet to a closed pipe system to prevent erosion at these locations. Design of an energy dissipater can vary significantly from highly engineered systems (concrete or rock gabion structures) to the more commonly used rock pad. The rock pad is typically constructed of 4- to 12-inch diameter rocks a minimum of 12 inches thick and is often lined with filter fabric. The rock pad should extend above the top of the pipe a minimum of 1 foot.

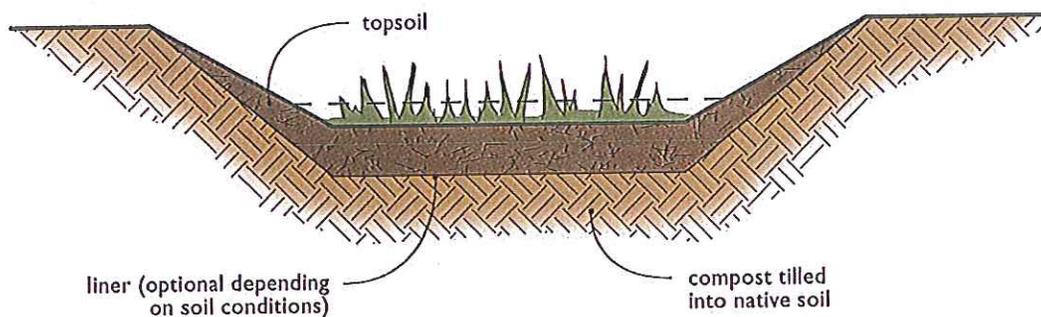
Biofiltration swales provide stormwater quality control (treatment), but do not provide stormwater quantity control (detention/retention).
