March 30, 2023  
ES-8303

## Earth Solutions NW LLC

**Subject: Infiltration Evaluation and Seasonal Groundwater Monitoring  
Proposed Duplexes  
433 and 409 – 43<sup>rd</sup> Avenue Southwest  
Puyallup, Washington**

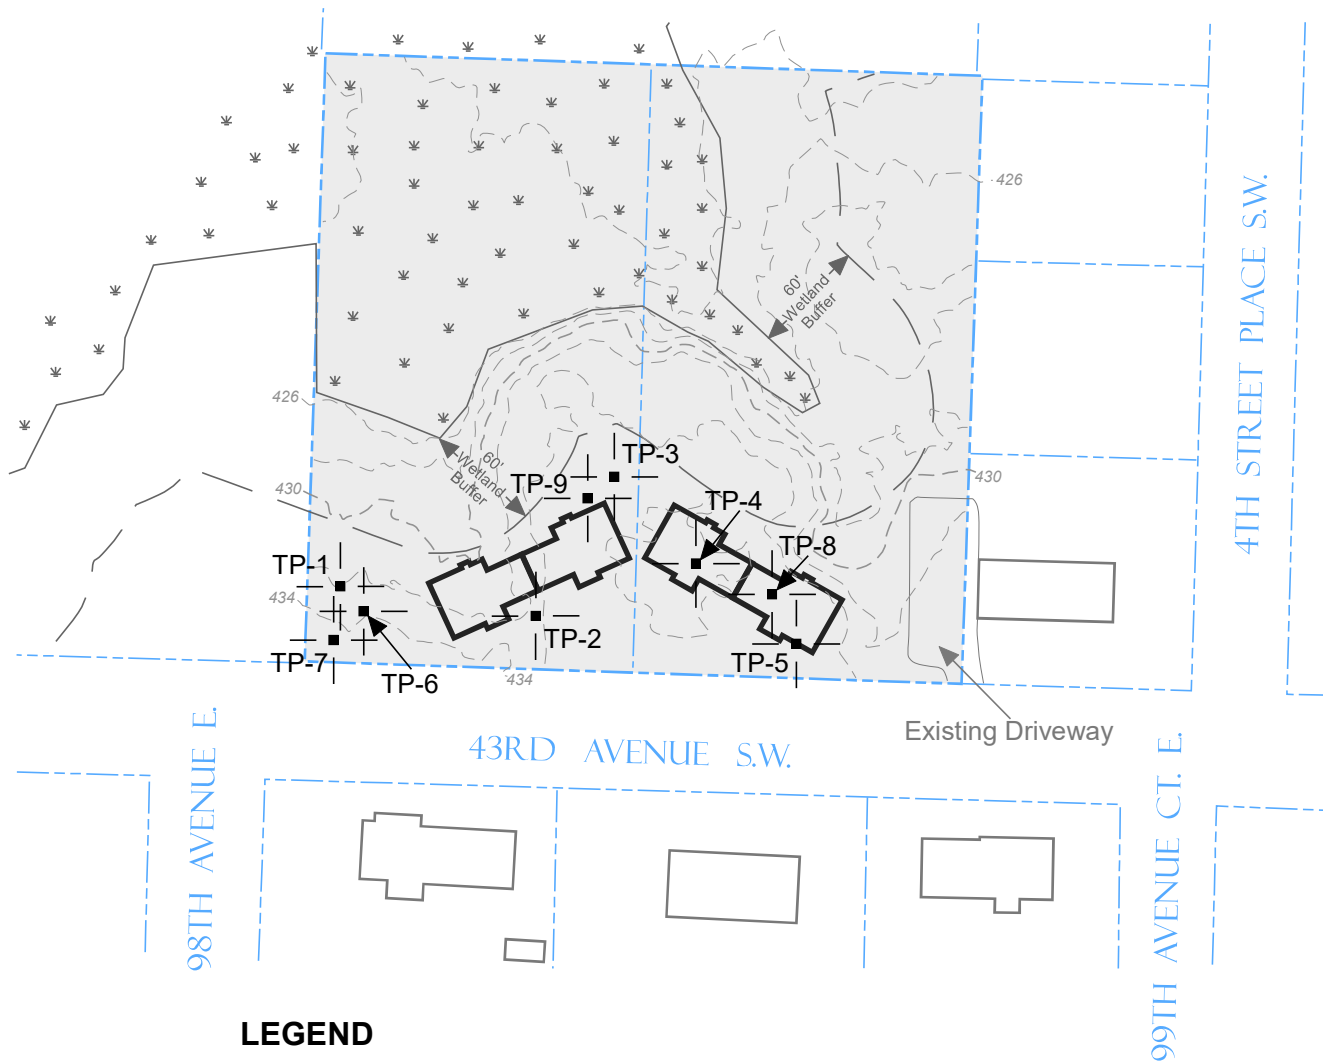
<b>Earth Solutions NW<sub>LLC</sub></b> Geotechnical Engineering, Construction Observation/Testing and Environmental Services		
<b>Test Pit Location Plan</b> <b>Puyallup Duplex</b> <b>Puyallup, Washington</b>		
Drwn. CAM	Date 03/27/2023	Proj. No. 8303
Checked SKH	Date Mar. 2023	Plate 2

- TP-1 | — ■ — | Approximate Location of ESNW Test Pit, Proj. No. ES-8303, Dec. 2021 & Jan. 2022
- Subject Site
- Proposed Building
- Existing Building
- Wetland (Delineated by Others)

The approximate locations of the test pits are depicted on Plate 2 (Test Pit Location Plan). Please refer to the attached test pit logs for a more detailed description of subsurface conditions. Representative soil samples collected at the test pit locations were analyzed in general accordance with both Unified Soil Classification System (USCS) and USDA methods and procedures.
