**Drainage Report and Stormwater
Pollution Prevention Plan**

East Town Crossing

City of Puyallup, Washington

6/29/2023

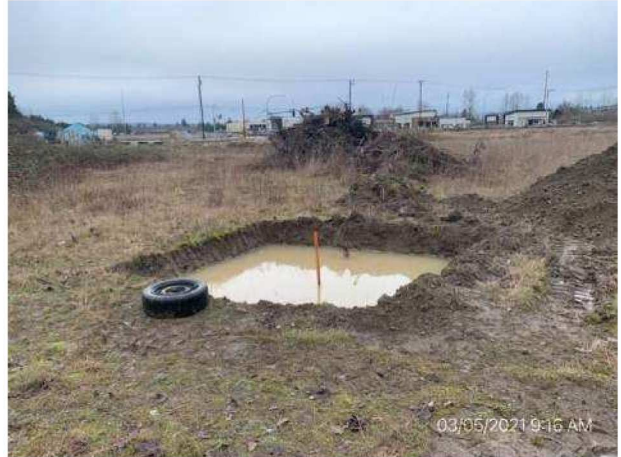
Water in Pit P-2 on March 5, 2021.

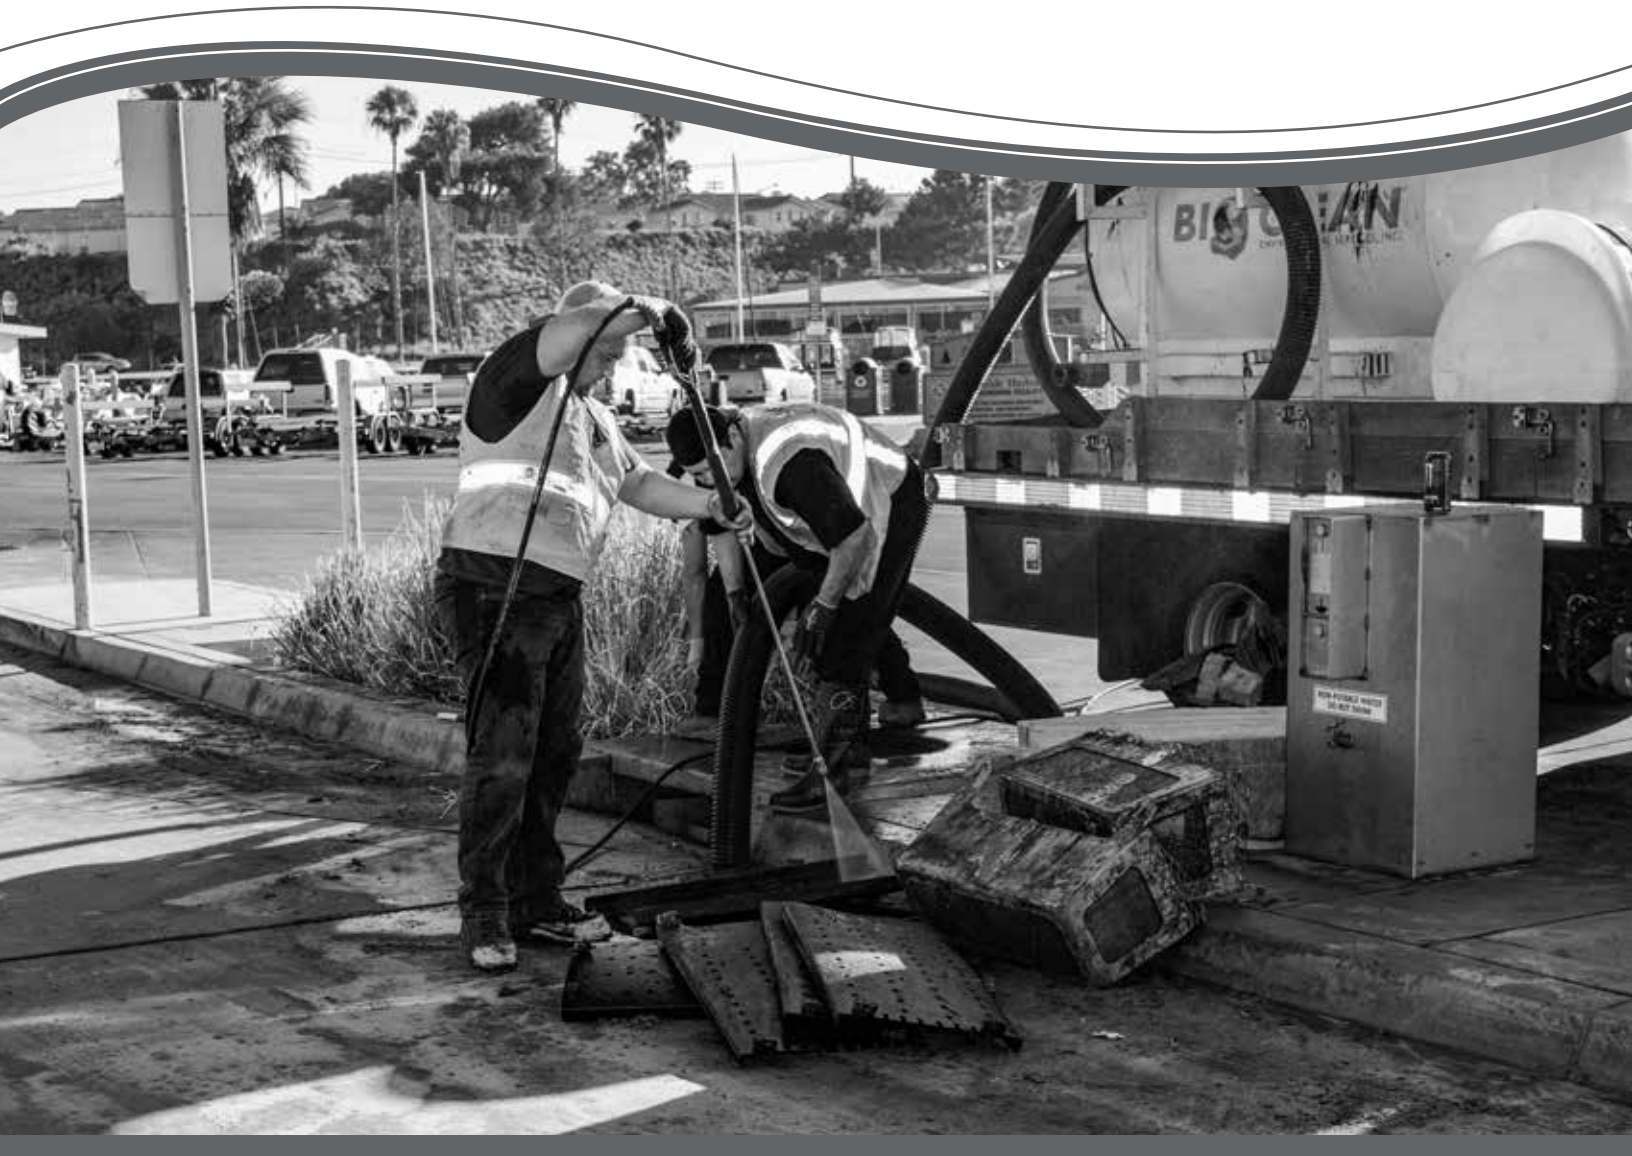
Modular Wetlands[®] Linear Operation & Maintenance Manual

Maintenance Summary

- Remove Trash from Screening Device – average maintenance interval is 6 to 12 months.
 - (5 minute average service time).
- Remove Sediment from Separation Chamber – average maintenance interval is 12 to 24 months.
 - (10 minute average service time).
- Replace Cartridge Filter Media – average maintenance interval 12 to 24 months.
 - (10-15 minute per cartridge average service time).
- Replace Drain Down Filter Media – average maintenance interval is 12 to 24 months.
 - (5 minute average service time).
- Trim Vegetation – average maintenance interval is 6 to 12 months.
 - (Service time varies).

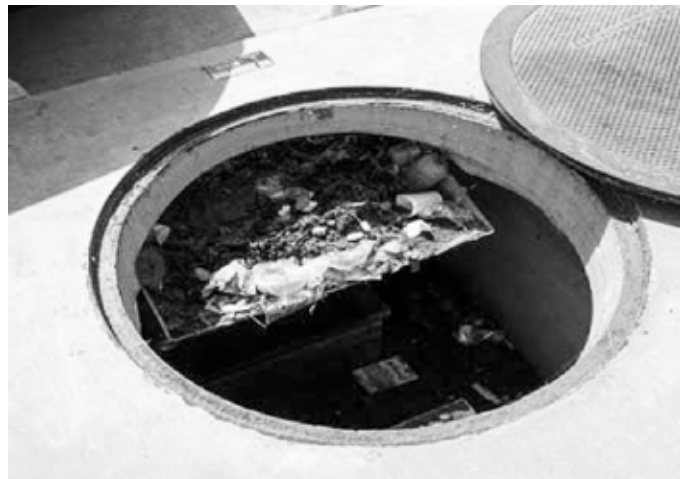
Separation Chamber

The screening device is located directly under the manhole or grate over the Pre-Treatment Chamber. It's mounted directly underneath for easy access and cleaning. Device can be cleaned by hand or with a vacuum truck.

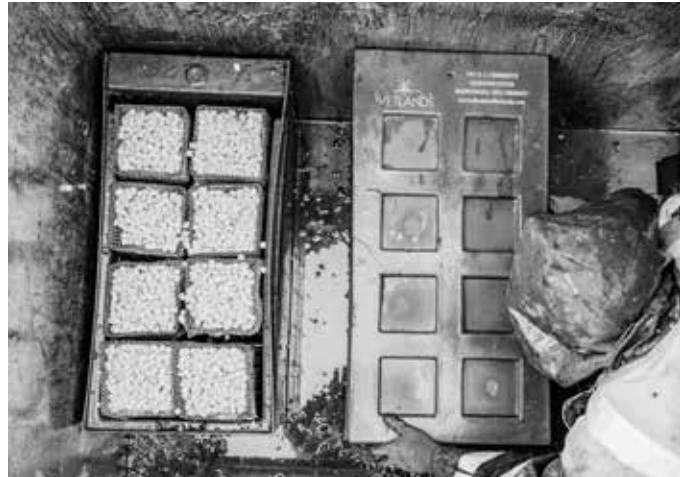
Drain Down Filter

The cartridge filters are located in the Pre-Treatment chamber connected to the wall adjacent to the biofiltration chamber. The cartridges have removable tops to access the individual media filters. Once the cartridge is open media can be easily removed and replaced by hand or a vacuum truck.

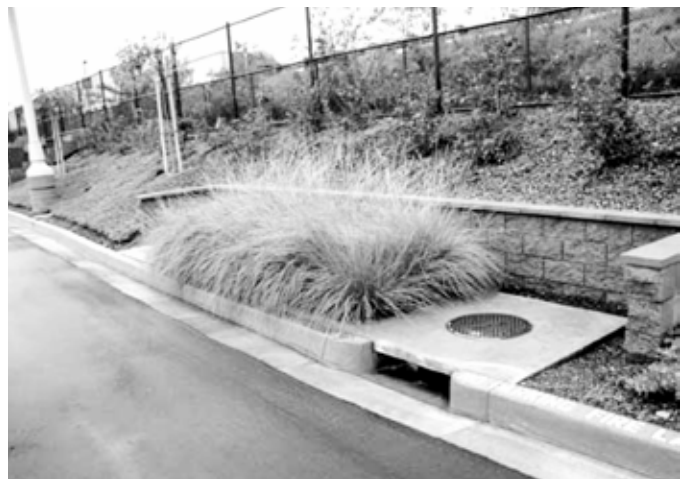
Vegetation should be maintained in the same manner as surrounding vegetation and trimmed as needed. No fertilizer shall be used on the plants. Irrigation per the recommendation of the manufacturer and or landscape architect. Different types of vegetation requires different amounts of irrigation.
