# FARRIS SHORT PLAT

## Lot 2 Improvements

## Stormwater Site Plan – Drainage Report

DATE: April 12, 2023

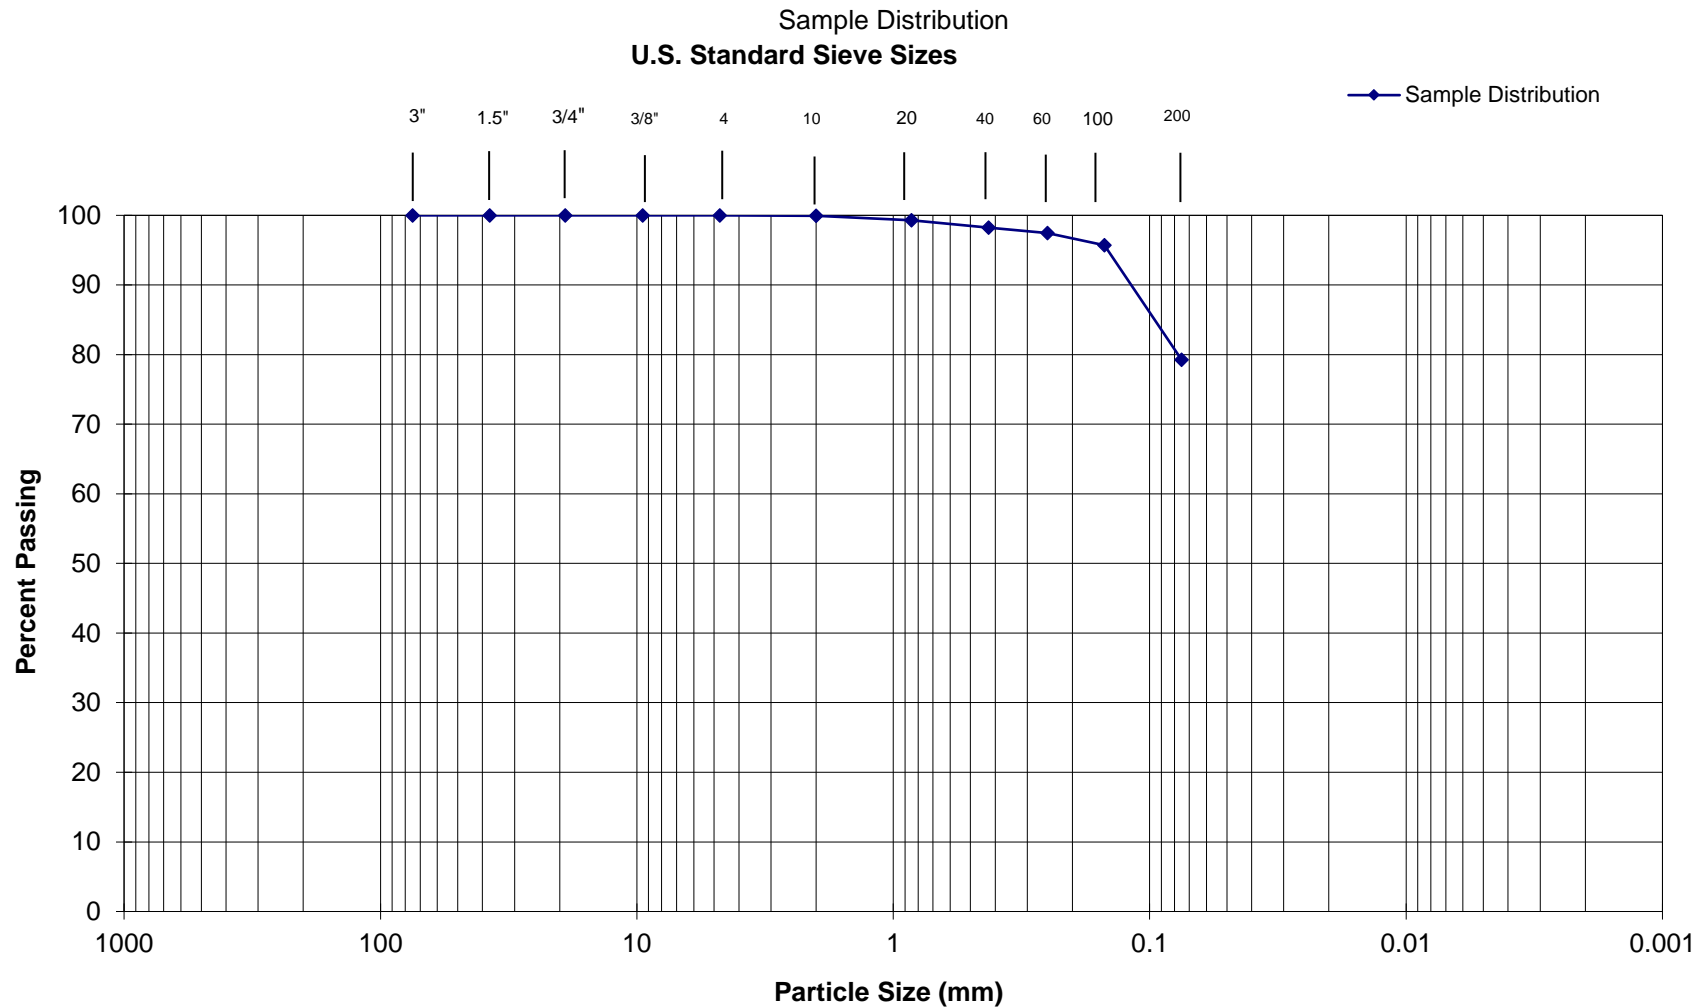
Figure B-3

Soil Classification Data Sheet
