Soils Report: Stormwater Feasibility
Proposed Commercial Development
2315 Inter Ave
Puyallup, Washington
PN: 2105200140
Doc ID: CIMCO.InterAve.SR

Site & Exploration Map
 Proposed Commercial Development
 2315 Inter Avenue
 Puyallup, Washington
 PN: 2105200140

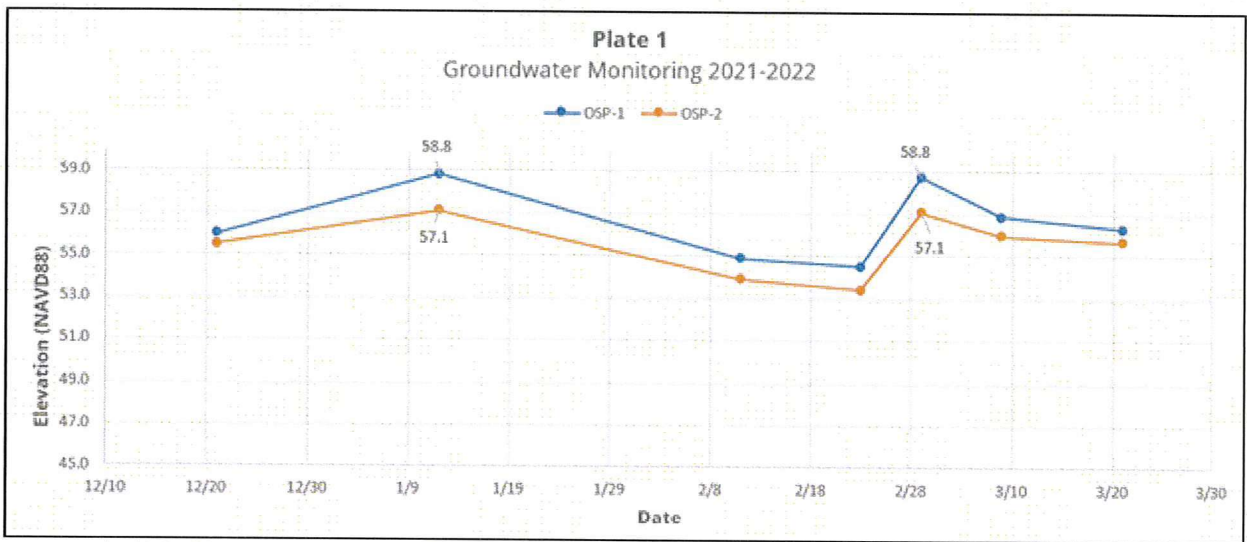
Based on our wet season monitoring, it appears that seasonal high groundwater occurs at about Elevation 59 feet (NAVD 88) at the locations monitored, approximately 1.2 feet below the ground surface. These levels were recorded on January 12, 2022 and March 1, 2022. Plate 1, below, summarizes the groundwater levels recorded as part of our groundwater monitoring program during our monitoring period.

We anticipate fluctuations in the local groundwater levels will occur in response to precipitation patterns, off site construction activities, and site utilization. As such, water level observations made at the time of our field investigation may vary from those encountered during the construction phase. Analysis or modeling of anticipated groundwater levels during construction is beyond the scope of this report.

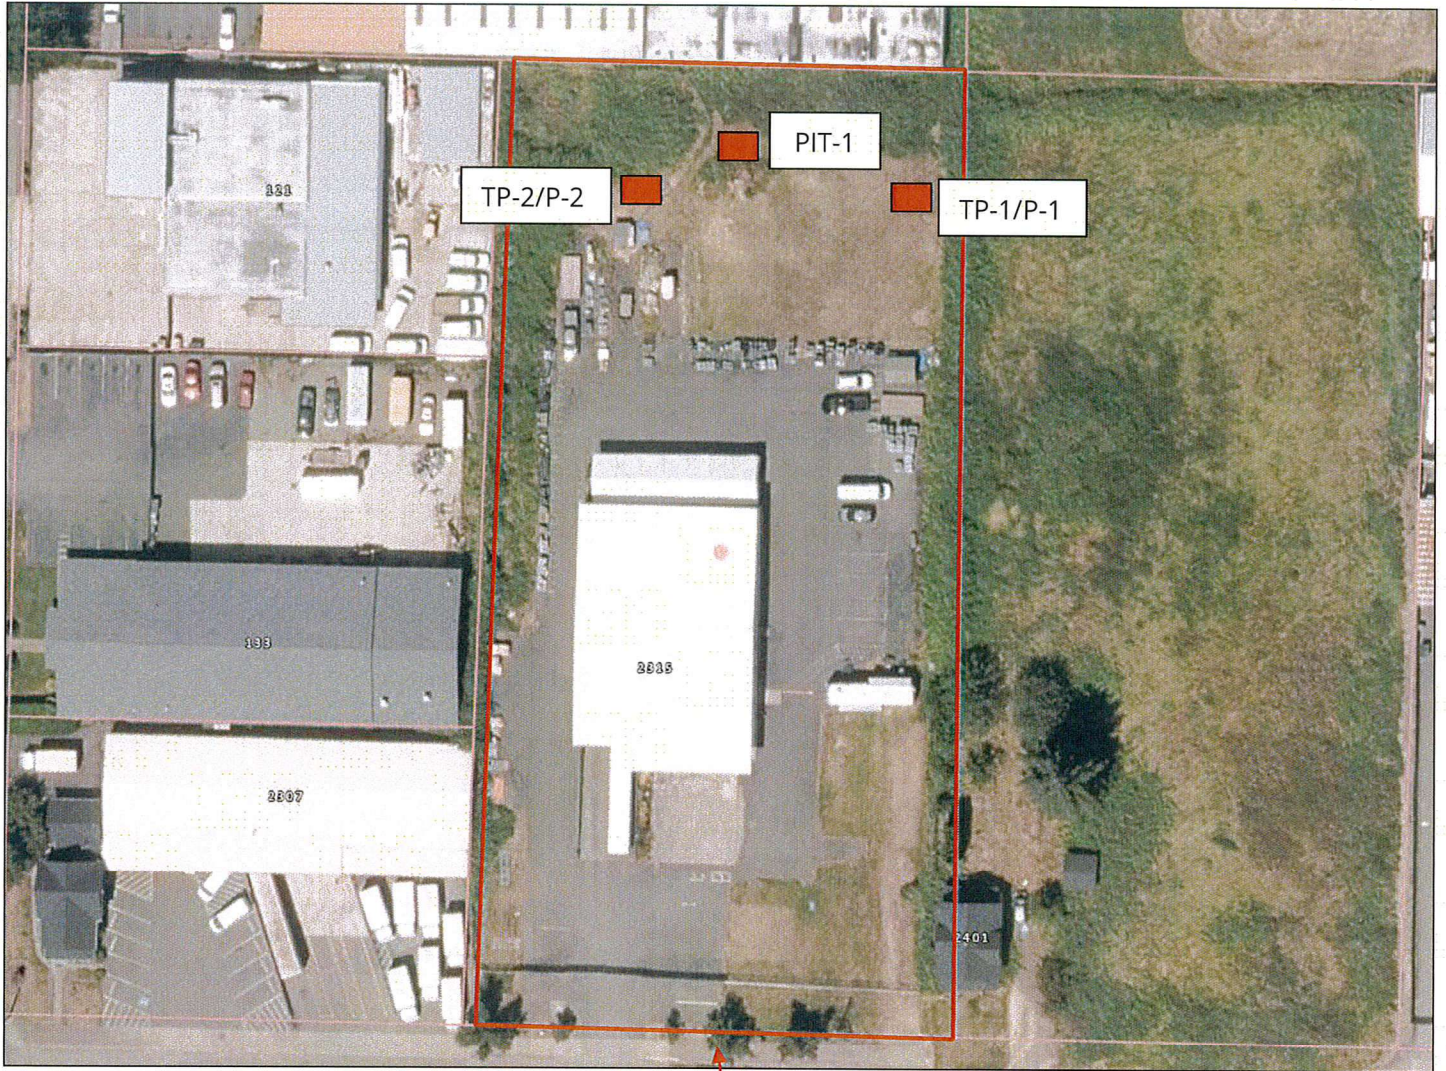
Doc ID: CIMCO.InterAve.F	April 2022	Figure 2
--------------------------	------------	----------

Number and approximate location of test pit/Pilot Infiltration Test

The site generally flat with less than 2 feet of topographic relief. The vegetation in the area of the proposed development had been generally cleared and consisted of grasses, brambles, and other low lying native and invasive species. No areas of surficial erosion, seeps, or springs were observed at the time of our reconnaissance. Standing water was not observed in the existing pond/depressions on the northwest and portions of the site at the time of our December 2021 site visit. The existing site topography is shown on the Site Exploration Map, Figure 2.

The approximate locations and numbers of our test pits are shown on the attached Site Exploration Map, Figure 2. The soils encountered were visually classified in accordance with the Unified Soil Classification System (USCS) and ASTM D: 2488. The USCS is included in Appendix A as Figure A-1, while the descriptive logs of our test pits are included as Figure A-2.

At the time of exploration, groundwater seepage was observed at depths of 4 to 4.5 feet below existing grades. Groundwater monitoring wells were installed at the site at the time of exploration. The locations of the observation wells are shown on the Site & Exploration Plan, Figure 2. Groundwater readings for the observation wells were manually measured on a bi-monthly basis from December 21, 2021 to March 21, 2022.

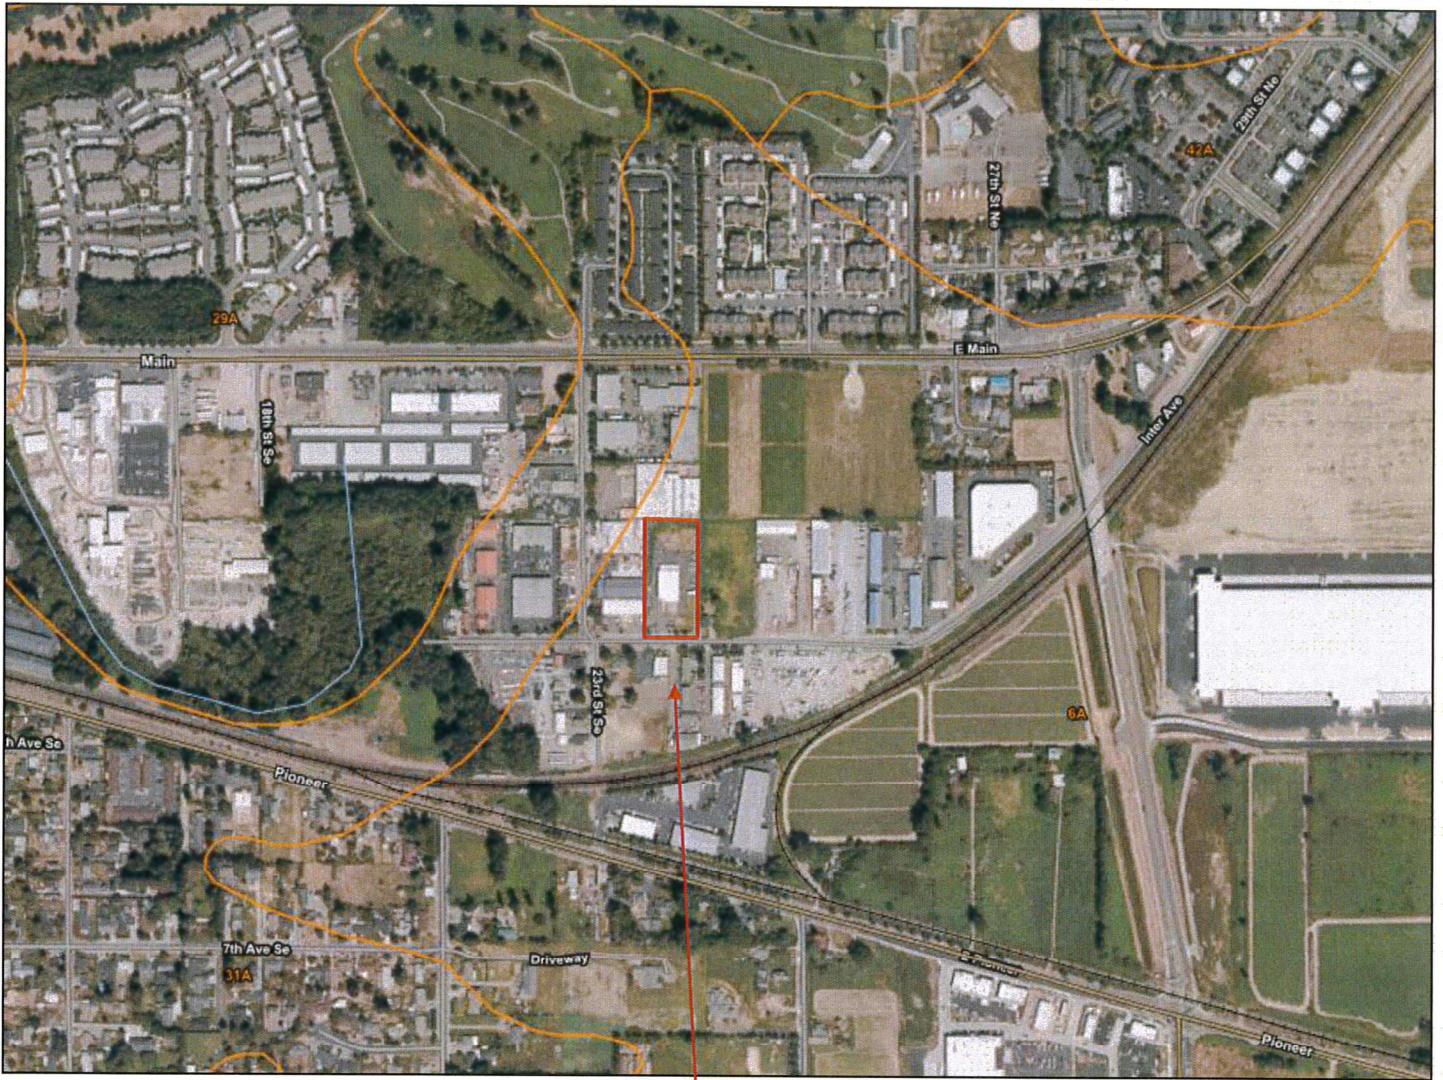
Figure 3

Soil Type	Soil Name	Parent Material	Slopes	Erosion Hazard	Hydrologic Soils Group
6A	Briscot loam	Alluvium	-	Slight	D
31A	Puyallup fine sandy loam	Alluvium	0 to 3	Slight	B

NRCS Soils Map
 Proposed Commercial Development
 2315 Inter Avenue
 Puyallup, Washington
 PN: 2105200140

The USDA Natural Resource Conservation Services (NRCS) Web Soil Survey maps the site as being underlain by Briscot loam soils (6A). The Briscot soil type 6A is derived from alluvium, form on slopes of 0 to 2 percent and has a "slight" potential for erosion when exposed. The upper, weathered soil horizons are listed in hydrologic soils group B, while the deeper soil horizons are listed in hydrologic soils group D. A copy of the referenced NRCS Soils Map for the site area is included as Figure 3.
