GEOTECHNICAL REPORT

**Freeman Logistics
Freeman Road East and 19th Avenue Northwest
Pierce County, Washington**

Project No. T-8565

Terra Associates, Inc.

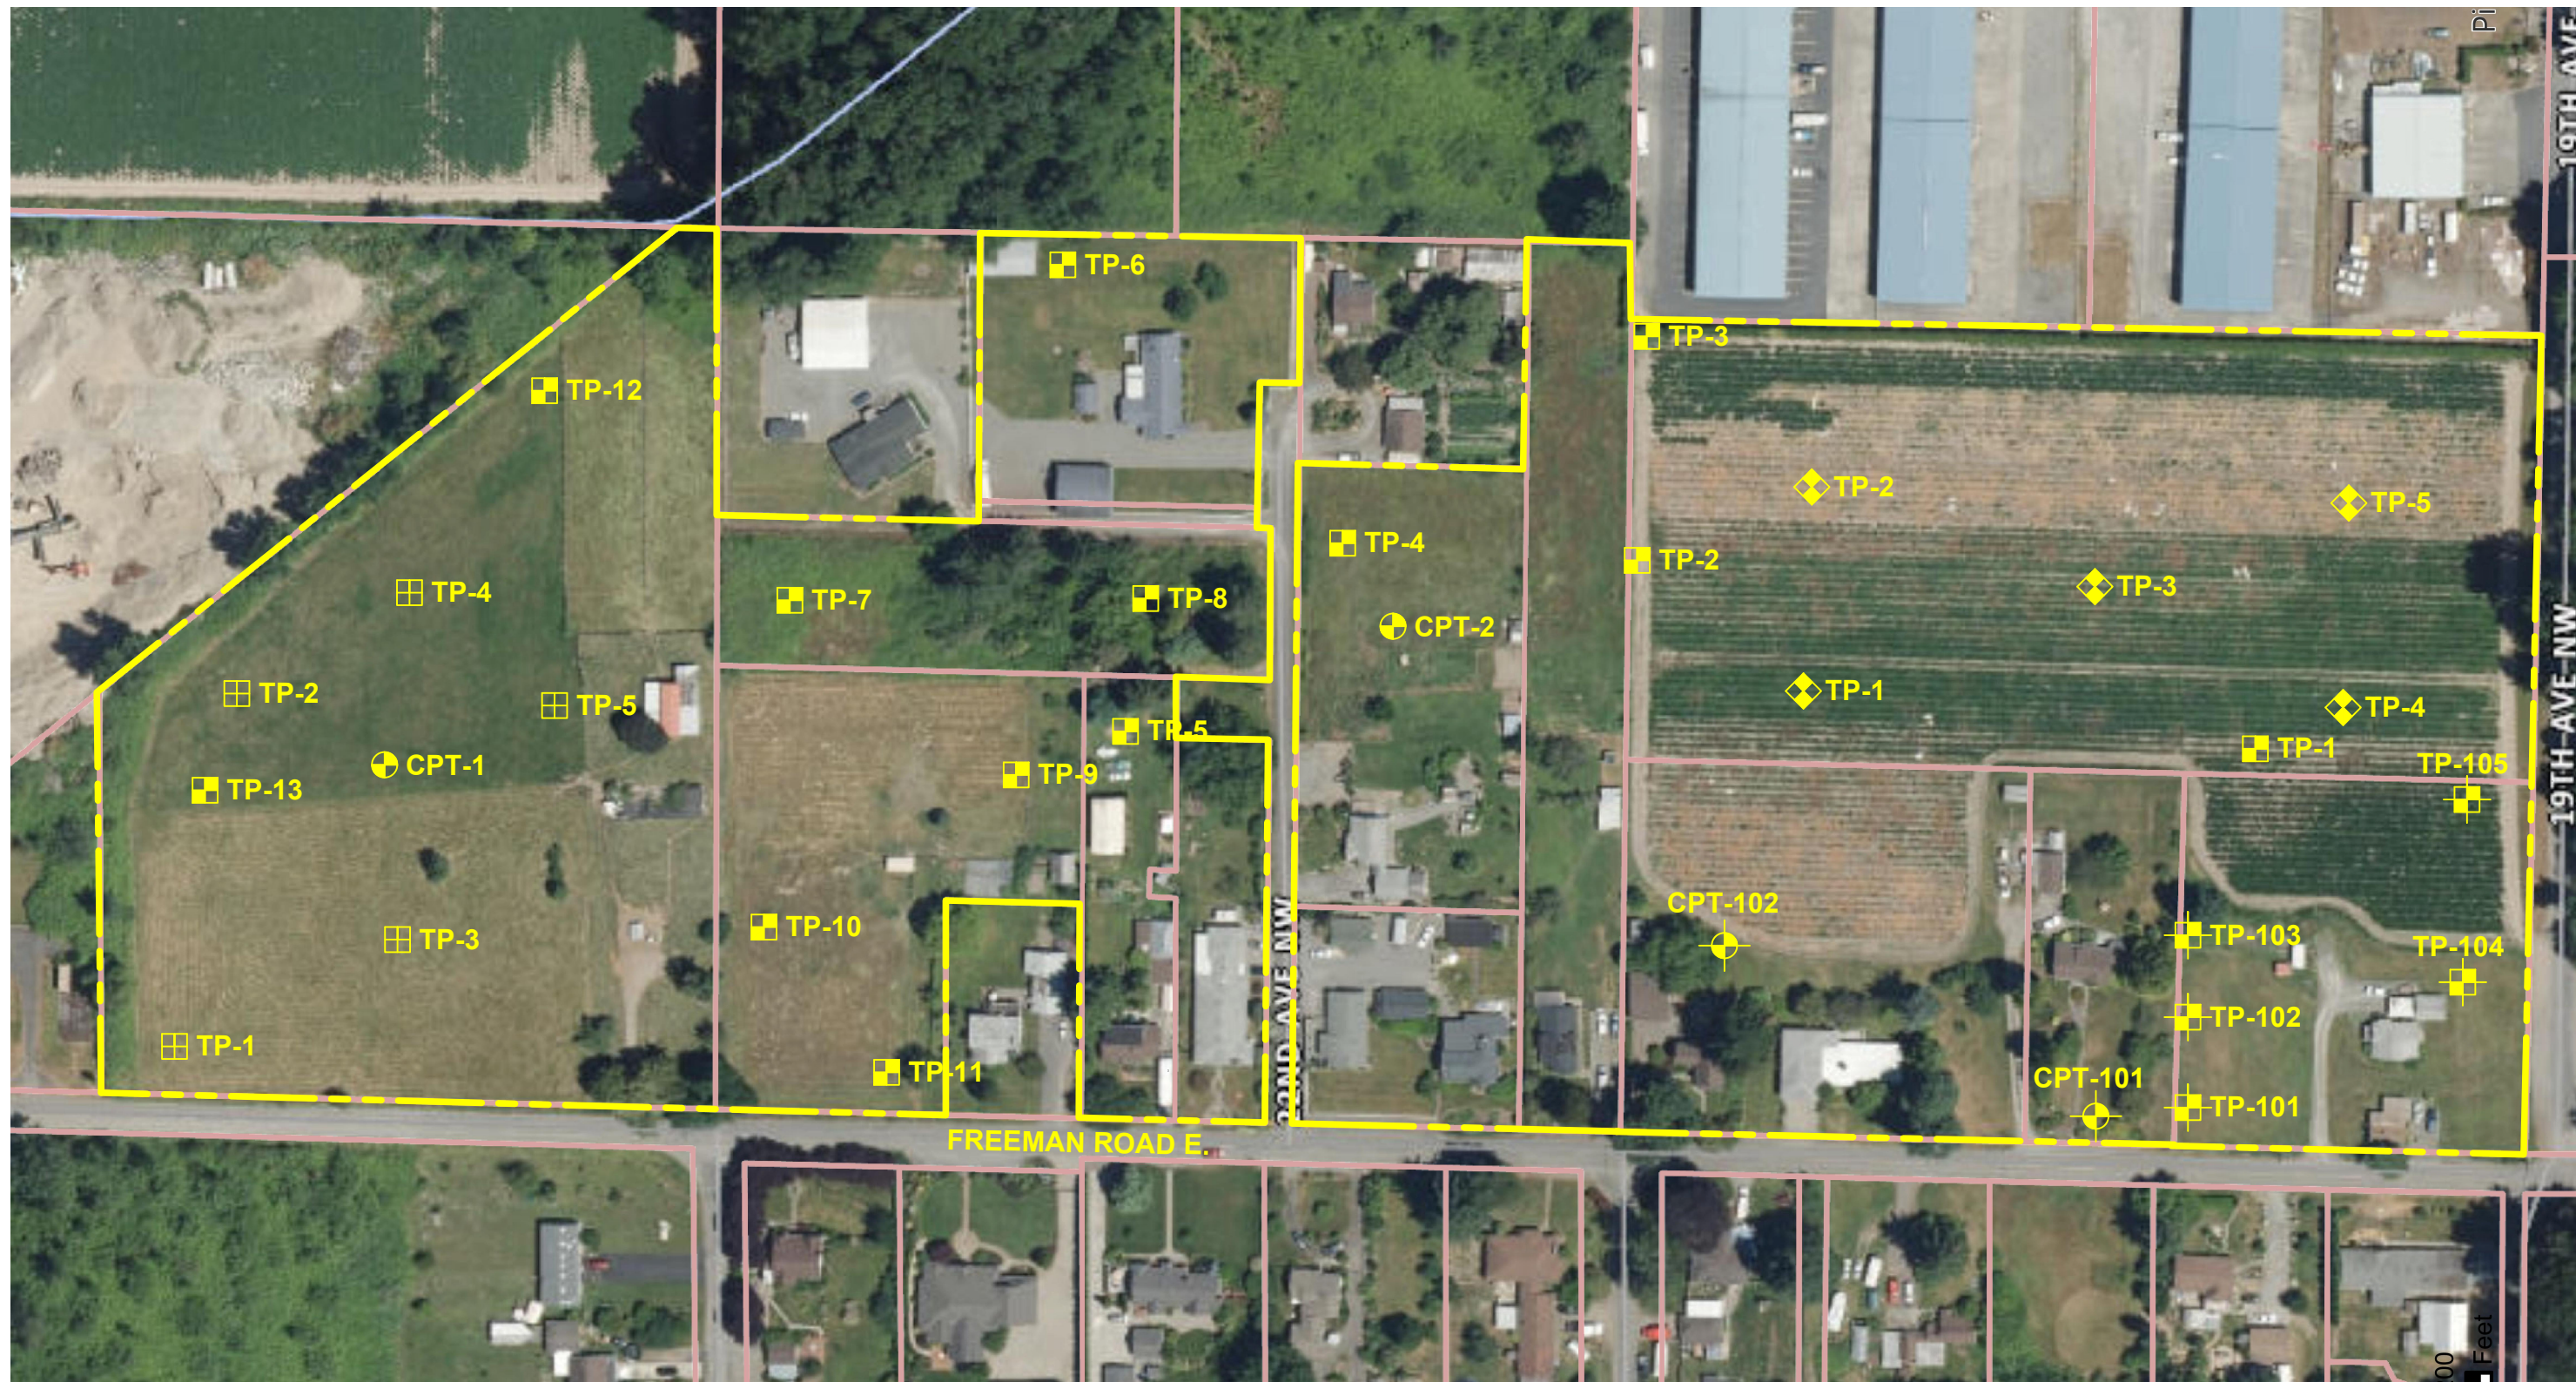
Proj. No.T-8565	Date JULY 2022	Figure 2
-----------------	----------------	----------

Detailed descriptions of the subsurface conditions observed in our subsurface explorations are given on the Test Pit Logs. The Test Pit Logs and CPT Data are attached in Appendix A. The approximate test pit and CPT locations are shown on Figure 2.

**EXPLORATION LOCATION PLAN
FREEMAN LOGISTICS
PIERCE COUNTY, WASHINGTON**

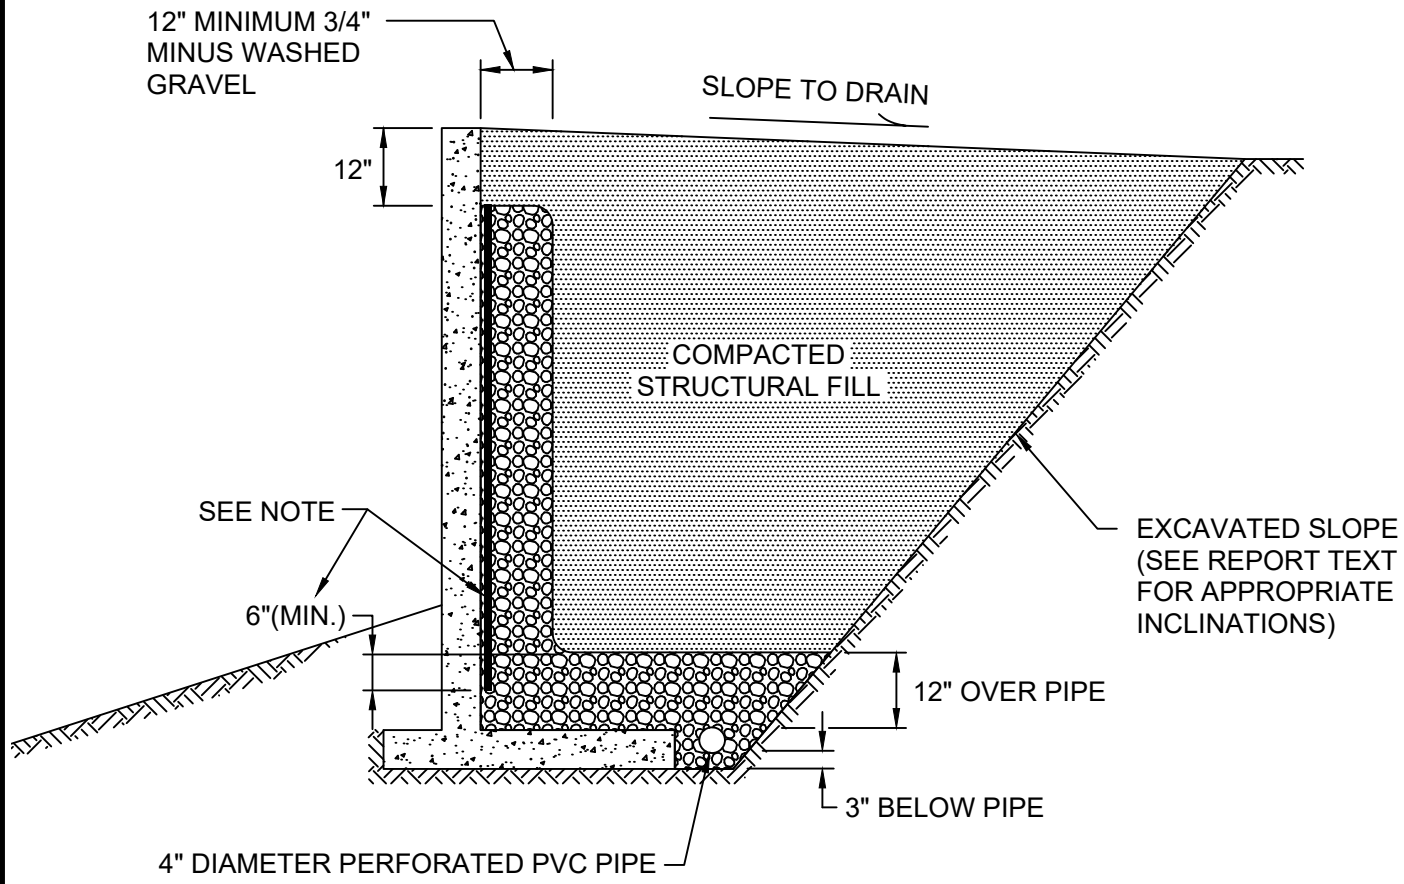
The magnitude of earth pressure development on below-grade walls, such as basement or retaining walls, will partly depend on the quality of the wall backfill. We recommend placing and compacting wall backfill as structural fill as described in Section 5.2 of this report. To guard against hydrostatic pressure development, drainage must be installed behind the wall. A typical wall drainage detail is shown on Figure 4.

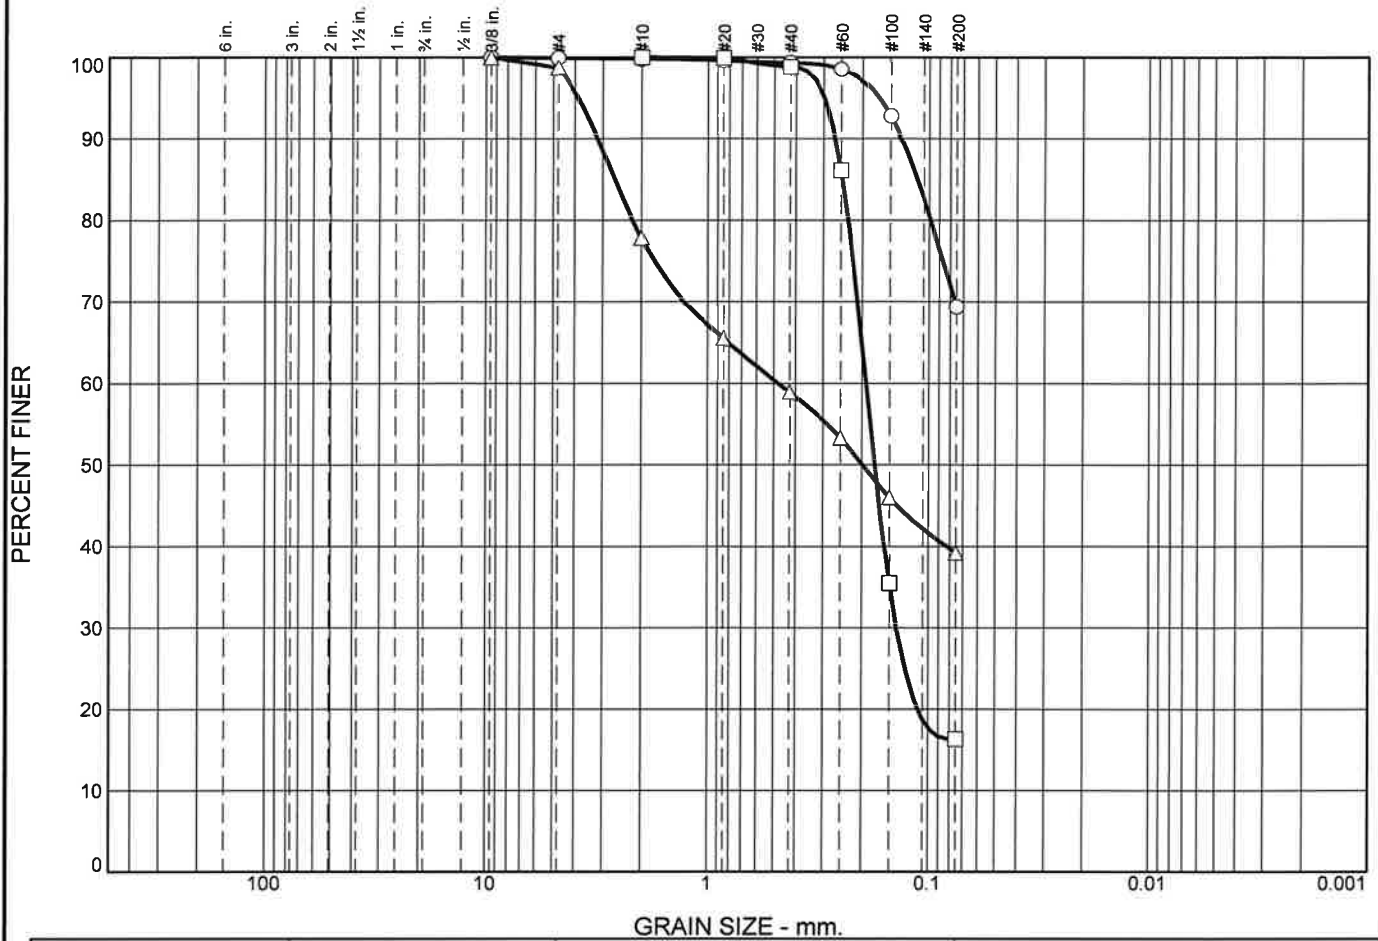
Particle Size Distribution Report

% +3"	% Gravel		% Sand			% Fines			
		Coarse	Fine	Coarse	Medium	Fine	Silt	Clay		
○	0.0	0.0	0.1	0.1	0.5	29.9	69.4			
□	0.0	0.0	0.0	0.0	1.2	82.5	16.3			
△	0.0	0.0	1.3	20.9	18.9	19.7	39.2			
×	LL	PL	D ₈₅	D ₆₀	D ₅₀	D ₃₀	D ₁₅	D ₁₀	C _c	C _u
○			0.1137							
□			0.2463	0.1912	0.1745	0.1395				
△			2.6410	0.4781	0.1982

Material Description	USCS	AASHTO
○ sandy SILT	ML	
□ silty SAND	SM	
△ silty SAND	SM

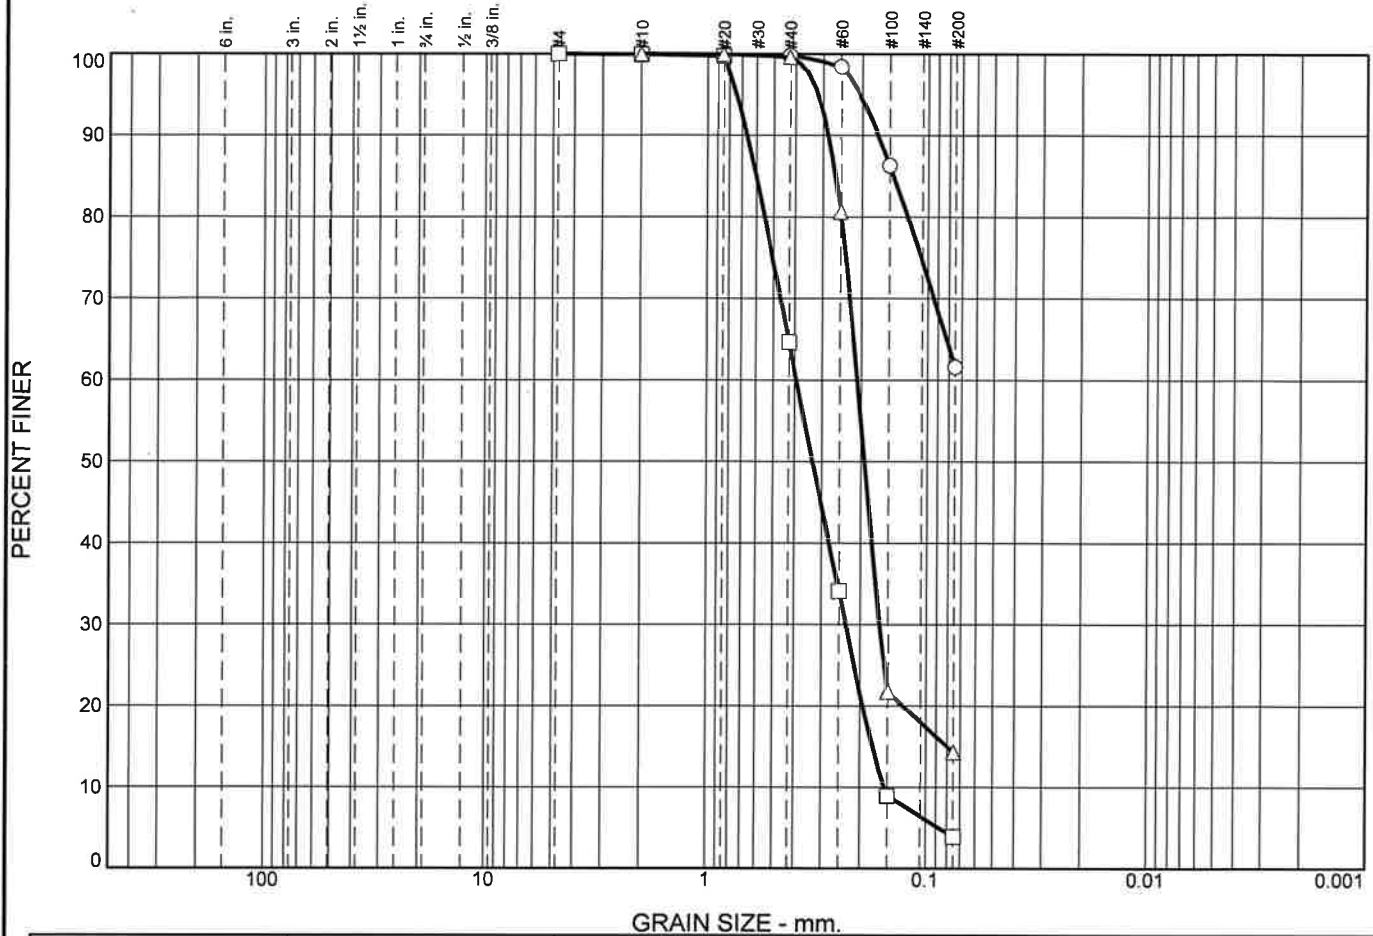
Particle Size Distribution Report

% +3"	% Gravel		% Sand			% Fines			
		Coarse	Fine	Coarse	Medium	Fine	Silt	Clay		
○	0.0	0.0	0.0	0.1	0.1	38.2	61.6			
□	0.0	0.0	0.0	0.1	35.3	60.7	3.9			
△	0.0	0.0	0.0	0.0	0.4	85.3	14.3			
⊗	LL	PL	D ₈₅	D ₆₀	D ₅₀	D ₃₀	D ₁₅	D ₁₀	C _c	C _u
○			0.1440							
□			0.6016	0.3932	0.3306	0.2327	0.1753	0.1550	0.89	2.54
△			0.2635	0.2081	0.1925	0.1633	0.0801

Material Description	USCS	AASHTO
○ sandy SILT	ML	
□ poorly graded SAND	SP	
△ silty SAND	SM

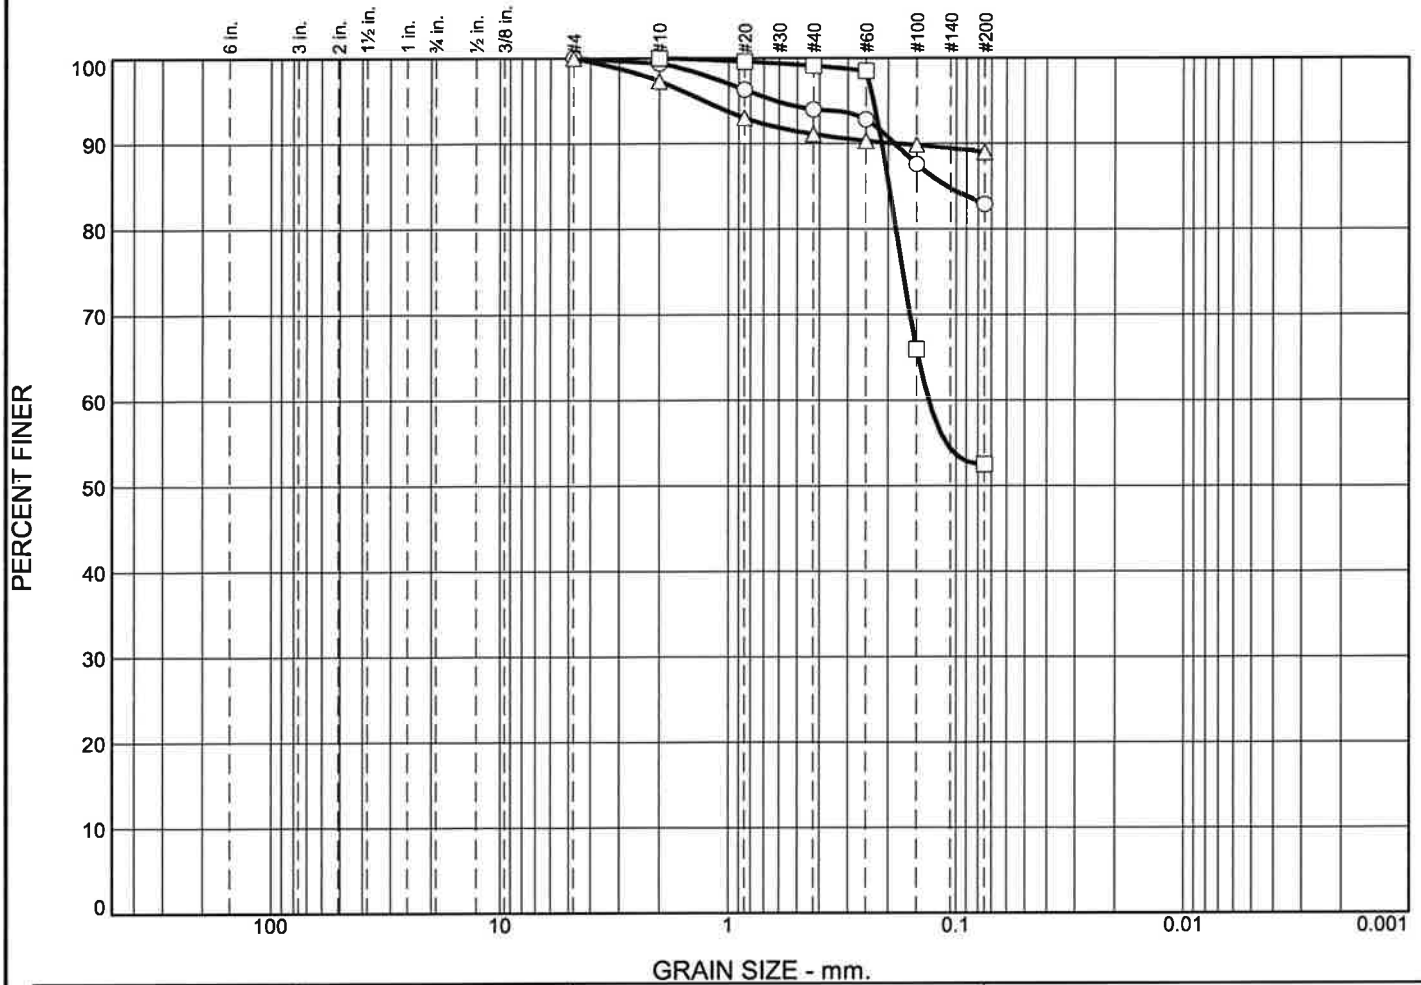
Particle Size Distribution Report

% +3"	% Gravel		% Sand			% Fines			
		Coarse	Fine	Coarse	Medium	Fine	Silt	Clay		
○	0.0	0.0	0.0	0.6	5.4	11.1	82.9			
□	0.0	0.0	0.0	0.0	0.9	46.6	52.5			
△	0.0	0.0	0.0	2.7	6.2	2.1	89.0			
×	LL	PL	D ₈₅	D ₆₀	D ₅₀	D ₃₀	D ₁₅	D ₁₀	C _c	C _u
○			0.1106							
□			0.1980	0.1323						
△

Material Description	USCS	AASHTO
○ SILT with sand	ML	
□ Sandy SILT	ML	
△ SILT	ML

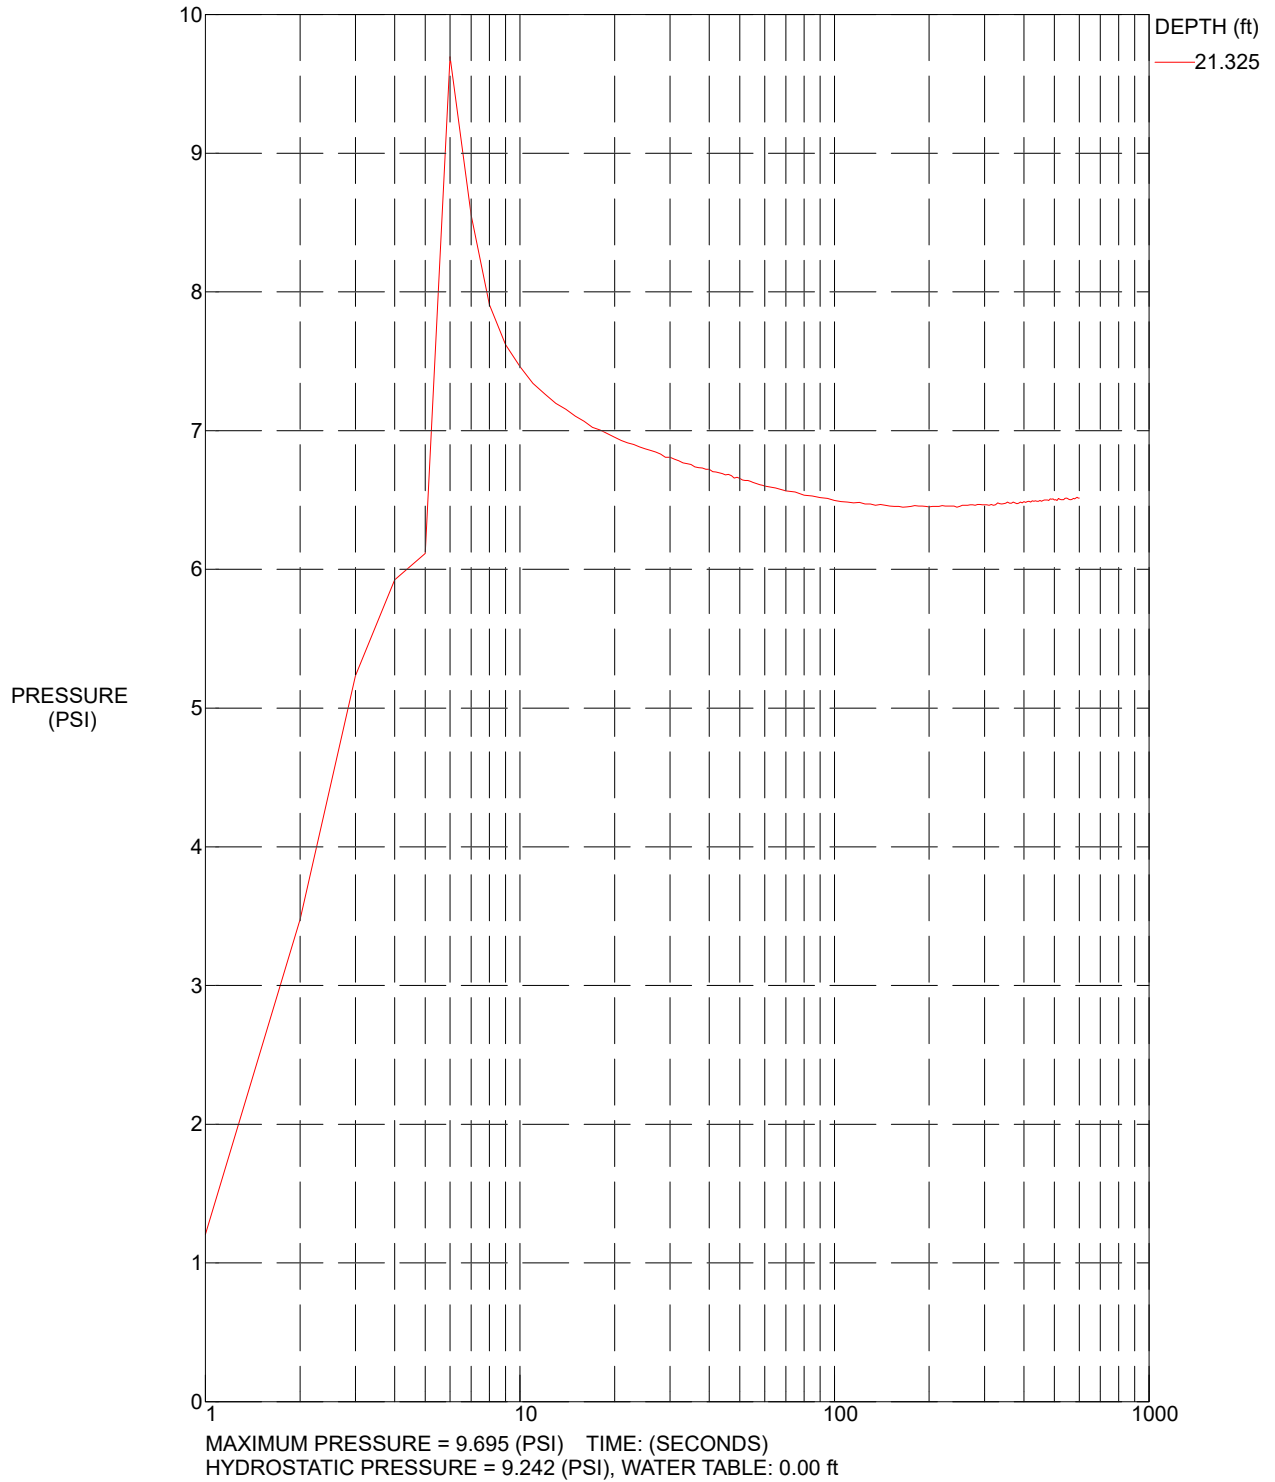
CPT-101

CPT CONTRACTOR: In Situ Engineering
 CUSTOMER: Terra Associates
 LOCATION: Puyallup
 JOB NUMBER: T-8565

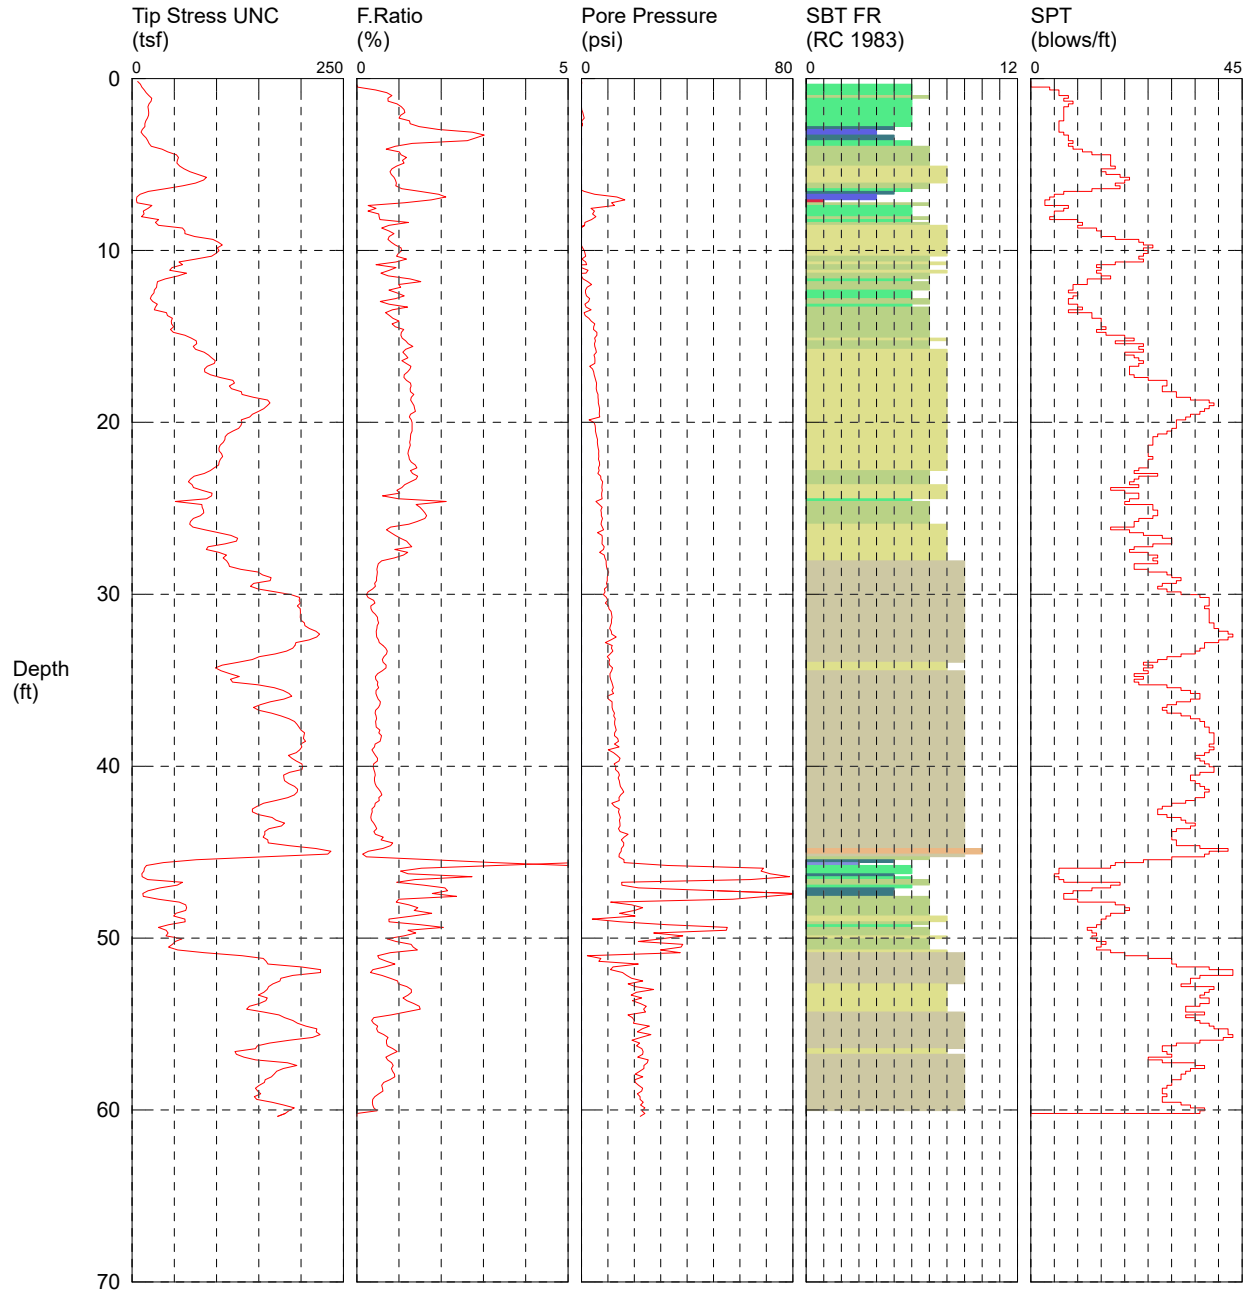
CPT CONTRACTOR: In Situ Engineering
 CUSTOMER: Terra Associates
 LOCATION: Puyallup
 JOB NUMBER: T-8565

OPERATOR: Okbay/Forinash
 CONE ID: DDG1263
 TEST DATE: 6/9/2022 1:01:45 PM
 PREDRILL:
 BACKFILL:
 SURFACE PATCH:

| 1 sensitive fine grained | 4 silty clay to clay | 7 silty sand to sandy silt | 10 gravelly sand to sand |

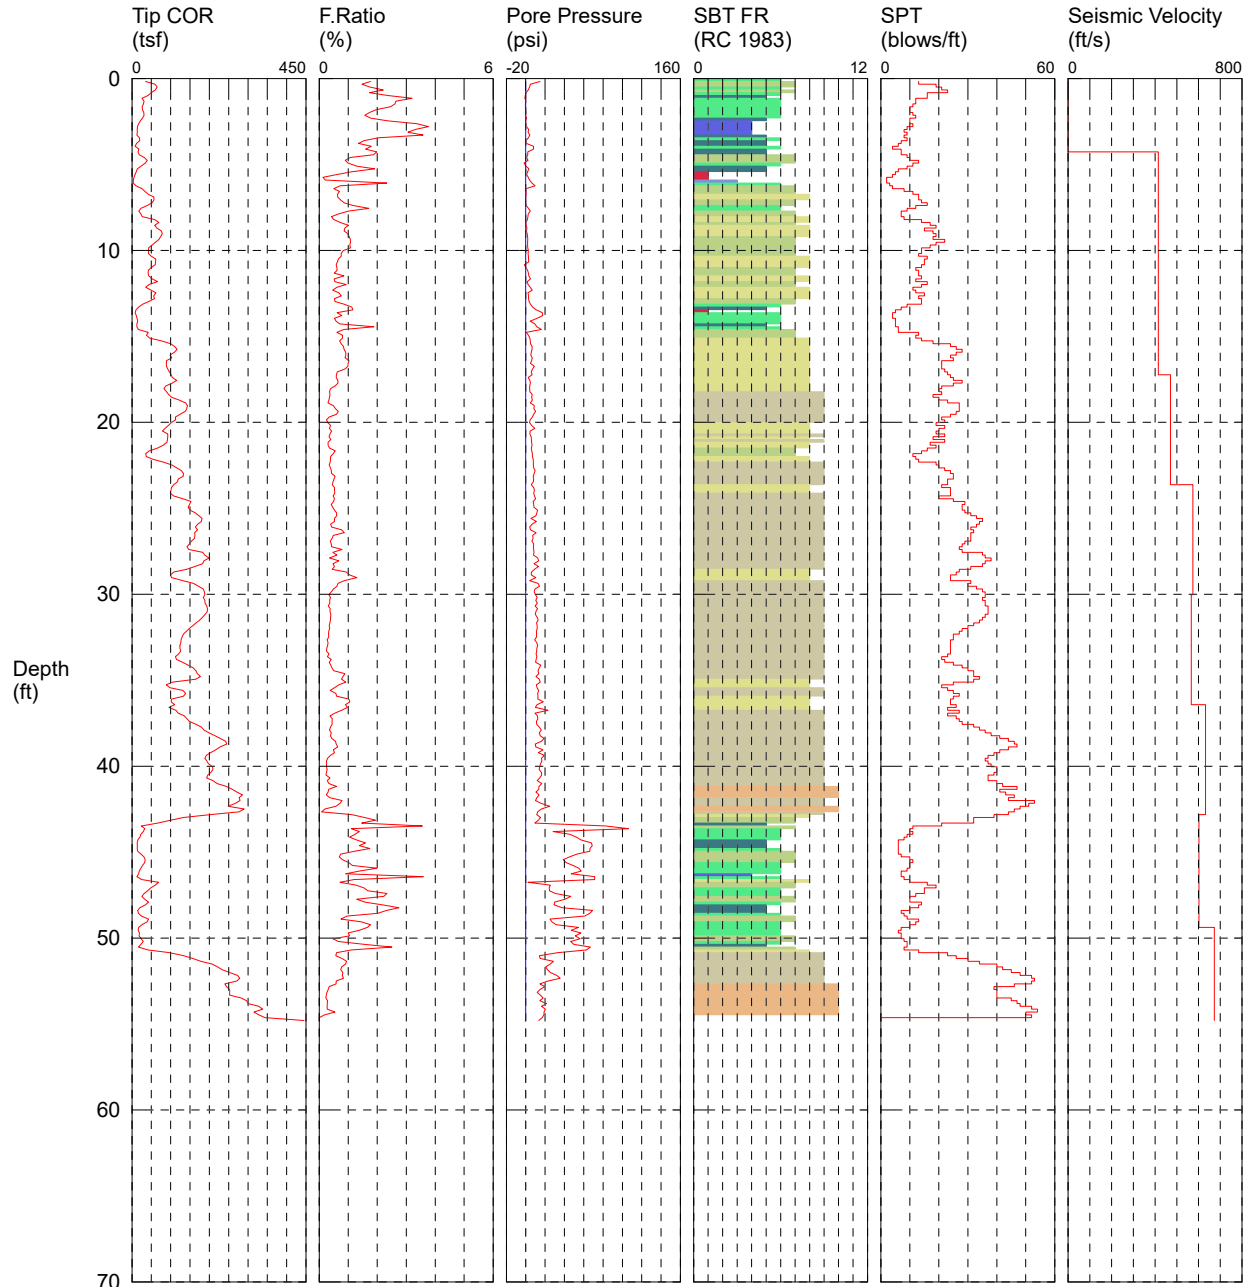
CPT CONTRACTOR: In Situ Engineering
 CUSTOMER: Terra Associates
 LOCATION: Puyallup
 JOB NUMBER: T-8565

OPERATOR: Mayfield/Okbay
 CONE ID: DDG1394
 TEST DATE: 7/8/2021 1:09:48 PM
 PREDRILL:
 BACKFILL: 20% Bentonite Grout + Bentonite Chip
 SURFACE PATCH:

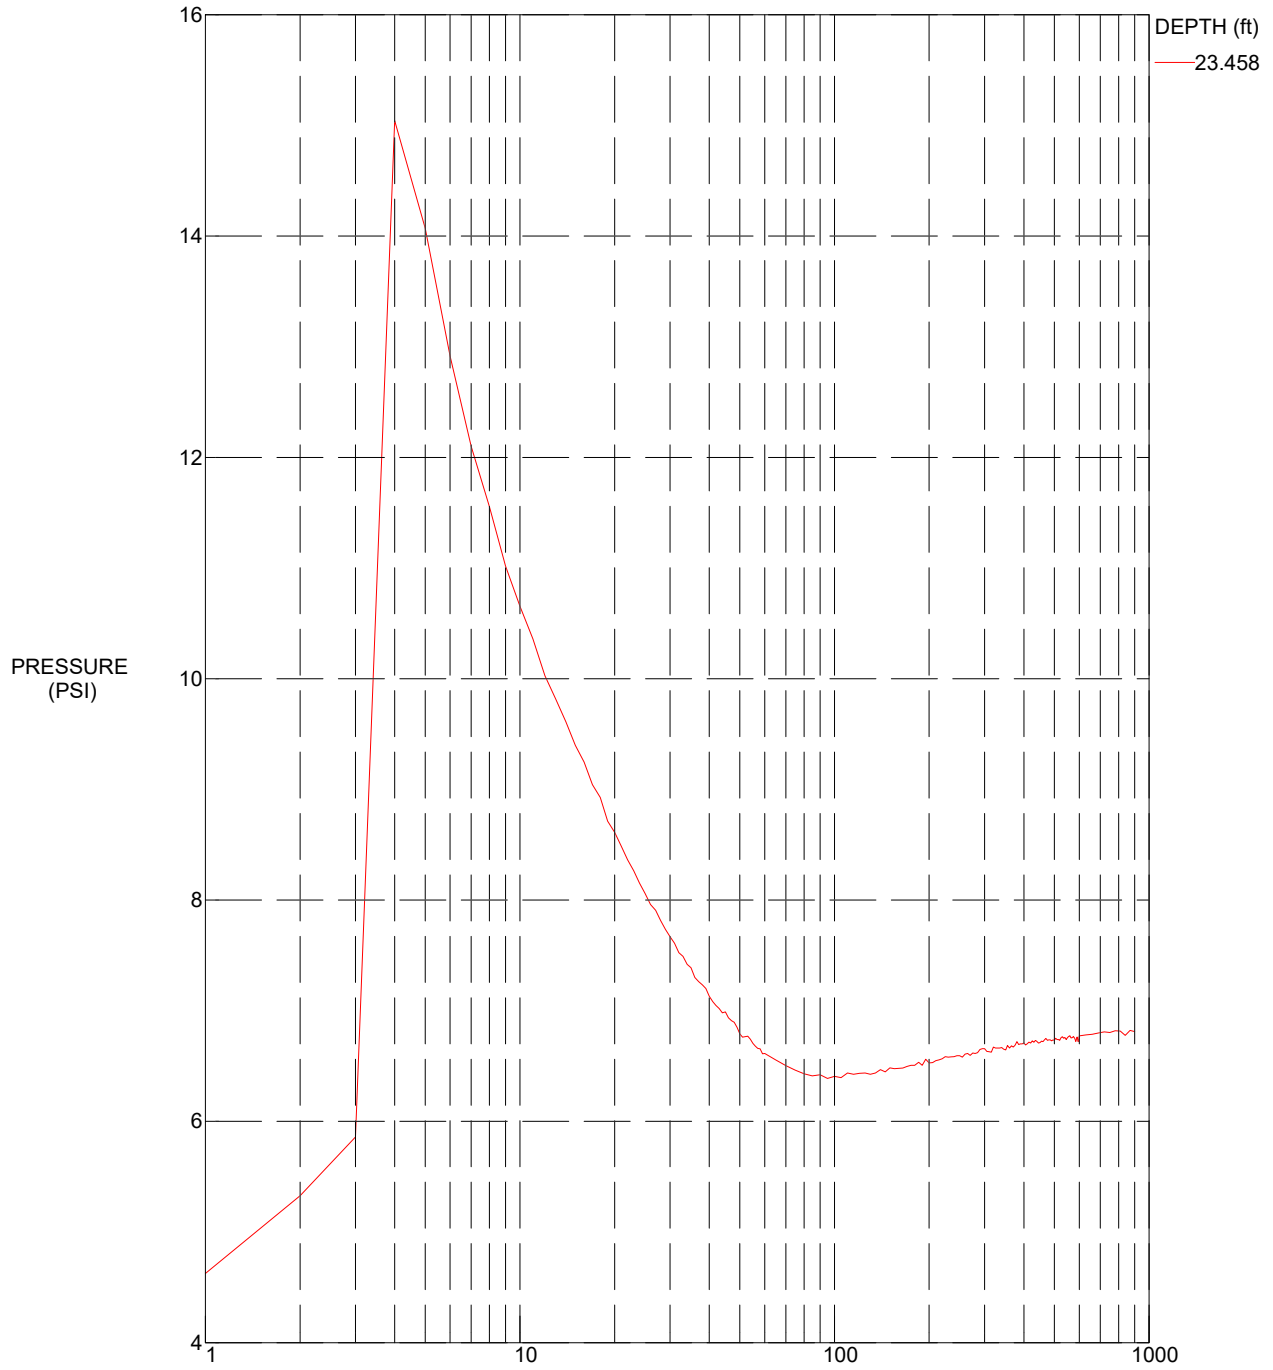
MAXIMUM PRESSURE = 15.041 (PSI) TIME: (SECONDS)
HYDROSTATIC PRESSURE = 10.167 (PSI), WATER TABLE: 0.00 ft

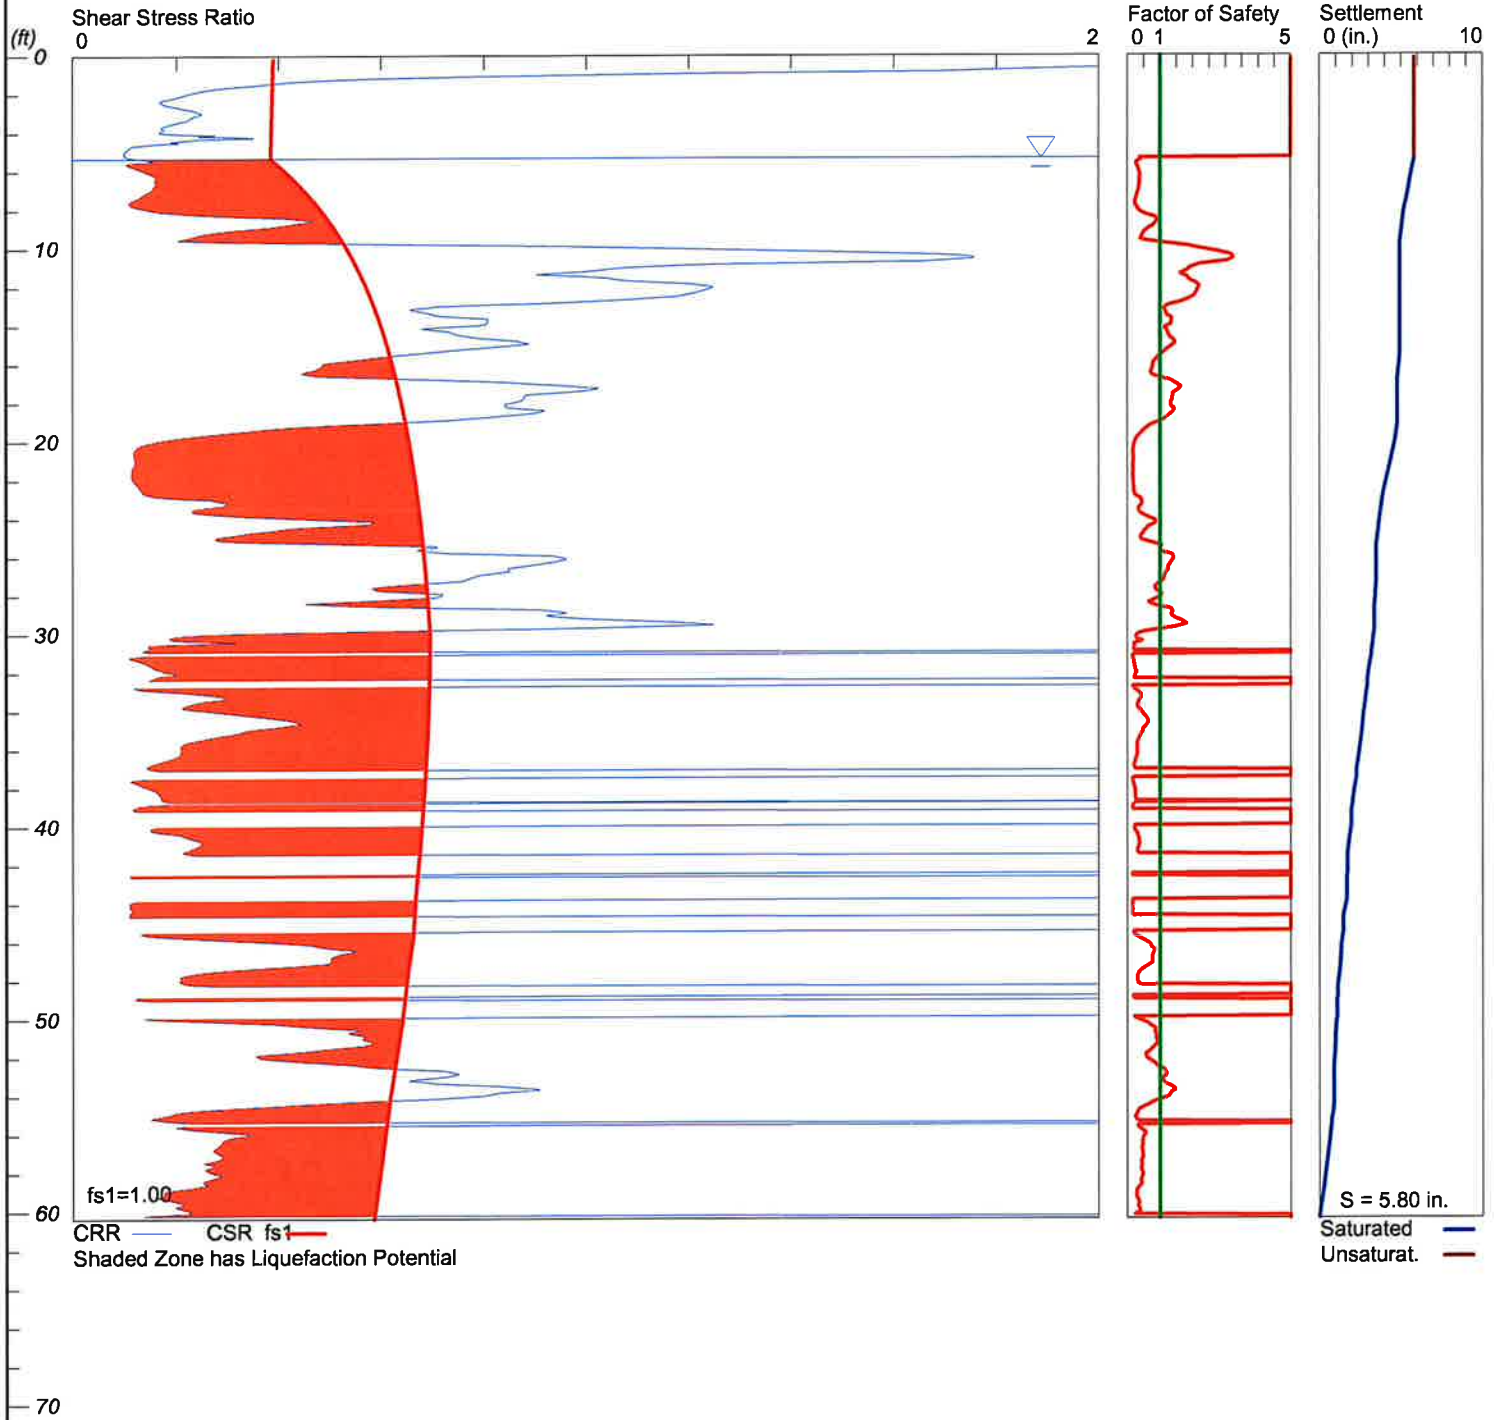
Hole No.=CPT-1 Water Depth=5.3 ft

Magnitude=7
Acceleration=0.6g

The results of our analysis indicate that soil liquefaction could occur during the design earthquake event resulting in total settlements ranging between about 2.8 and 5.8 inches with about one-half of this settlement likely being differential in nature. In our opinion, this amount of settlement would not structurally impair the building. However, cosmetic damage to the structure in the form of misaligned doors and windows, cracking, and floor settlement could occur. Some utility connections may also be impacted. If the owner is not willing to accept the risk of building damage requiring repair should liquefaction-induced settlements occur, foundations should be supported on ground improved using stone columns designed to mitigate soil liquefaction settlements below the building foundations. The results of the liquefaction analysis are attached in Appendix B.

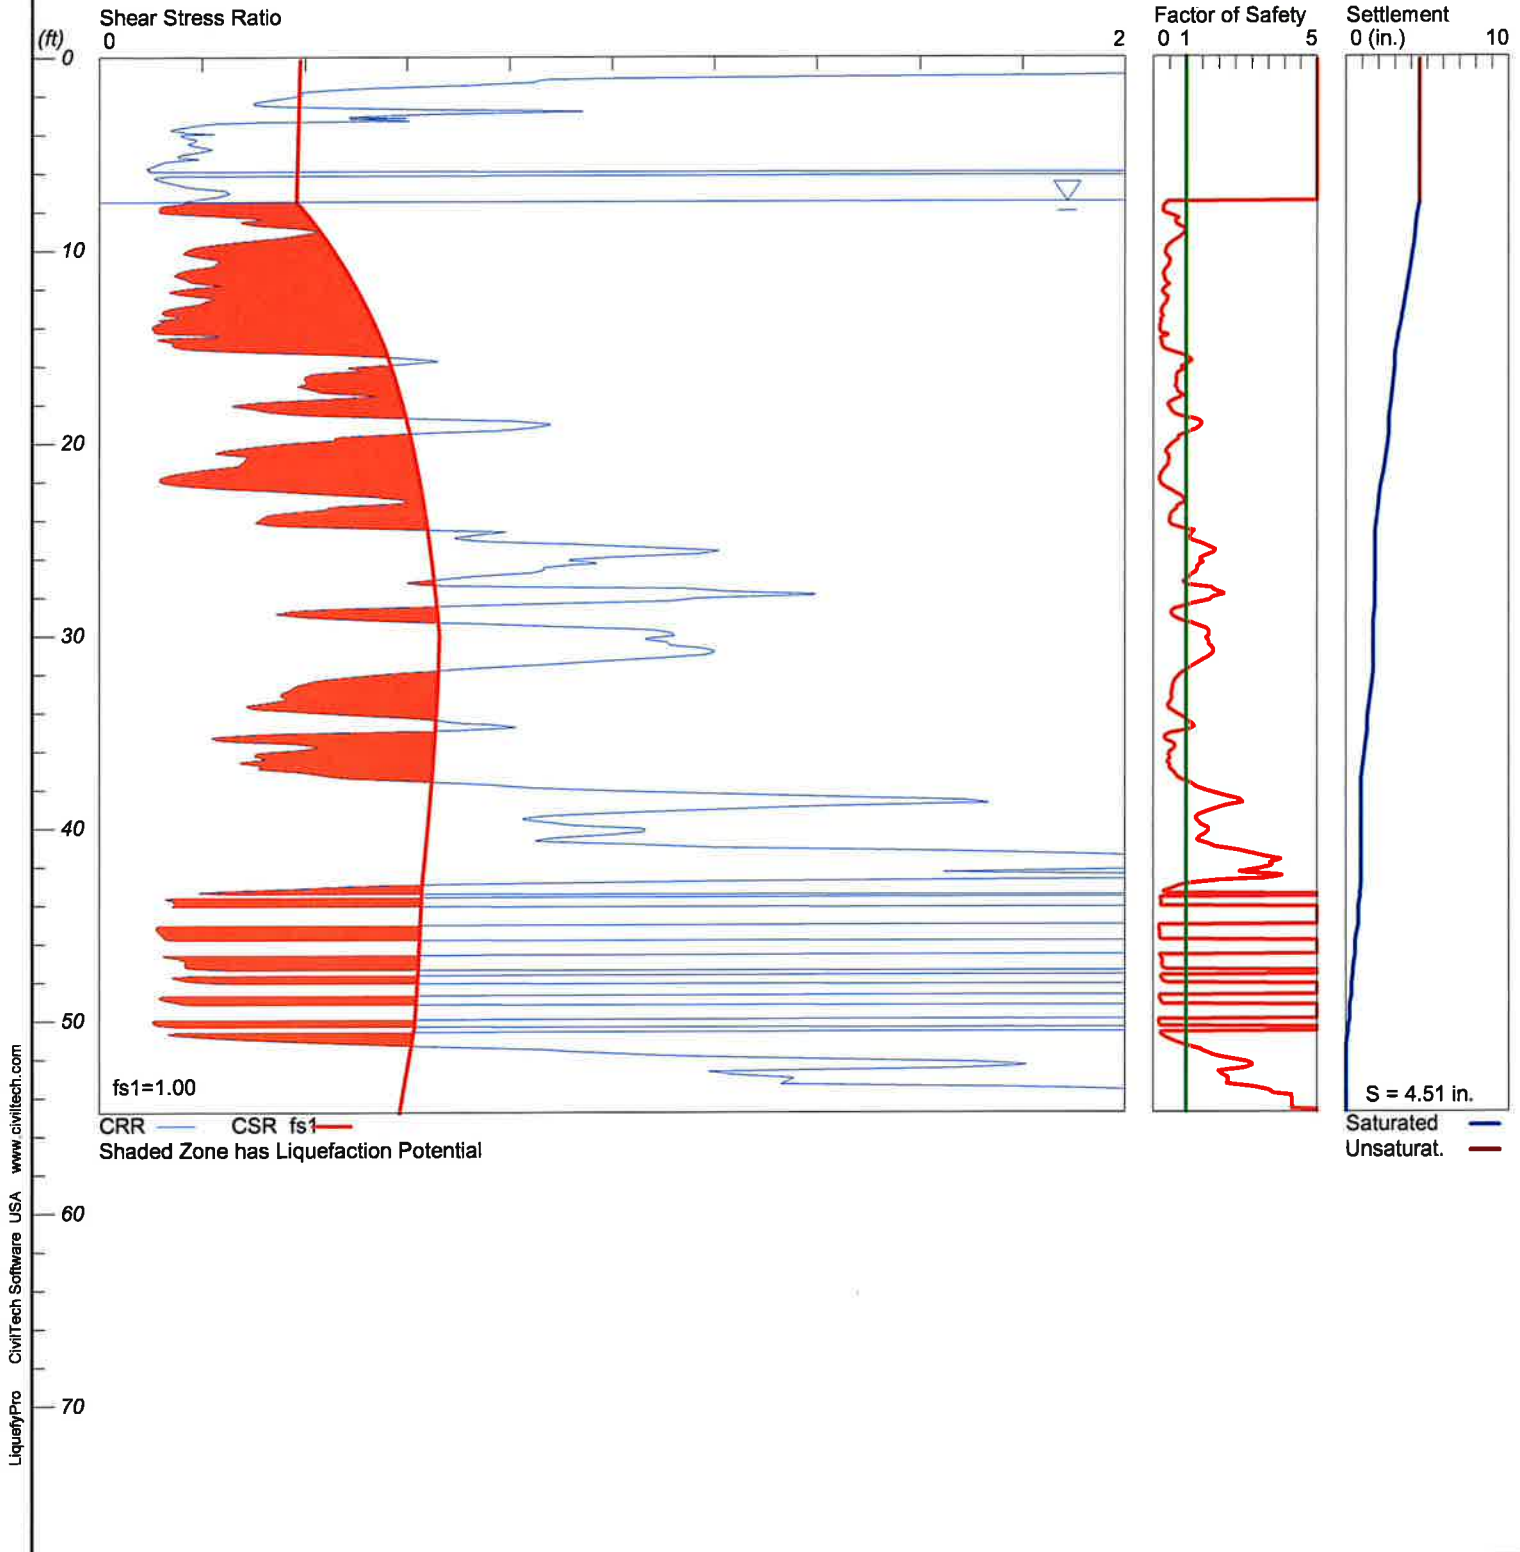
Hole No.=CPT-2 Water Depth=7.5 ft

Magnitude=7
Acceleration=0.6g
