GEOTECHNICAL REPORT

**Freeman Logistics
Freeman Road East and 19th Avenue Northwest
Pierce County, Washington**

Project No. T-8565

Terra Associates, Inc.

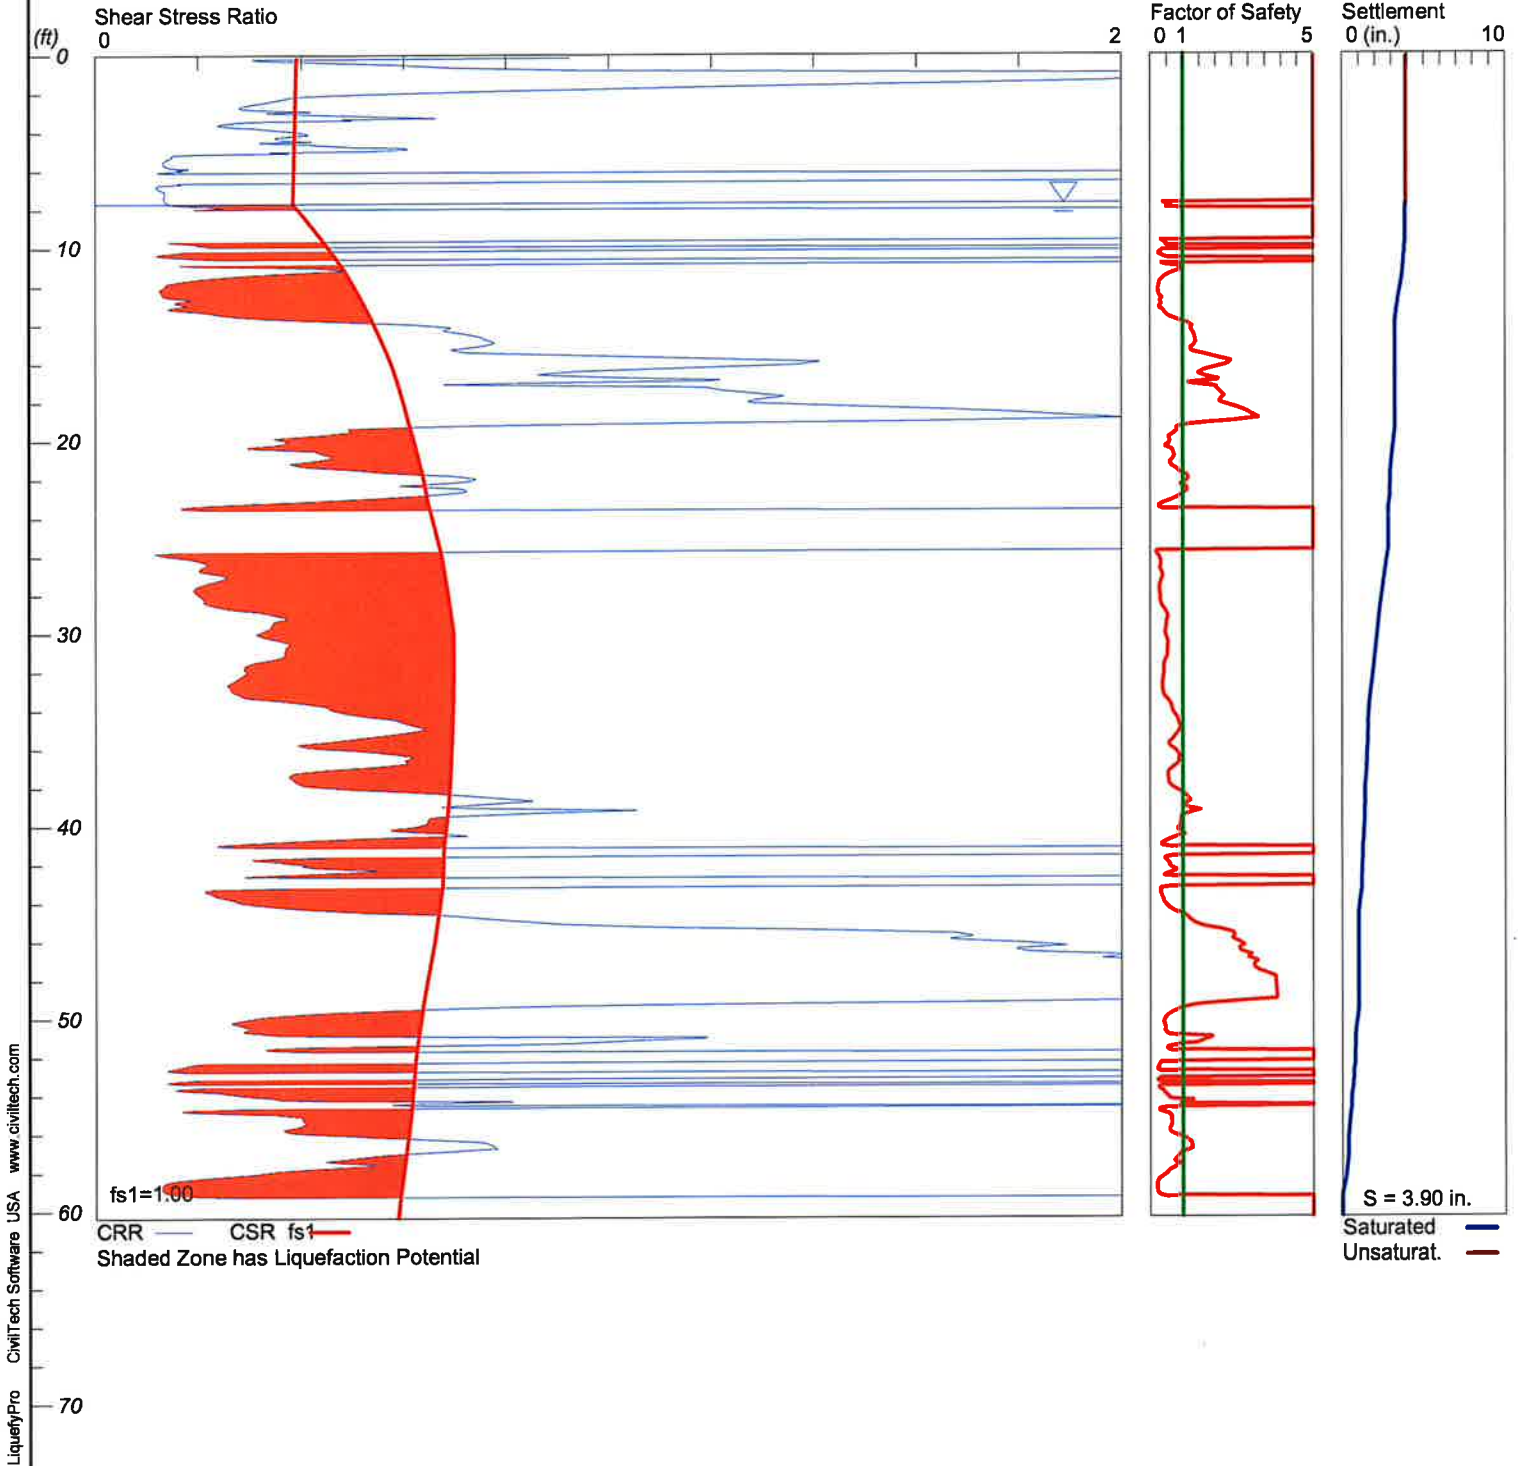
Hole No.=CPT-3 Water Depth=7.7 ft

Magnitude=7
Acceleration=0.6g

The results of our analysis indicate that soil liquefaction could occur during the design earthquake event resulting in total settlements ranging between about 2.8 and 5.8 inches with about one-half of this settlement likely being differential in nature. In our opinion, this amount of settlement would not structurally impair the building. However, cosmetic damage to the structure in the form of misaligned doors and windows, cracking, and floor settlement could occur. Some utility connections may also be impacted. If the owner is not willing to accept the risk of building damage requiring repair should liquefaction-induced settlements occur, foundations should be supported on ground improved using stone columns designed to mitigate soil liquefaction settlements below the building foundations. The results of the liquefaction analysis are attached in Appendix B.
