Stormwater Site Plan

Pierce College Puyallup
Campus Parking Expansion – Lot A
Puyallup, WA
2200718.13

Claire Hovde, PE
Project Engineer

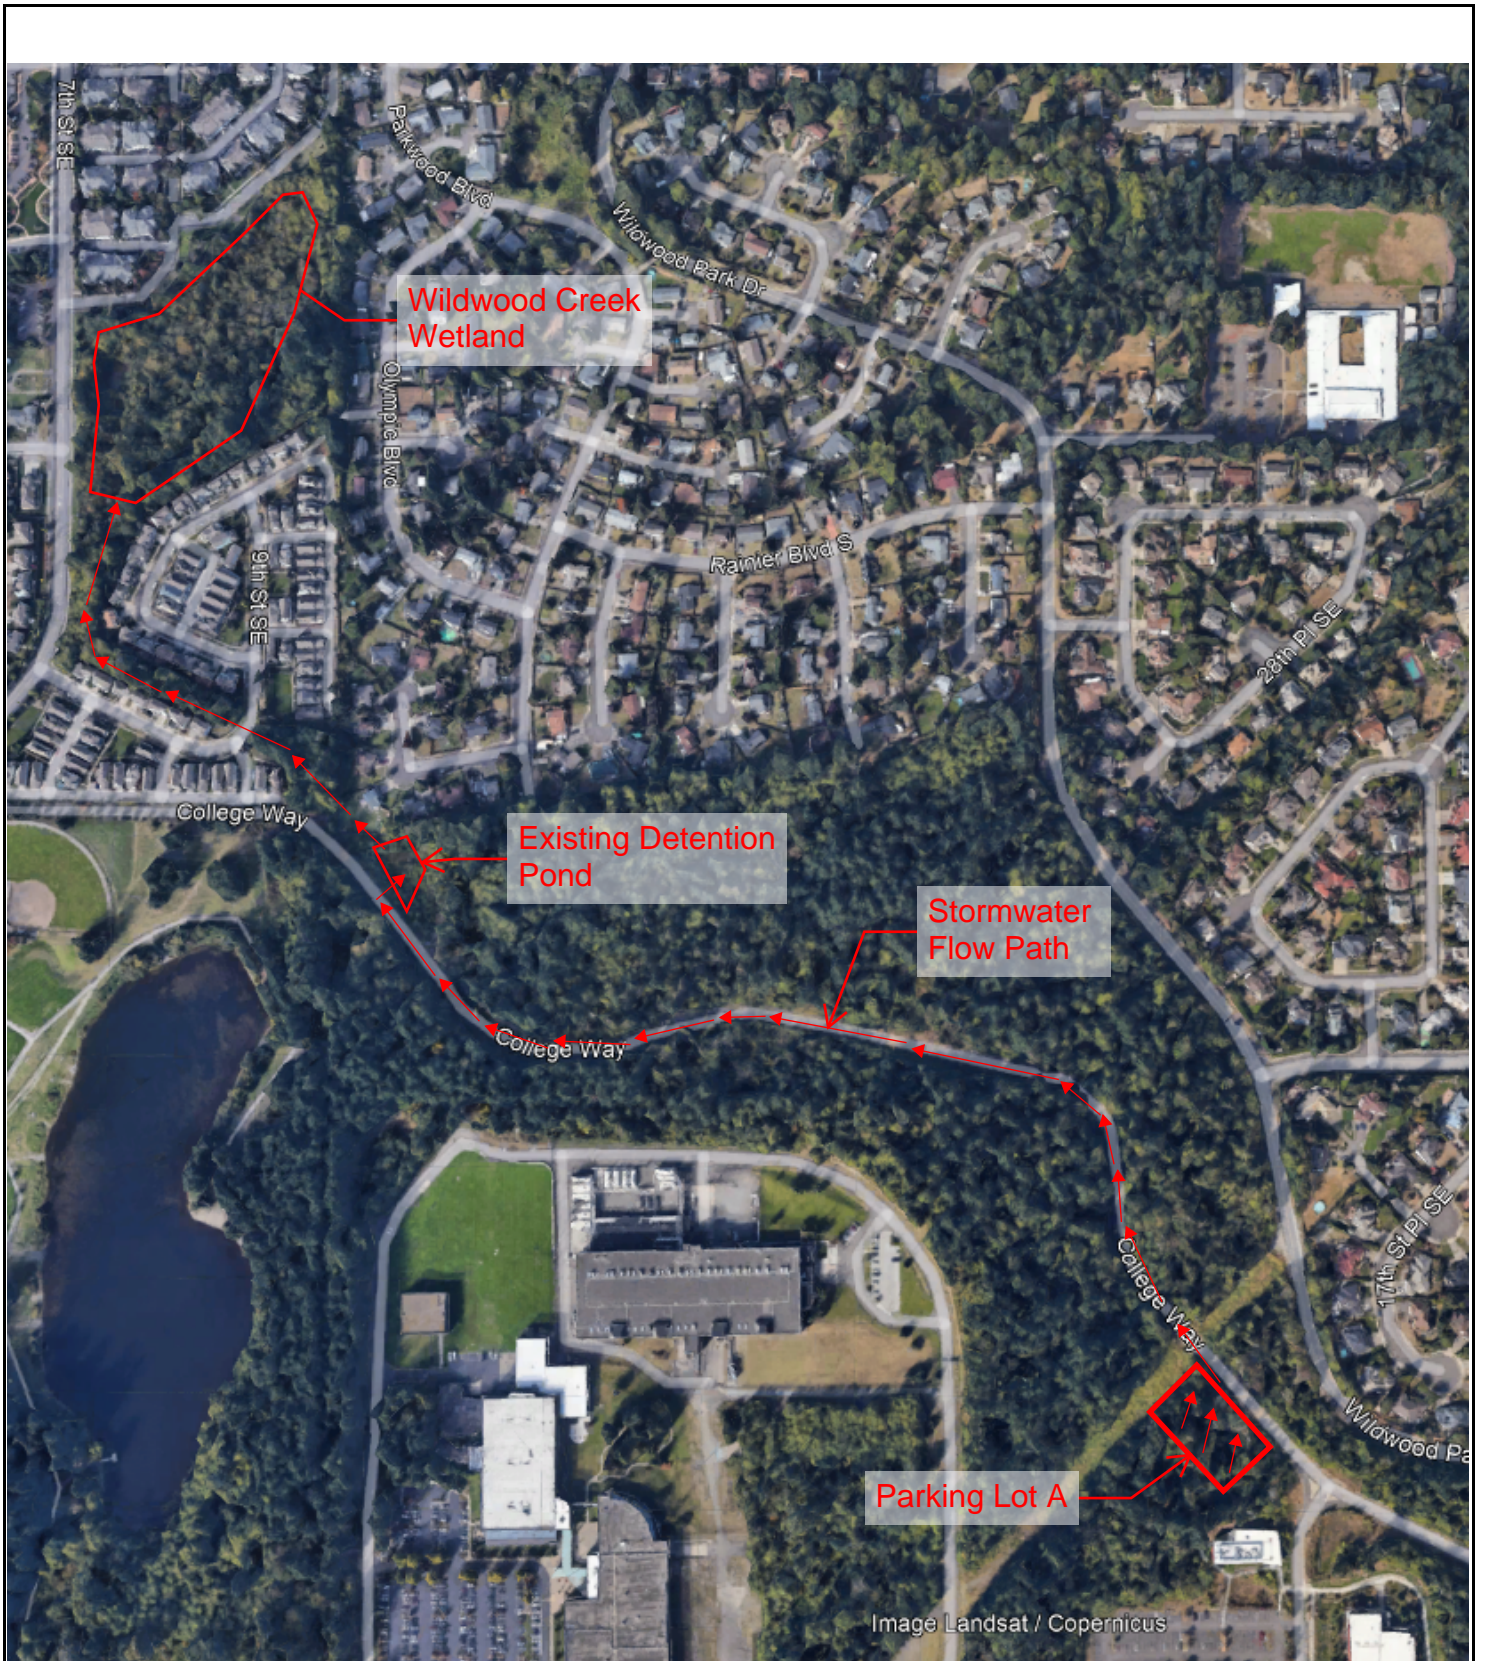
Appendix A-6 Downstream Map

Pierce College Puyallup - Parking Lot A

Parking Lot A is located at the northwest corner of the campus approximately 65 feet north of the existing HEP. Refer to Appendix A-5, Campus Map, for the building location. Refer to Appendix A-6, Downstream Map, for the parking lot location. The site is located within the State Highway Basin. The existing conditions at Parking Lot A consist of a heavily wooded area adjacent to the northwest campus driveway. Topography generally slopes from southwest to northeast. Refer to Appendix A-2, Existing Conditions Map, for more information on the Parking Lot A existing basin.

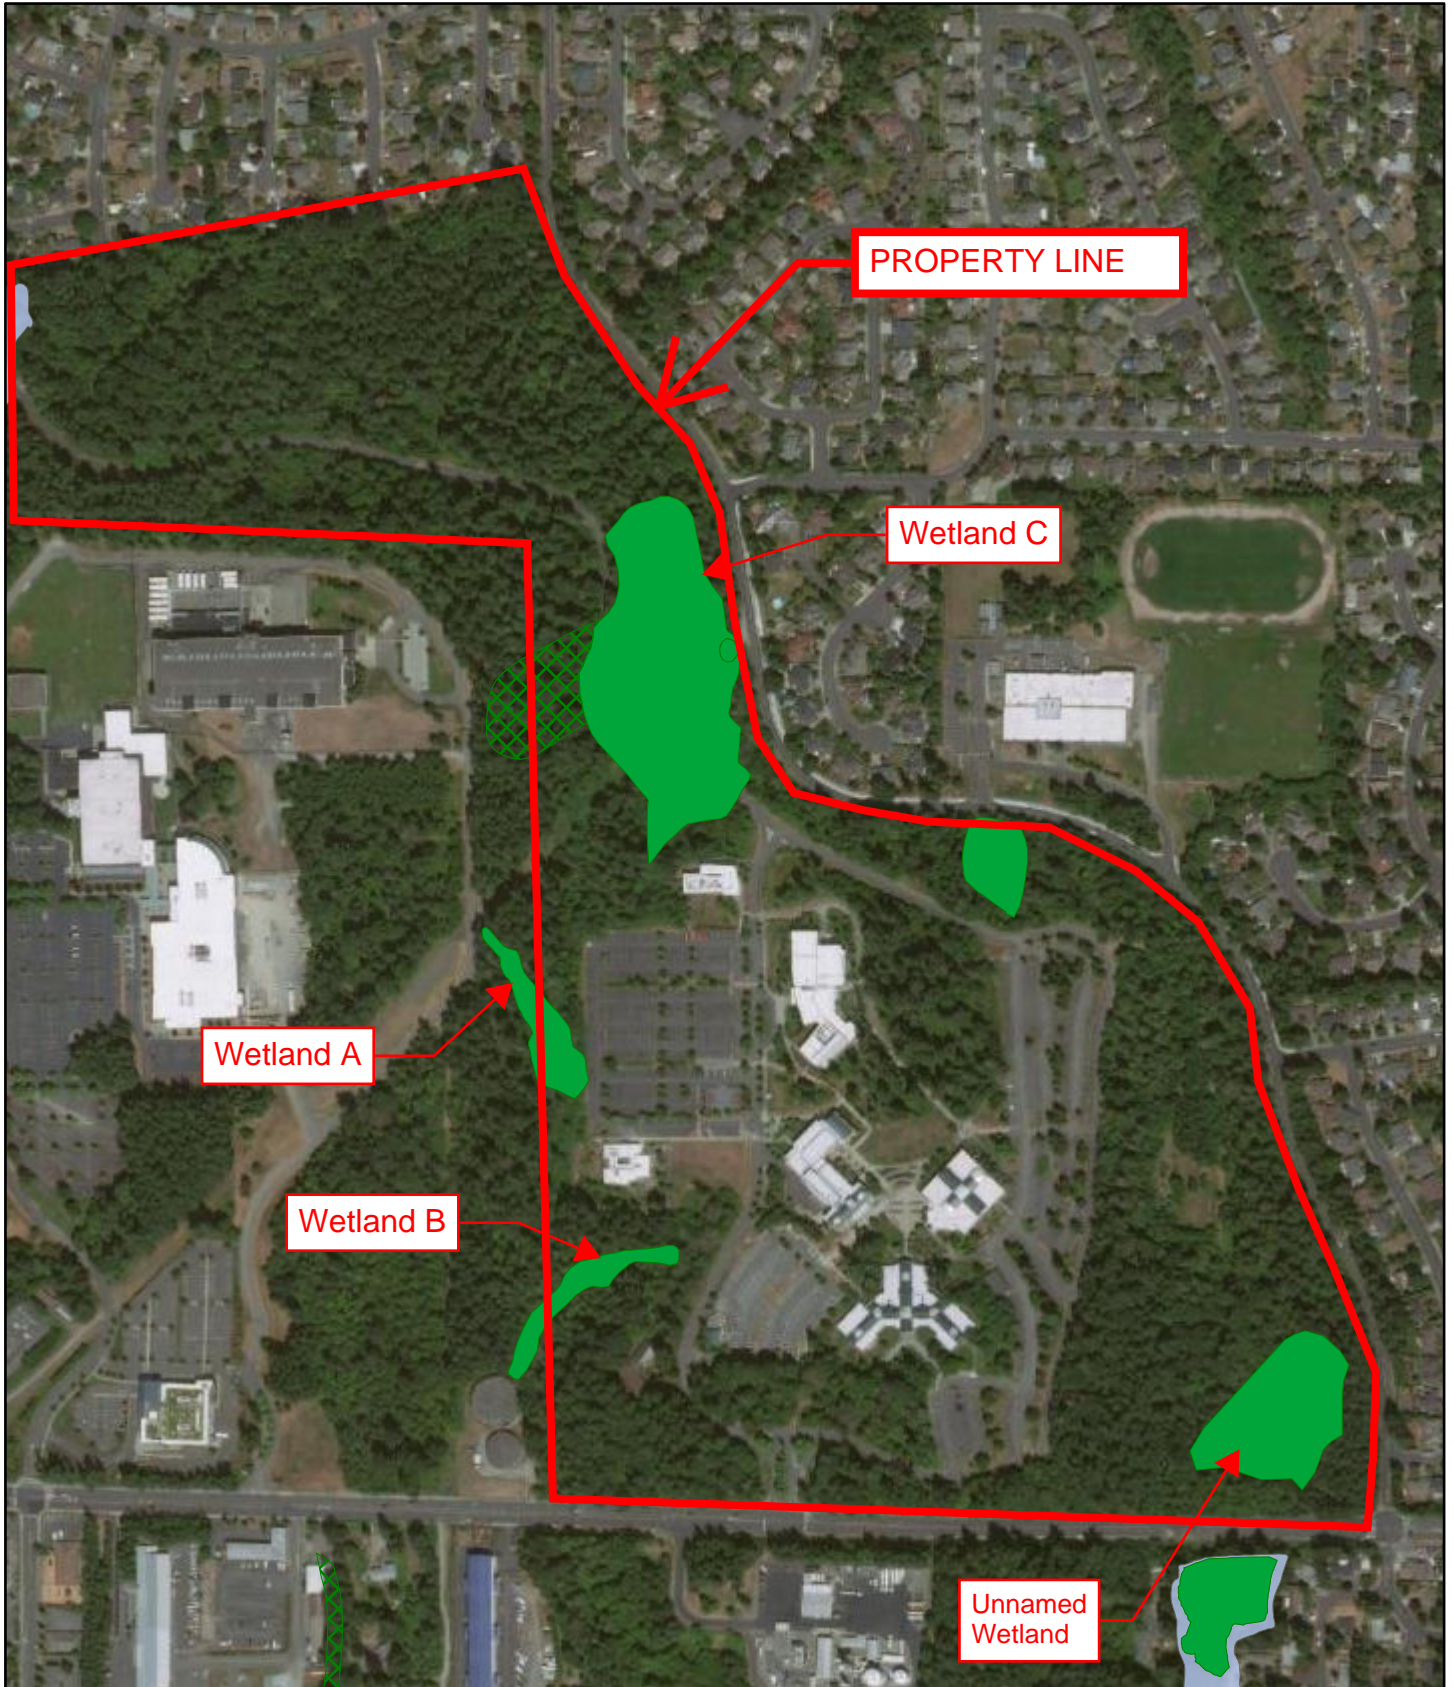
National Flood Hazard Layer FIRMette

The flood hazard information is derived directly from the authoritative NFHL web services provided by FEMA. This map was exported on 6/29/2021 at 4:45 PM and does not reflect changes or amendments subsequent to this date and time. The NFHL and effective information may change or become superseded by new data over time.

According to FEMA, the site is mapped within Zone X, Area of Minimal Flood Hazard. Refer to Appendix A-8 for the FEMA Flood Map.

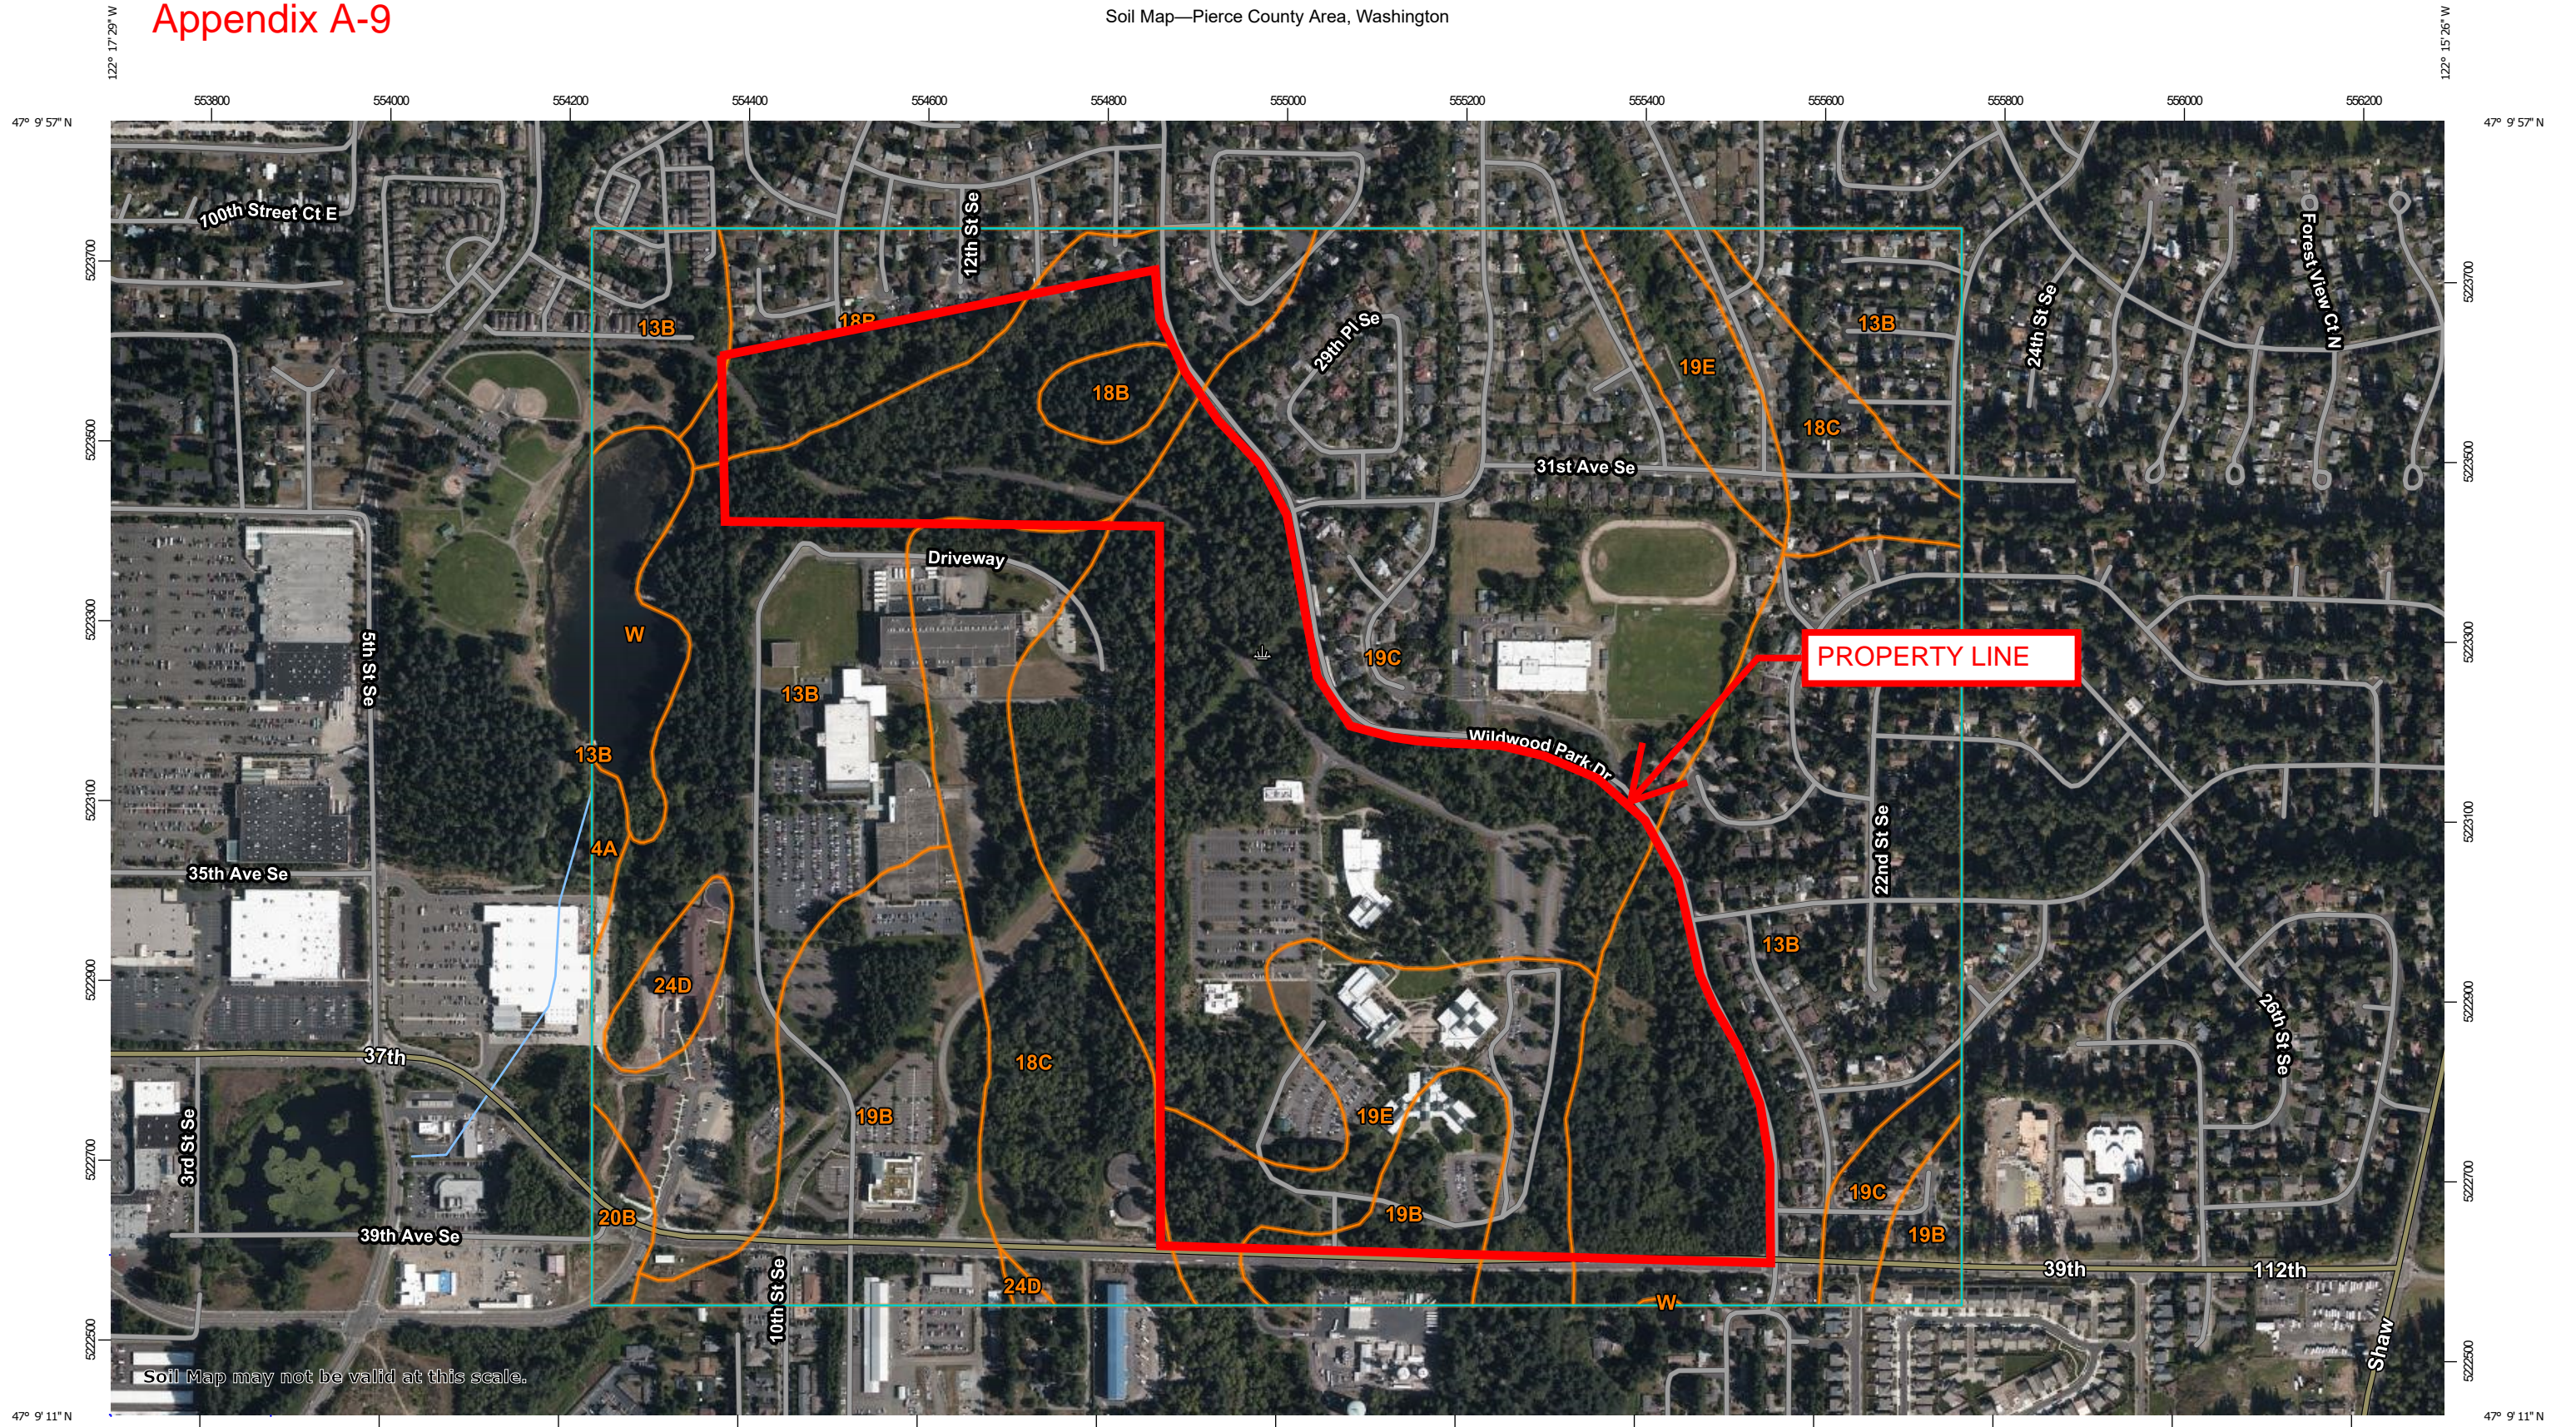
Appendix A-9

Soil Map—Pierce County Area, Washington

Based on the Geotechnical Engineering Services Report by GeoEngineers, dated January 31, 2022, the site is underlain by glacial till. The report notes long-term design infiltration rates ranging from 0.015 to 0.043 in/hr. The long-term design infiltration rate is less than 0.3 in/hr; therefore, infiltration is considered infeasible.

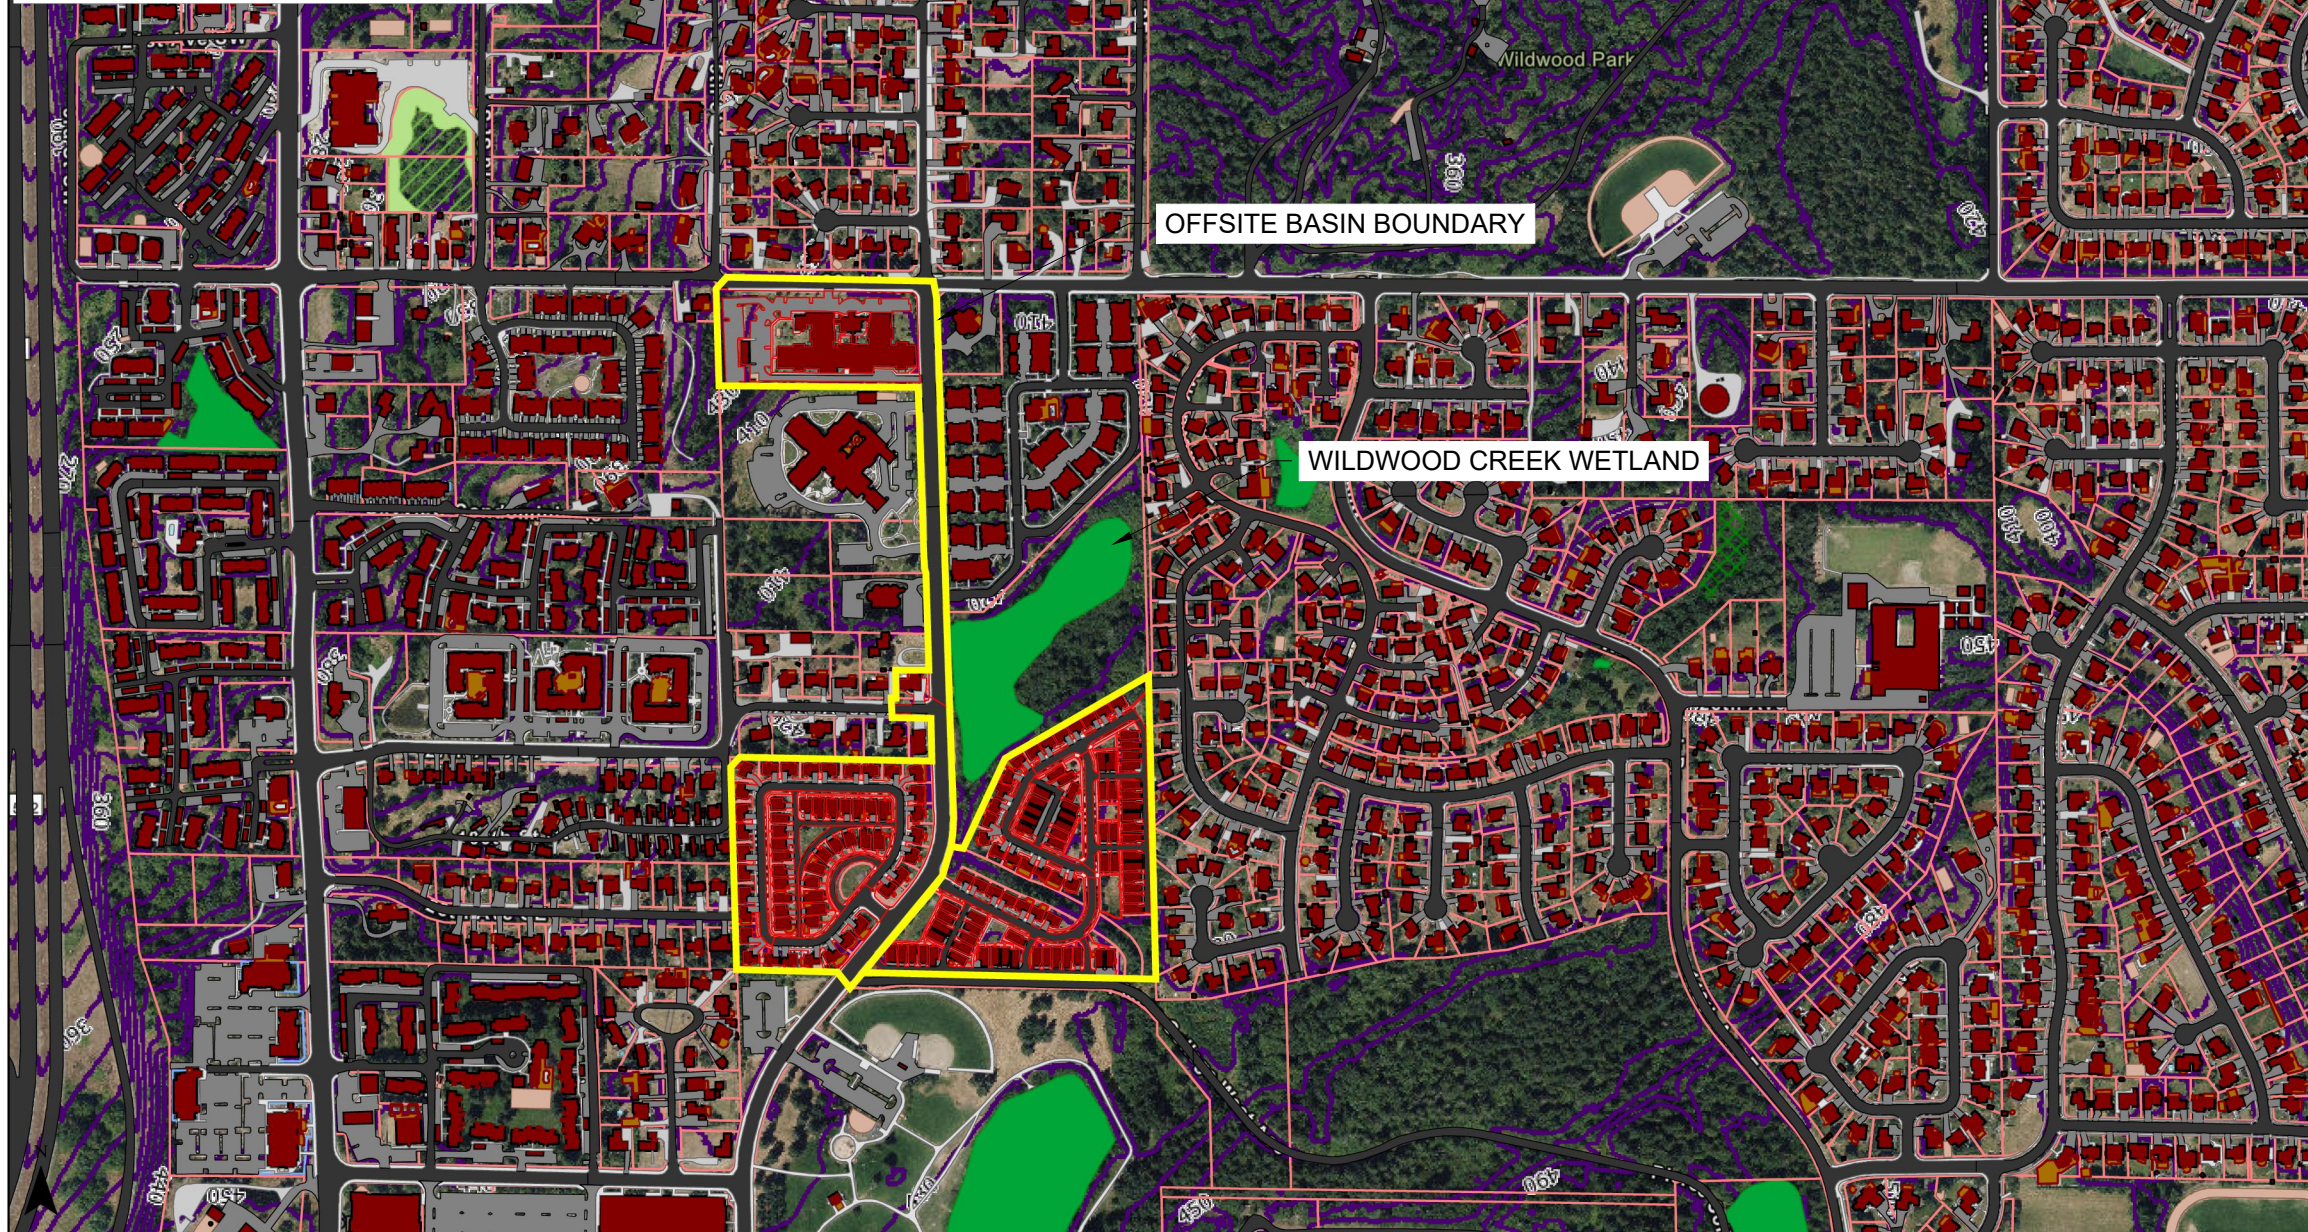
A-11

Total offsite area upstream = 2,659,322 sf (61.05 ac)
 Impervious area = 1,759,131 sf (40.38 ac)
 Pervious area = 900,191 sf (20.67 ac)

PIERCE COLLEGE PUYALLUP
 CAMPUS PARKING EXPANSION
 WETLAND BASIN MAP
 OFFSITE STORM DRAINING TO WETLAND

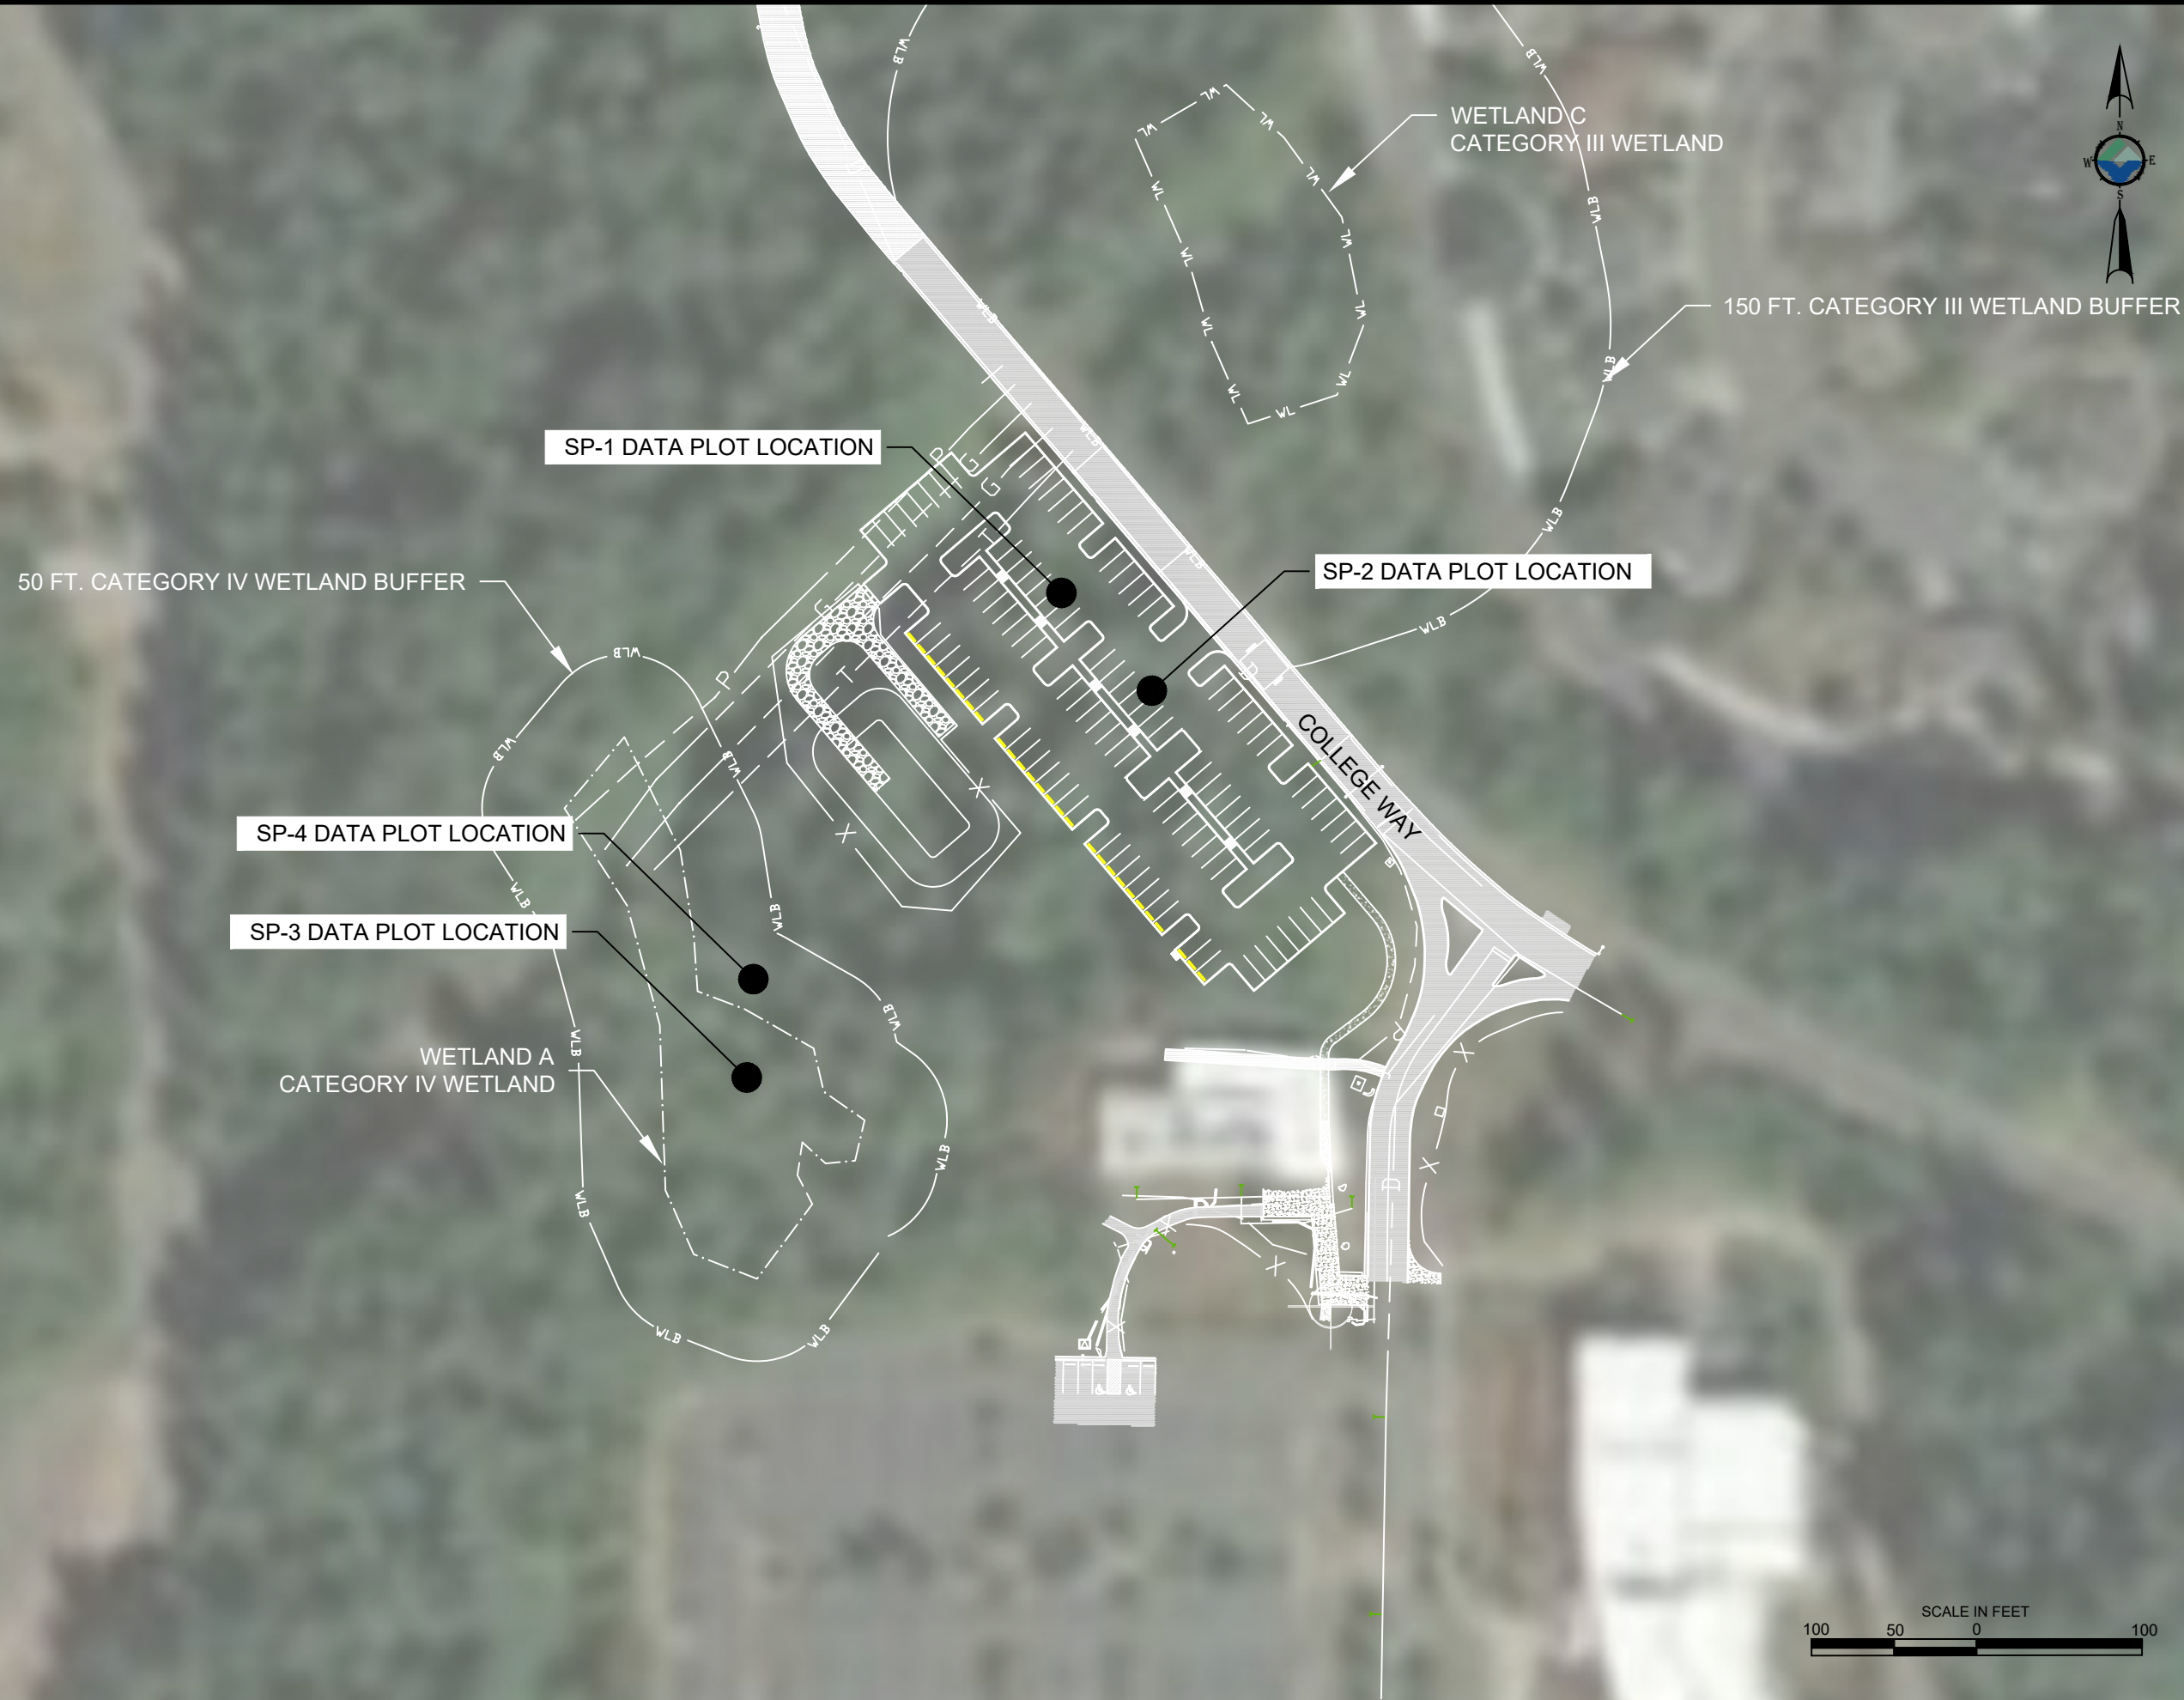
SHEET
1
 OF
3

WETLAND DELINEATION MAP

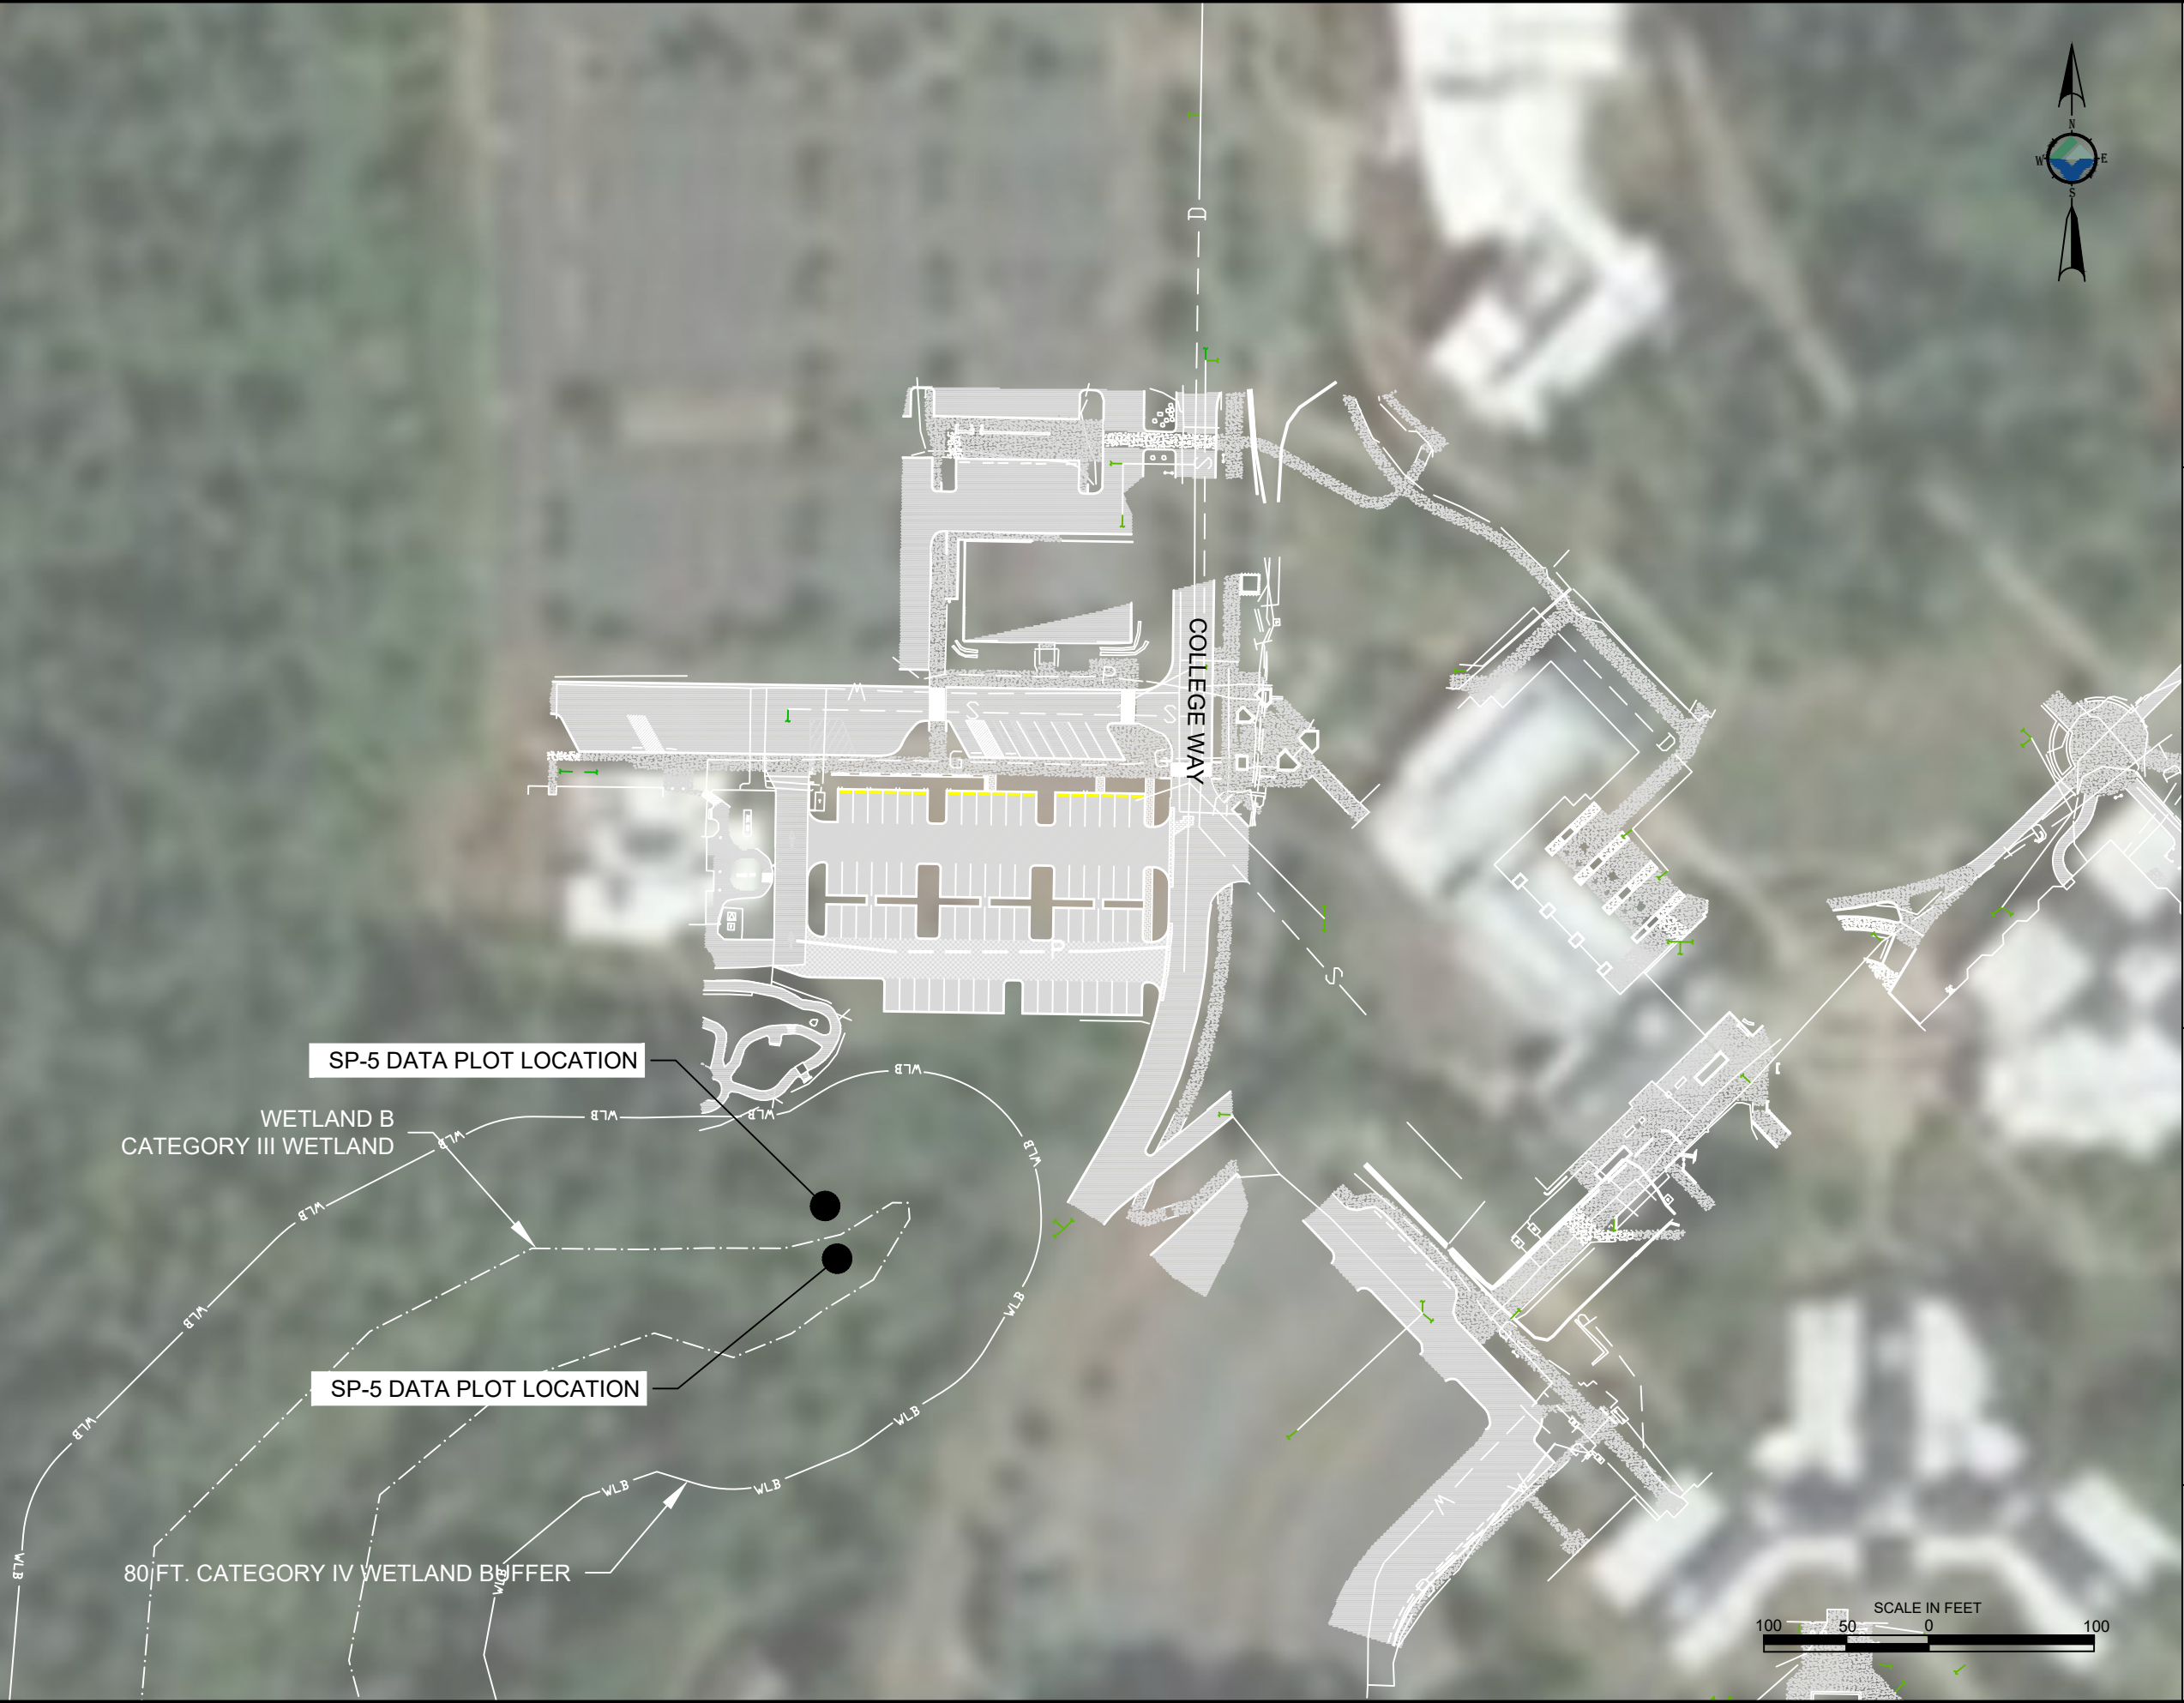
WETLAND DELINEATION MAP

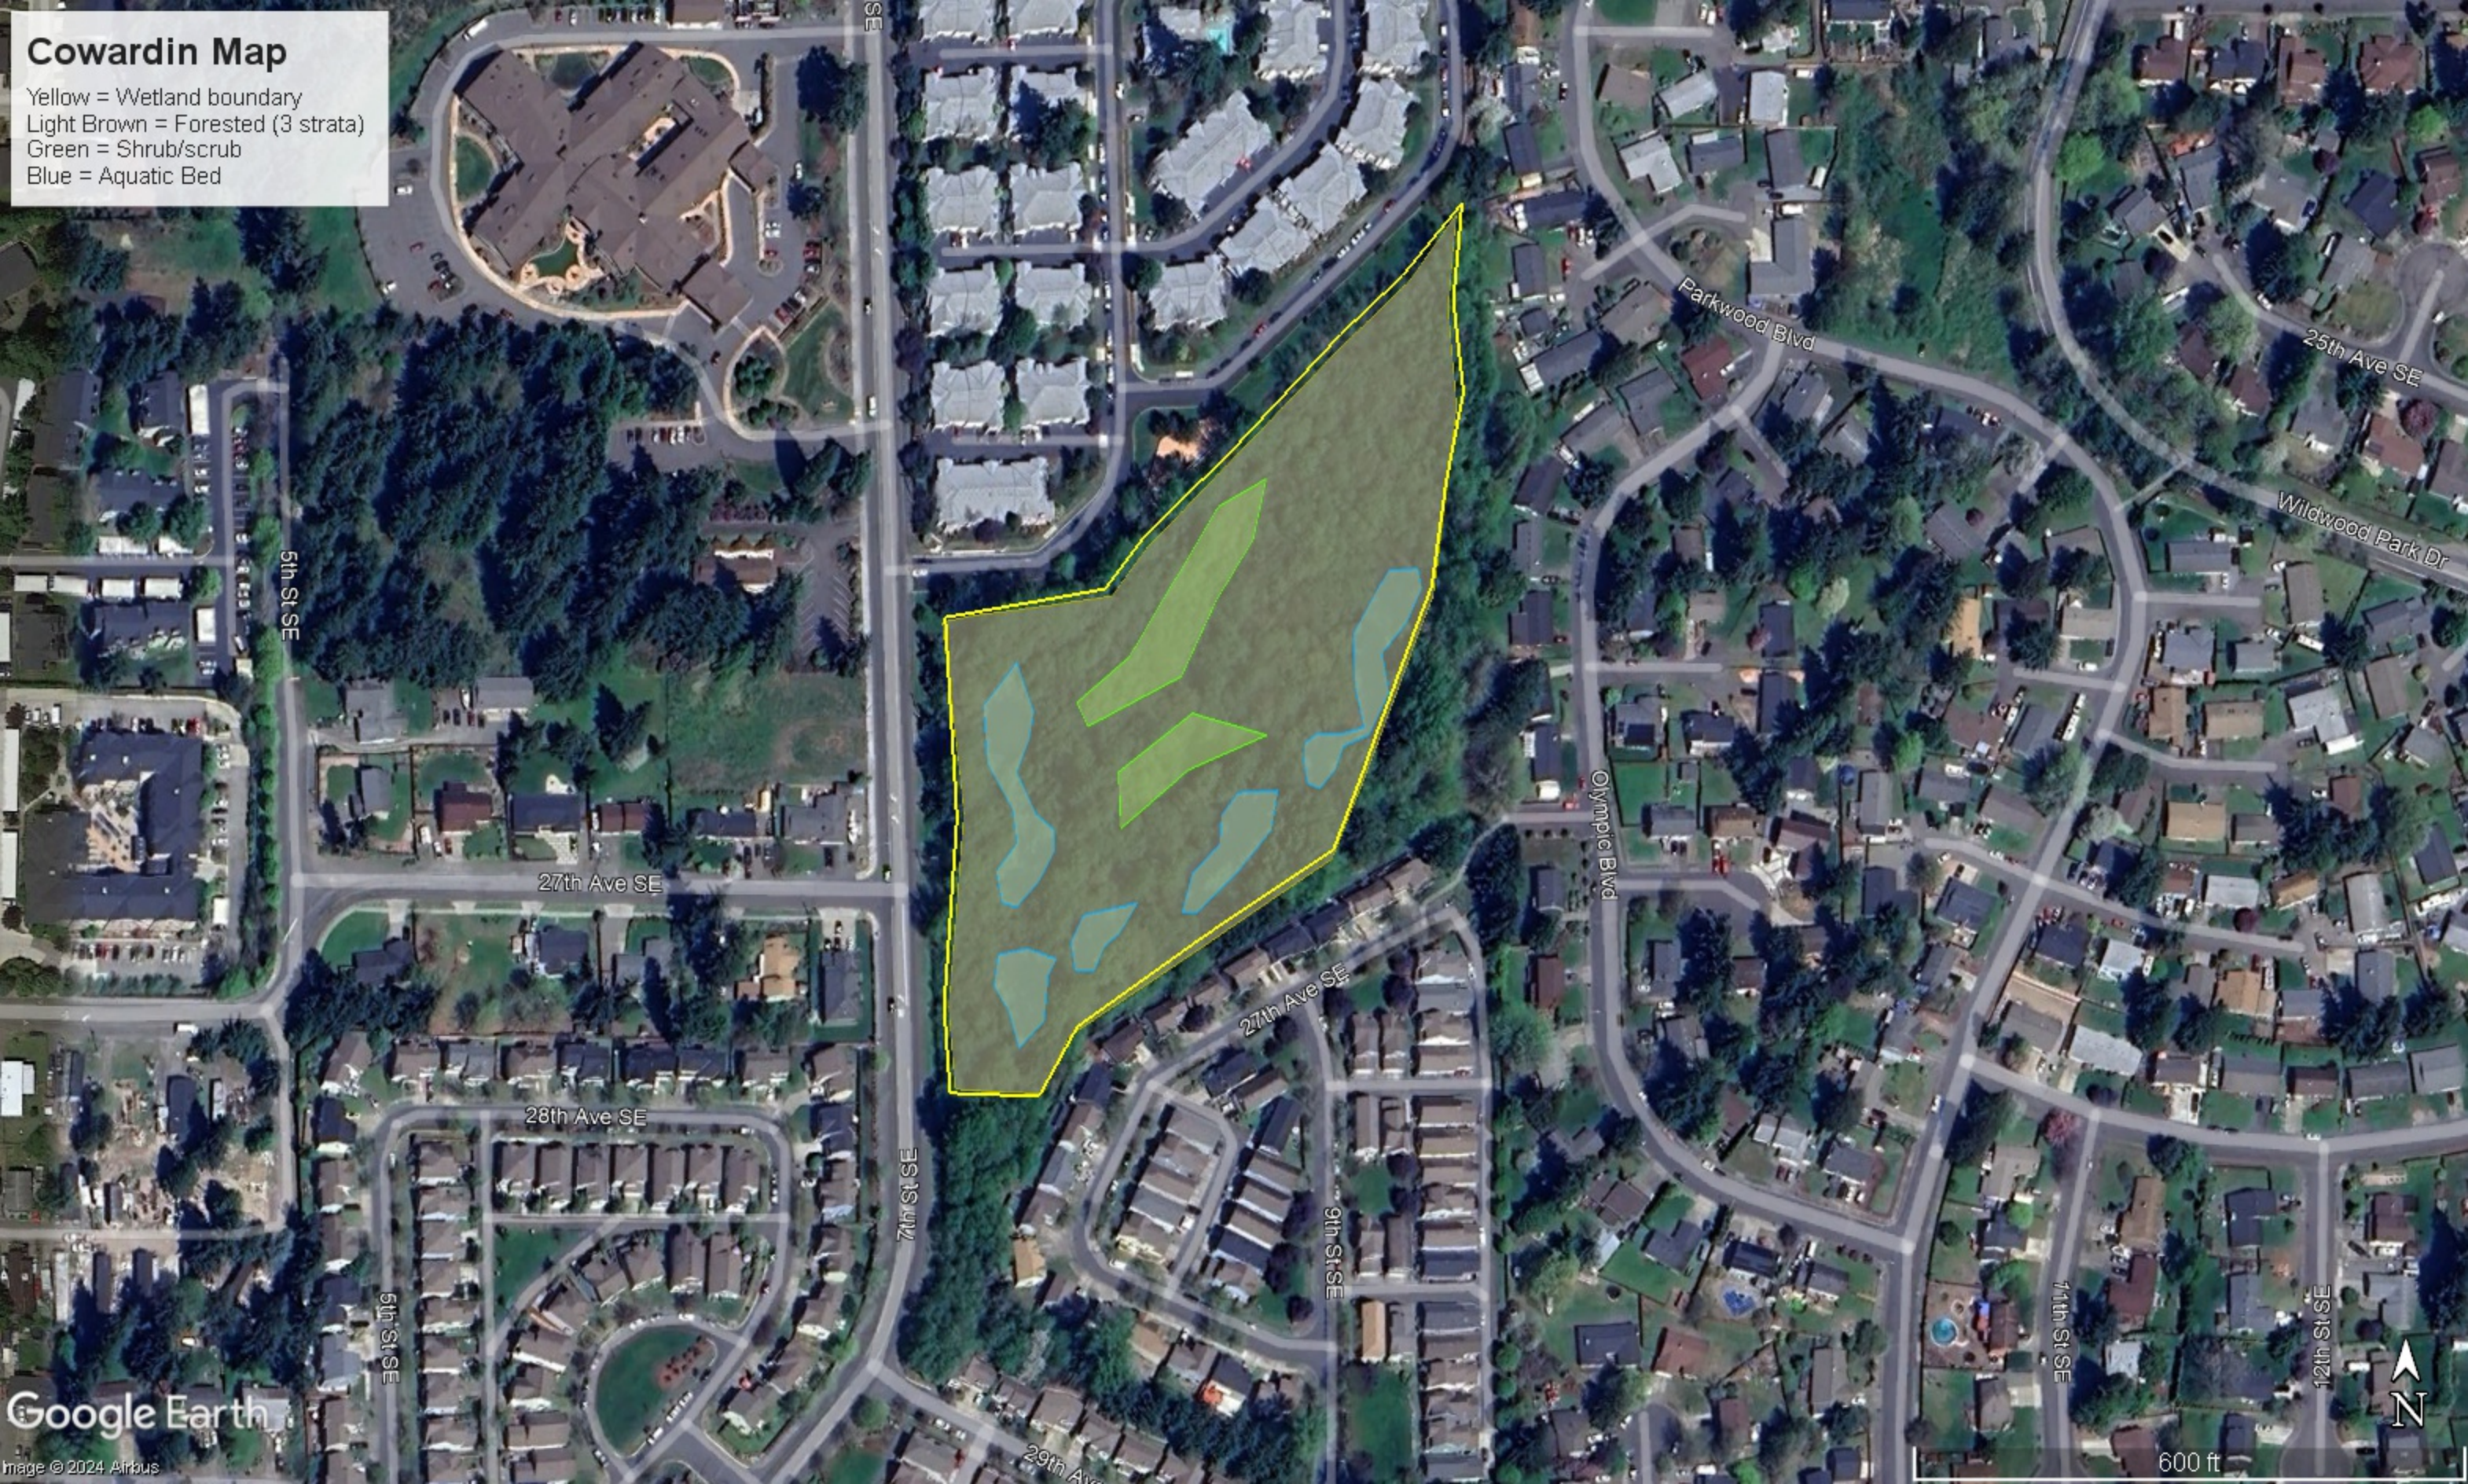
Cowardin Map

- Yellow = Wetland boundary
- Light Brown = Forested (3 strata)
- Green = Shrub/scrub
- Blue = Aquatic Bed
