Stormwater Site Plan

Pierce College Puyallup
Campus Parking Expansion – Lot A
Puyallup, WA
2200718.13

Claire Hovde, PE
Project Engineer

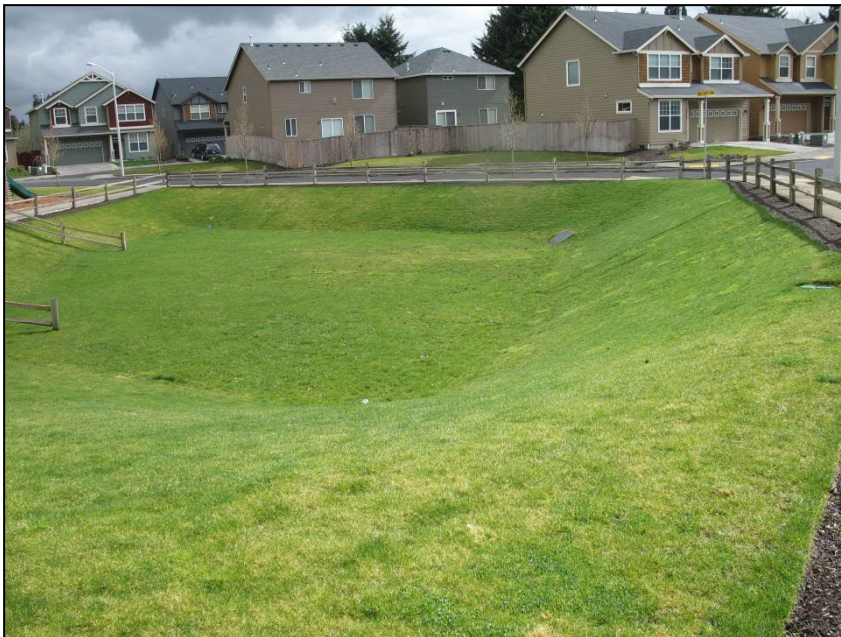
Example of a Manicured Detention Pond

Key Operations and Maintenance Considerations
