**GEOTECHNICAL ENGINEERING INVESTIGATION  
EAST TOWN CROSSING  
PARCEL NOS. 0420264053, 0420264054, 0420351066  
SE CORNER OF E. SHAW ROAD & E. PIONEER WAY  
PUYALLUP, WASHINGTON**

**PROJECT NO. 062-19005  
APRIL 11, 2019**

**GEOTECHNICAL ENGINEERING INVESTIGATION  
EAST TOWN CROSSING  
PARCEL NOS. 0420264053, 0420264054, 0420351066  
SE CORNER OF EAST SHAW ROAD AND EAST PIONEER WAY  
PUYALLUP, WASHINGTON**

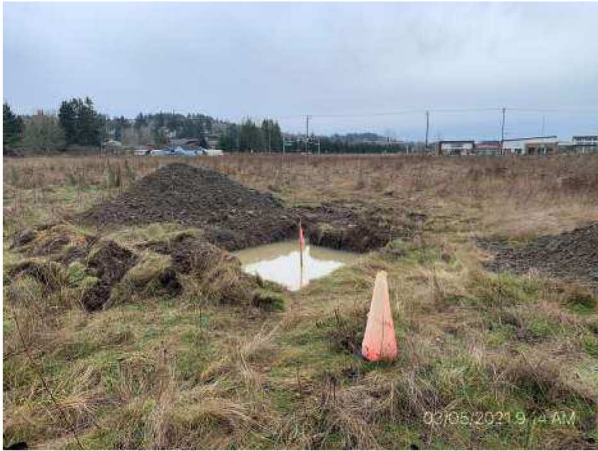
**Water in Pit P-1 on March 5, 2021.**

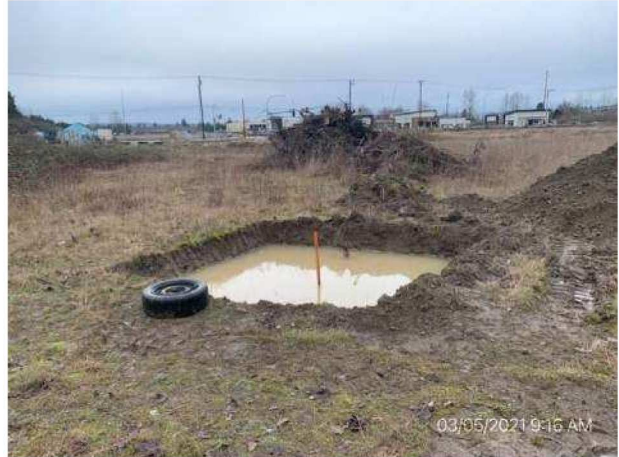
**Water in Pit P-2 on March 5, 2021.**

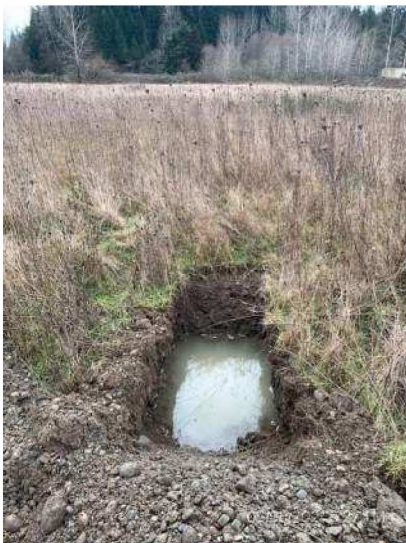
**Water in Test Pit on March 5, 2021. Test pit was excavated in NE portion of site on March 4, 2021.**
