STORMWATER SITE PLAN  
FOR  
PUYALLUP DUPLEXES

# STORMWATER SITE PLAN

## Puyallup Duplexes City of Puyallup, Washington

REPORT #20069

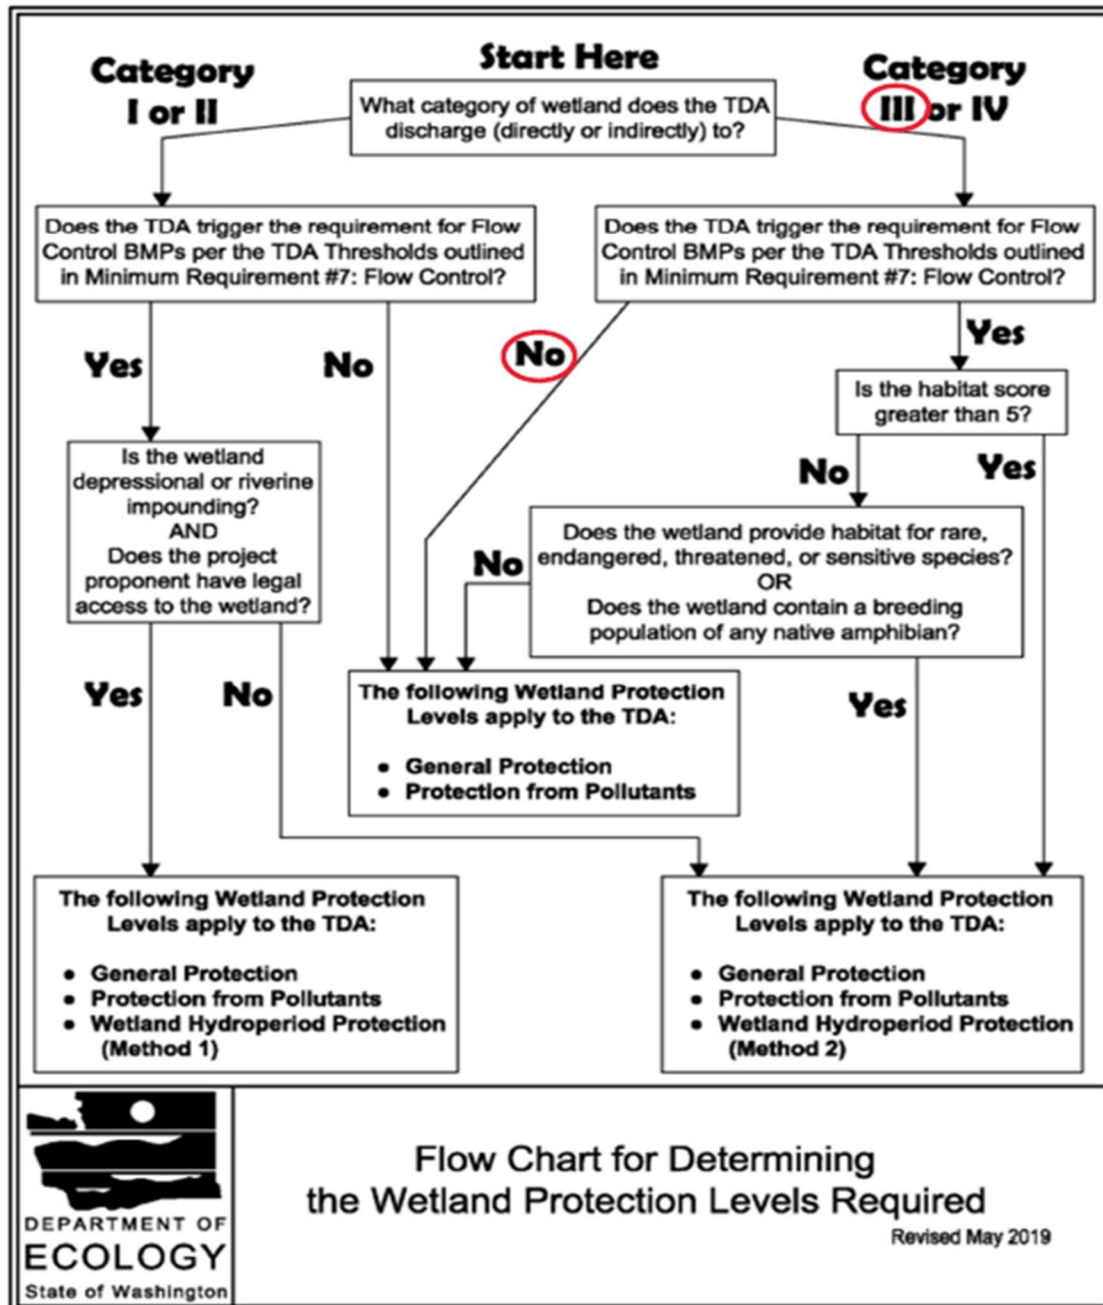
**Figure I-3.5: Flow Chart for Determining Wetland Protection Level Requirements**

outside of the required 60' wetland buffer, installing temporary silt fence protecting the wetland during construction, and by installing permanent buffer signs staked every 50' around the perimeter of the wetland buffer. Protection from Pollutants will be achieved by directing stormwater runoff from pollution generating impervious surfaces away from the wetland other than those surfaces that currently drain to the wetland under existing conditions.

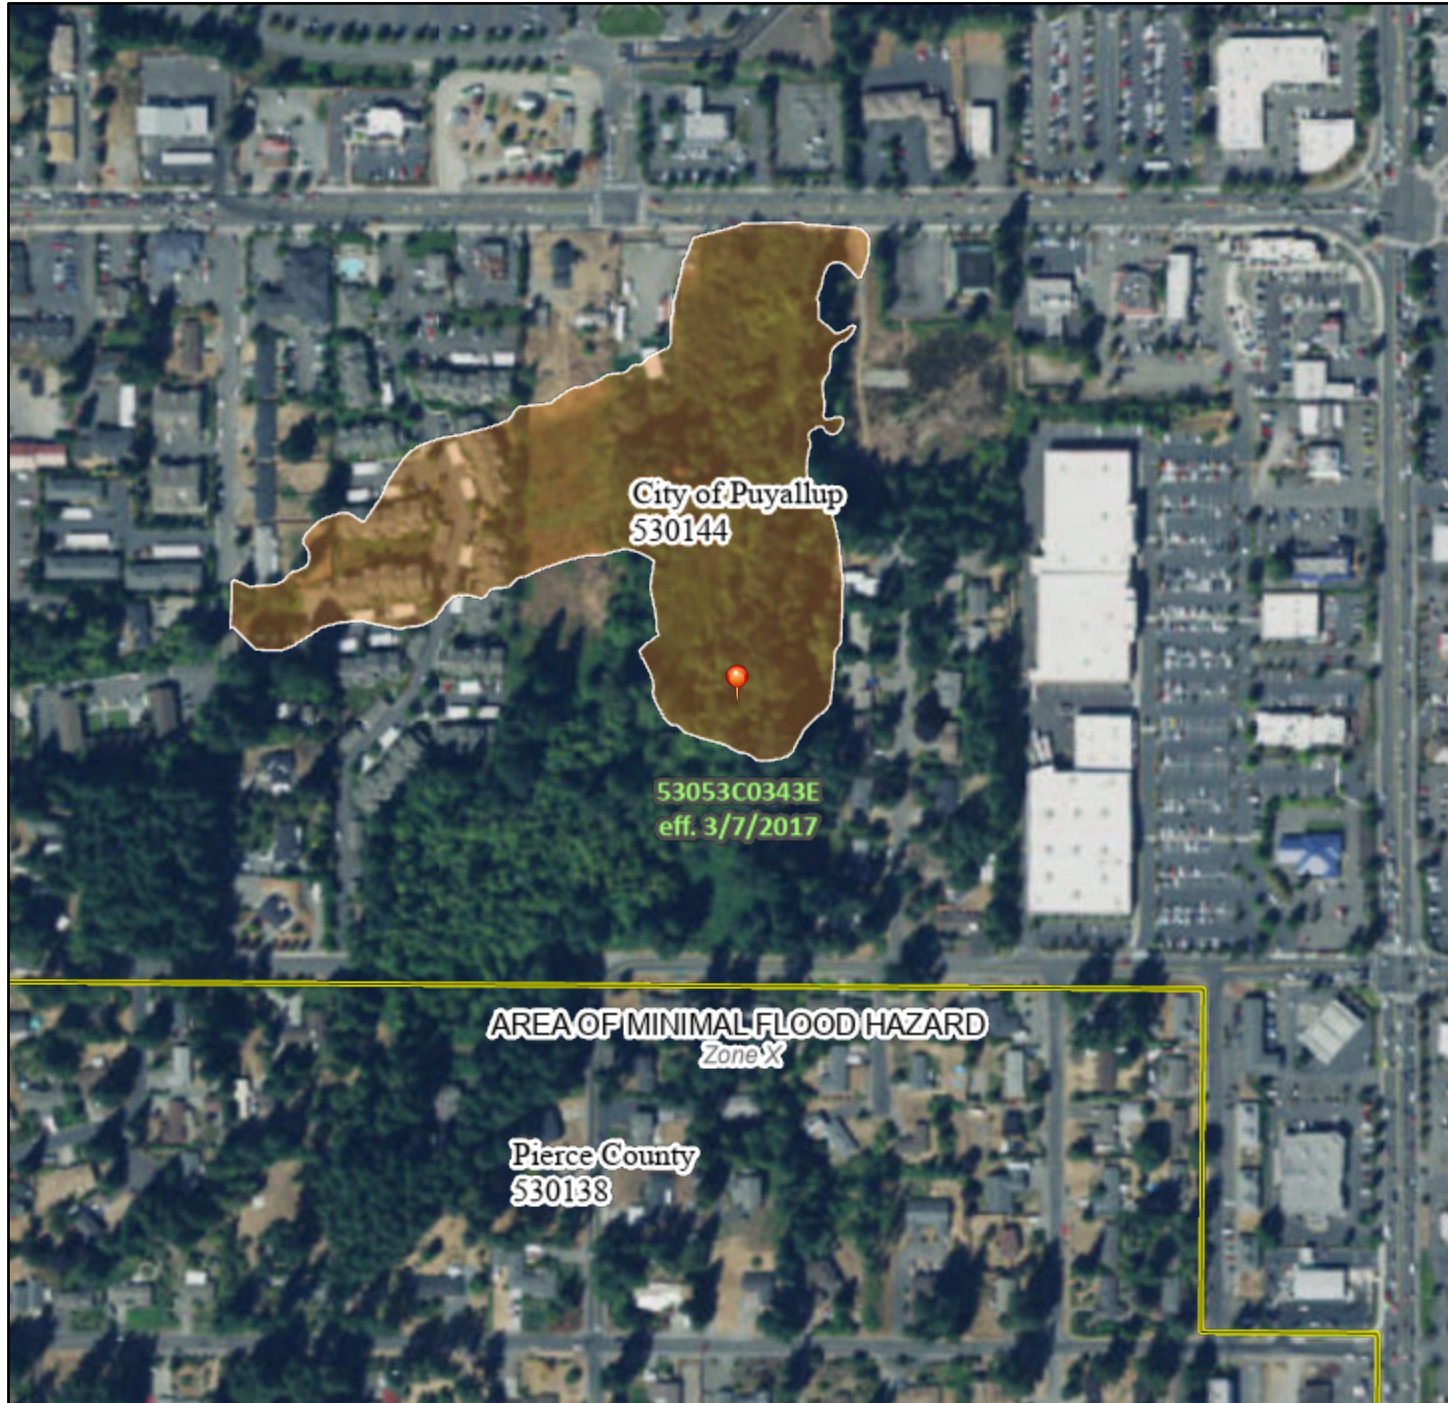
# National Flood Hazard Layer FIRMette

Federal Emergency Management Agency (FEMA) has prepared flood insurance maps identifying floodplains within the City of Puyallup. Based on FIRM map 53053C0343E), The parcel and all the proposed improvements are located within Zone X, which is the area determined to be outside the 500-year flood and protected by levee from the 100-year flood. A copy of the FIRM Panel 53053C0343E can be found in Appendix “A” of this report.

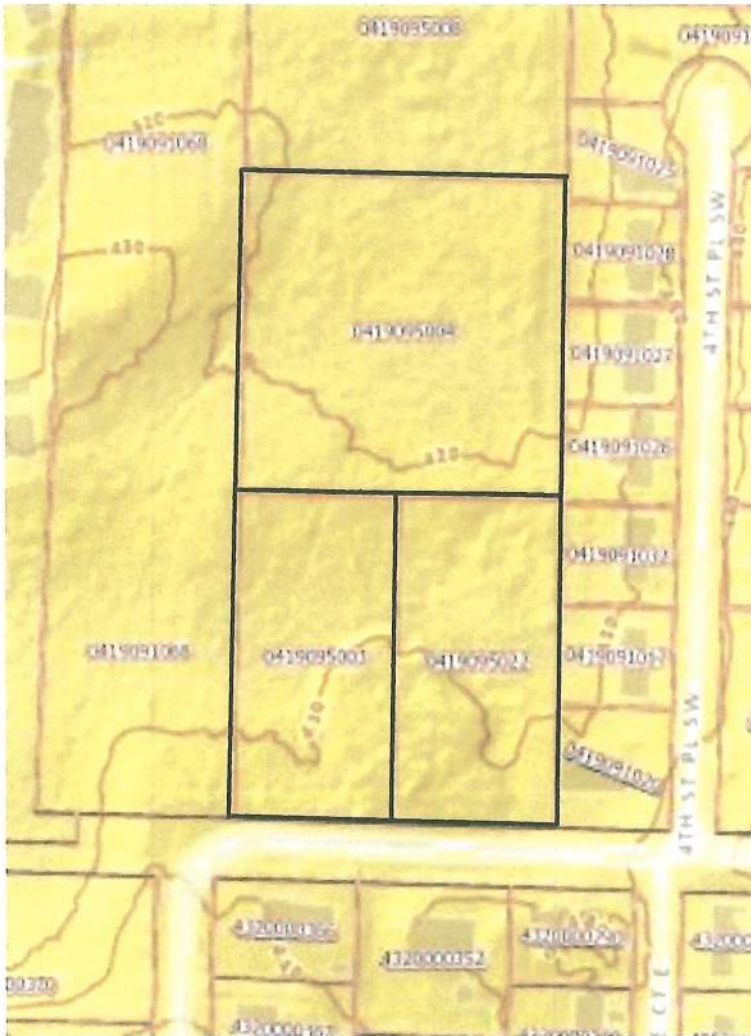
The project involves of three parcels located north of 43<sup>rd</sup> AV SW (116<sup>th</sup> ST E) between 4<sup>th</sup> ST PL SW and 98<sup>th</sup> AV E on South Hill, Puyallup. The two southern lots are currently being developed; the northern lot will not be developed at this time. The two southern parcels are 54,450 sf each (1.25 ac.) and the

northern parcel is 109,336 sf (2.51 ac). The vacant land is covered with berry vines and a few hardwood and conifer trees. Topographically the surface of the three lots is best described as nearly level with a rolling surface descending gently to the northeast and northwest. There are isolated areas with short moderate slopes with grades measured in the field of less than 5%.

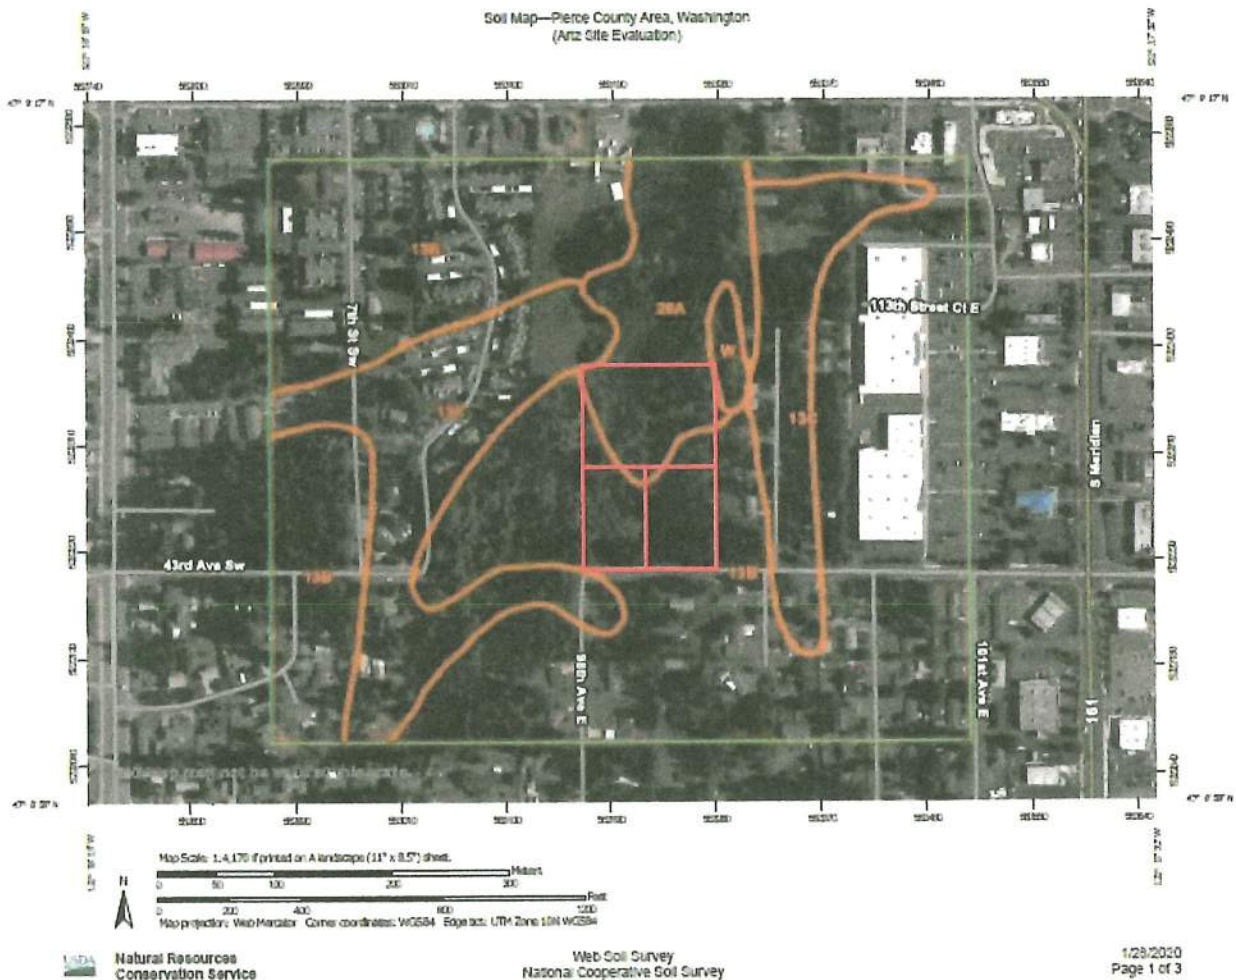
Map Unit Symbol	Map Unit Name	Acres in AOI	Percent of AOI
13B	Everett very gravelly sandy loam, 0 to 6 percent slopes	49.2	67.6%
13C	Everett very gravelly sandy loam, 8 to 15 percent slopes	16.3	22.3%
28A	Norma fine sandy loam	6.7	9.1%
W	Water	0.8	0.9%
Totals for Area of Interest		72.9	100.0%

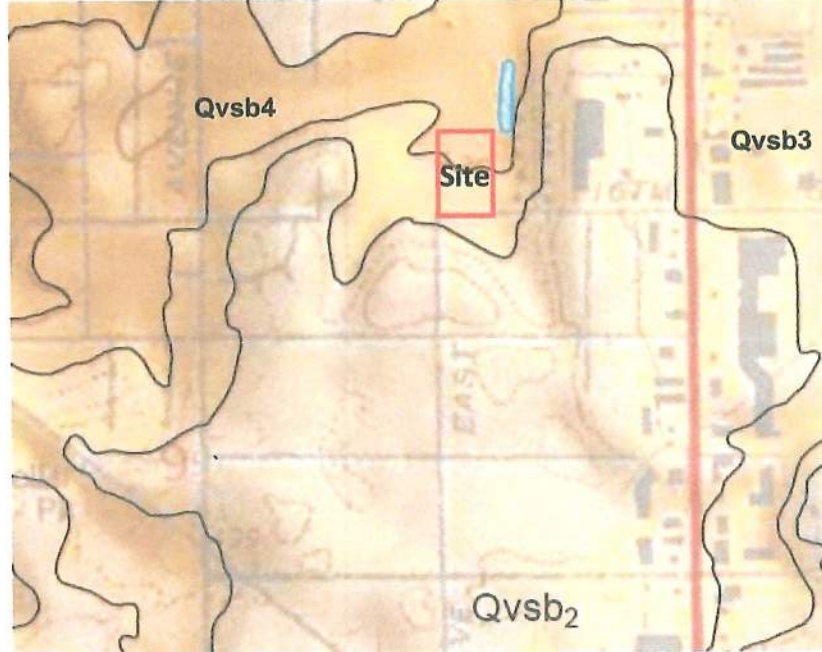
**USGS Geologic Map of the Puyallup 7.5 Minute Quadrangle (Excerpt)**

According to the USGS *Draft Geologic Map of the Puyallup 7.5 Minute Quadrangle* in Figure 2 below: this plateau region was formed by the gradual emplacement glacial drift stratigraphy; followed by the erosion of the previously emplaced glacial drift deposits by channelized glacial meltwater incision along the west side, and by ice lobe truncation within the Puyallup valley. The map shows that the slope section dipping to the northeast provides a depositional record of the pre-vashon mixed fine and coarse deposits, overlain by the Vashon advance outwash, overlain by the Vashon till, and finally overlain by the Vashon recessional outwash. The slope face represents the location where the much larger glacier within the valley truncated the slope face thus exposing a stratigraphic record of deposits. Figure 2 illustrates the site's position relative to the geology.

Qvs	Steilacoom Gravel of Walters and Kimmel (1968)—Sandy gravel and cobbles; clean to silty; poorly to well sorted; horizontally to cross bedded; loose to dense. Deposits vary from veneer of 1 to 15 m (3 to ~ 50 ft) thick. Deposited by multiple outburst floods from subsequently lower elevations of Glacial Lake Puyallup. Locally subdivided first by channel affiliation (Clover Creek or Bradley) and secondarily by relative age in descending series of deposits; higher number denotes younger (lower) deposit. Clover Creek channel (Bretz, 1913) begins in section 8, T19N, R4E. Bradley channel; herein named for Lake Bradley in section 3, T19N, R4E; begins in section 2, T19N, R4E. Numbering system contiguous w/adjacent Tacoma South quadrangle where multiple Clover Creek deposits are mapped (Troost, 2006). Mapable deposits consist of:
Qvs 221	Clover Creek deposit at elevation ~380 ft
Qvs 24	Bradley deposit at elevation ~400 ft
