## Geotechnical Engineering Services Report

Pierce College Puyallup – STEM Building Design Study  
Puyallup, Washington

**File No. 21342-002-00**

**January 21, 2021**

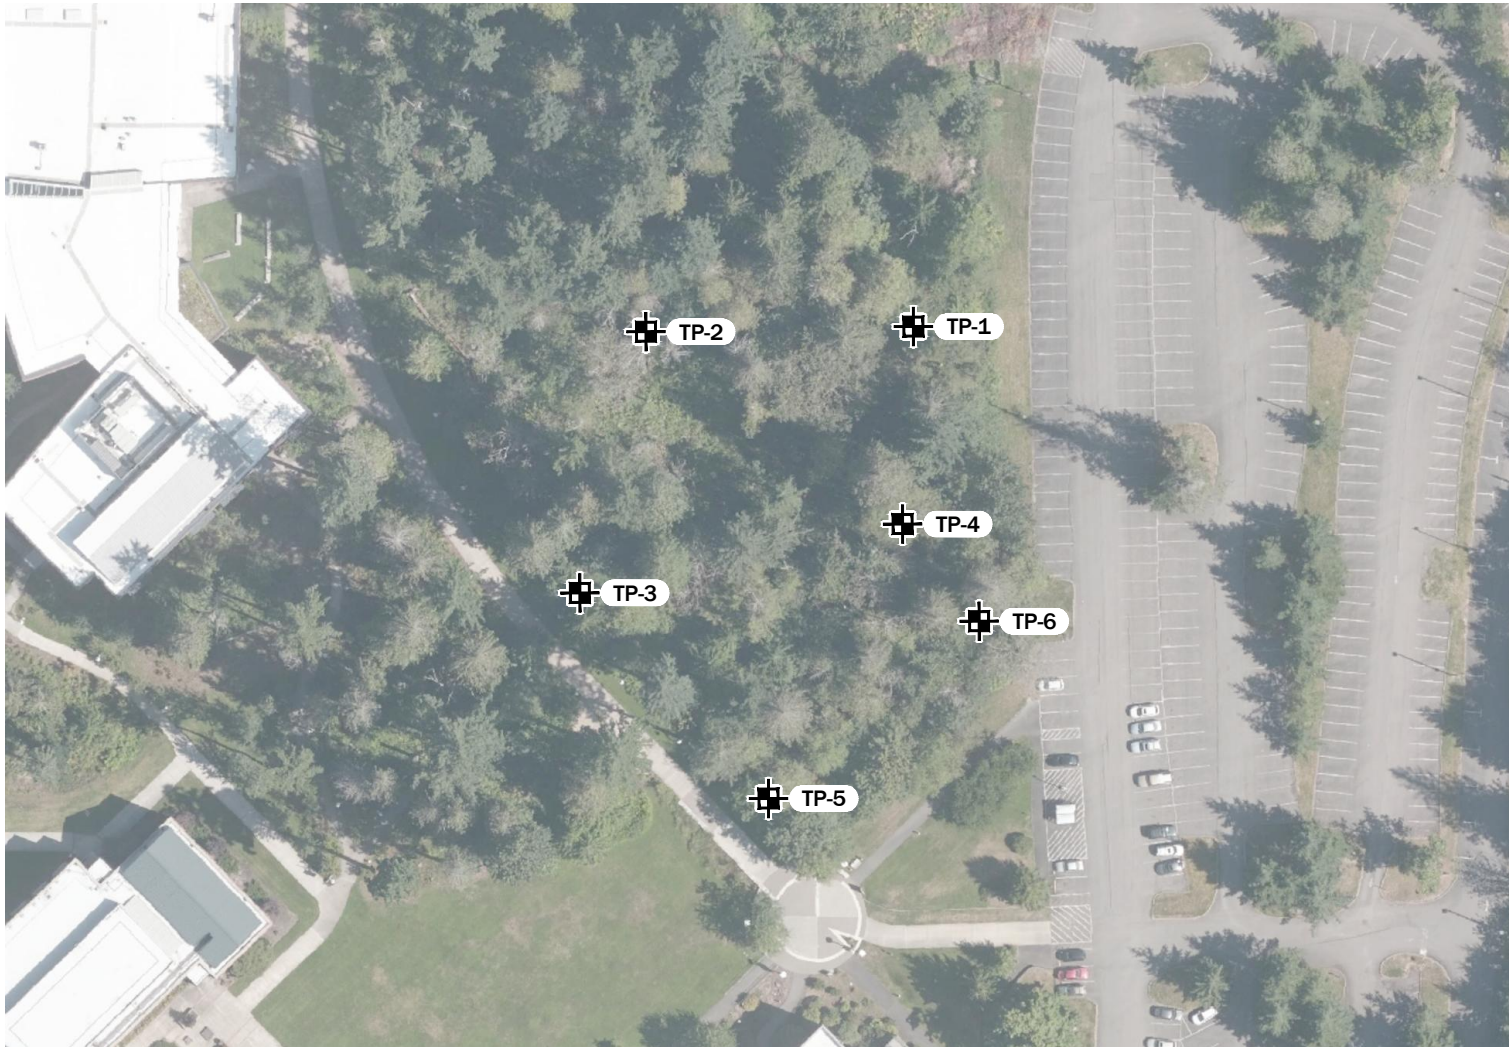
We explored subsurface conditions at the site by excavating six test pits (TP-1 through TP-6) at the approximate locations shown on the attached Site Plan, Figure 2. A description of our subsurface exploration program and summary exploration logs are provided in Appendix A.
