Stormwater Site Plan – Frontage Improvements

East Town Crossing
2902 E Pioneer
Puyallup, WA 98372
2230752.10

April 2024

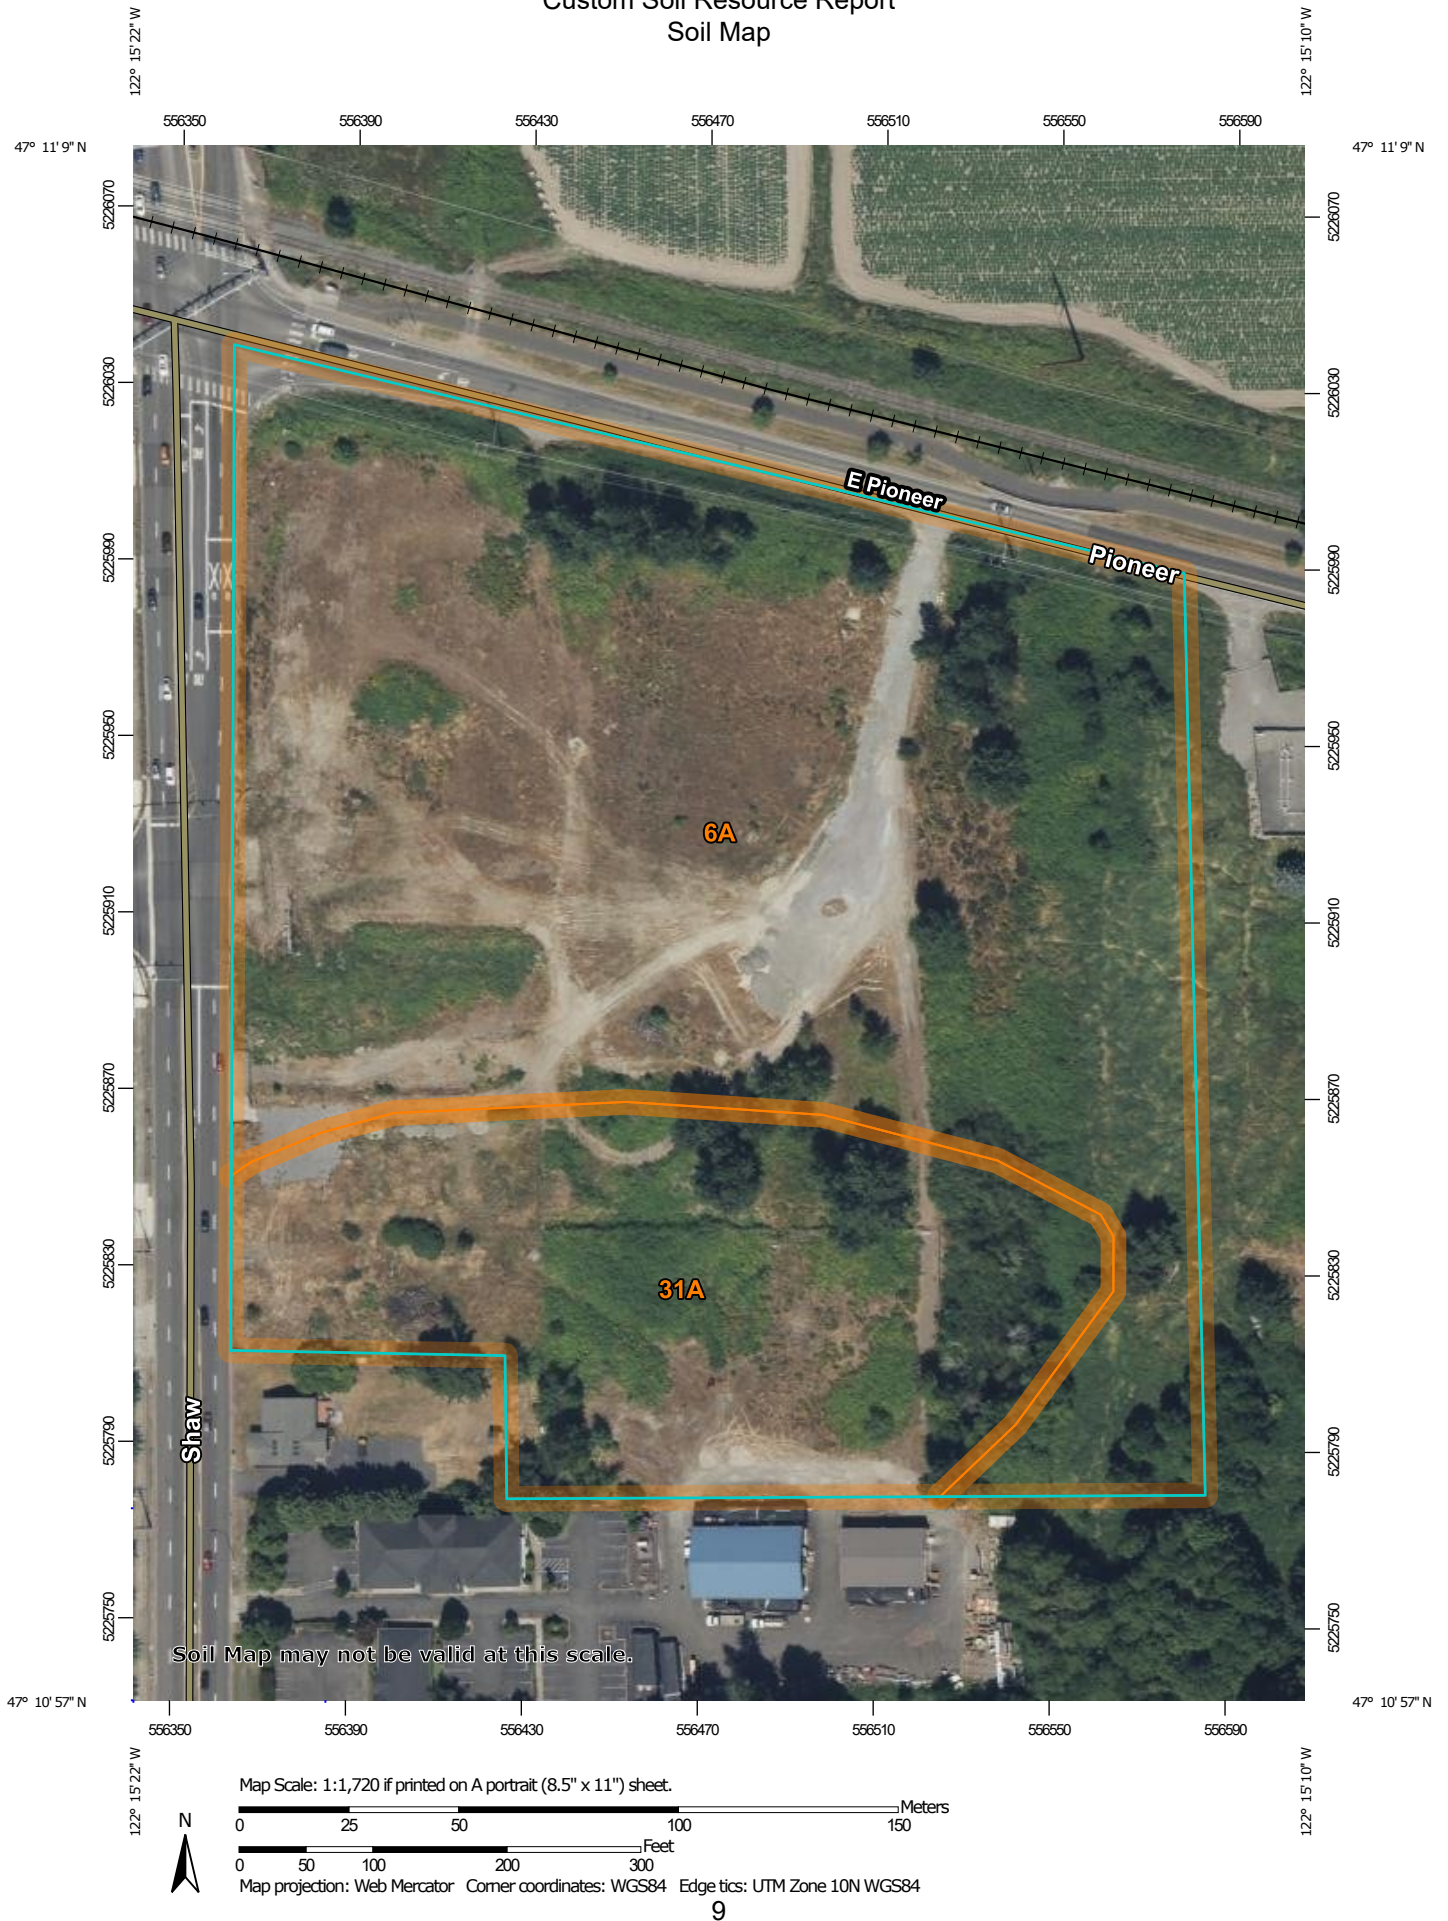
Custom Soil Resource Report Soil Map

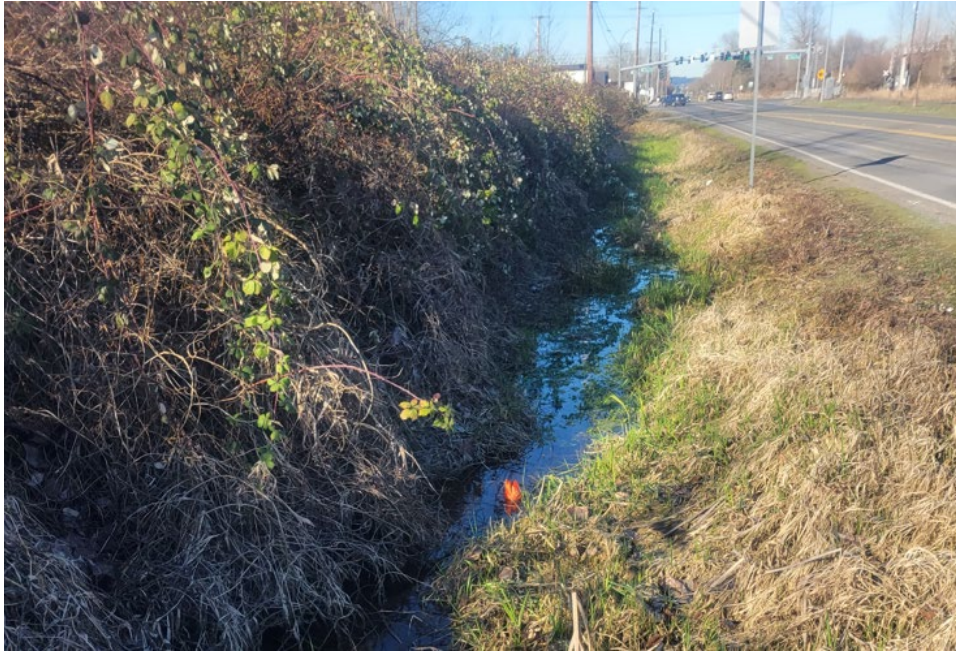
Typical degraded conditions of Stream Z within ROW of East Pioneer Avenue

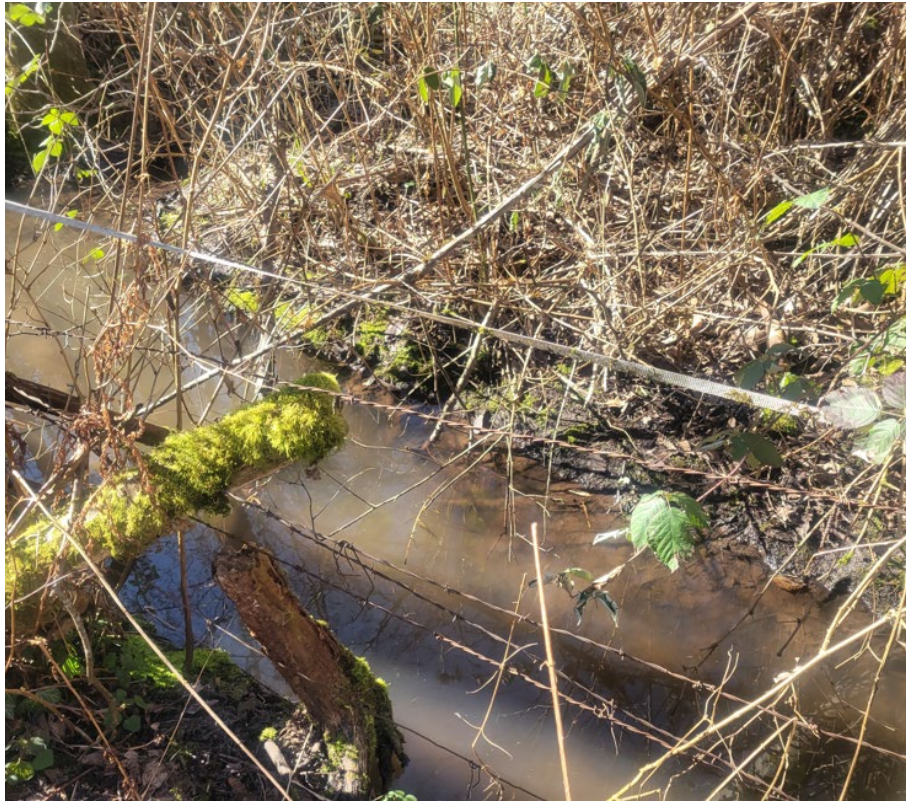
Typical conditions of Stream Y
