3rd Review
PRCCP20240569
Feb 2025

Stormwater Site Plan – Frontage Improvements

East Town Crossing
2902 E Pioneer
Puyallup, WA 98372
2230752.10

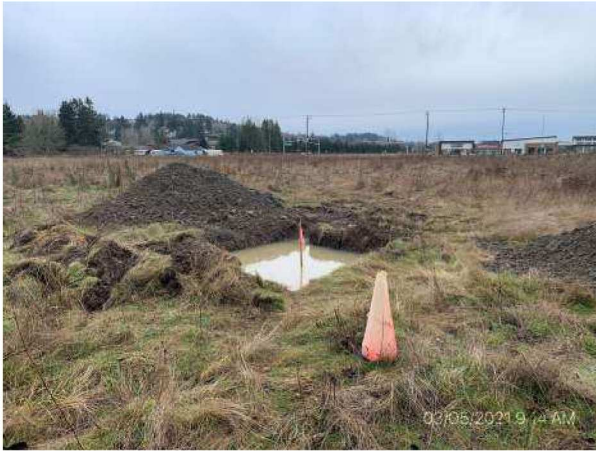
Water in Pit P-1 on March 5, 2021.

Two (2) test pits, designated P-1 and P-2, were excavated near Monitoring Wells MW-1 and MW-2, respectively, on March 4, 2021 at the approximate locations indicated on the Site Plan, Figure 1, in order to conduct large-scale infiltration tests in accordance with the 2014 Stormwater Management Manual for Western Washington (SWMWW). The infiltration test locations were selected in the field by the client and excavated using a client provided excavator and operator. The bottom of each pit was excavated 10-feet wide by 10-feet long, which met the minimum required horizontal surface area of 100 square feet (sf). Each test pit was initially excavated to a depth of 2 feet below the existing ground surface (bgs), which exposed silty sand (SM) soils at the pit bottom. Water was observed seeping from the sides of pit P-1 during excavation, and was observed ponded at the ground surface at several locations in the vicinity of pit P-1. Test pits P-1 and P-2 encountered undocumented fill to a depth of 1.8 feet and 0.5 feet bgs, respectively, followed by native brown silty sand (SM) with trace gravel and occasional sandy silt and sandy clay seams and layers to the bottom of the test pits. The soils exposed at the PIT test depth were similar to those encountered in the geotechnical borings conducted during our original exploration of the site.

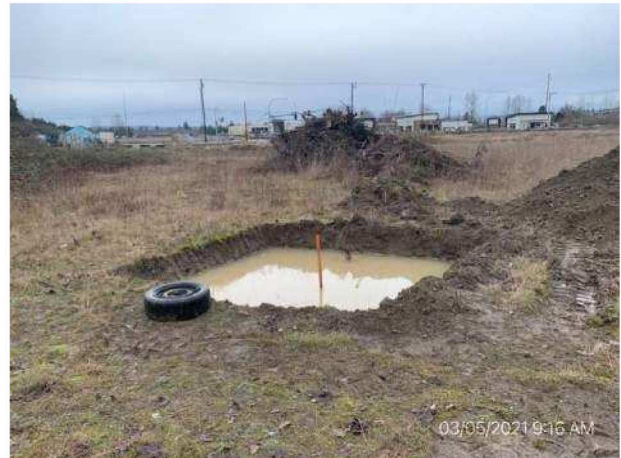
Water in Pit P-2 on March 5, 2021.

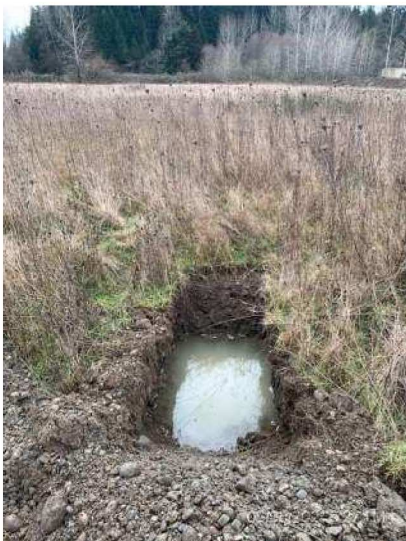
Figure 2 - Photos (March 5, 2021)

Water in Test Pit on March 5, 2021. Test pit was excavated in NE portion of site on March 4, 2021.

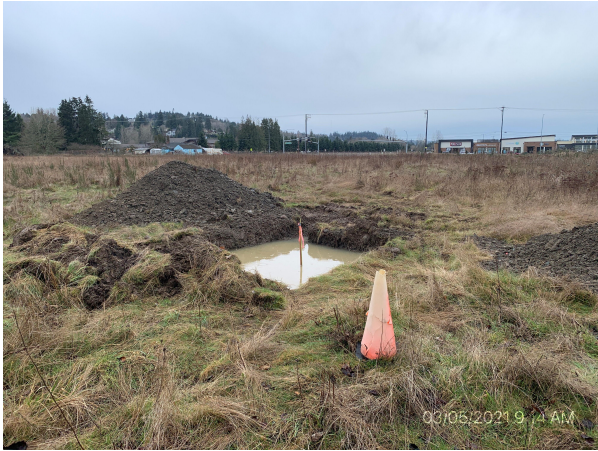
Water in Pit P-1 on March 5, 2021.

Two (2) test pits, designated P-1 and P-2, were excavated near Monitoring Wells MW-1 and MW-2, respectively, on March 4, 2021 at the approximate locations indicated on the Site Plan, Figure 1, in order to conduct large-scale infiltration tests in accordance with the 2014 Stormwater Management Manual for Western Washington (SWMWW). The infiltration test locations were selected in the field by the client and excavated using a client provided excavator and operator. The bottom of each pit was excavated 10-feet wide by 10-feet long, which met the minimum required horizontal surface area of 100 square feet (sf). Each test pit was initially excavated to a depth of 2 feet below the existing ground surface (bgs), which exposed silty sand (SM) soils at the pit bottom. Water was observed seeping from the sides of pit P-1 during excavation, and was observed ponded at the ground surface at several locations in the vicinity of pit P-1. Test pits P-1 and P-2 encountered undocumented fill to a depth of 1.8 feet and 0.5 feet bgs, respectively, followed by native brown silty sand (SM) with trace gravel and occasional sandy silt and sandy clay seams and layers to the bottom of the test pits. The soils exposed at the PIT test depth were similar to those encountered in the geotechnical borings conducted during our original exploration of the site.

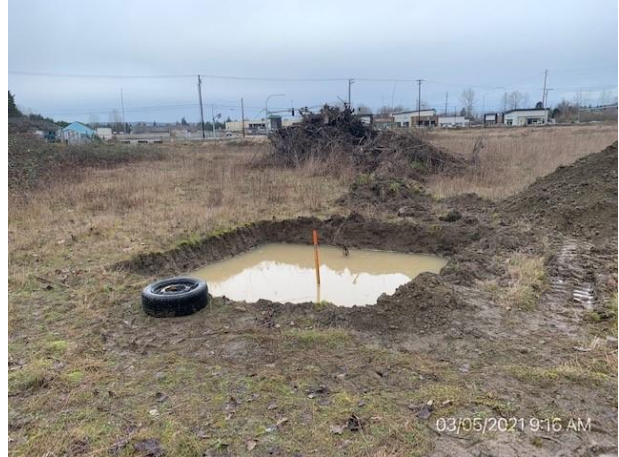
Water in Pit P-2 on March 5, 2021.

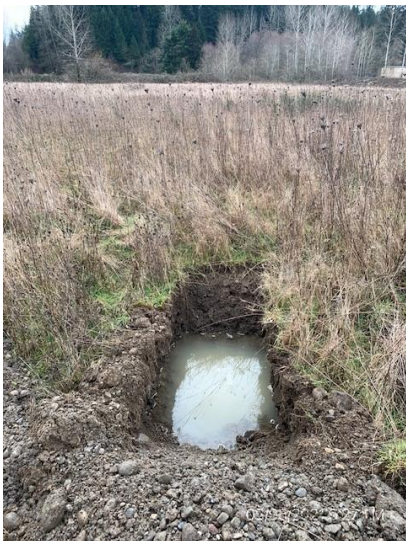
Figure 2 - Photos (March 5, 2021)

Water in Test Pit on March 5, 2021. Test pit was excavated in NE portion of site on March 4, 2021.

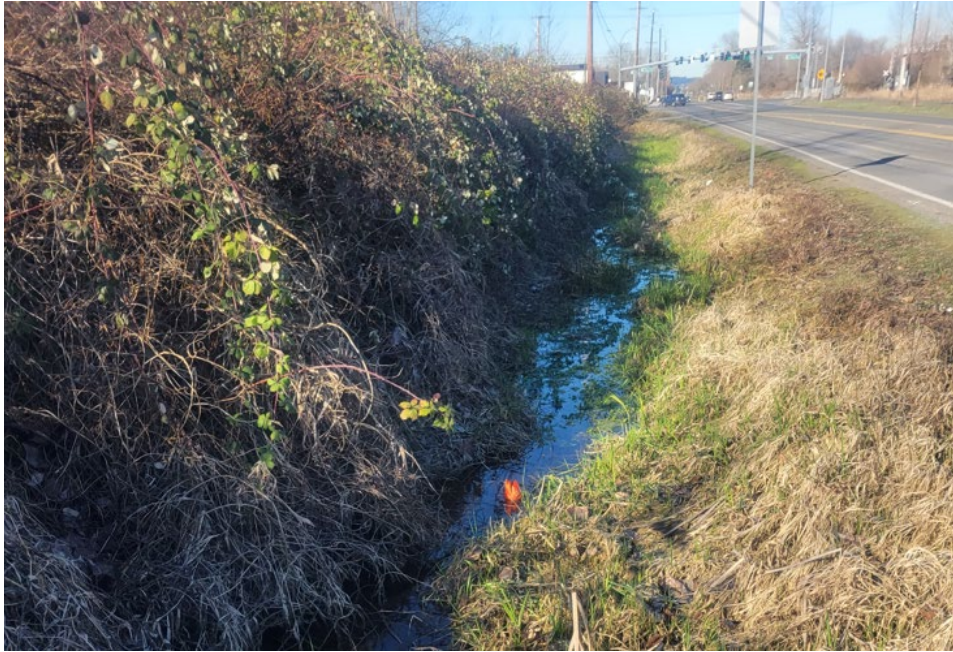
Typical degraded conditions of Stream Z within ROW of East Pioneer Avenue

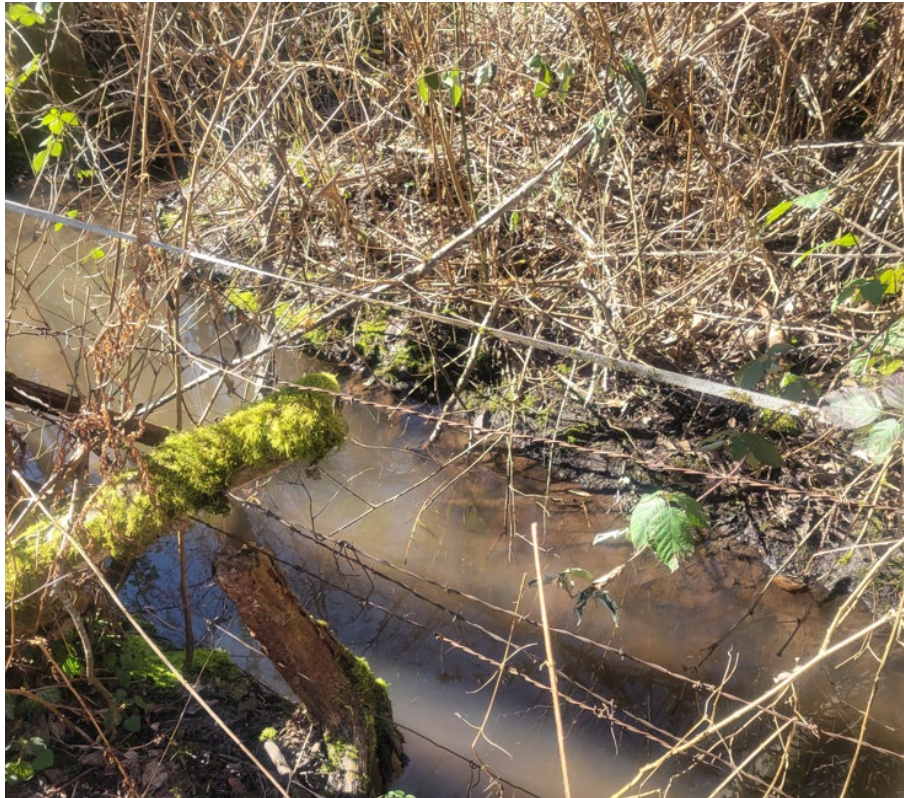
Typical conditions of Stream Y

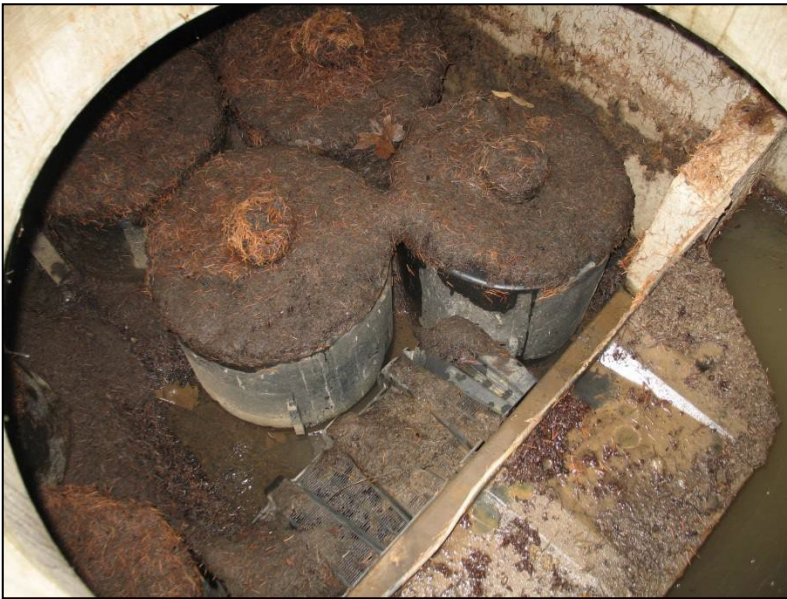
Media Cartridge Filter Vault with Accumulated Sediment

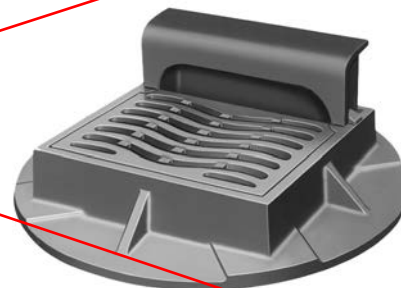
R-3161**Combination Inlet Frame, Grate, Curb Box**

| CATALOG NUMBER | GRATE TYPE | SQ. FT. OPEN | WEIR PERIMETER LINEAL FEET |
|---|---|---|---|
| R-3161 | S | 1.3 | 4.7 |

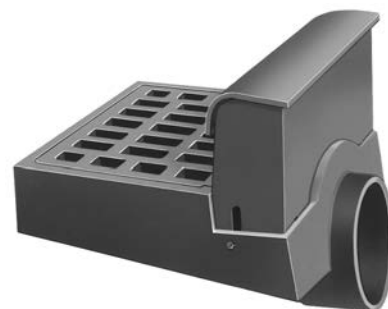
R-3165**Combination Inlet Frame, Grate, Curb Box**

Furnished standard with Ductile Iron grate.

For use where conditions do not permit catch basin under inlet.

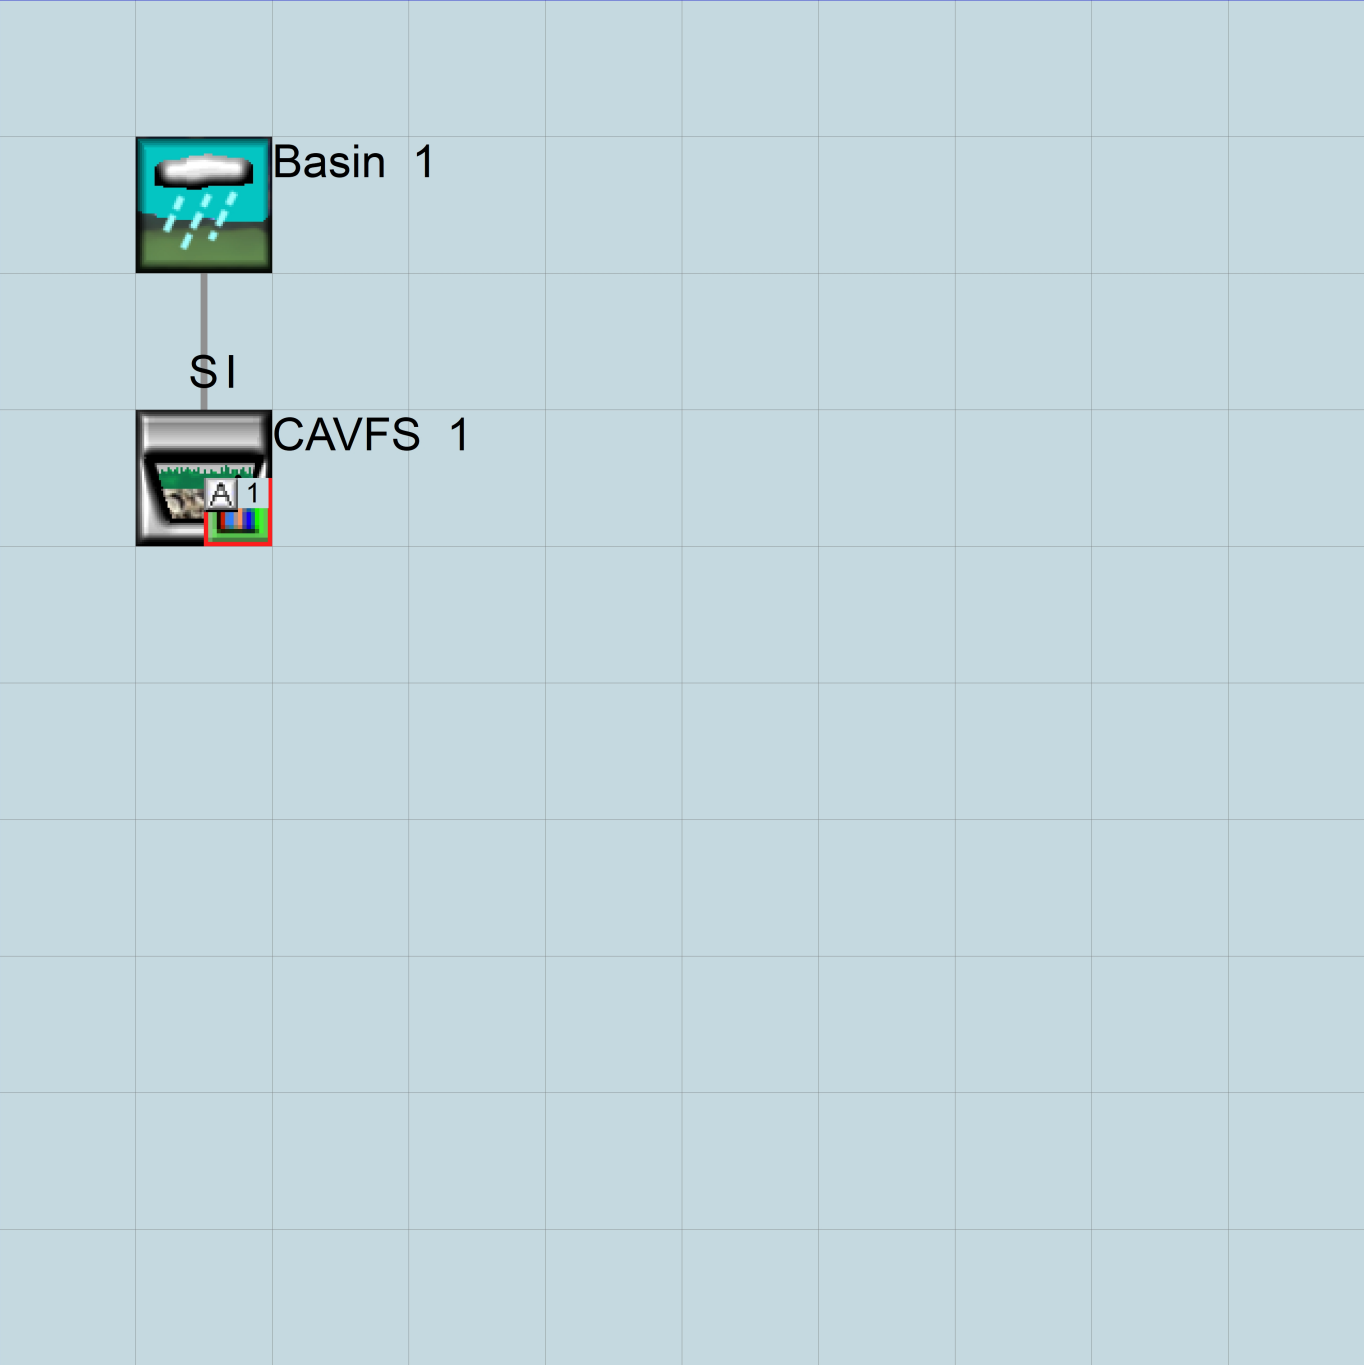
Mitigated Schematic
