May 24, 2019

Eagle Works LLC
2504 – 43rd Street East
Puyallup, WA 98374
rick@harvestrealtyinc.com

Soils Report: Infiltration Feasibility
Proposed Multi-Family Development
xxx – 5th Street Southeast
Puyallup, Washington
PN: 0419036002, -6003
Doc ID: EagleWorksLLC.5thStreetSE.SR

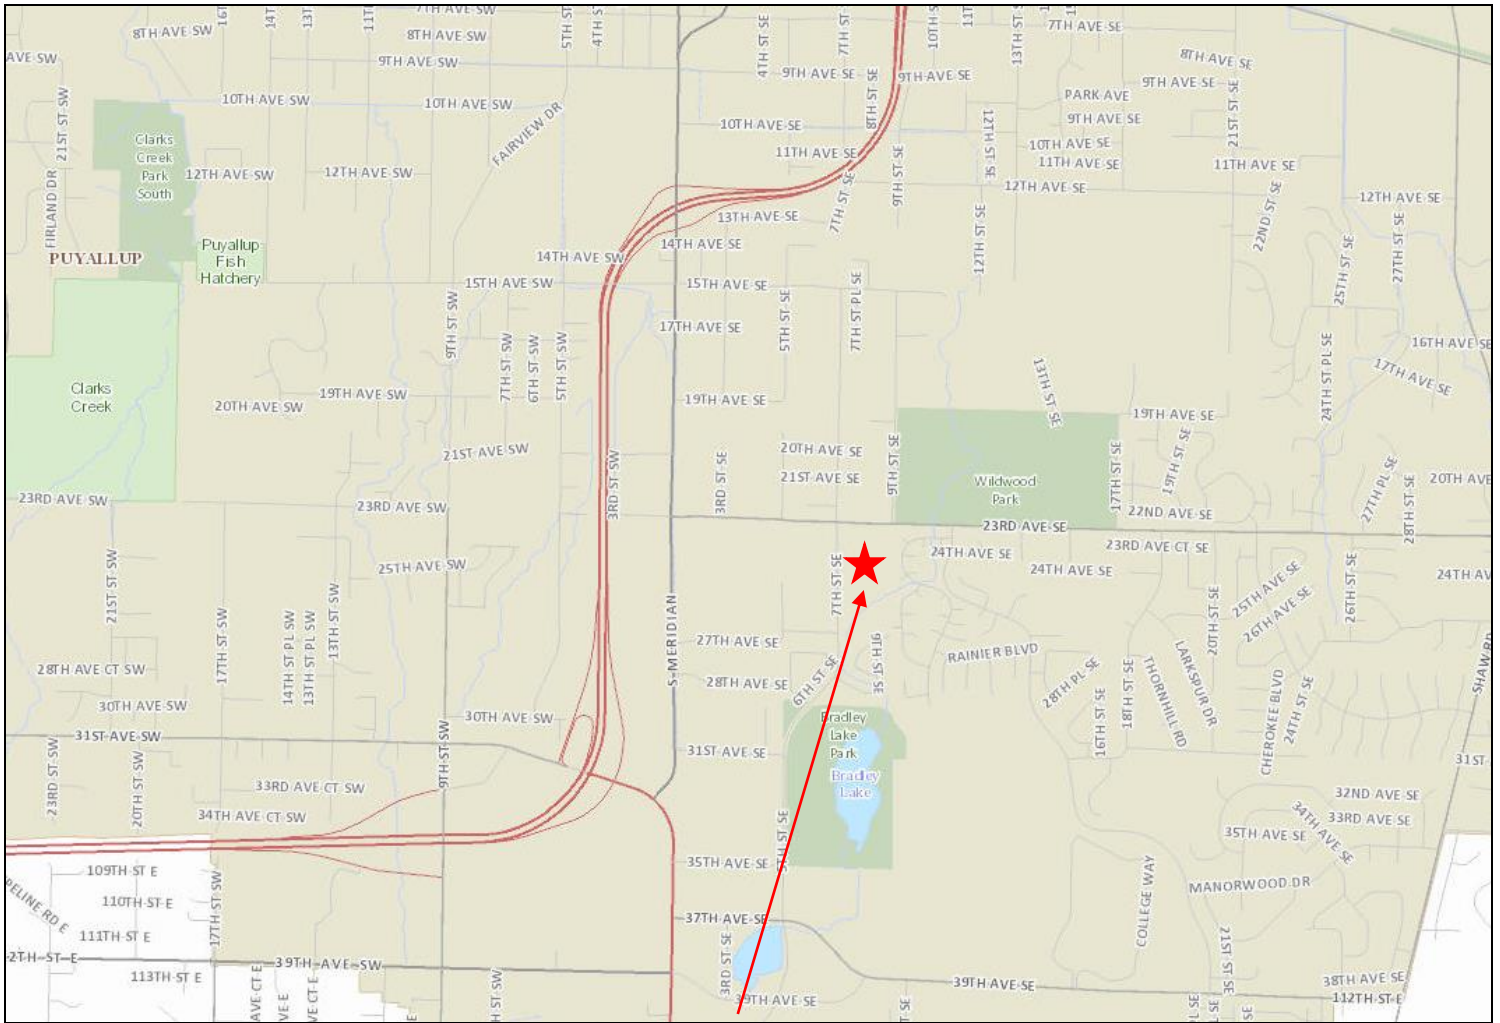
Approximate Site Location

Map created from Pierce County Public GIS (<https://matterhornwab.co.pierce.wa.us/publicgis/>)

This soils report addresses the feasibility of the site soils to support the infiltration of stormwater runoff generated by the proposed residential development to be constructed at xxx – 5th Street in the City of Puyallup located in Pierce County, Washington. The general site location is shown on the Site Location Map, Figure 1.

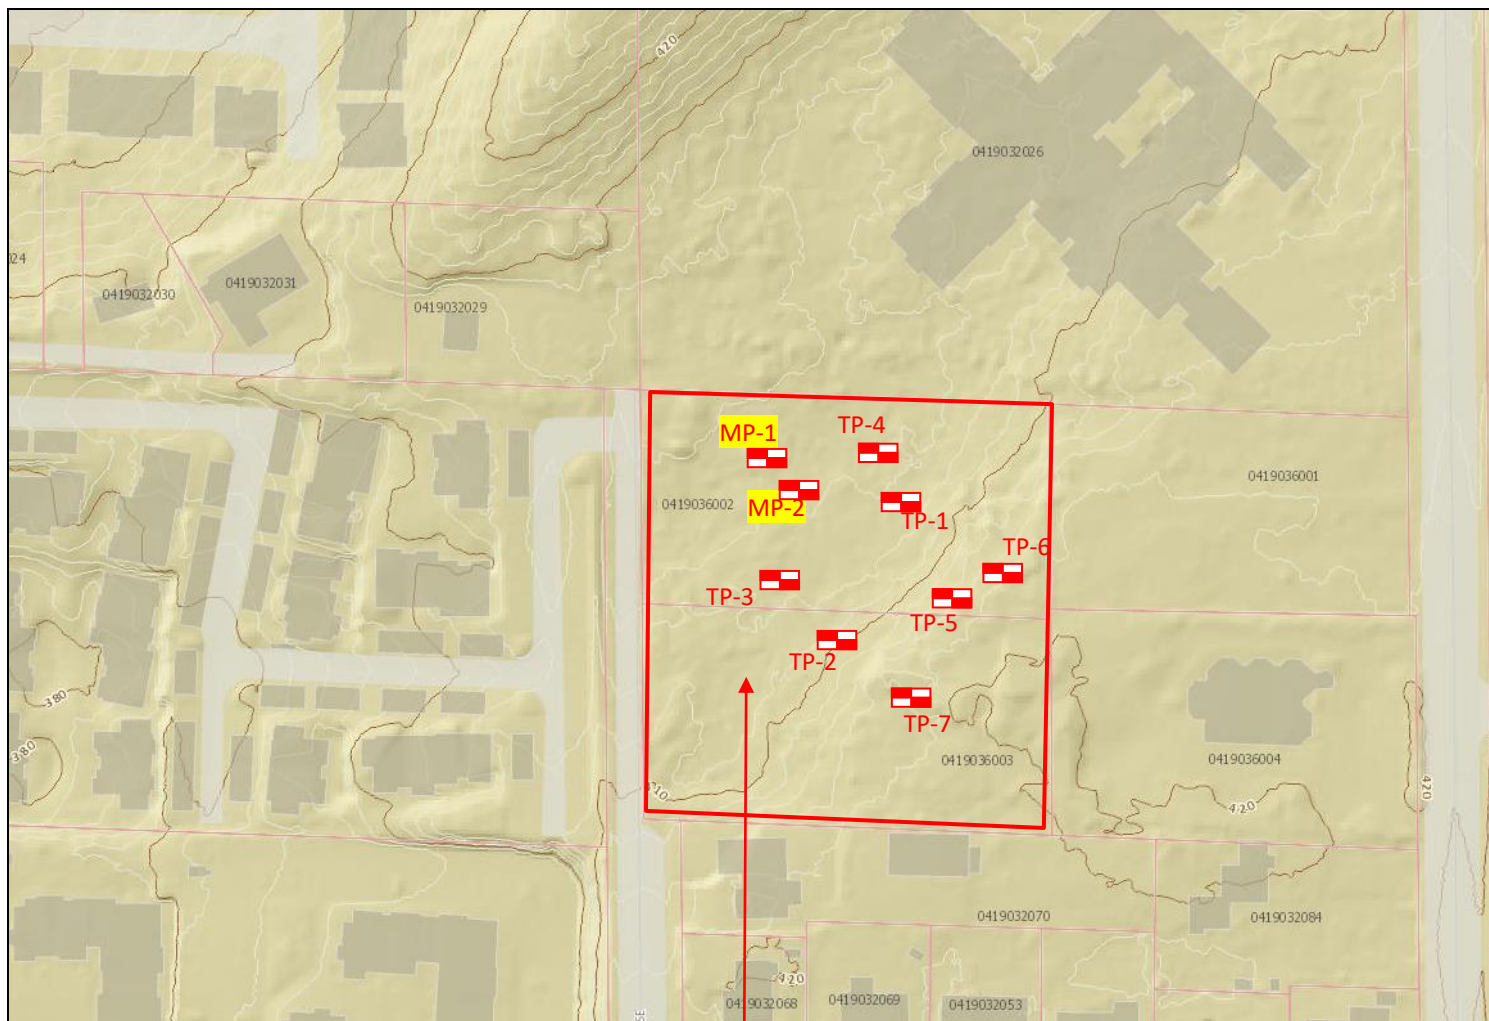
Site & Exploration Map

Approximate location and number of test pit

The site is located on the north margin of the Puyallup-South Hill glacial upland area. Based on information obtained from Pierce County PublicGIS and our site observations, the site slopes up towards the southeast, generally getting steeper towards the southeast portion. The northwest to southwest portion of the site is flat to gently sloping up towards the southeast at less than 3 percent. The slopes in the southeastern portion slope up at a steeper inclination of 10 to 14 percent before transitioning to about 4 to 6 percent in the southeastern corner. The total topographic relief across the parcel is on the order of about 15 feet. The existing site configuration and topography is shown on the Site and Exploration Map, Figure 2.

The approximate locations and numbers of our test pits are shown on the attached Site and Exploration Map, Figure 2. The soils encountered were visually classified in general accordance with the Unified Soil Classification System (USCS) and ASTM D: 2488. The USCS is included in Appendix A as Figure A-1, while the descriptive logs of our test pits are included as Figure A-2 through A-6.

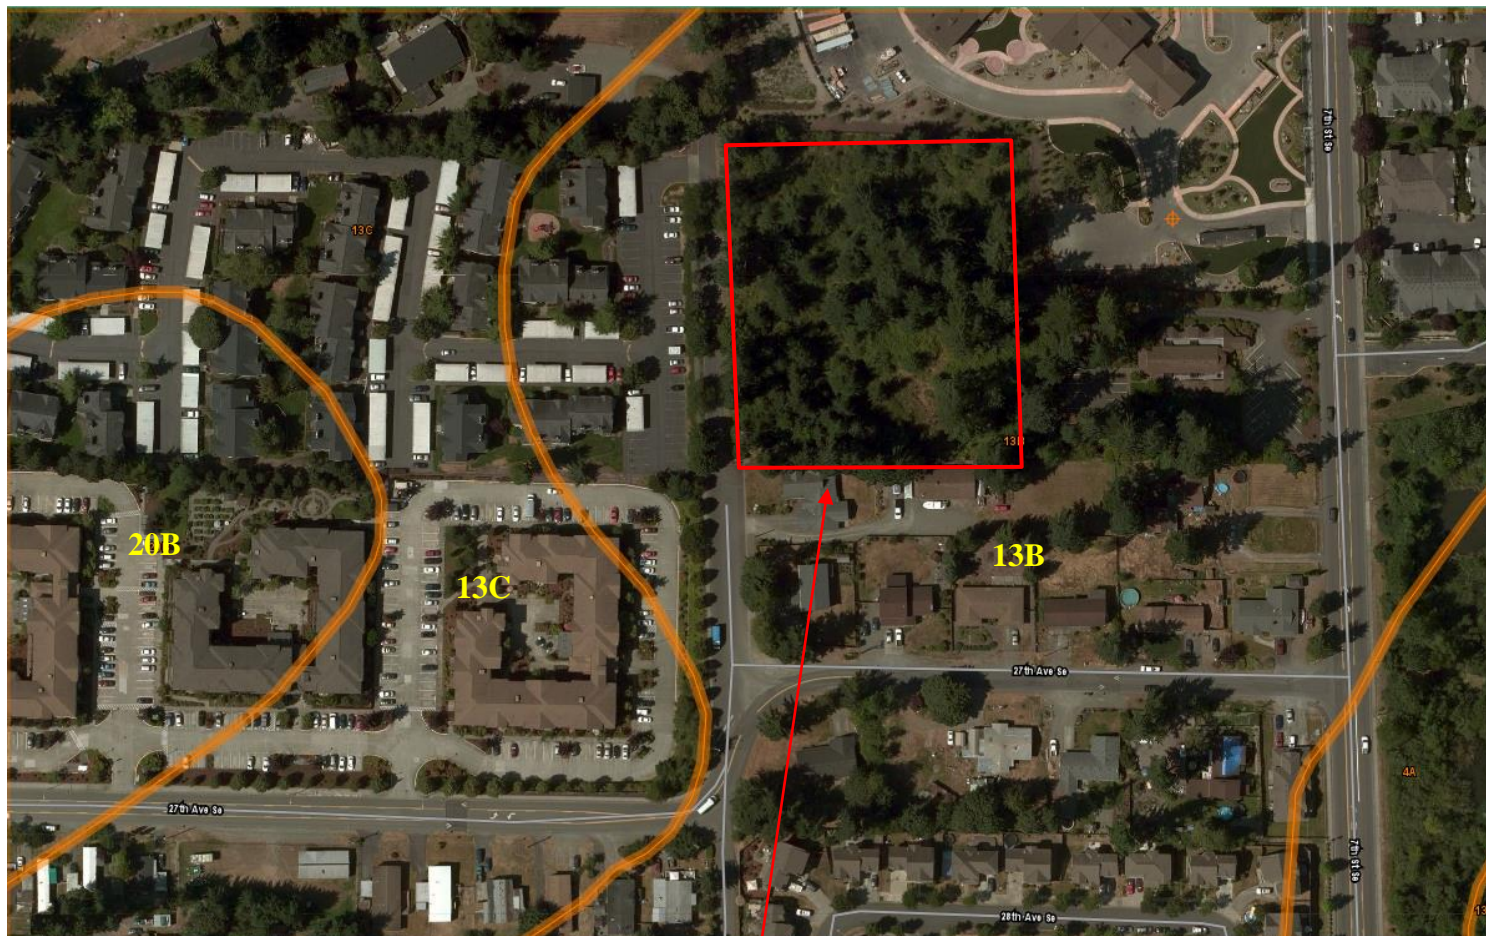
Soil Type	Soil Name	Parent Material	Slopes (%)	Erosion Hazard	Hydrologic Soils Group
13B	Everett very gravelly sandy loam	Sandy and gravelly glacial outwash	0 to 8	Slight	A
13C			8 to 15	Slight to Moderate	
20B	Kitsap silt loam	Glaciolacustrine deposits	2 to 8	Slight	C/D

The USDA Natural Resource Conservation Service (NRCS) Web Soil Survey maps the site and surrounding areas as being underlain by Everett very gravelly sandy loam (13B) soils. The Everett soils are derived from sandy and gravelly glacial outwash and are included in hydrologic soils group A. The 13B soil type forms on slopes of 0 to 8 percent and have a “slight” erosion hazard when exposed. Our subsurface explorations generally confirm the NRCS map for the site. A copy of the NRCS Soil Survey Map for the site and surrounding area is included as Figure 3.

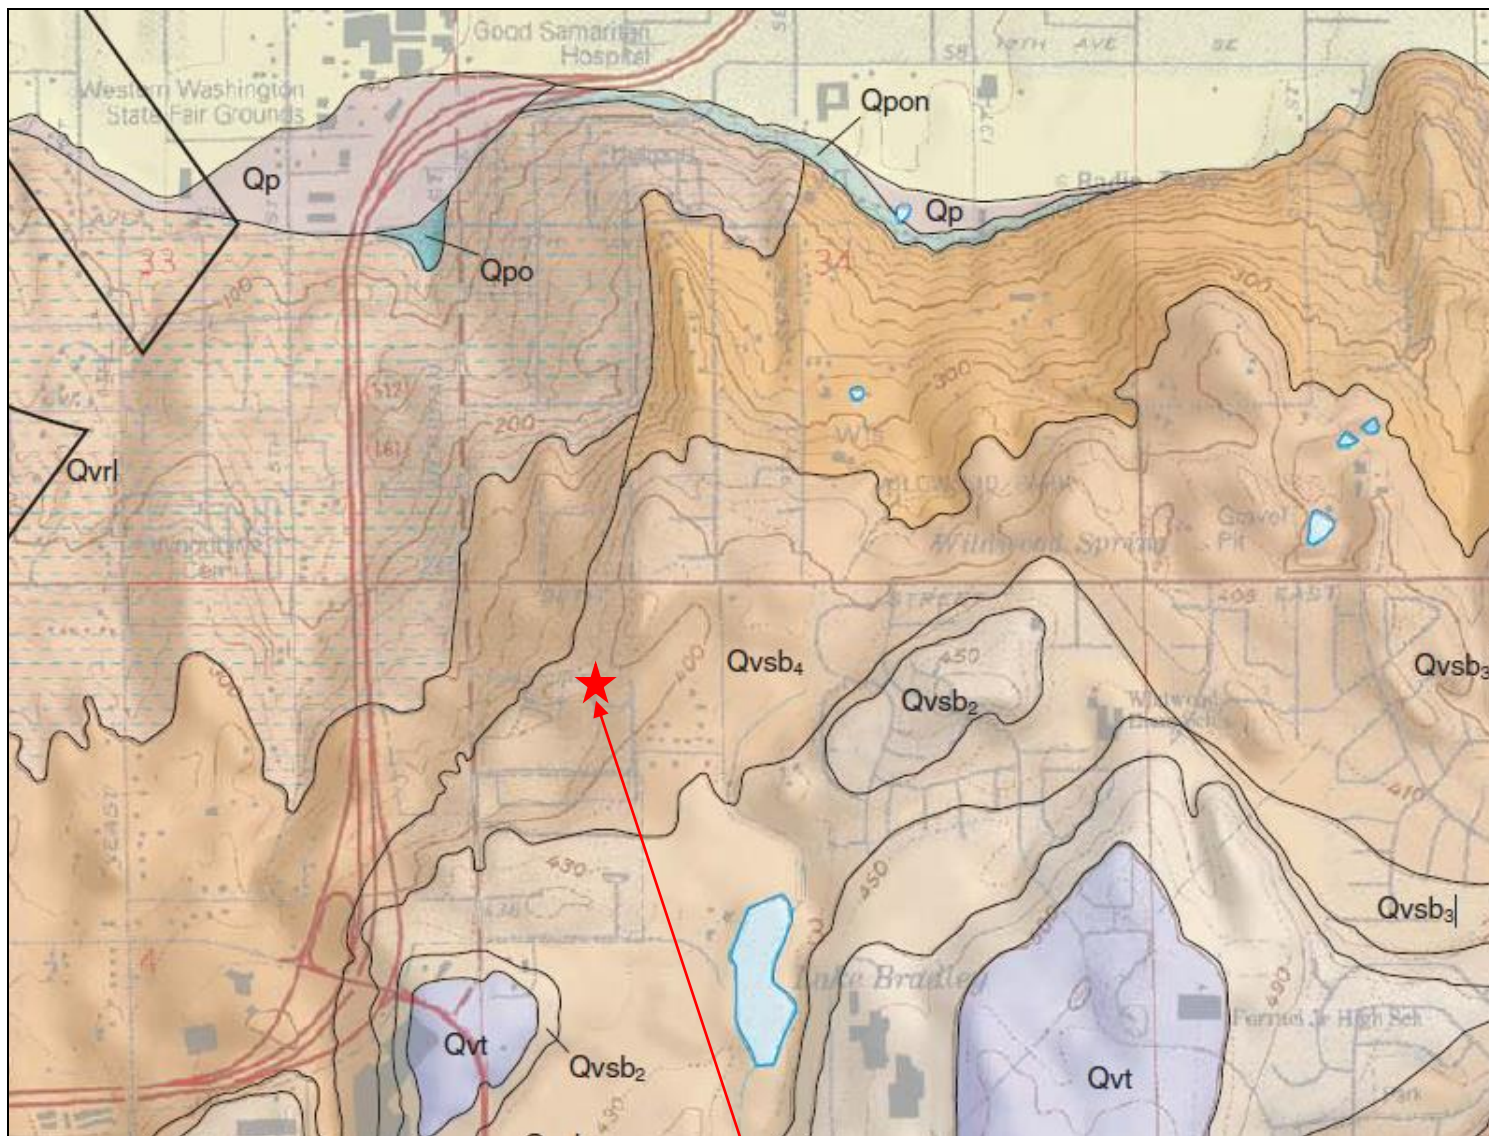
USGS Geologic Map

An excerpt from the draft *Geologic Map of the Puyallup 7.5-minute Quadrangle, Washington*, by Troost, K.G.

Qvsb ₄	Steilacoom Gravel – Bradley Channel
Qvsb ₃	Steilacoom Gravel – Bradley Channel
Qvsb ₂	Steilacoom Gravel – Bradley Channel
Qvt	Vashon glacial till

The draft *Geologic Map of the Puyallup 7.5-Minute Quadrangle, Washington* (Troost et Al.) maps the site as being underlain by recessional outwash (Qvsb₄). These glacial outwash soils were generally deposited during the Vashon stage of the Fraser Glaciation, some 12,000 to 15,000 years ago. The recessional deposits typically consist of a poorly-sorted, lightly-stratified mixture of sand and gravel that may locally contain silt and clay that were deposited by meltwater streams issuing from the retreating ice mass. The Qvsb₄ deposits are part of the Bradley Channel, a subunit of Steilacoom gravel, outwash flood channel deposits. The recessional outwash is considered to be normally consolidated and generally exhibits moderate strength and compressibility characteristics where undisturbed. An excerpt of the above referenced geologic map is included as Figure 4.

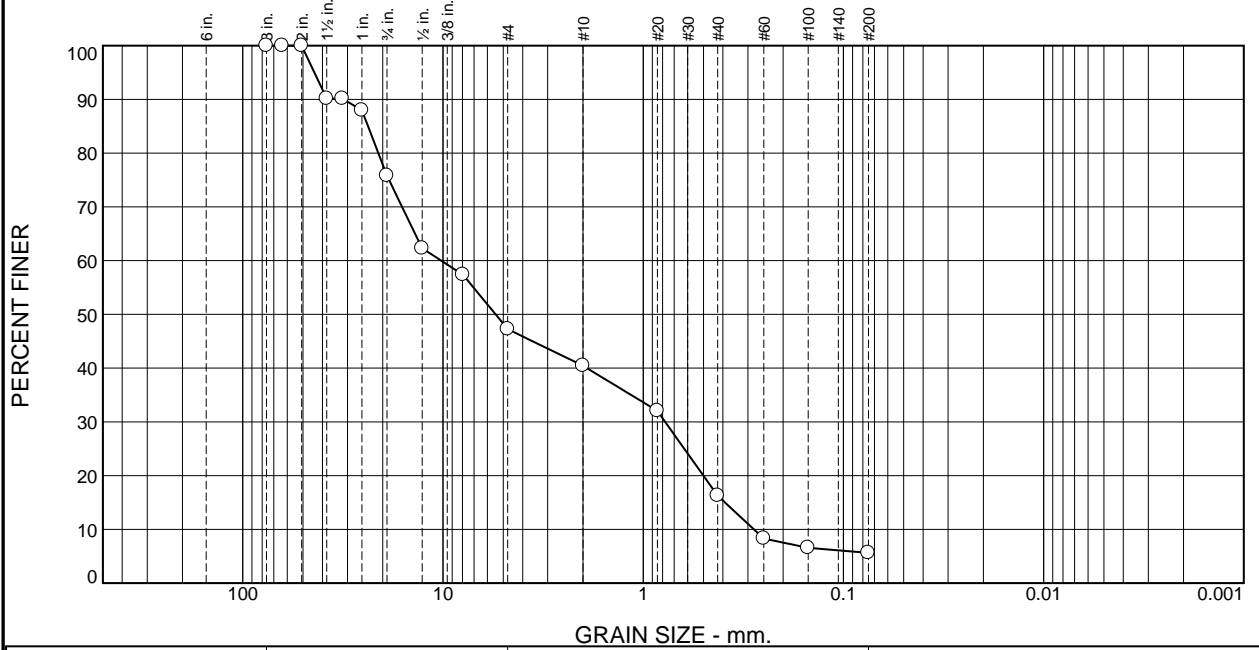
Particle Size Distribution Report

% +3"	% Gravel		% Sand			% Fines	
	Coarse	Fine	Coarse	Medium	Fine	Silt	Clay
0.0	24.2	28.5	6.9	24.1	10.7	5.6

Test Results (ASTM D 422 & ASTM C 117)			
Opening Size	Percent Finer	Spec.* (Percent)	Pass? (X=Fail)
3.0	100.0	100.0 75.0 - 100.0	
2.5	100.0		
2.0	100.0		
1.5	90.1		
1.25	90.1		
1	88.0	22.0 - 100.0	
.75	75.8		
.5	62.3		
.3125	57.4		
#4	47.3		
#10	40.4		
#20	32.0		
#40	16.3		
#60	8.3		
#100	6.6		
#200	5.6	0.0 - 10.0

USCS (D 2487)= GP-GM AASHTO (M 145)= A-1-a

D₉₀= 31.2741 D₈₅= 23.6789 D₆₀= 10.2112
D₅₀= 5.4615 D₃₀= 0.7768 D₁₅= 0.3905
D₁₀= 0.2801 C_u= 36.46 C_c= 0.21

Location: GW Monitoring Port MP-1/S-1
Sample Number: 097147 Depth: 3'-4'

Based on our grain size analysis and in accordance with the 2012 SWMMWW, we recommend a long-term design infiltration rate of 7 inches per hour be used to design infiltration facilities in the upper gravelly soils where infiltration is feasible. Appropriate correction factors for test method and plugging have been applied to these values, but the project civil engineer should include a correction factor for geometry.

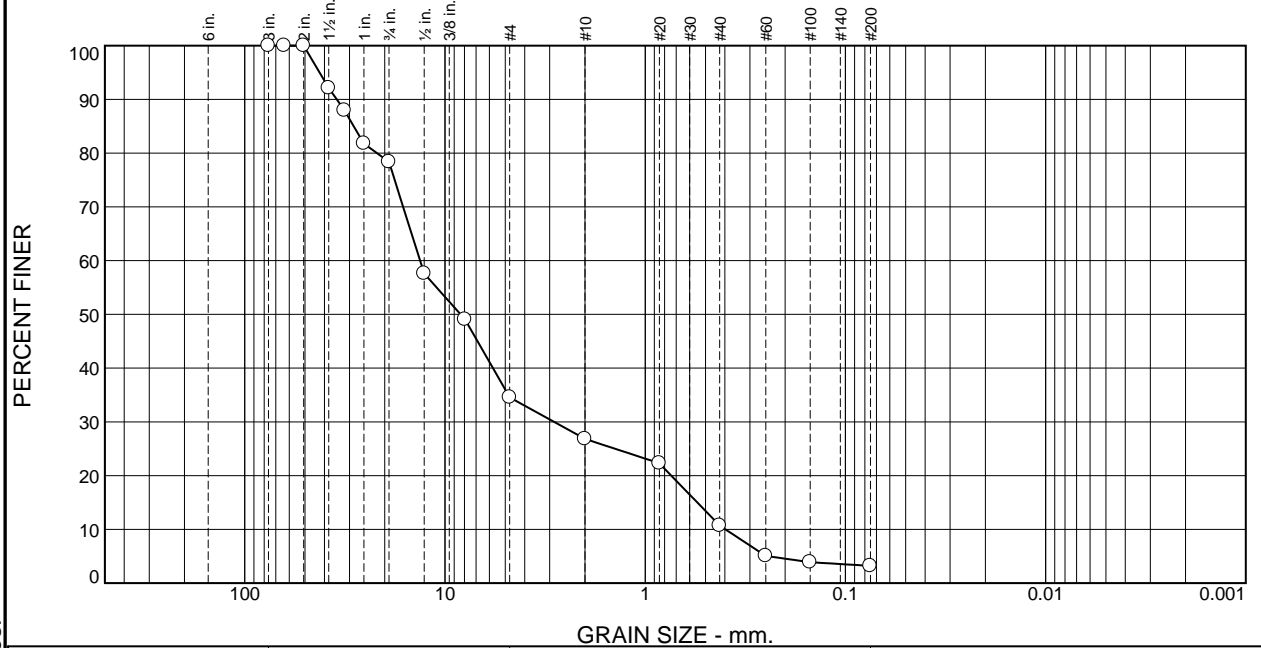
Particle Size Distribution Report

% +3"	% Gravel		% Sand			% Fines	
	Coarse	Fine	Coarse	Medium	Fine	Silt	Clay
0.0	21.6	43.9	7.7	16.1	7.5	3.2

Test Results (ASTM D 422 & ASTM C 117)			
Opening Size	Percent Finer	Spec.* (Percent)	Pass? (X=Fail)
3.0	100.0	100.0 75.0 - 100.0	
2.5	100.0		
2.0	100.0		
1.5	92.1		
1.25	87.9		
1	81.8	22.0 - 100.0	
.75	78.4		
.5	57.6		
.3125	49.1		
#4	34.5		
#10	26.8		
#20	22.3		
#40	10.7		
#60	5.1		
#100	3.9		
#200	3.2	0.0 - 10.0
