DRAINAGE REPORT AND STORMWATER POLLUTION PREVENTION PLAN

2401 INTER

**PUYALLUP, WASHINGTON
PARCEL NO. 2105200150**

ENGINEER:
MCINNIS ENGINEERING
202 E 34th St. Tacoma, WA
CONTACT: WILL MCINNIS
(253) 414-1992

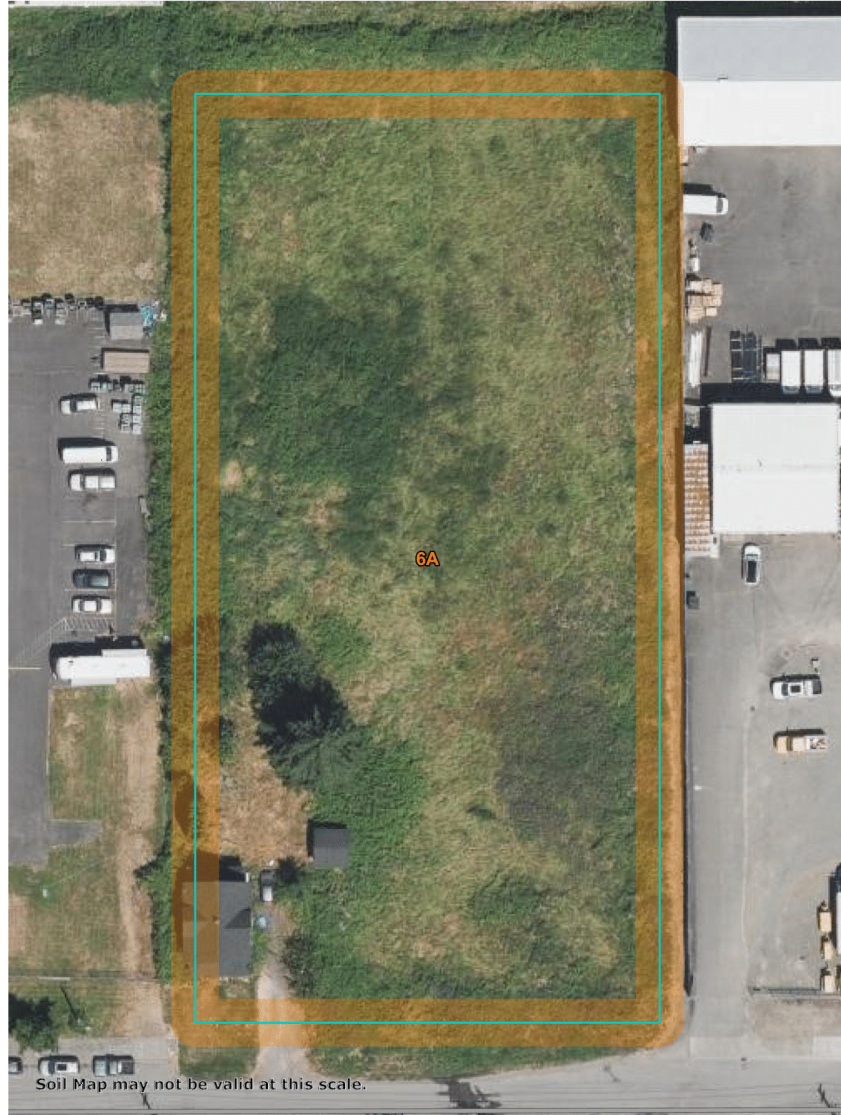
Figure 2: Site Soils

6A = BRISCOT LOAM

The USDA National Resource Conservation Service (NRCS) Web Soil Survey maps the proposed project as consisting of 100% Briscot loam (6A). According to the geotechnical report, the soil infiltrates at 0.35 in/hr, however, the groundwater was very high and therefore storm water will not be infiltrated but stored in a Stormtech Chamber and drain to the swale at the north end of the property. (see Figure 2 in Appendix A)
