Stormwater Soils Report: Infiltration Feasibility
Proposed Permeable Pavement
2511 Inter Avenue
Puyallup, Washington
PN: 2105200-180, -192
Doc ID: CES.ProVac.InterAve.SR

Site Location Map

Site & Exploration Plan

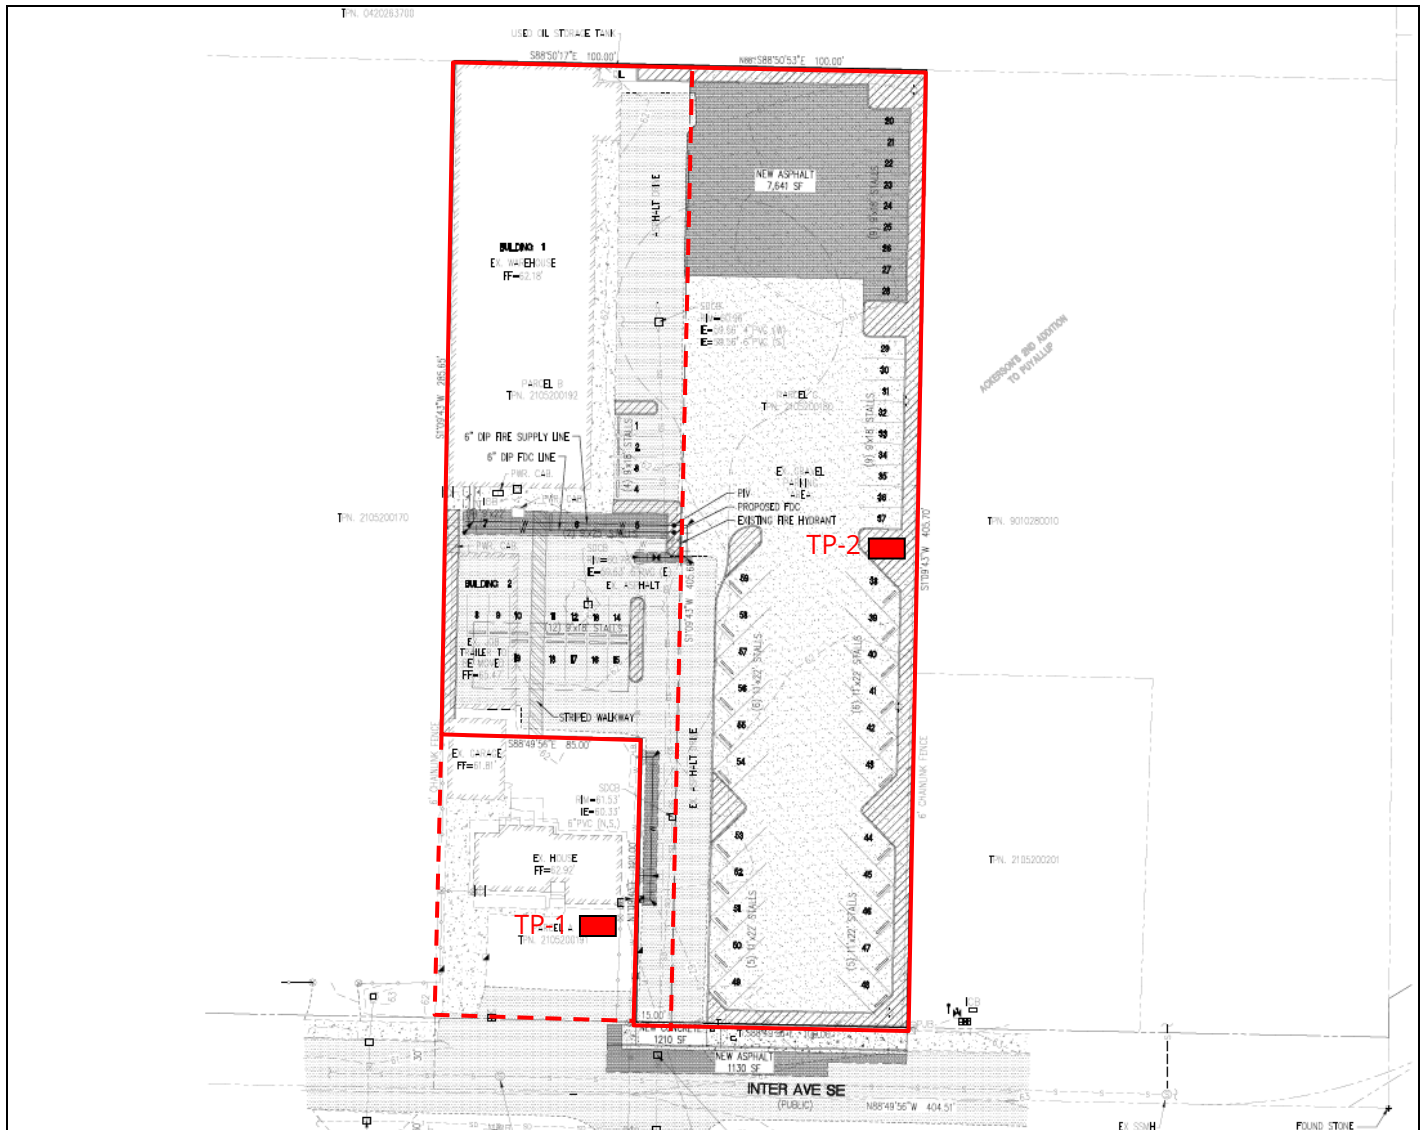
Figure 2

- Approximate test pit and piezometer location
- Approximate site boundary
- Approximate locations of property lines

The approximate locations and numbers of our explorations are shown on the attached Site & Exploration Plan, Figure 2. The soils encountered were visually classified in accordance with the Unified Soil Classification System (USCS) and ASTM D2488. The USCS is included in Appendix A as Figure A-1, while the descriptive logs of our explorations are included as Figure A-2.

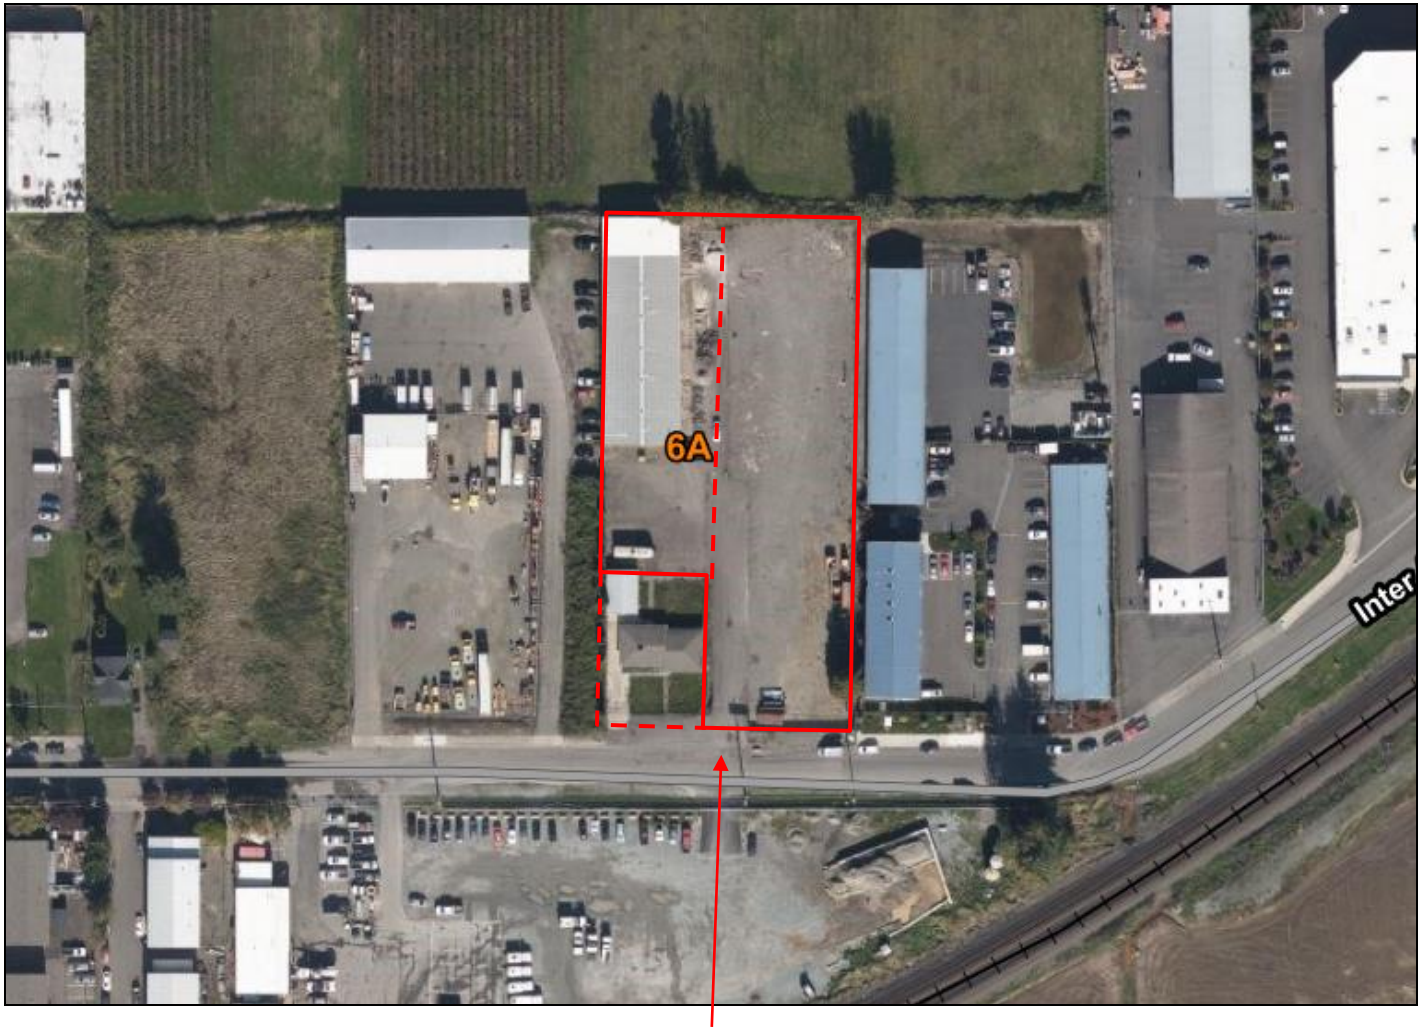
Figure 3

Soil Type	Soil Name	Parent Material	Slopes	Erosion Hazard	Hydrologic Soils Group
6A	Briscot silt loam	Alluvium	0 to 2	Slight	B/D

NRCS Soils Map

The USDA Natural Resources Conservation Service (NRCS) Web Soil Survey maps the site as being underlain by Briscot silt loam (6A) soils. A copy of the NRCS soils map for the site area is included as Figure 3.

- Briscot silt loam (6A): The Briscot soils are derived from alluvium and are included in hydrologic soils group B/D. These soils typically form on slopes of 0 to 2 percent and are listed as having a “slight” erosion hazard when exposed.

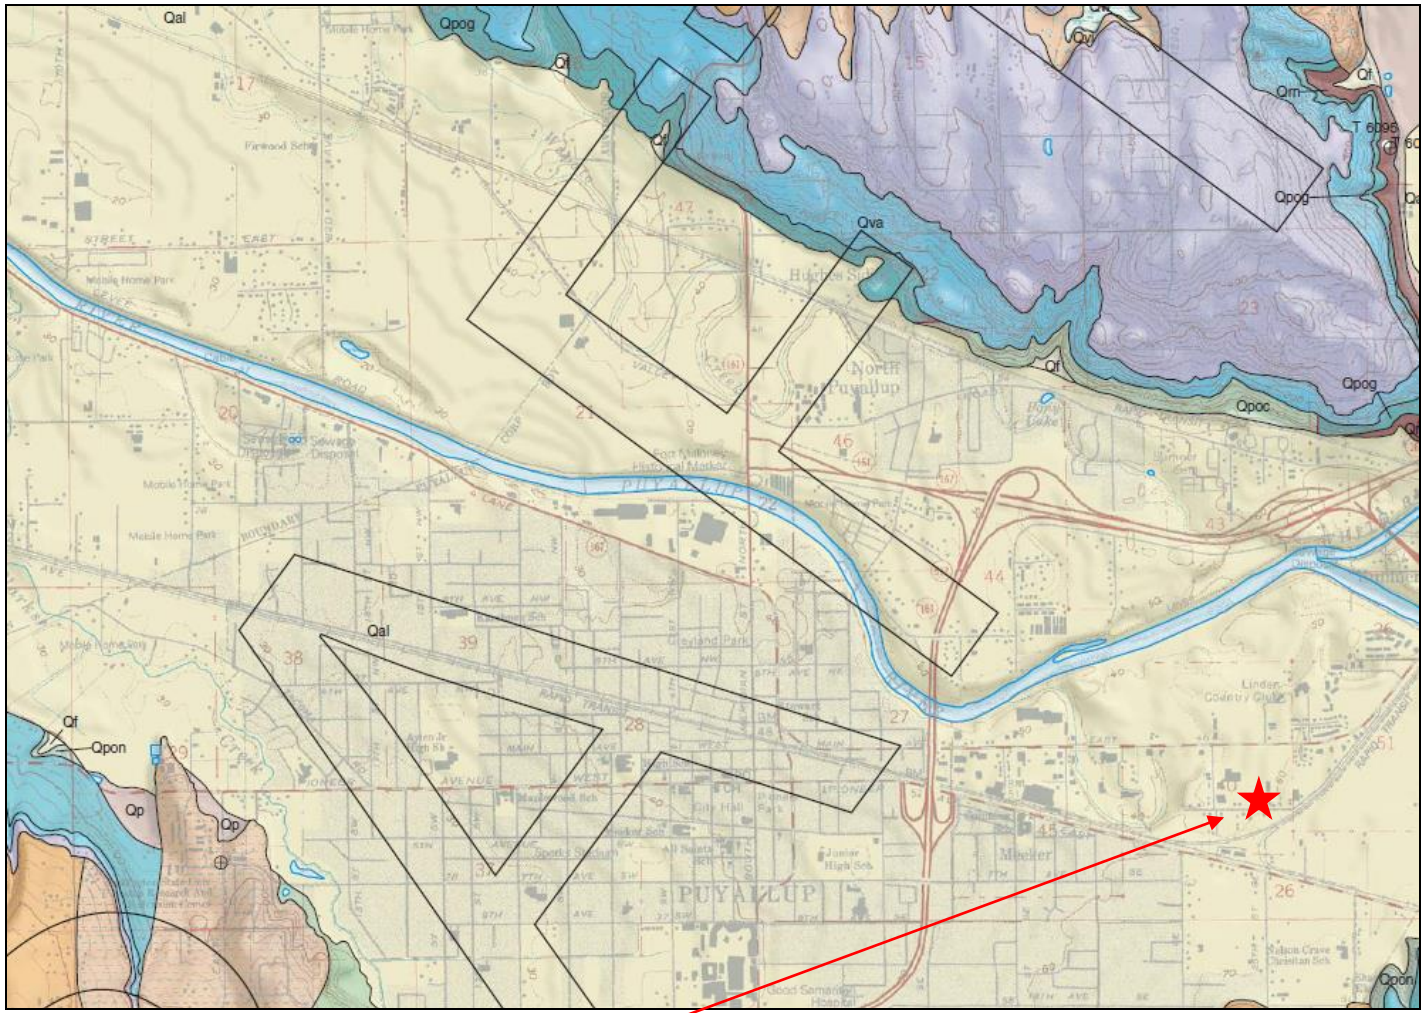
USGS Geologic Map

An excerpt from the draft *Geologic Map of the Puyallup 7.5-minute Quadrangle, Washington*, by K.G. Troost (in review)

Qal	Alluvium
-----	----------

The draft *Geologic Map of the Puyallup 7.5-minute Quadrangle, Washington* by K.G. Troost maps the site as being underlain by alluvium (Qal). An excerpt of the above referenced geologic map is included as Figure 4.

- Alluvium (Qal): Alluvial soils generally consist of normally consolidated, stratified deposits of sand, silt, clay, and occasional peat that were deposited along the Puyallup River channel. The existing topography, as well as the surficial and shallow soils in the area, are the result of fluvial action, including down-cutting by the river, channel meandering and migration, and flood deposits. Alluvium typically offers unfavorable infiltration characteristics because of the silty nature of the soils.
